**UNMANNED AERIAL VEHICLE REMOTE SENSING TECHNOLOGY FOR
STRUCTURAL DAMAGE ASSESSMENTS IN LOW-LIGHT CONDITIONS**

A Dissertation

Submitted to the Faculty of Purdue University

August 2019

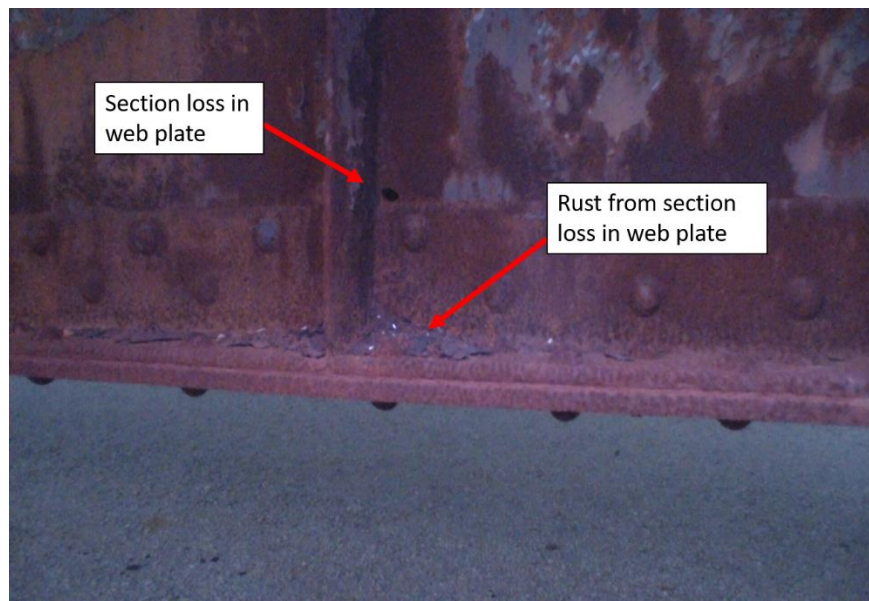
Figure 9 is captured from the RGB low-light camera. The 0.748 inches (19 mm) hole in the web plate is easily identified as are the rust chips. The RGB low-light camera image provides high resolution detail of the steel girder. The angle plate and rivets used to reinforce the joint between the web and flange are easily discerned. The level of oxidation of the steel girder is seen clearly in the image.

Figure 9: RGB low-light camera image of 0.748-inch (19 mm) hole in web steel girder span D234.

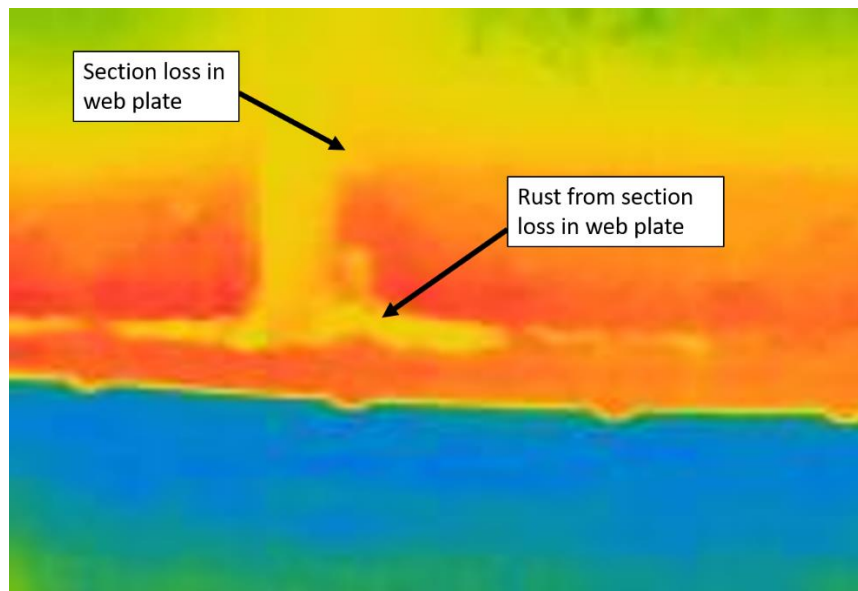
Figure 10 is a thermal image of the same section of NSR steel girder span D234 obtained using the RGB low-light camera. The thermal imaging color pallet used in Figure 10 is rainbow. In the rainbow thermal image, the rust chip is easily identified but the section loss in the web plate is more difficult to identify. This may be due to the angle

the image was captured. The angle plate and rivets used to reinforce joint between the web and flange are identifiable. The areas of oxidation appear yellow (i.e. hotter) and areas less oxidized appear green (i.e. cooler).

Figure 10: Thermal image of 0.748 inch (19 mm) in web of NSR steel girder span D234 (rainbow pallet).

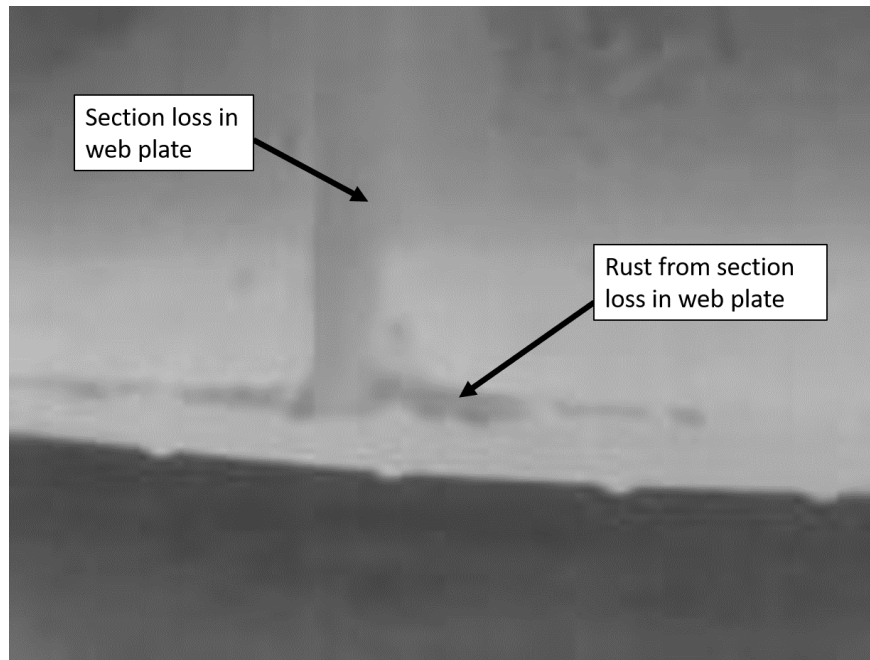
Figure 11 is a thermal image of the same section of NSR steel girder span D234 obtained using the RGB low-light camera and rainbow thermal imaging color pallet. The thermal imaging color pallet used in Figure 11 is white hot. This color pallet was chosen for a black and white representation of the steel girder. In the white-hot thermal image, the rust flakes are easily identified due to the rust flakes having a lower temperature than the steel girder. The section loss in the web plate is cannot be discerned at this angle from the rest of the web. The lack of discernibility may be a result to the resolution of the thermal camera and angle the images was obtained.

Figure 11: Thermal image of 0.748-inch hole in web of NSR steel girder span D234 (white hot pallet).

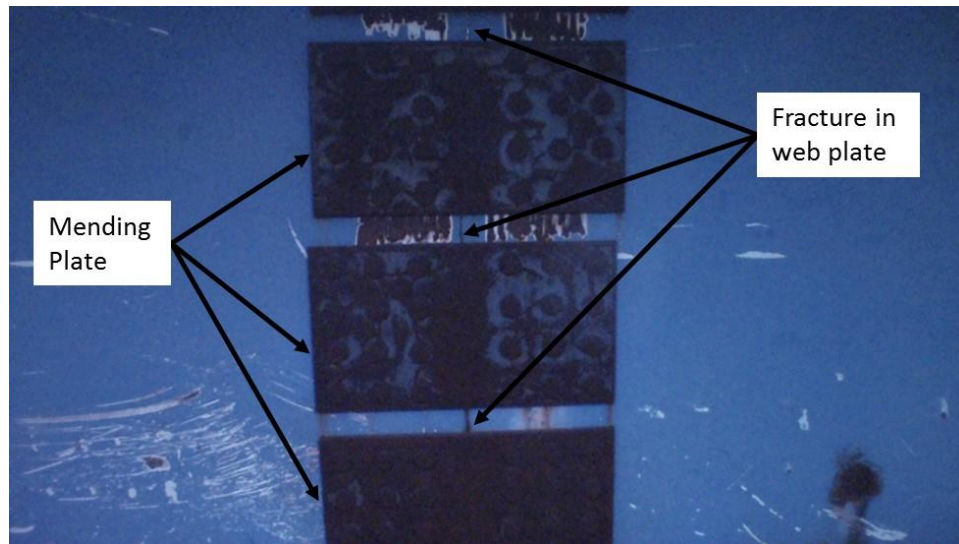
The image of the north bound girder, Figure 12 is captured using the RGB low-light camera. All three cracks; 0.039 inches (1 mm) wide between mending plates one and two, 0.079 inches (2 mm) between mending plates two and three, and 0.138 inches (3.5 mm) below mending plate three, in the web are easily identified as are the mending plates and bolts. The lowlight camera image provides additional details of abrasion in the lower left of the image that is evidence of the girder being struck by an object.

Figure 12: RGB low-light image of crack in web of Virginia Avenue bridge steel girder.

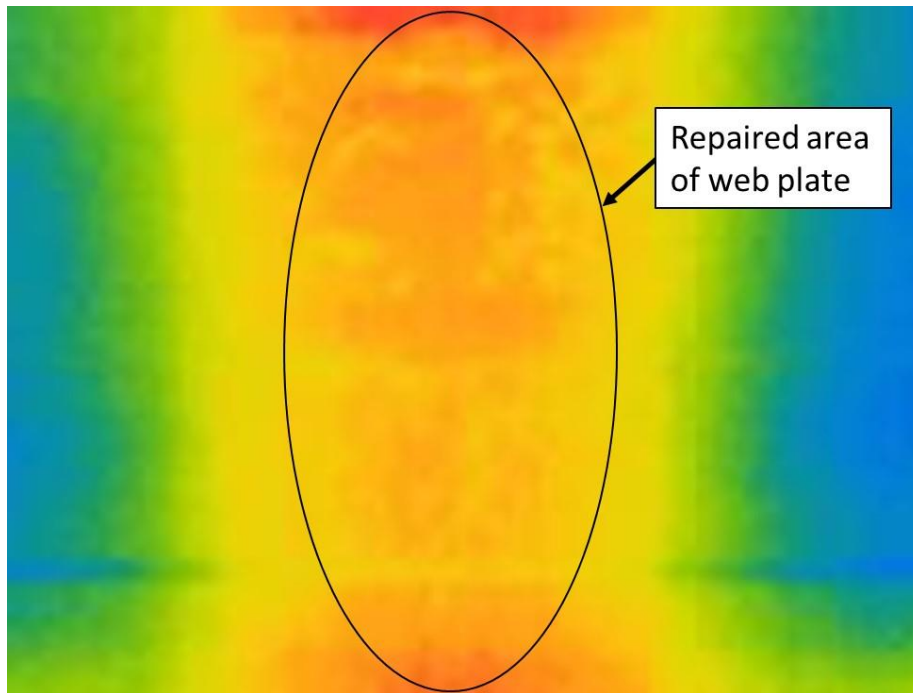
Figure 13 is a thermal image of the same section of Virginia Avenue Bridge's north bound steel girder obtained with the RGB low-light camera. The thermal imaging color pallet used in Figure 13 is rainbow. This color pallet was chosen due to the greater number of colors used to discern different temperatures of infrared heat emitted by the steel girder. In the rainbow thermal image, the repaired area is easily identified from the rest of the steel girder but the fracture in the web plate not distinguishable.

Figure 13: Thermal image of crack in web of Virginia Avenue steel girder (rainbow pallet).

Although the fracture in the web plate is not discernable, the area of damage is discernable. Note the cooler blue area to the left and right of the fracture area, these areas have a coating of gloss paint (lower emissivity) and the repaired area has rough steel mending plates (higher emissivity). Additionally, the larger crack, 0.138 inches (3.5 mm), below mending plate three is faintly noticeable. The image shows the painted area radiates energy less than the areas where there is no paint.

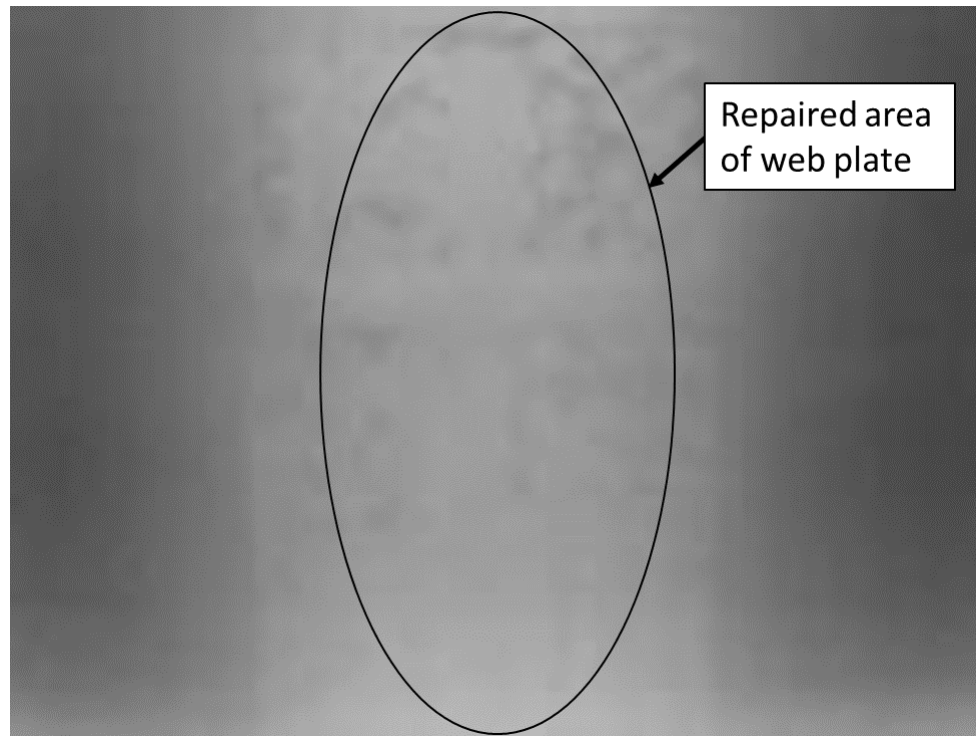
heat emitted by identifying high heat signatures with white and cooler areas with black. In the white-hot thermal image, the mending plates are easily identified along with most of the bolts but the fracture in the web plate is not discernable from the rest of the web.

Figure 14: Thermal image of crack in web of Virginia Avenue steel girder (white hot pallet)

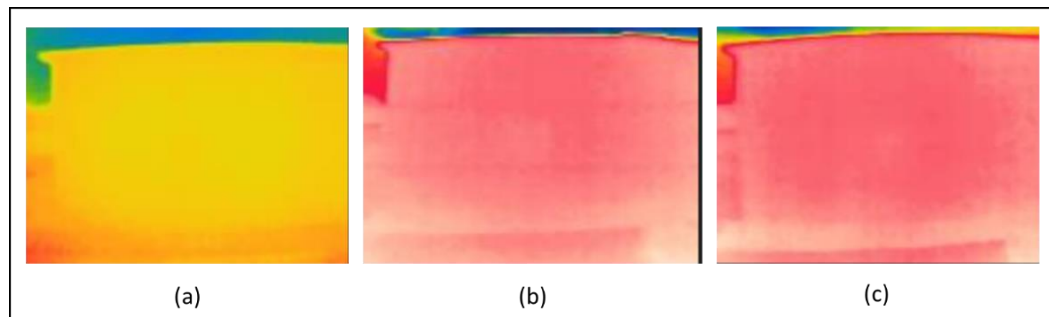
None of the damage or defects were observed in the thermal images (Figure 15). This is most likely due to the low temperature range of the day and only 4-degree Fahrenheit (2 Celsius) difference from the day's high at the time of the experiment. Figure 9 shows the lack of detail visible in the thermal images, where even the five-inch (12.7 cm) diameter hole is not visible.

Figure 15: Thermal camera images of Virginia Ave girder from 6 ft: (a) Nautical twilight; (b) Astronomical Twilight; (c) Night.

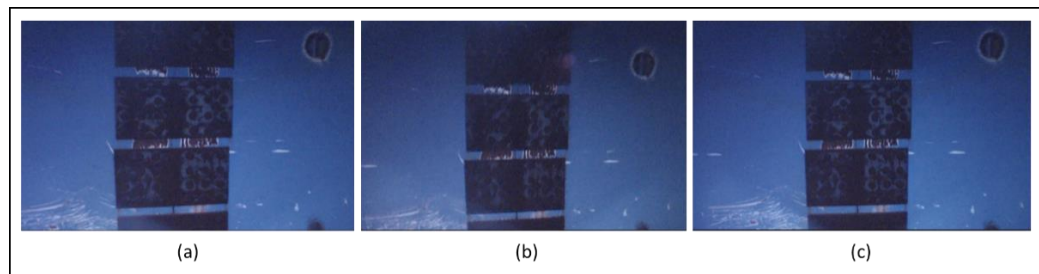
The RGB low-light camera images at a distance of four feet (1.219m) all three cracks measuring 0.039 inches (1 mm) wide between mending plates one and two, 0.079 inches (2 mm) between mending plates two and three, and 0.138 inches (3.5 mm) below mending plate three were visible in the images captured by the RGB low-light camera during nautical and astronomical twilight, and night. Additionally, the five-inch (12.7 cm) diameter hole in the upper right of the images is visible along with rust on the web and marks from where the girder had been struck (Figure 16).

Figure 16: Low-Light RGB camera images of Virginia Ave girder from 4 ft: (a) Nautical twilight; (b) Astronomical Twilight; (c) Night.

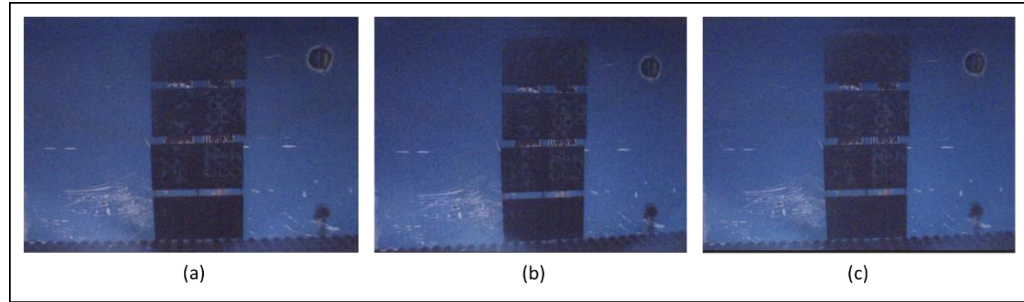
At six feet (1.829m) from the web only the two larger cracks measuring 0.079 inches (2 mm) between mending plates two and three, and 0.138 inches (3.5 mm) below mending plate three were visible during nautical and astronomical twilight. During night the only crack visible in the image at six feet (1.829 m) is the crack measuring 0.138 inches (3.5 mm) below mending plate three. Again, the five-inch (12.7 cm) diameter hole in the upper right of the images are still visible along with rust between the mending plates and the lower right on the web, as well as the white marks in the blue paint coating on web where the girder had been struck (Figure 17).

Figure 17: Low-Light RGB camera images of Virginia Ave girder from 6 ft: (a) Nautical twilight; (b) Astronomical Twilight; (c) Night.

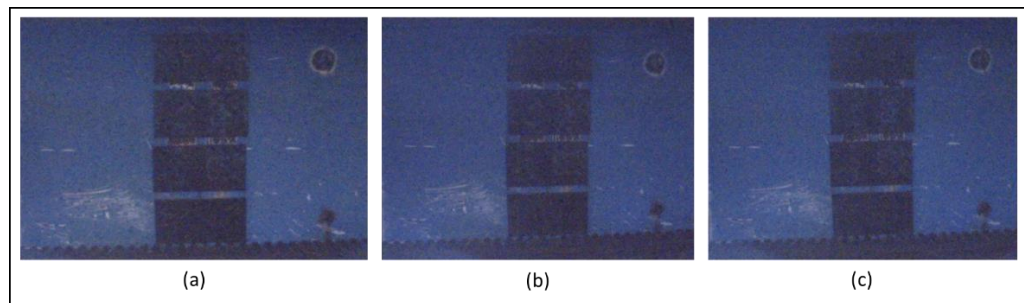
At eight feet (2.438m) only the crack measuring .138 inches (3.5 mm) below mending plate three were visible in the images captured during nautical and astronomical, and night. Again, the five-inch (12.7 cm) diameter hole in the upper right of the images are still visible along with rust between the mending plates and the on lower right of the web, as well as the white marks in the blue paint coating from where the girder had been struck (Figure 18).

Figure 18: Low-Light RGB camera images of Virginia Ave girder from 8 ft: (a) Nautical twilight; (b) Astronomical Twilight; (c) Night.

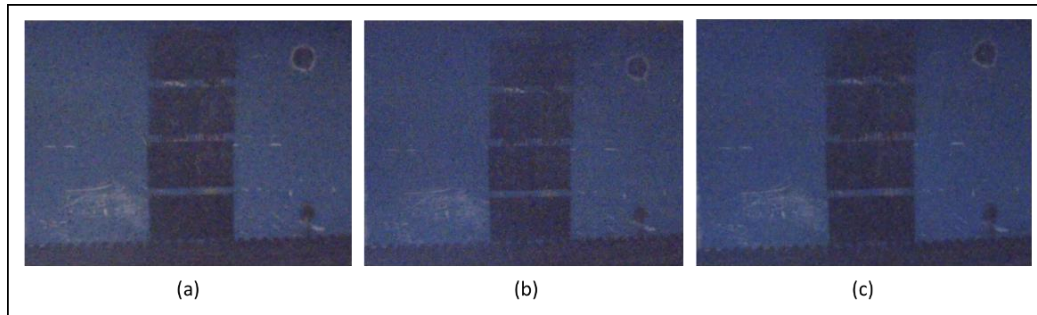
At 10 feet (3.048m) none of the three cracks are visible, but the five-inch (12.7 cm) diameter hole in the upper right of the images are still visible although becoming less distinguishable for the rust on the web. The white marks in the blue paint coating on the web where the girder had been struck are still visible (Figure 19).

Figure 19: Low-Light RGB camera images of Virginia Ave girder from 10 ft: (a) Nautical twilight; (b) Astronomical Twilight; (c) Night.

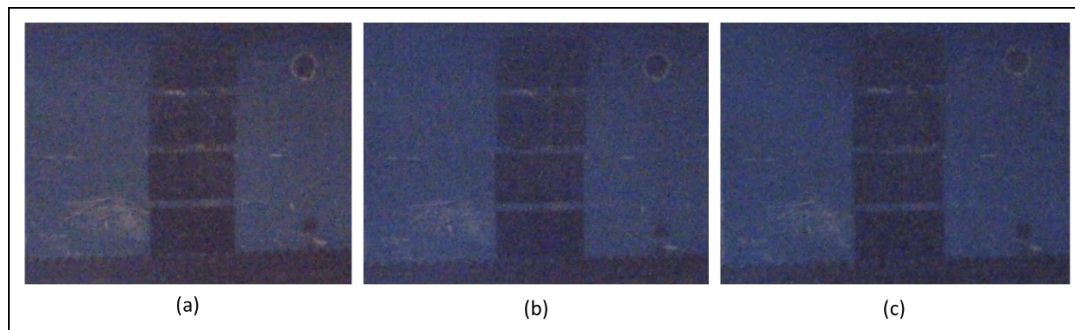
At 12 feet (3.658m) none of the three cracks are visible and the five-inch (12.7 cm) diameter hole in the upper right of is distinguishable in the image captured during nautical twilight but is not distinguishable from the rust on the web in the astronomical twilight or night image. The rust between the mending plates is becoming less distinct on all three images but more so on the images captured during astronomical twilight and night. The white marks in the blue paint coating on the web from where the girder had been struck are still visible but are but are less apparent then from the ten-foot (3.048m) images (Figure 20).

Figure 20: Low-Light RGB camera images of Virginia Ave girder from 12 ft: (a) Nautical twilight; (b) Astronomical Twilight; (c) Night.

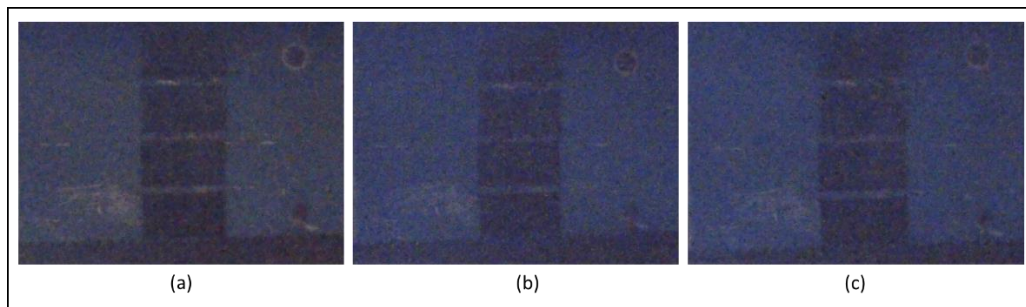
At 14 feet (4.267m) none of the three cracks are visible and the five-inch (12.7 cm) diameter hole in the upper right of the images appears as rust. The rust between the mending plates has become less distinct between mending plates on the image captured during nautical twilight and difficult to identify as rust on the images captured during astronomical twilight and night. The white marks in the blue paint coating on the web where the girder had been struck are still visible but are less apparent on images captured during astronomical twilight and night (Figure 21).

Figure 21: Low-Light RGB camera images of Virginia Ave girder from 14 ft: (a) Nautical twilight; (b) Astronomical Twilight; (c) Night.

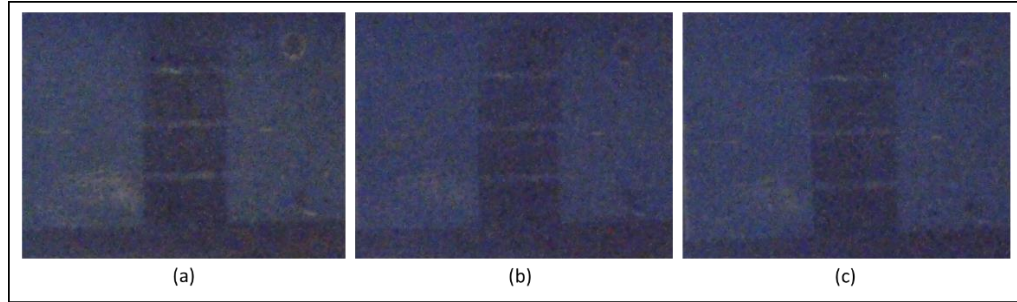
At 16 feet (4.877m) none of the three cracks are visible and the five-inch (12.7 cm) diameter hole in the upper right of the images appears as rust in the images captured during nautical and astronomical twilight, and less so on the night image. The rust between the mending plates has become less distinct on the image captured during nautical twilight and difficult to identify as rust on the image captured during astronomical twilight, and indistinguishable on the image capture at night. The white marks in the blue paint coating on the web where the girder had been struck are slightly visible on the image captured at nautical twilight and even less distinct on images captured during astronomical twilight and night (Figure 22).

Figure 22: Low-Light RGB camera images of Virginia Ave girder from 16 ft: (a) Nautical twilight; (b) Astronomical Twilight; (c) Night.

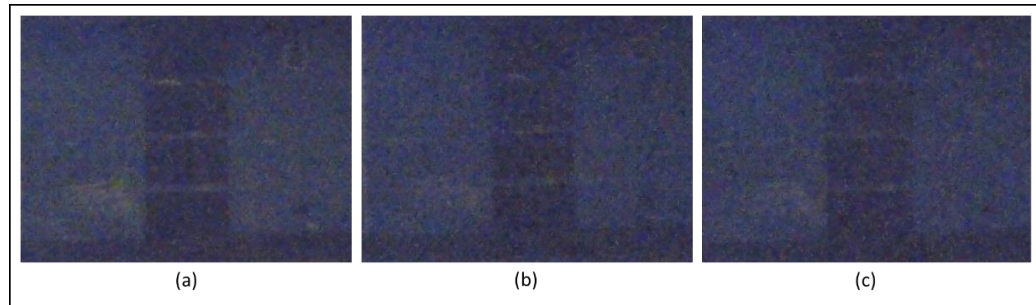
At 18 feet (5.486m) none of the three cracks are visible and the five-inch (12.7 cm) diameter hole in the upper right of the images appears as rust in the image captured during nautical twilight and is less distinct in the image captured during astronomical twilight. The hole is no longer visible in the image captured during night. The rust between the mending plates has become less distinct on the image captured during nautical twilight and vaguely identifiable between mending plates two and three, and plates three and four on the image captured during astronomical twilight. The rust on the image captured during night is longer identifiable. The white marks in the blue paint coating on the web where the girder had been struck are less visible on the image captured at nautical twilight and difficult to identify on images captured during astronomical twilight and night (Figure 23).

Figure 23: Low-Light RGB camera images of Virginia Ave girder from 18 ft: (a) Nautical twilight; (b) Astronomical Twilight; (c) Night.

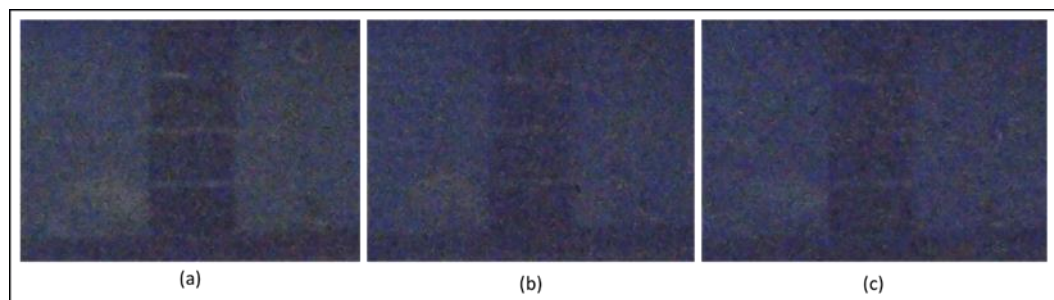
At 20 feet (6.096m) none of the three cracks are visible and the five-inch (12.7 cm) diameter hole in the upper right of the images appears as rust in the images captured during nautical twilight and is not visible on the images captured during astronomical twilight and night images. The rust between the mending plates has become indistinguishable on all three images. The white marks in the blue paint coating on the web where the girder had been struck are vaguely visible on the images captured at nautical and astronomical twilight and not visible on image captured during night (Figure 24).

Figure 24: Low-Light RGB camera images of Virginia Ave girder from 20 ft: (a) Nautical twilight; (b) Astronomical Twilight; (c) Night.

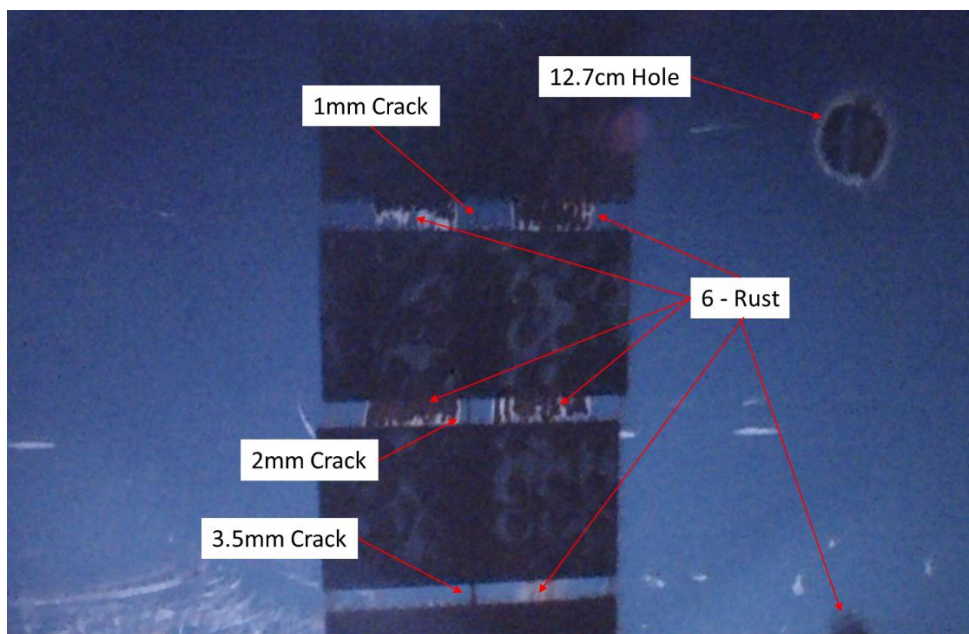
Based off the section of the Virginia Ave steel girder used in the low-light inspection distance, four defects were recorded. The four defects were the crack in the web ranging from 0.039 inches (1 mm) to 0.138 inches (3.5 mm) in width, a hole in the web measuring five inches (12.7 cm) in diameter, impact scratches grouped into three areas on the web (white marks on right side, center, and left side of mending plates), and rust grouped into 6 areas on the web (Figure 25).

Figure 25: Damage and defects in Virginia Ave steel girder.

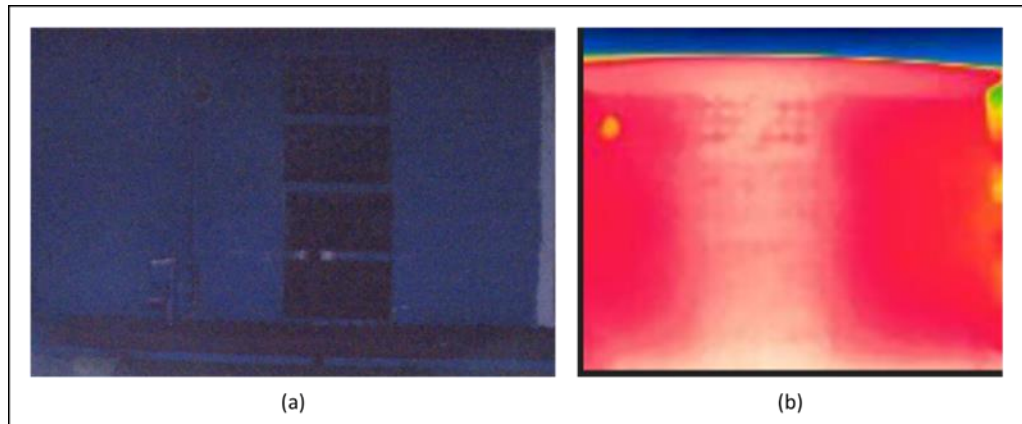
Figure 27: Low-Light RGB (a) and thermal (b) camera images of southwest side of the Virginia Ave girder during nautical twilight from 8 ft.

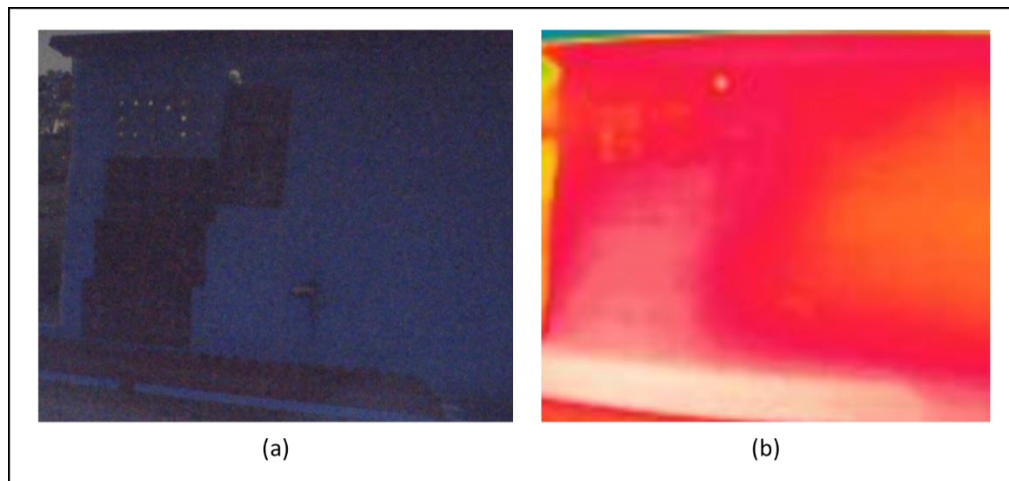
crack was not visible. The thermal image validated the one-inch (2.54cm) diameter holes (Figure 28b) and the three-inch (7.62cm) diameter hole.

Figure 28: Low-Light RGB (a) and thermal (b) camera images of northwest side of Virginia Ave girder during nautical twilight from 8 ft

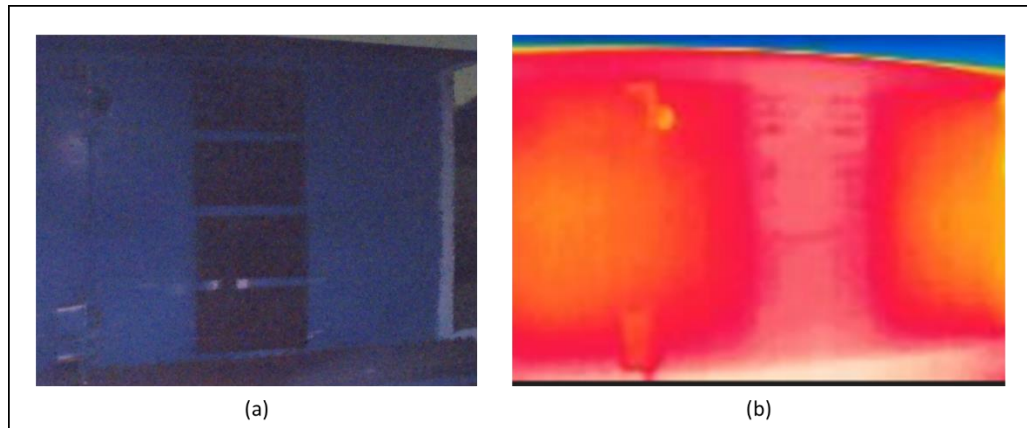
The second flight was at astronomical twilight and the 0.039 inches (1 mm) crack in the web was visible but the 0.079 inches (2 mm) and 0.138 inches (3.5 mm) crack were not. Additionally, the five-inch (12.7 cm) hole, rust, and impact scratches on the south

end of the girder were visible in the RGB lowlight images (Figure 29a). Thermal image confirmed the presences of the five-inch (12.7 cm) hole but the cracks and rust were not confirmed in the thermal image (Figure 29b). The one-inch (2.54 cm) diameter holes and three-inch diameter hole (7.62 cm) on the north end of the steel girder were visible (Figure 30a) but the 0.1 mm crack was not visible. The thermal image validated the one-inch (2.54 cm) diameter holes and the three-inch (7.62 cm) diameter hole (Figure 30b).

Figure 29: Low-Light RGB (a) and thermal (b) camera images of southwest side of Virginia Ave girder during astronomical twilight from 8 ft (2.44m).

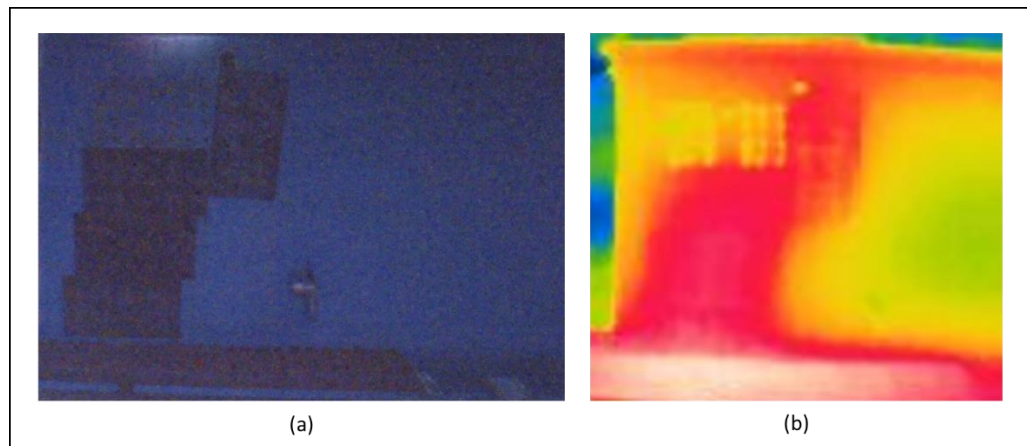
Figure 30: Low-Light RGB (a) and thermal (b) camera images of northwest side of Virginia Ave girder during astronomical twilight from 8 ft (2.44m).

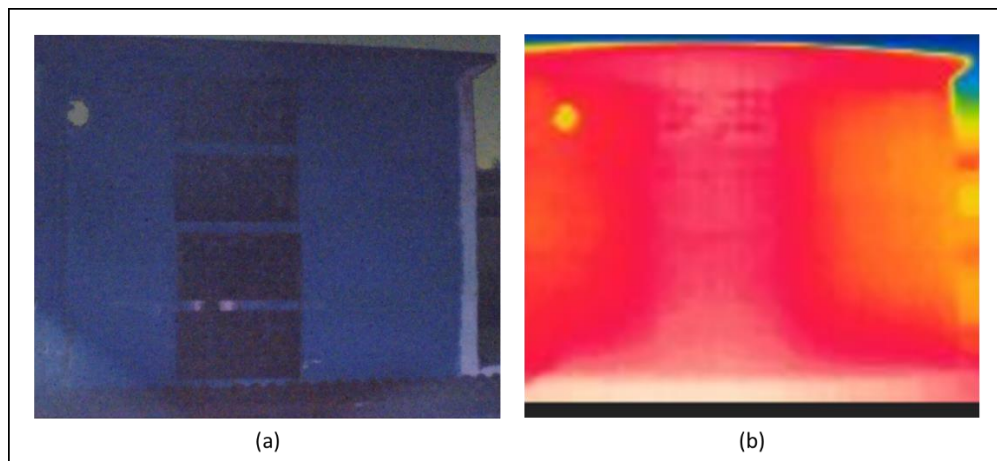
Figure 31: Low-Light RGB (a) and thermal (b) camera images of southwest side of Virginia Ave girder during night from 8 ft (2.44m).

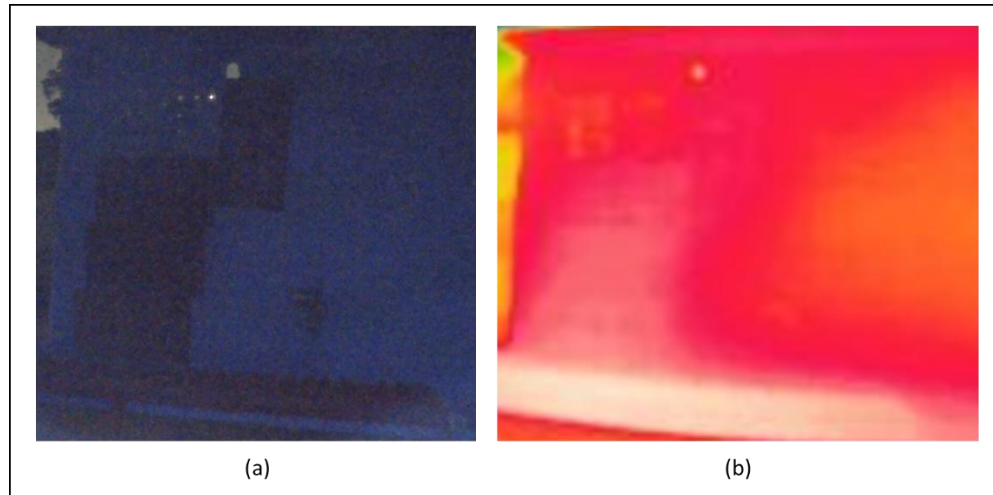
The third flight was at night and the 0.138 inches (3.5 mm) crack in the web was visible but the 0.039 inches (1 mm) and 0.079 inches (2 mm) crack were not. Additionally, the five-inch (12.7 cm) hole, rust, and impact scratches on the south end of the girder were visible in the RGB lowlight images (figure 31a). Thermal image confirmed the presences of the five-inch (12.7 cm) hole but the cracks and rust were not confirmed in the thermal image (Figure 31b). The one-inch (2.54 cm) diameter holes and three-inch diameter hole (7.62 cm) on the north end of the steel girder were visible (Figure 32a) but the 0.1 mm crack was not visible. The thermal image validated the one-inch (2.54cm) diameter holes and the three-inch (7.62cm) diameter hole (Figure 32b).

Figure 32: Low-Light RGB (a) and thermal (b) camera images of northwest side of Virginia Ave girder during night from 8 ft (2.44m).
