EVALUATION AND STRUCTURAL BEHAVIOR OF DETERIORATED PRECAST, PRESTRESSED CONCRETE BOX BEAMS

A Dissertation

Doctor of Philosophy

Lyles School of Civil Engineering West Lafayette, Indiana December 2019

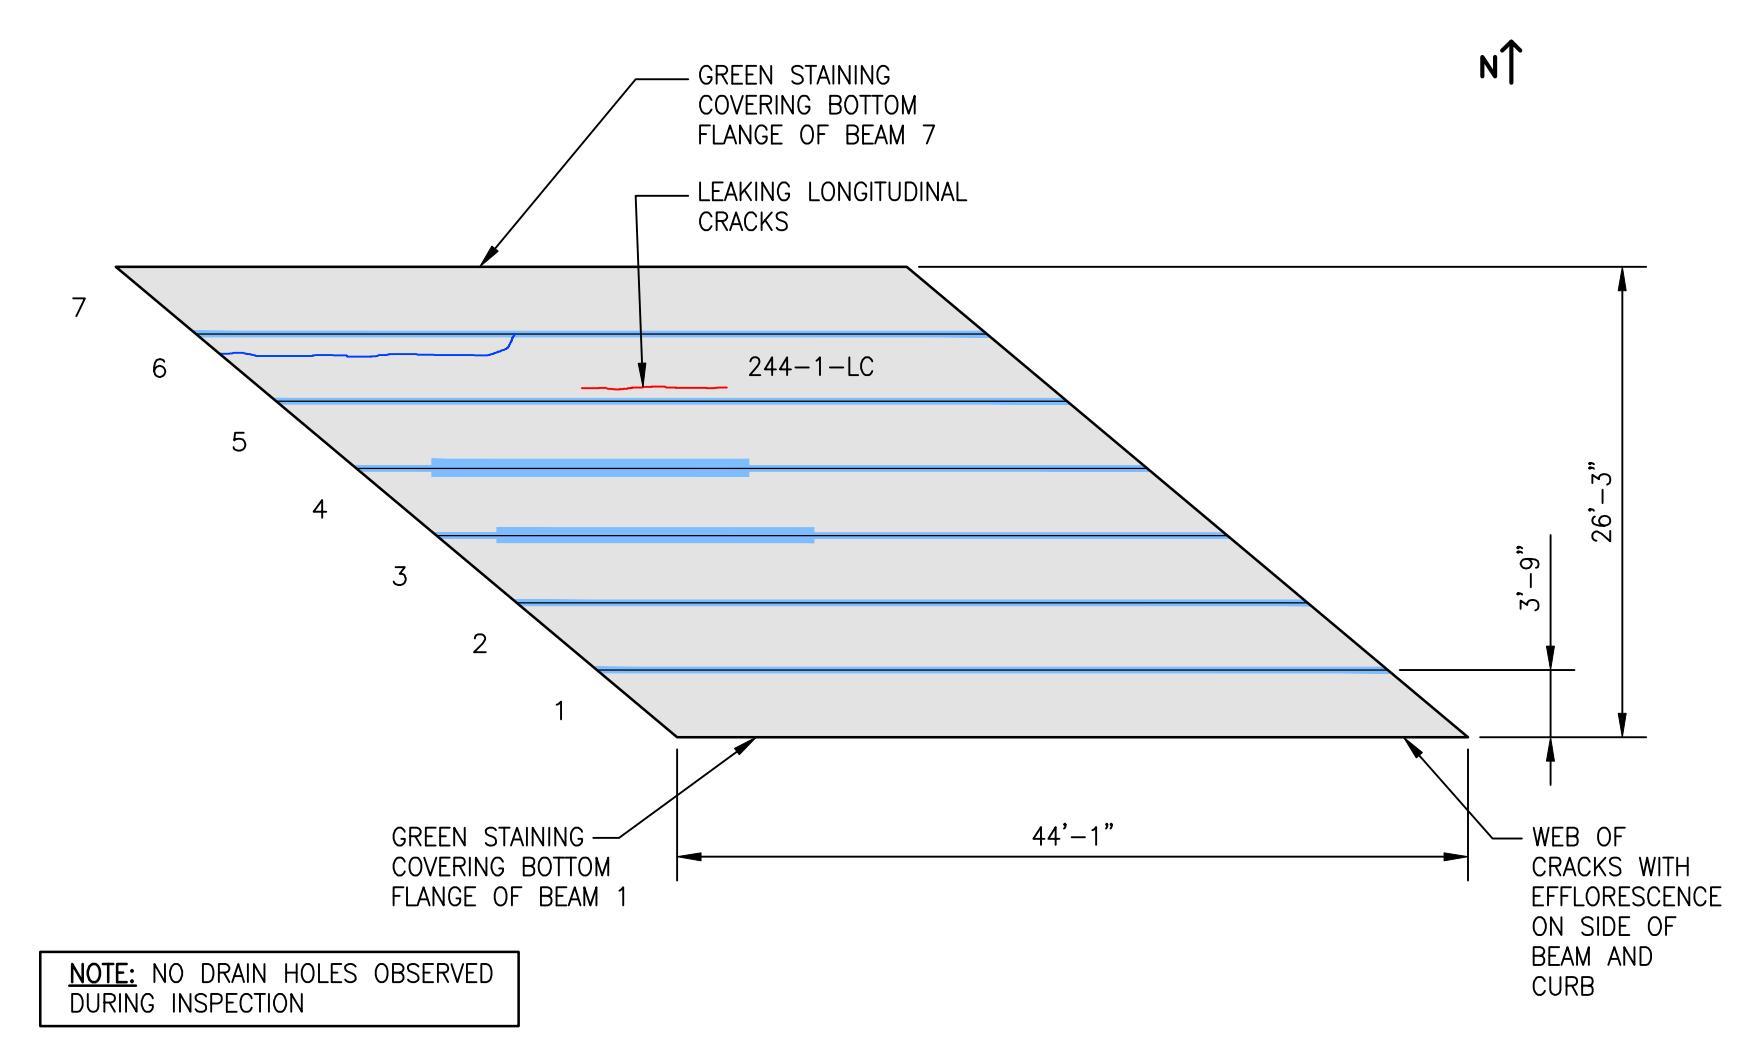
Figure 2.4: Tippecanoe 244 Deterioration Map

Tippecanoe 244 was inspected by the research team on 8 November 2017. The observed deterioration is summarized in Figure 2.4. Every joint between beams was found with water staining or efflorescence (Figure 2.5). The wearing surface was also observed to have reflective cracks along the length of the bridge. Two large longitudinal cracks were observed in Beam 6 (Specimen 244-6-LC). The crack at midspan was observed to be leaking during the inspection (Figure 2.6). Green staining covered most of the bottom flanges of Beam 1 (Figure 2.7) and Beam 7. The stain also partially extended onto the flange of Beam 6. In addition, spider web cracks were observed on the southeast corner of the bridge on the side of Beam 1 at the abutment (Figure 2.8). No drain holes were found in any of the beams.

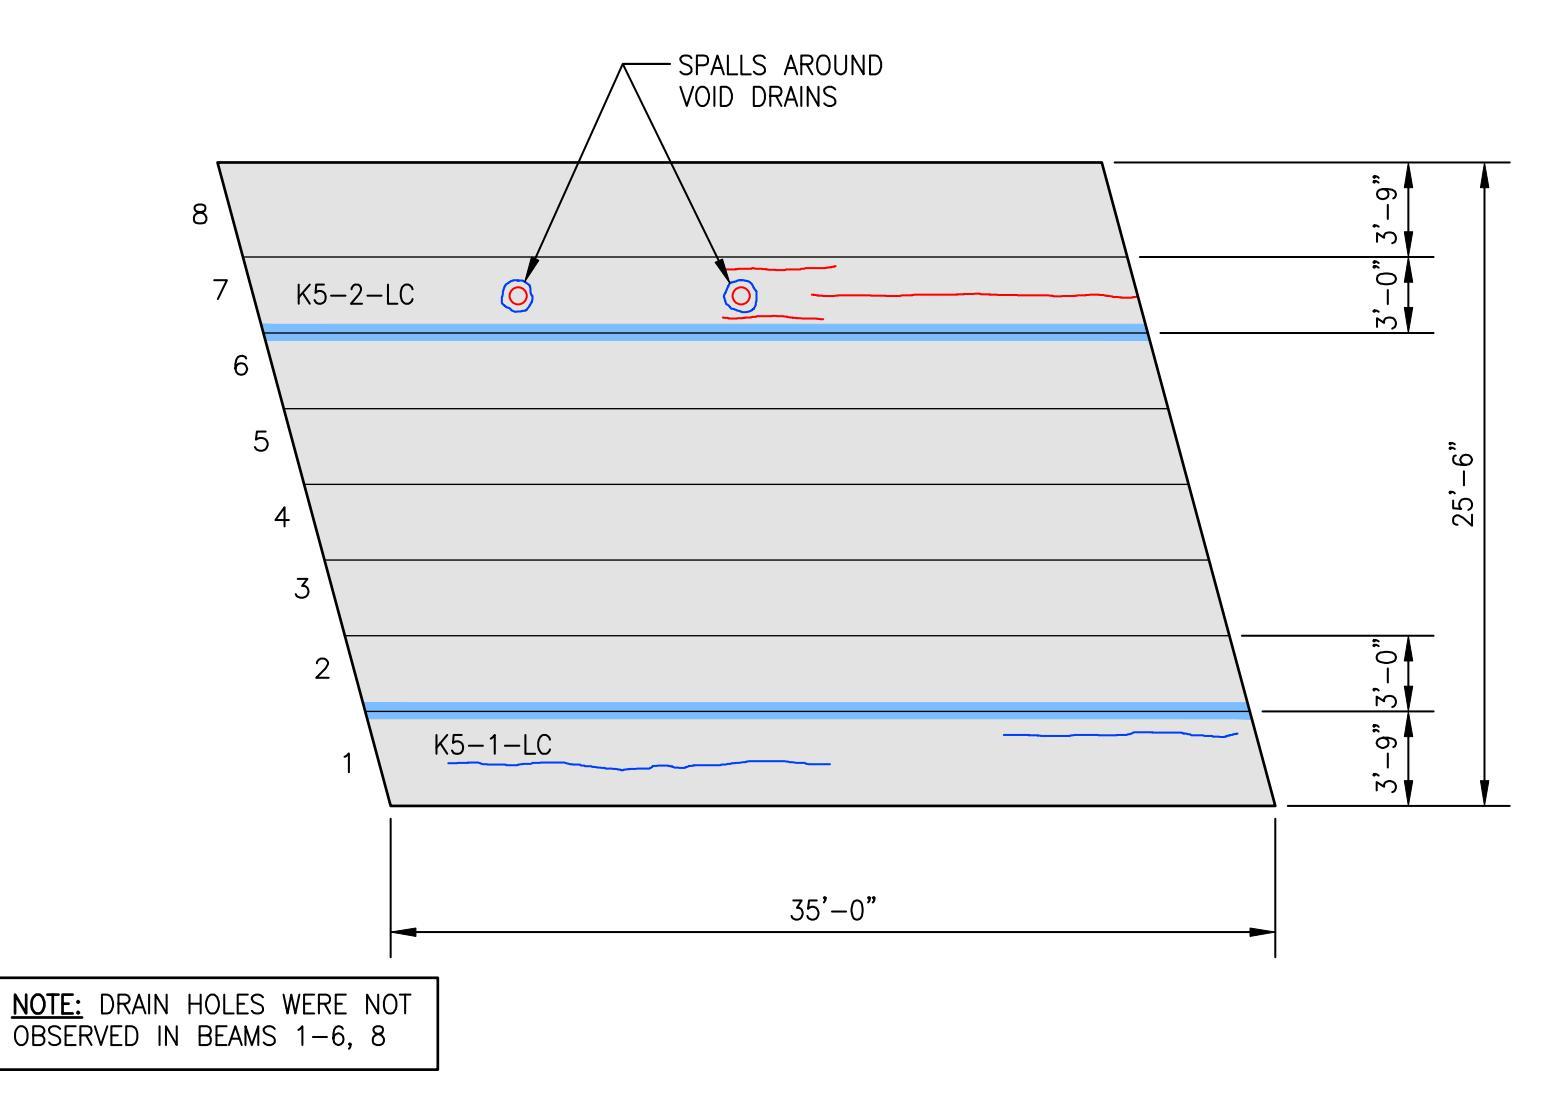
Figure 2.16: Newton K5 Deterioration Map

Newton K5 was inspected by the research team on 8 May 2017. A summary of the observed deterioration is provided in Figure 2.16. Two longitudinal cracks and joint staining were found in and around Beam 1 (Specimen K5-1-LC) with one of the longitudinal cracks extending from near the west support into midspan (Figure 2.17). Three rust-stained longitudinal cracks were observed in Beam 7 (Specimen K5-2-LC) along with spalling around the drain holes (Figure 2.18). In addition, reflective cracking was found in the wearing surface across the bridge (Figure 2.19). Please note that thin black lines have been drawn to the right of the actual cracks in Figure 2.19 to highlight the location of the cracks in the wearing surface.

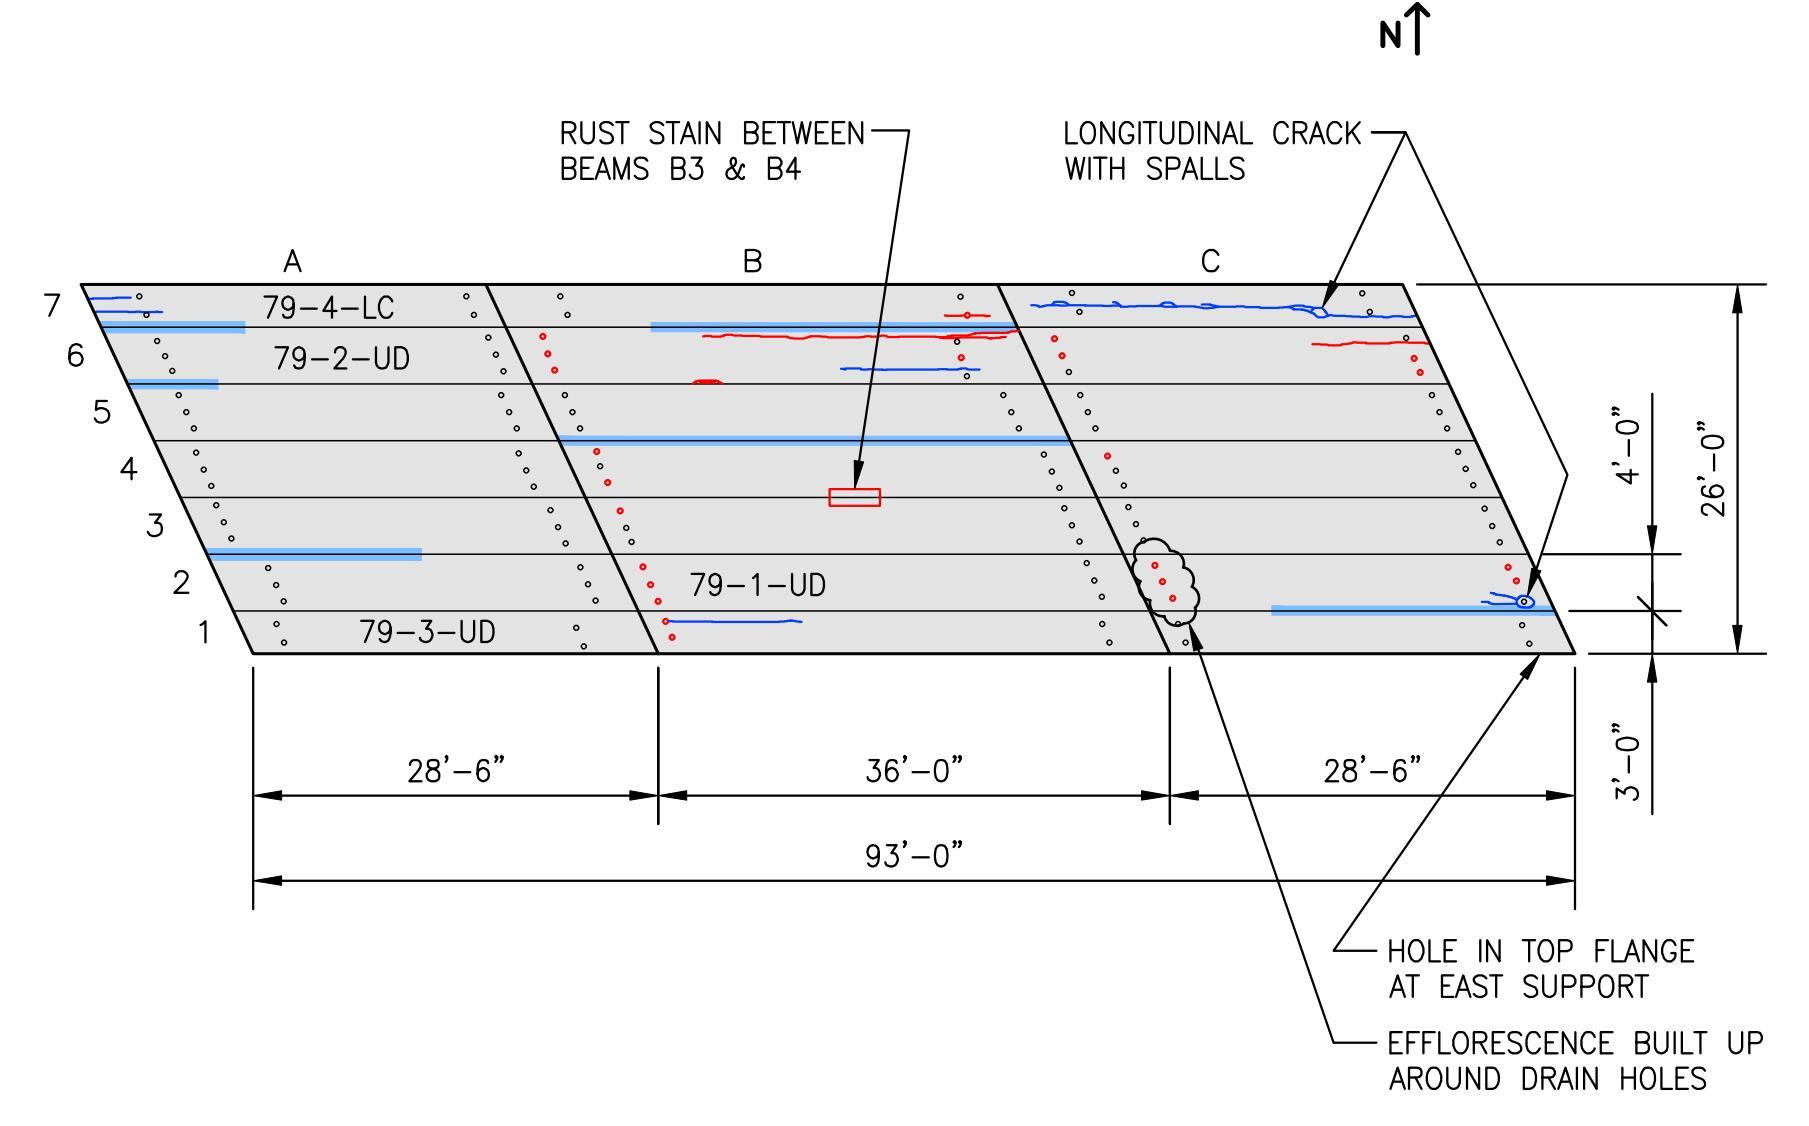
Figure 2.23: Wells 79 Deterioration Map

Wells 79 was inspected by the research team on 27 July 2016. The observed deterioration is summarized in Figure 2.23. Longitudinal cracks were found in six beams. The longitudinal cracks in Beam A7 (Specimen 79-4-LC) and Beams C2 and C6 were localized to the ends of the beams supported by the abutments (Figure 2.24 and Figure 2.25). The cracks in Beams B6 and C7 extended from the east support of each beam into midspan (Figure 2.26 and Figure 2.27). The crack in Beam C7 covered almost the entire length of the beam. When the wearing surface was inspected, a hole was found in the top flange of Beam C1 (Figure 2.28). The hole was filled with water, and vegetation was growing around the hole. When the bottom flange was inspected, no drain holes were present. In addition, reflective cracks were found in the wearing surface. The location of the reflective cracks corresponded with the joint between the adjacent beams below.

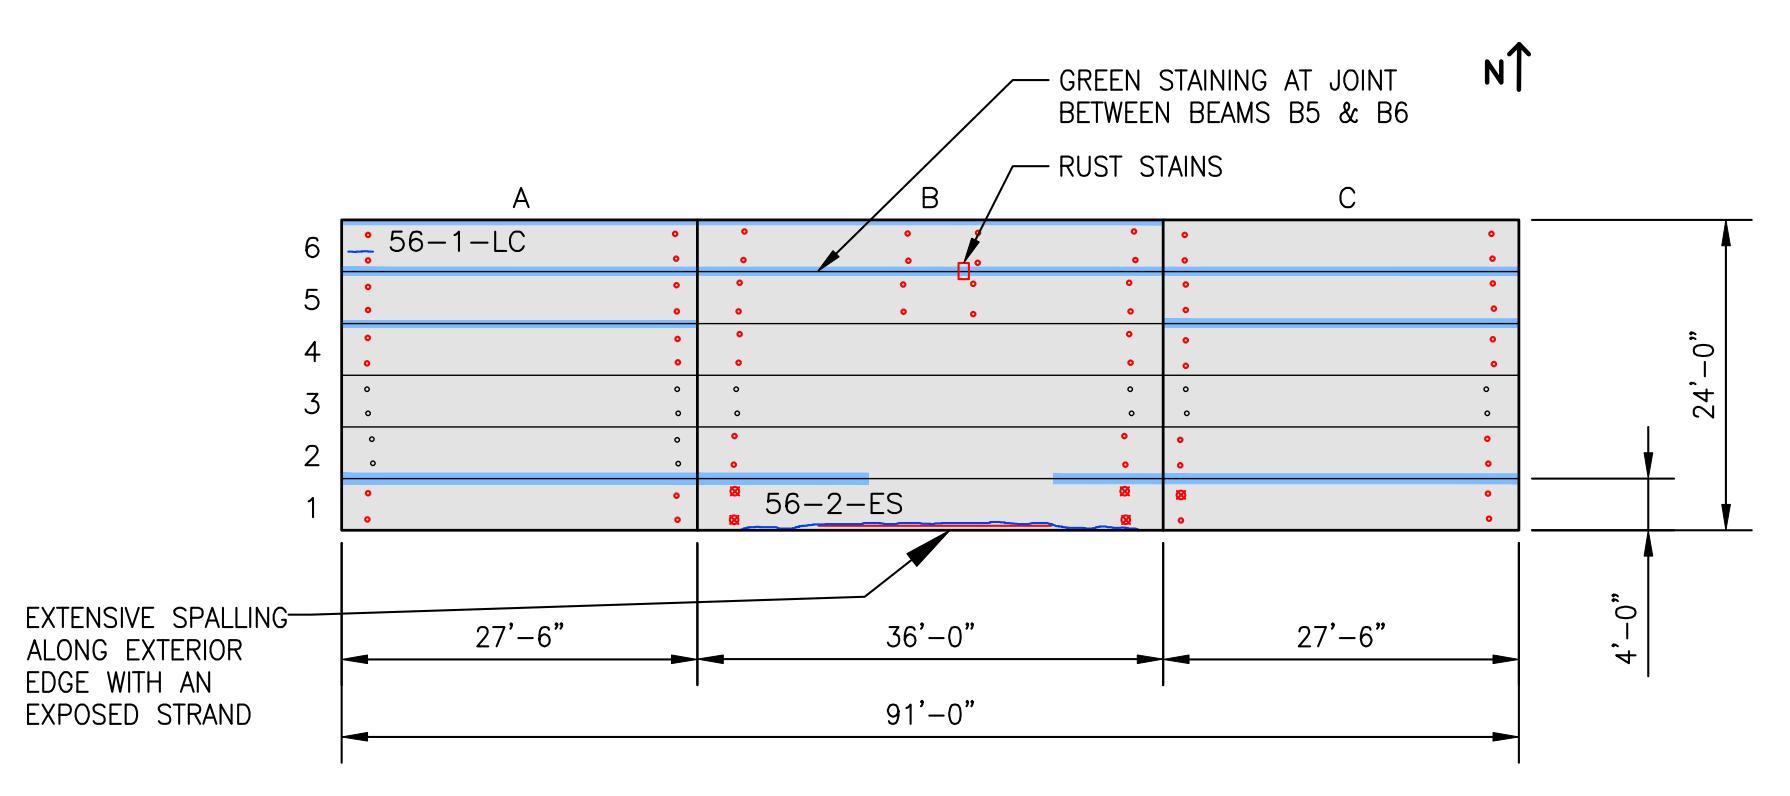
Figure 2.30: Newton 56 Deterioration Map

The bridge was inspected by the research team on 8 May 2017. The observed deterioration is summarized in Figure 2.30. Many of the joints showed signs of water leakage as staining around the joints between many of the beams. Examples of the observed staining is provided in Figure 2.31. The joint between Beams B5 and B6 had a large rust stain located near midspan. Because no spalling was observed on the bottom flanges of either beam, the rust was assumed to have originated from the transverse tie rod. A short longitudinal crack was observed in Beam A6 (Specimen 56-1-LC) at the west support (Figure 2.32). Beam B1 (Specimen 56-2-ES) was the most heavily deteriorated; nearly the entire exterior side of the beam had spalled off (Figure 2.33). Many stirrups were exposed, and a single strand was exposed at midspan (Figure 2.34). As shown in Figure 2.30, a majority of the drain holes were found to be rust stained or clogged (Figure 2.35). In addition, reflective cracking was observed in the bituminous wearing surface (Figure 2.36). Please note that a thin black line has been drawn to the right of the crack to highlight the location.

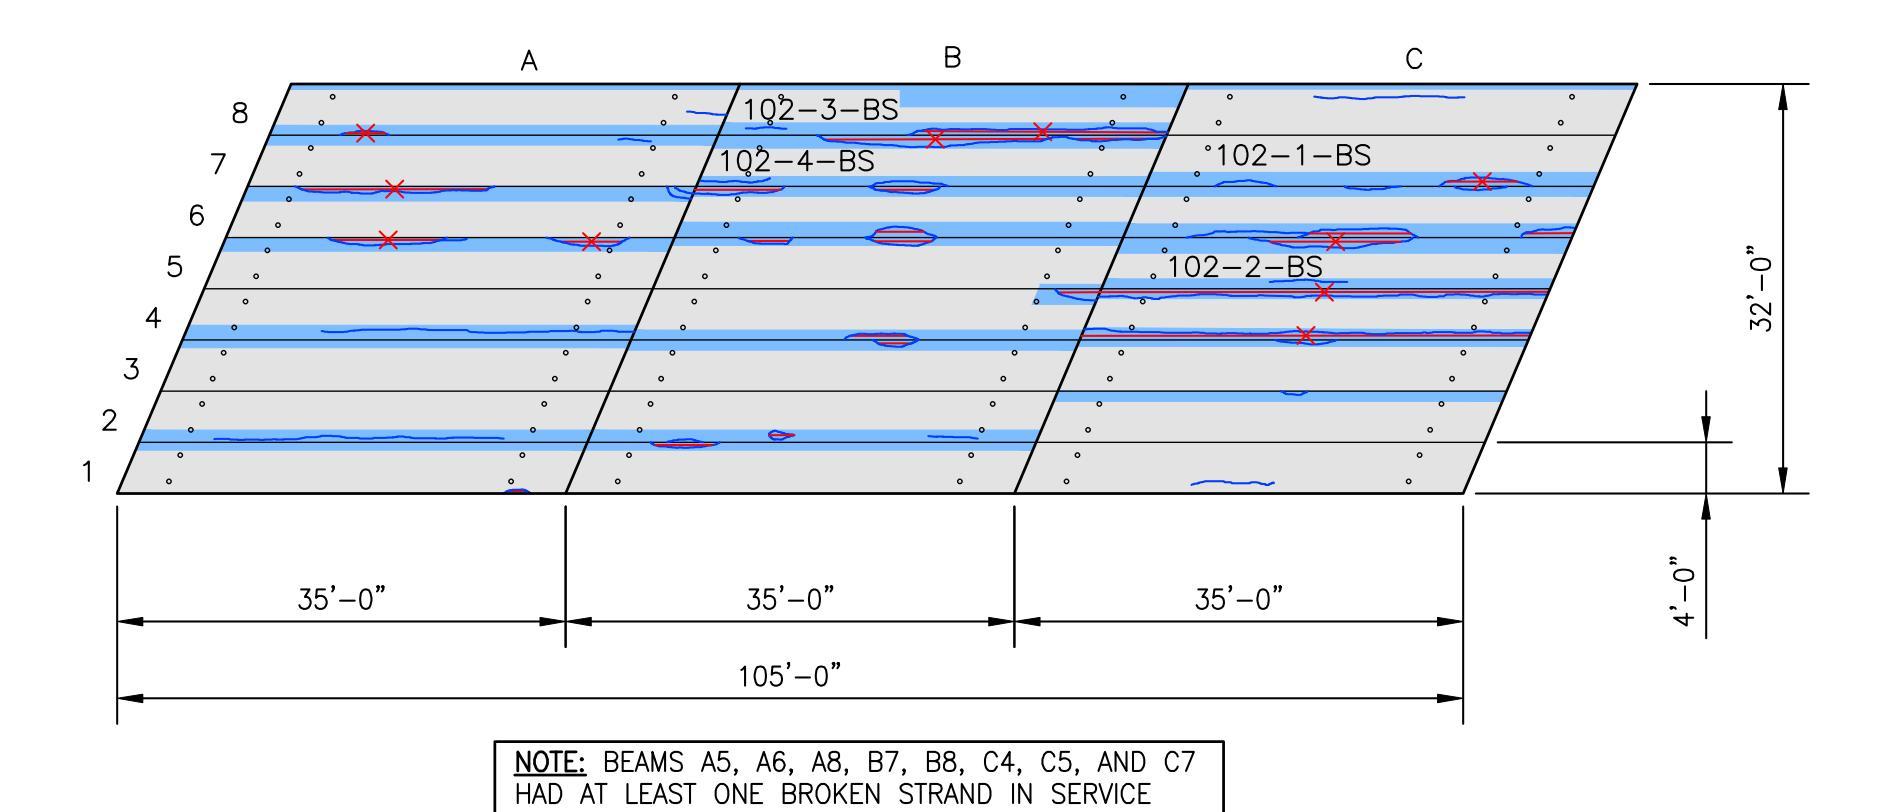
Figure 2.39: Elkhart 102 Deterioration Map

Elkhart 102 was inspected by the research team on 9 January 2018. The observed deterioration is summarized in Figure 2.39. In general, the bridge was in an advanced state of deterioration; only one beam out of the 24 total beams did not show any signs of deterioration. A total of 16 beams had exposed or broken strands. Examples of the deterioration are provided in Figure 2.40 to Figure 2.43. In Figure 2.40, Beam B7 (Specimen 102-3-BS) and Beam B8 (Specimen 102-3-BS) are shown with broken strands and wet edge staining. In Figure 2.41, Beam C5 (Specimen 102-2-BS) and Beam C6 are shown with longitudinal cracks, exposed strand, and broken strand. In Figure 2.42, Beam C6 and Beam C7 (Specimen 102-1-BS) are shown with a broken strand and a longitudinal crack. Notably, all observed deterioration was localized to the edges of each beam, and where the corner of the section had not cracked, there was evidence of water leaking onto the bottom flange (Figure 2.43). In addition, reflective cracks were observed in the wearing surface.

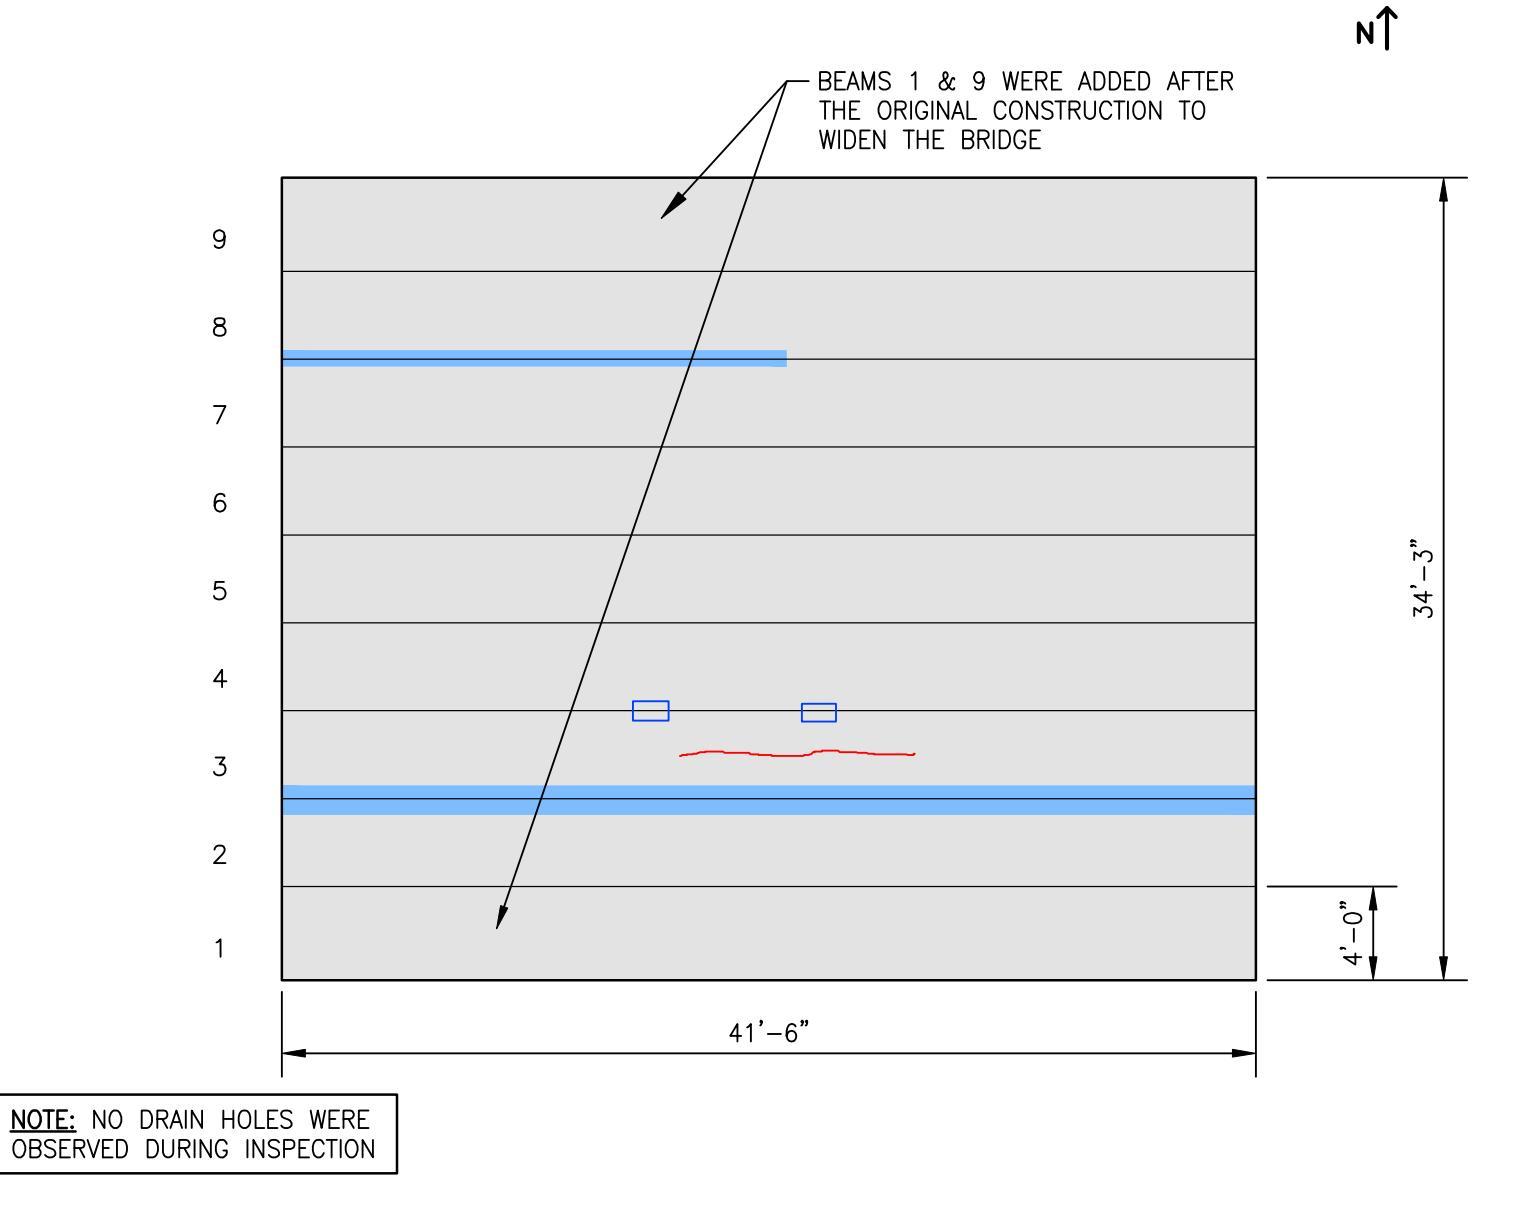
Figure 2.56: Elkhart 385 Deterioration Map

Elkhart 385 was inspected by the research team on 27 January 2017. The observed deterioration is summarized in Figure 2.56. A rust stained longitudinal crack was found at midspan on Beam 3 (Figure 2.57). The joints between Beams 2 and 3 and Beams 7 and 8 were stained from water leaking through the shear key. These locations are interesting as they are the locations of the first joint in the original configuration of the bridge prior to the addition of the new exterior beams. Small sections of efflorescence were also observed at the joint between Beams 3 and 4. No reflective cracks were observed in the wearing surface or concrete deck.

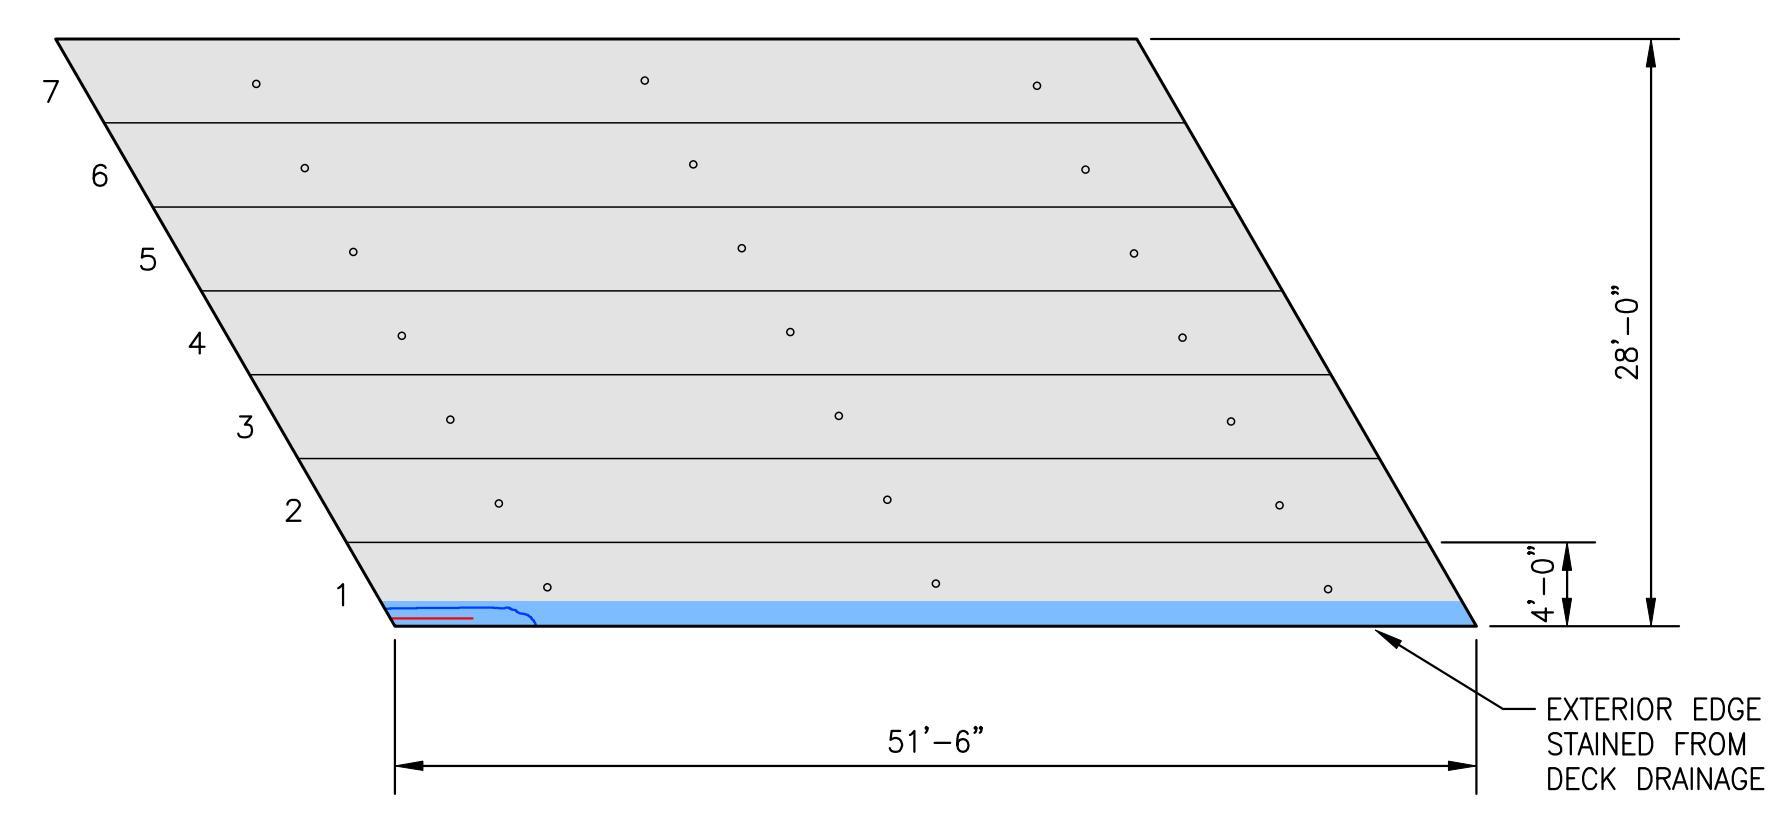
Figure 2.59: Elkhart 404 Deterioration Map

Elkhart 404 was inspected by the research team on 27 January 2017. The observed deterioration is summarized in Figure 2.59. As shown in Figure 2.58, the bridge was constructed with a sidewalk south of Beam 1. The sidewalk was placed on a beam separated from the road bridge (Figure 2.60). A single exposed strand on the west end of Beam 1 and staining on the exterior edge of Beam 1 were the only deterioration found (Figure 2.61). No reflective cracks in the wearing surface were observed by the research team, but hairline cracks were noted in the official inspection report.

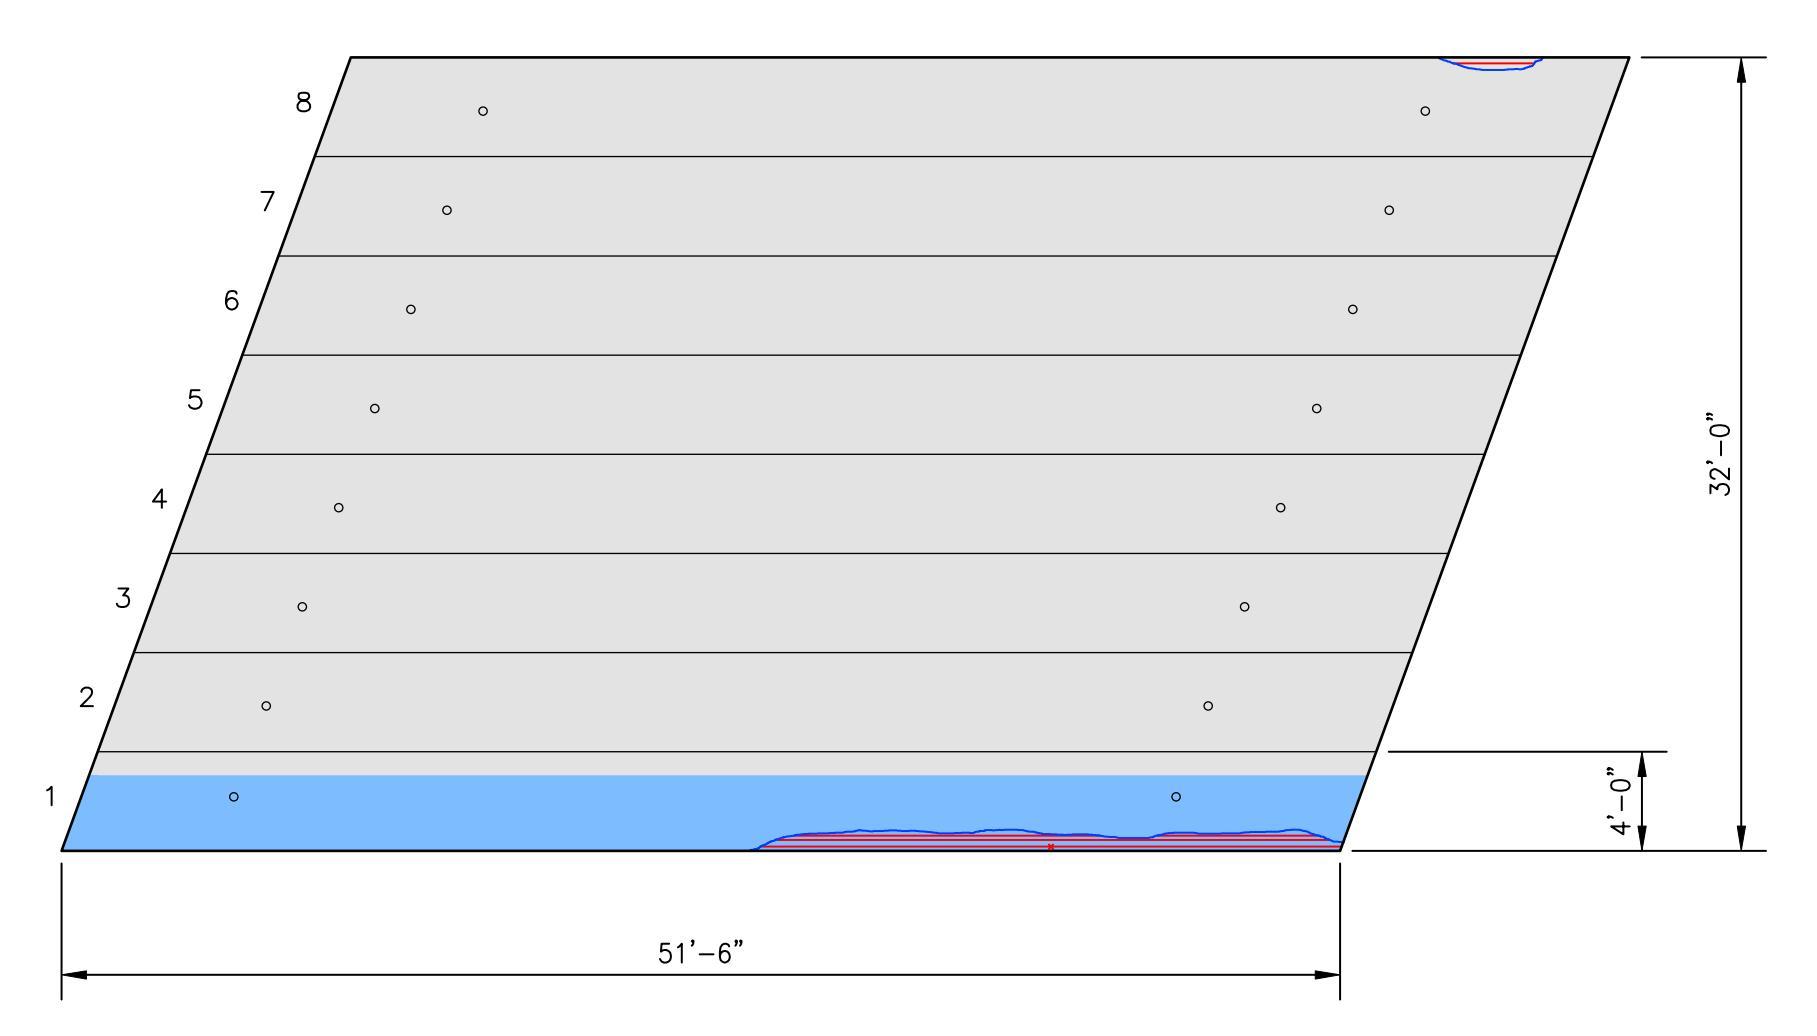
Figure 2.63: Elkhart 406 Deterioration Map

Elkhart 406 was visited by the research team on 27 January 2017. The observed deterioration is summarized in Figure 2.63. The deterioration of Elkhart 406 is localized to the exterior beams. Beam 1 and Beam 8 were both observed to have spalling with an exposed strand. A spall extending from the north support to midspan on Beam 1 exposed three strands (Figure 2.64), and a spall on Beam 8 exposed a single strand near the north support (Figure 2.65). No longitudinal cracks were found in the concrete deck. In addition, the footbridge beams on either side of the bridge were in excellent condition. Neither were found with any deficiencies.

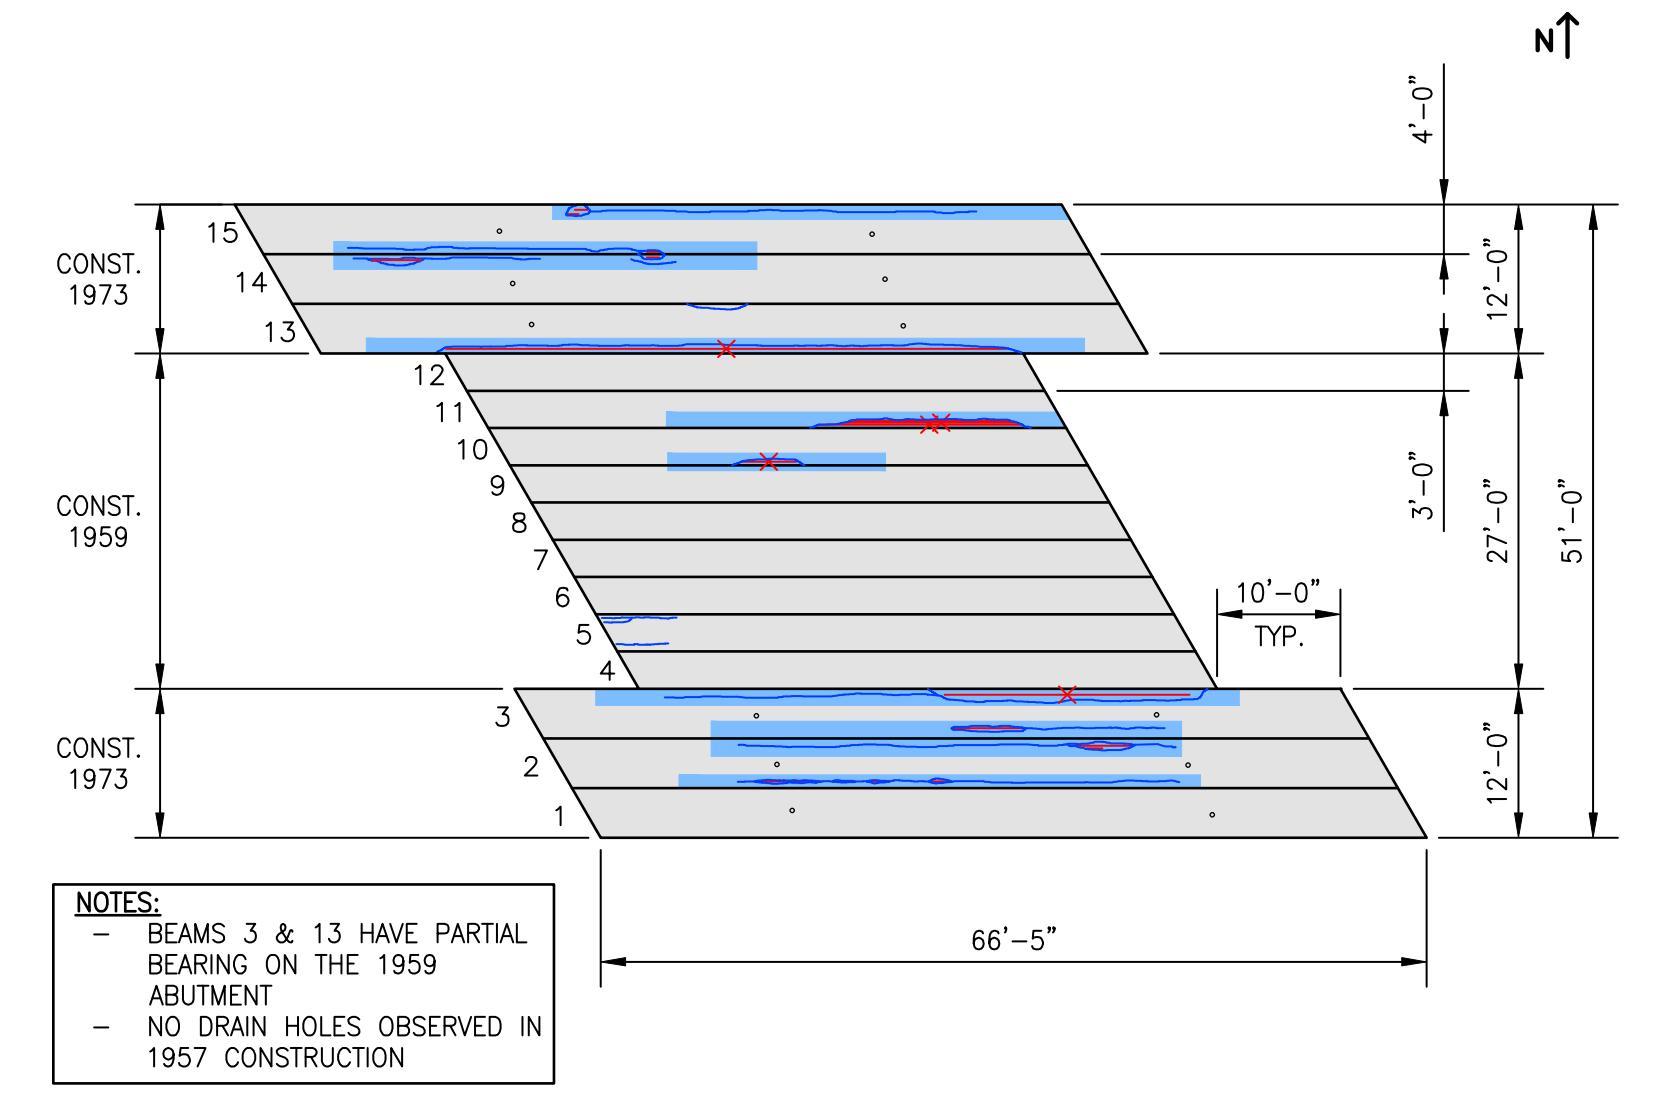
Figure 2.68: Elkhart 410 Deterioration Map

A comparison between the 1959 beams and 1973 beams (Figure 2.68) revealed that more of the 1973 beams were deteriorated. The direct cause of this discrepancy in deterioration is unknown, but the roadway is only two lanes (24 ft wide) which creates a very wide shoulder that is carried by the beams added during the 1973 reconstruction (Figure 2.71). During the winter there is potential for plowed snow to accumulate on the edges of the bridge. When the snow is removed from the traffic lane, road salts may be carried with the snow onto the edge of the bridge. If the snow is not removed from the bridge, the resulting chloride laden snow melt could be carried through the shear keys to the beams below. Over time, chlorides in the snow melt could reach the strand and induce corrosion. The described mechanism of deterioration implies, however, that the membrane between the wearing surface and the beams has failed and is not effective.

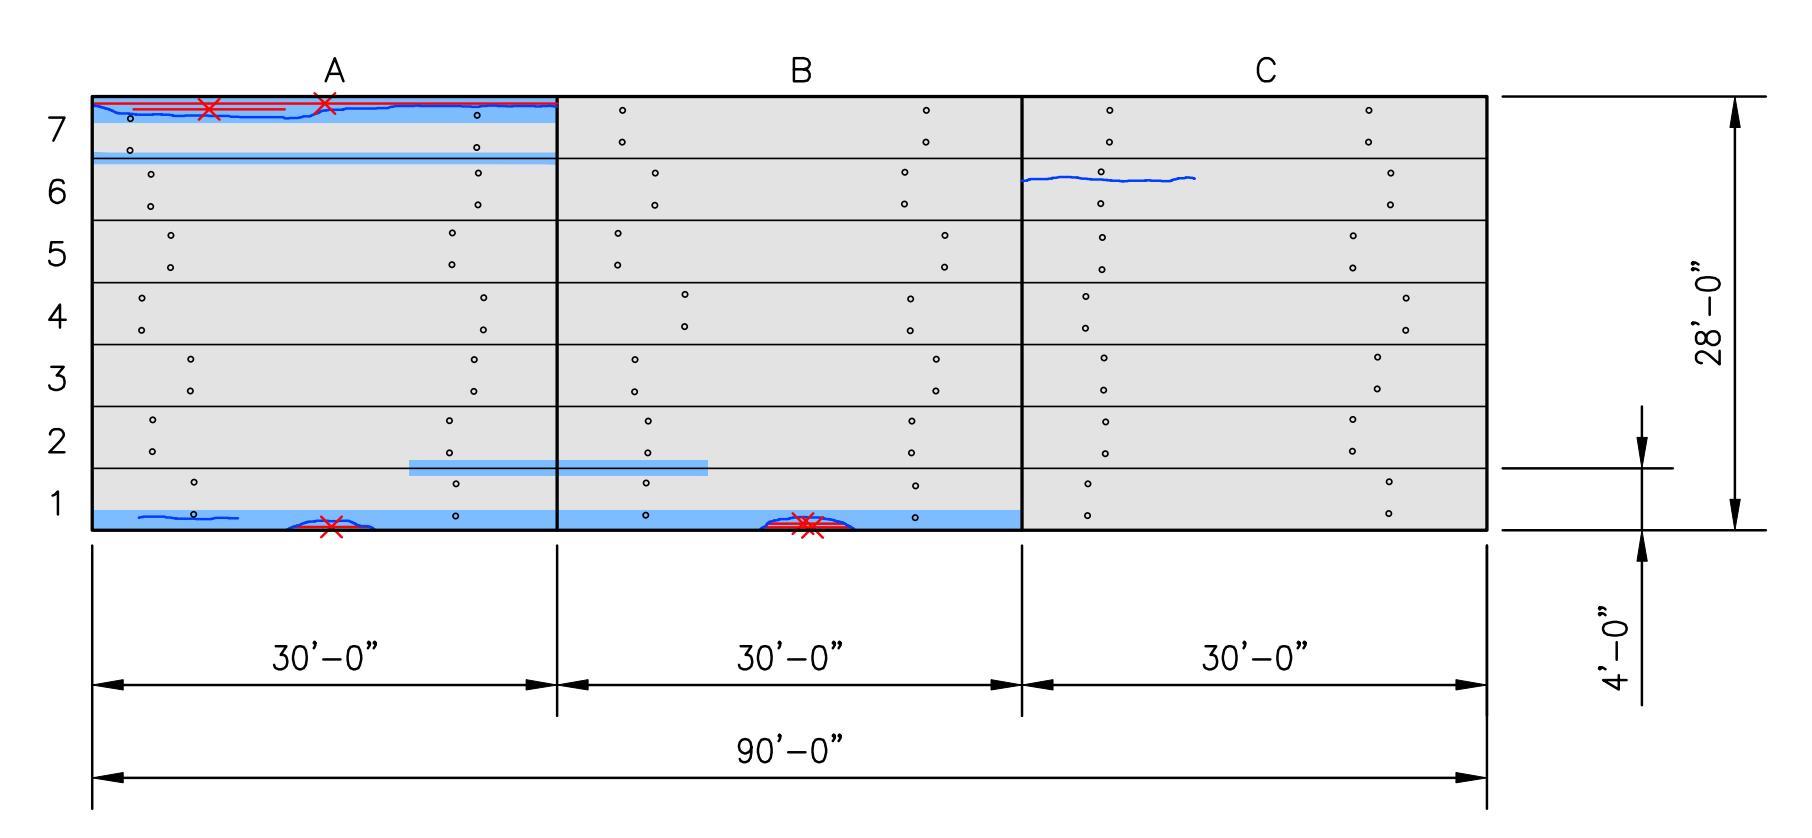
The research team inspected Kosciusko 18 on 9 January 2018. A summary of the deterioration is provided in Figure 2.78. Beams A1, A7, and B1 were all found to have exposed and broken strands located on the exterior corner of the respective sections (Figure 2.79). Longitudinal cracks were observed in Beams A1 and C6 (Figure 2.80). Melting frost was observed at the joint between Beams 1 and 2 over the pier between Spans A and B (Figure 2.81). The melting frost at the joint indicated that water from the bridge deck above was leaking into the joint and curling onto the bottom flange of the beams.

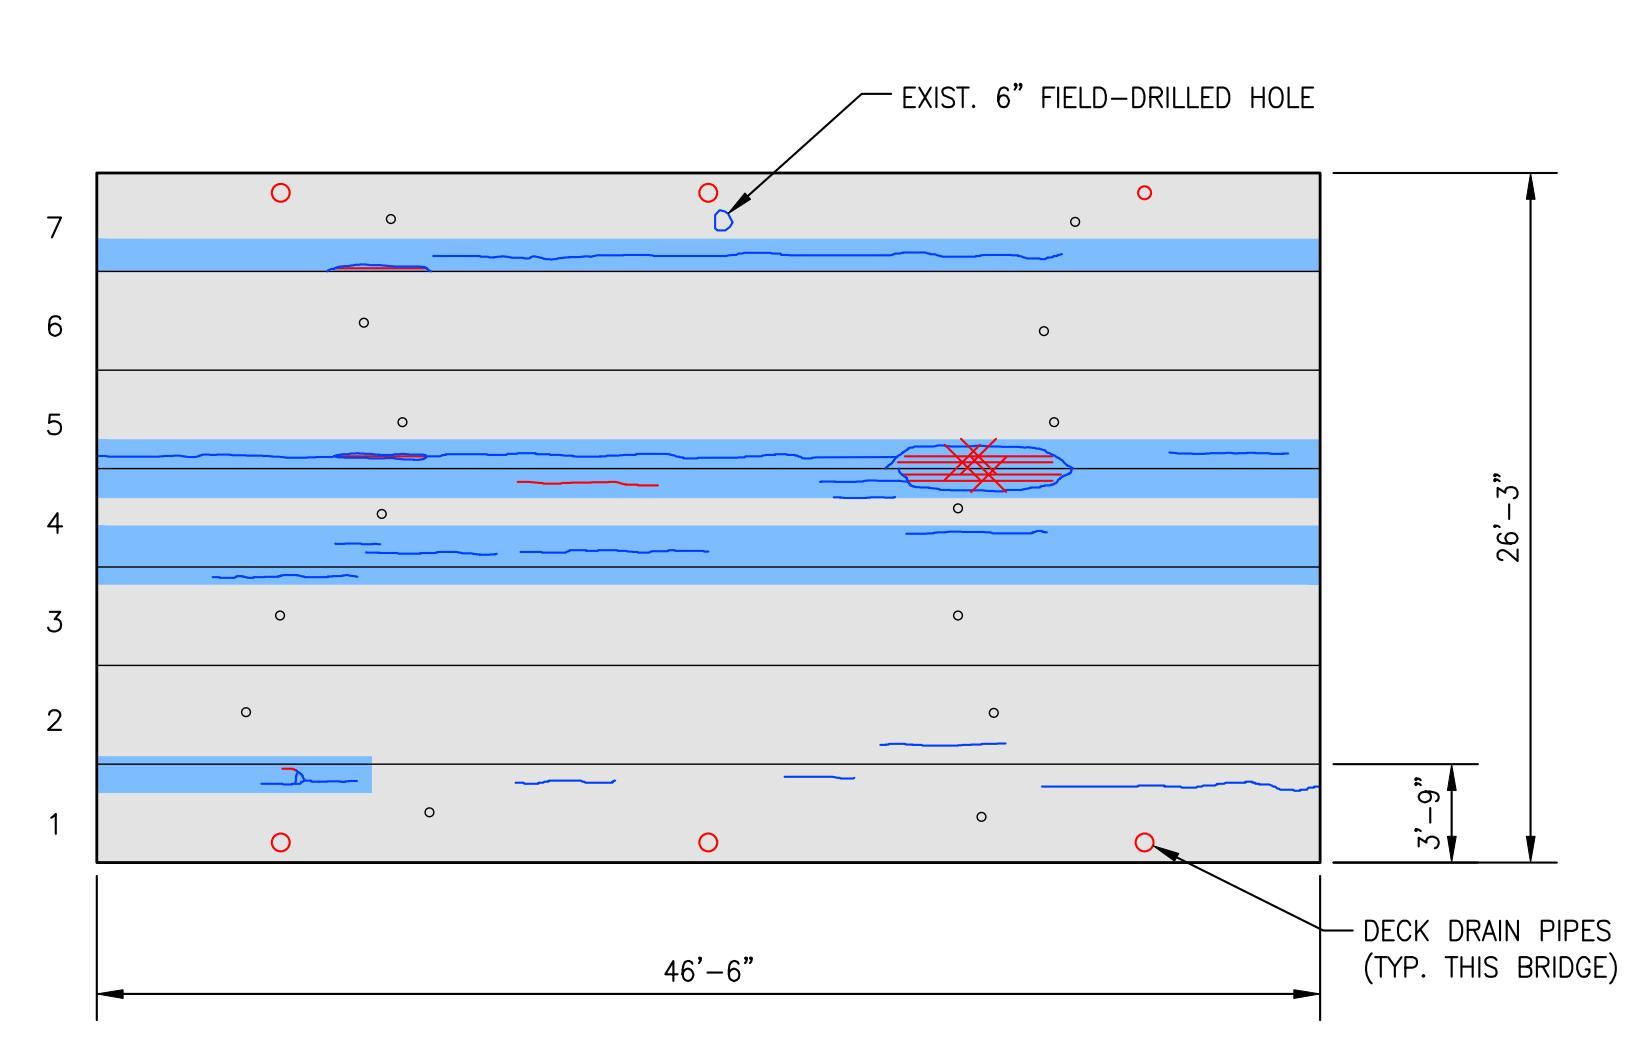
Lake 61 was inspected by the research team on 9 January 2018. A summary of the observed deterioration is provided in Figure 2.83. As shown, Beams 4 and 5 were found with multiple exposed and broken strand in addition to longitudinal cracks near the corners of the beams (Figure 2.84). Longitudinal cracks were also observed in Beams 1, 3, and 7 near the edges of the beams. Beam 1 exhibited a rust stained crack and spall next to a stained joint near the west support (Figure 2.85). Large drain pipes were cast into the beams for drainage. A single hole approximately 6 in. in diameter was also observed at midspan of Beam 7 (Figure 2.86). The shape of the hole indicates that a coring machine was used to create the hole. No explanation or documentation of this work was available in the official inspection reports.
