EVALUATION AND STRUCTURAL BEHAVIOR OF DETERIORATED PRECAST, PRESTRESSED CONCRETE BOX BEAMS

A Dissertation

Doctor of Philosophy

Lyles School of Civil Engineering West Lafayette, Indiana December 2019

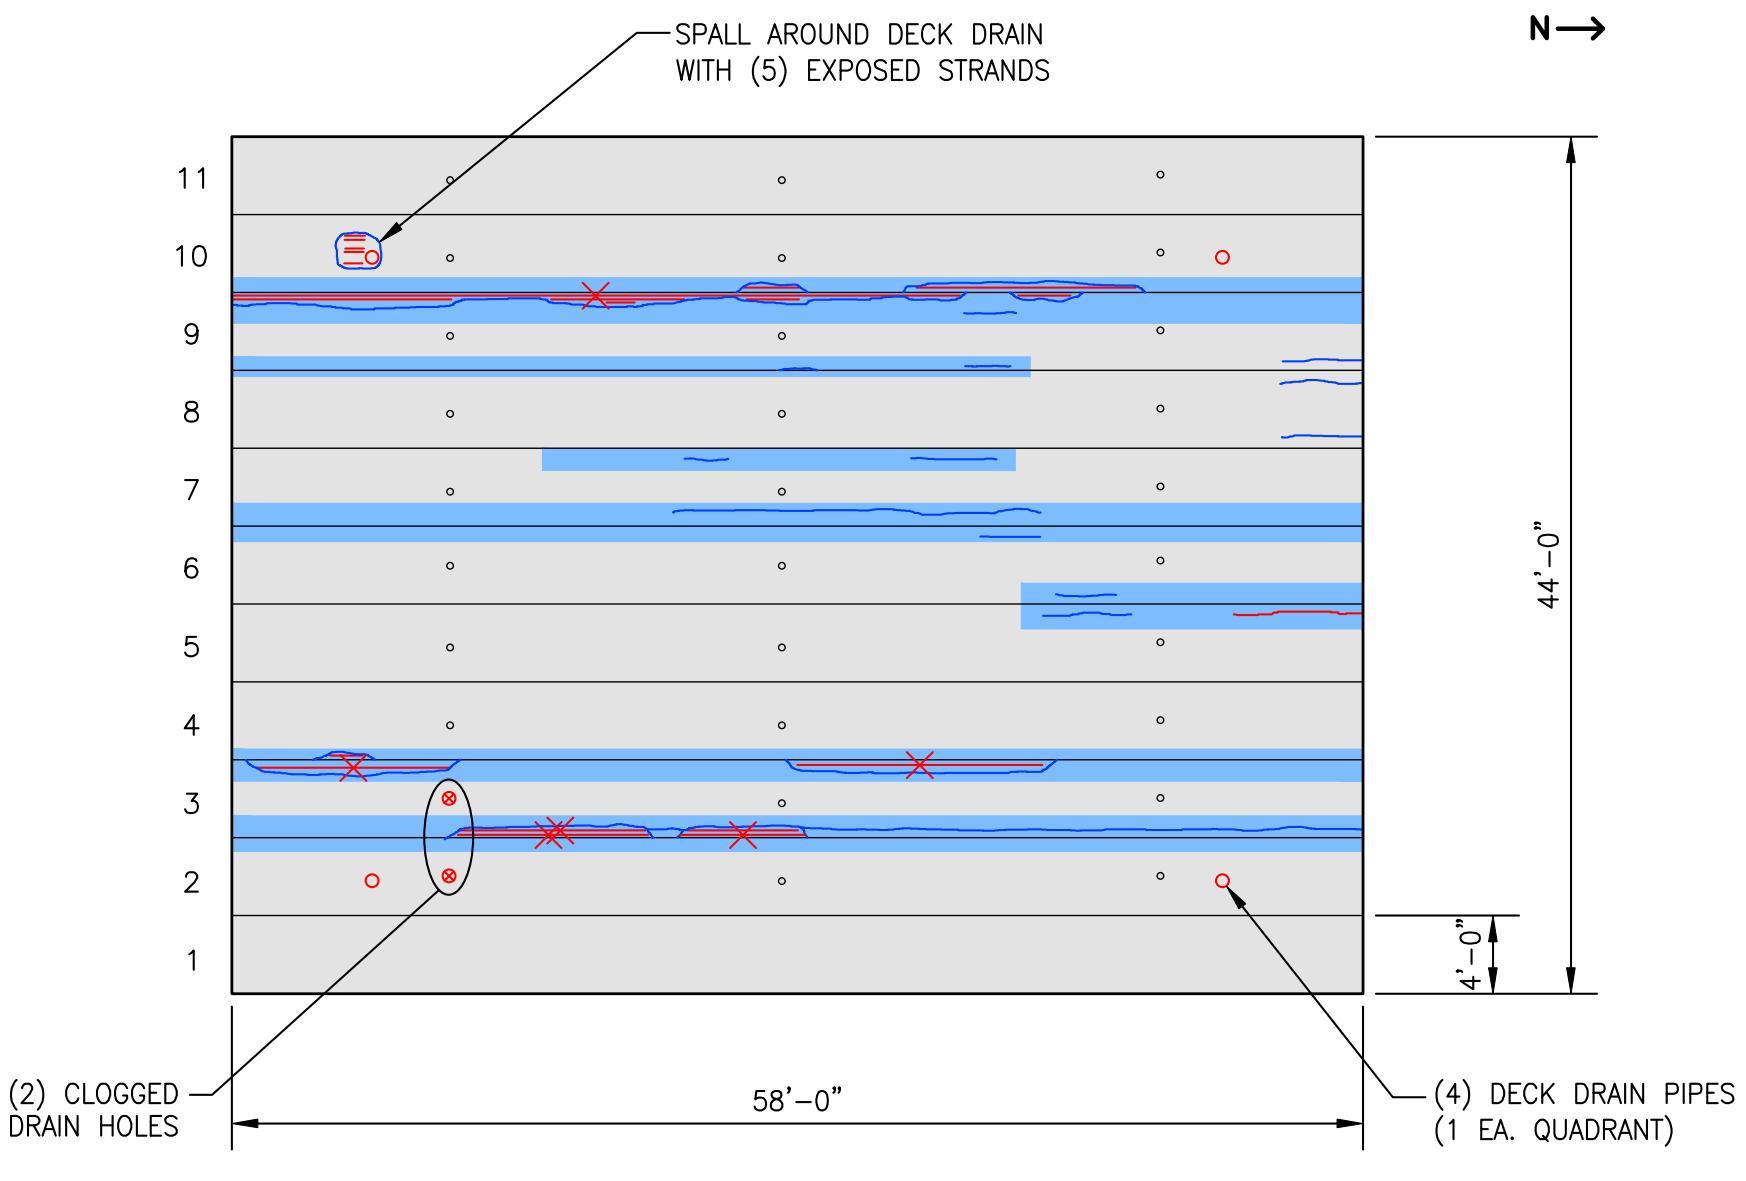
Figure 2.88: Lake 264 Deterioration Map

The lack of deterioration on beams 1 and 11 and in the joints between beams 1 and 2 and beams 10 and 11 may be due, in part, to the concrete sidewalk. The side walk is 5 ft wide and covers the both the exterior beams and the joint between the exterior beam and first interior beam. Concrete sidewalk provides a much greater resistance to cracking and moisture migration than the bituminous wearing surface. The difference in porosity between the two materials may have resulted in greater durability of the exterior beams.

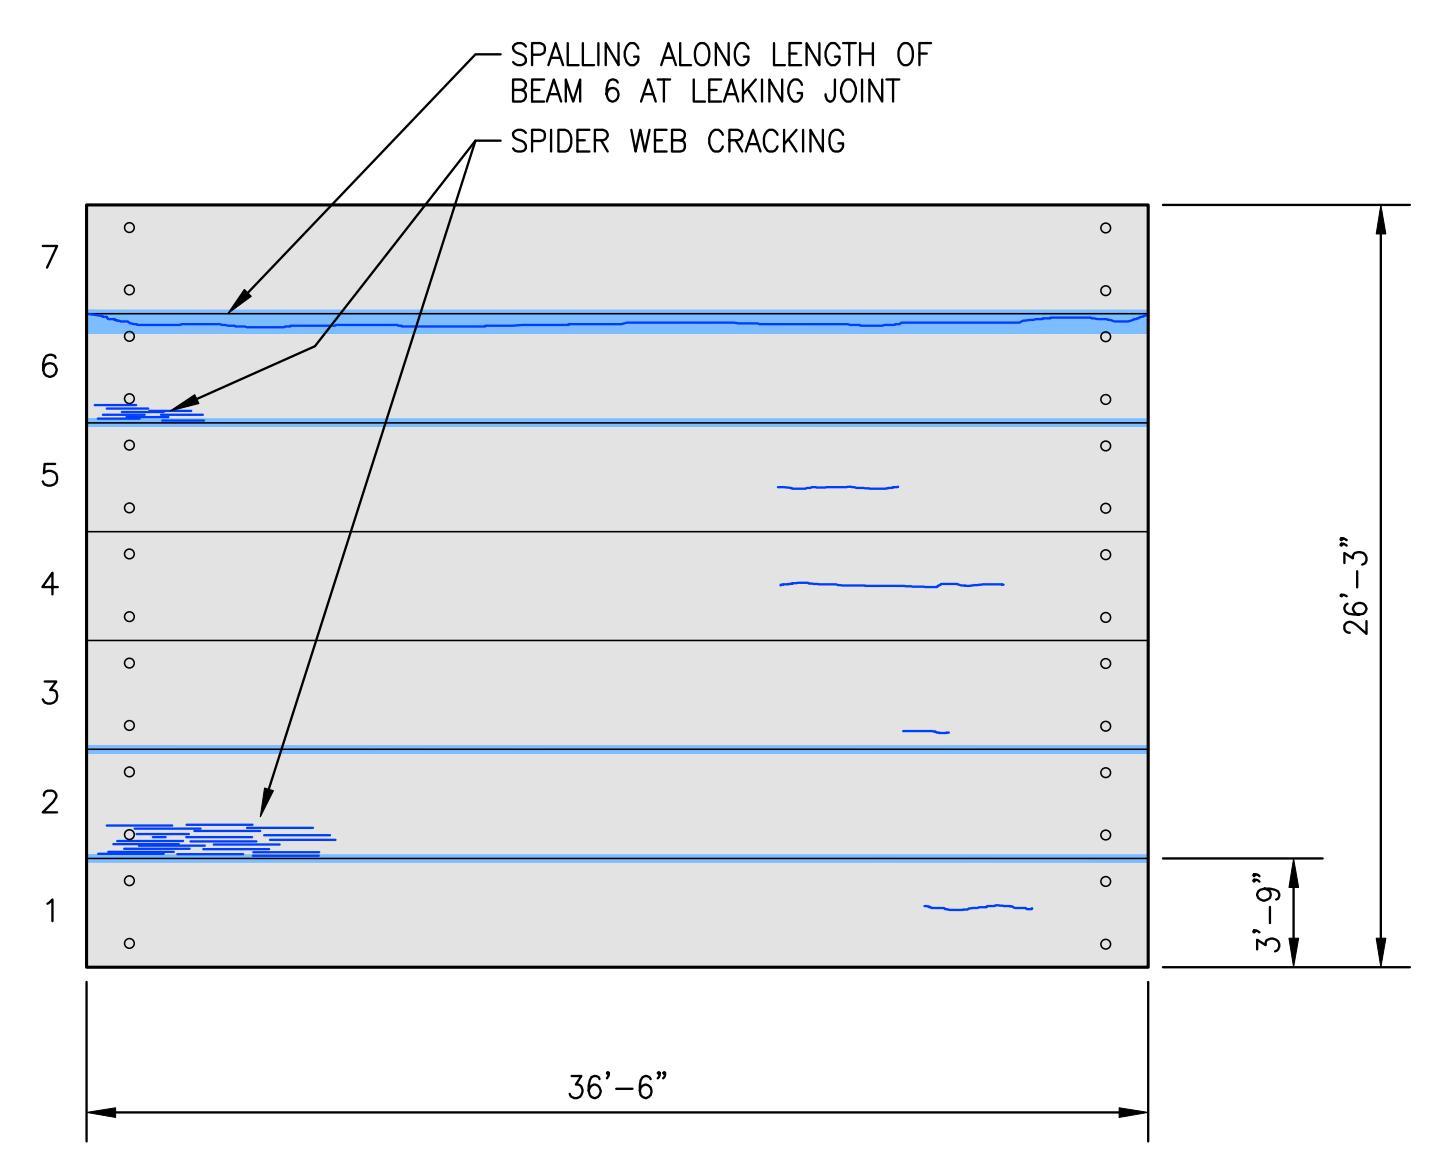
Figure 2.93: Tippecanoe 504 Deterioration Map

Tippecanoe 504 was inspected by the research team on 8 November 2018. A summary of the observed deterioration is presented in Figure 2.93. All beams in the bridge exhibited some form of longitudinal cracking with the exception of Beam 7. Beams 2 and 6 were observed to have spider web cracks at the south support of each beam (Figure 2.94). In addition to the spider web cracking, portions of the west edge of Beam 6 had spalled without exposing strand (Figure 2.95). Efflorescence was common at the exterior and first interior joints from both sides of the bridge (Figure 2.96).

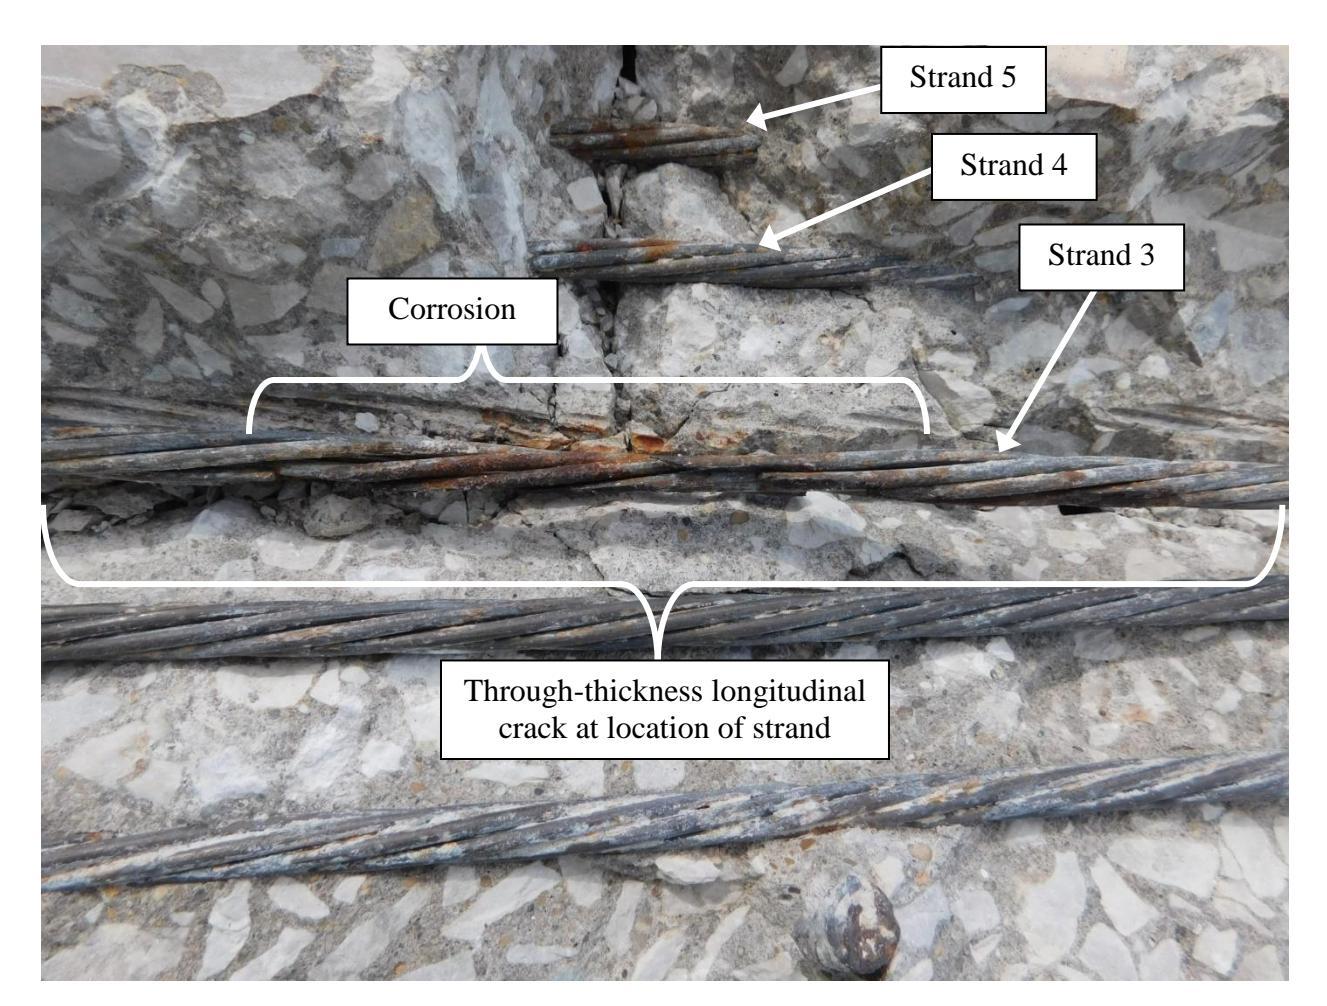
(b) Close-up view of strand corrosion Figure 3.61: Strand Condition at West Longitudinal Crack in Segment C of K5-2-LC

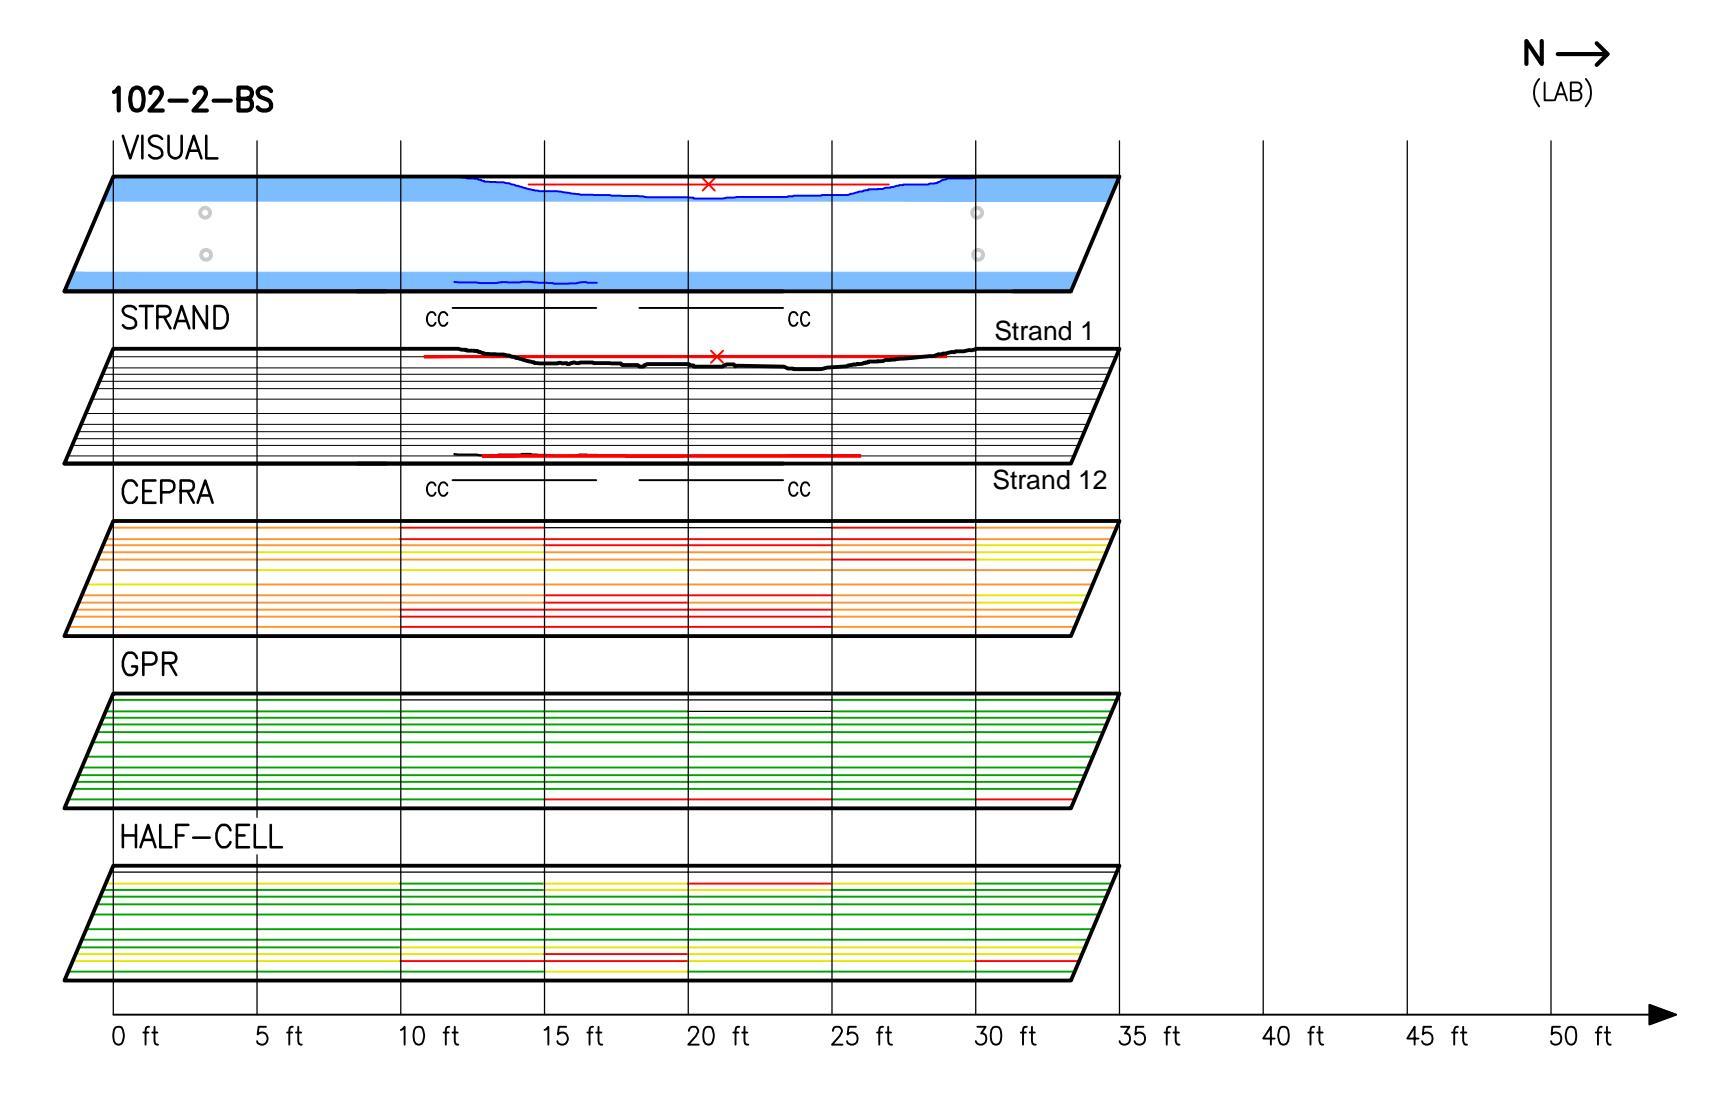
Figure 3.78: 102-2-BS Deterioration Map

As a supplemental example, the deterioration and NDT results of Specimen 102-2-BS are shown in Figure 3.78. The "Visual" and "Strand" deterioration maps show that strand corrosion was limited to the broken strand and strand at the longitudinal cracks and corner cracks. No readings were available at the broken strand; therefore, the strand is colored black in that location. The CEPRA results indicate "visible" corrosion throughout most of the specimen except for strands adjacent to the broken strand and longitudinal and corner cracks, where severe corrosion is indicted. These results are understood as corrosion of the adjacent strands is highly likely. The GPR results indicate corrosion on the strand at the corner crack at midspan and no corrosion throughout the rest of the specimen. Half-cell potentials indicated corrosion adjacent to the broken strand and in the strands adjacent to the longitudinal and corner cracking. These readings are understood to indicate corrosion in the adjacent strands.

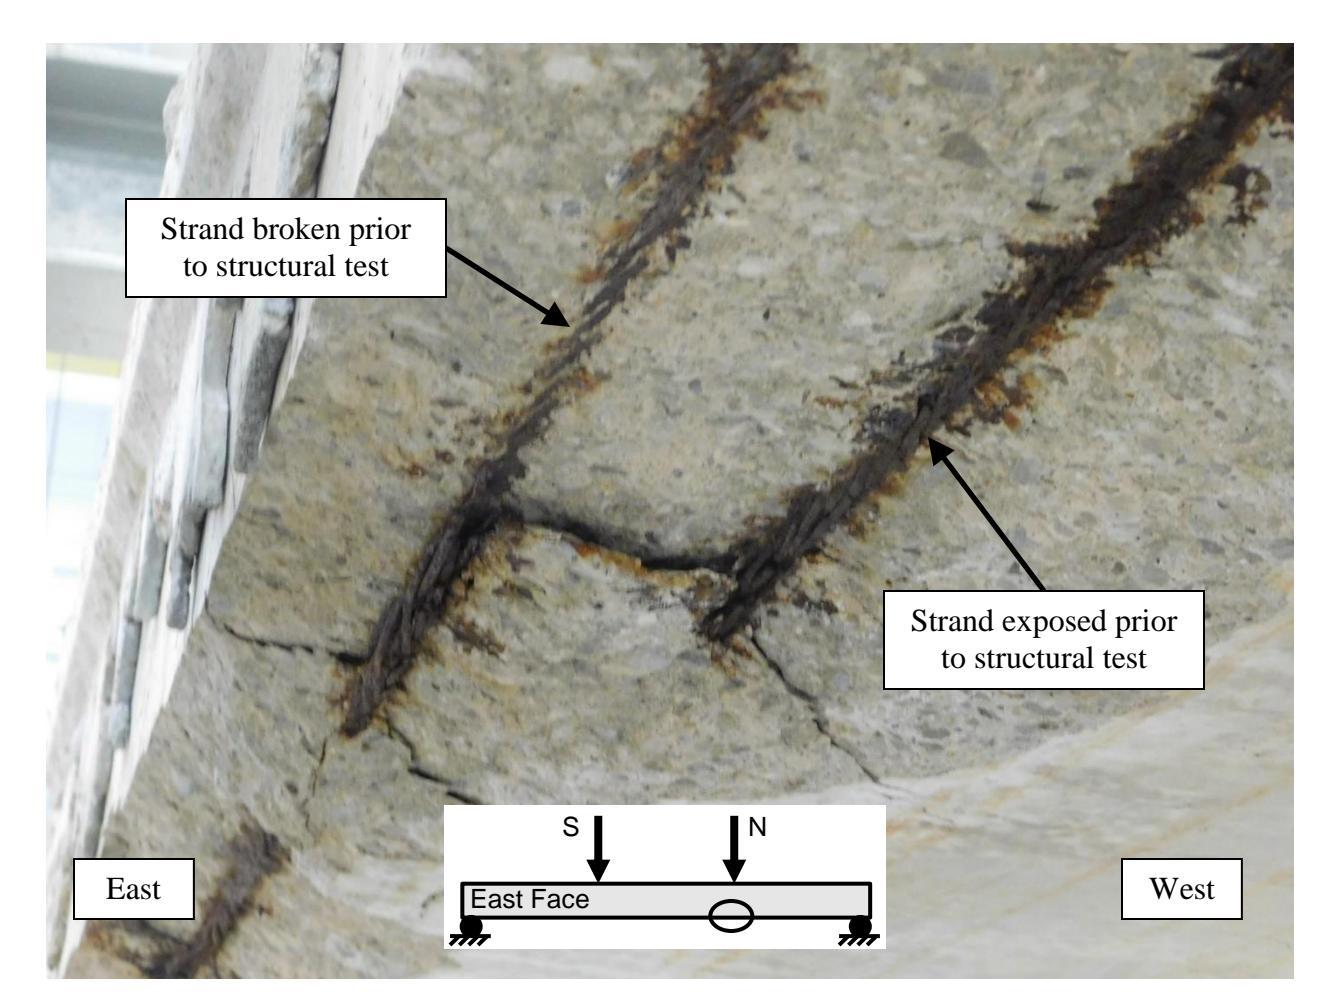
After failure, the corroded strands at the north and south load points were inspected. The corroded strands at the north load point were observed with heavy pitting and major section loss. On the east side of the bottom flange, the exposed strand adjacent to the broken strand was observed to have wire fractures along the length of the strand (Figure 4.117). No bright steel was observed at the interface of the wire fractures indicating that the strand was broken prior to testing. The same observation was made during inspection of the strand on the west side of the bottom flange (the strand exposed at a midspan deflection of 3 in. (Figure 4.113)). Based on these observations, three strands near the north load point were assumed to be broken prior to testing.

Figure 4.117: Existing Exposed and Broken Strand Near North Load Point After Test

The observations of the corroded strands near the north and south load points indicate that three strands near the north load point were ineffective prior to testing. After failure, three of the four strands near the south load point were observed with pitting and indications that wire fractures occurred during testing. Based on these observations, the initial stiffness of the beam was assumed to be controlled by the weak section near the north load point. As testing commenced, the corroded strands near the south load point began to fracture and ultimately controlled the failure mode of the specimen.

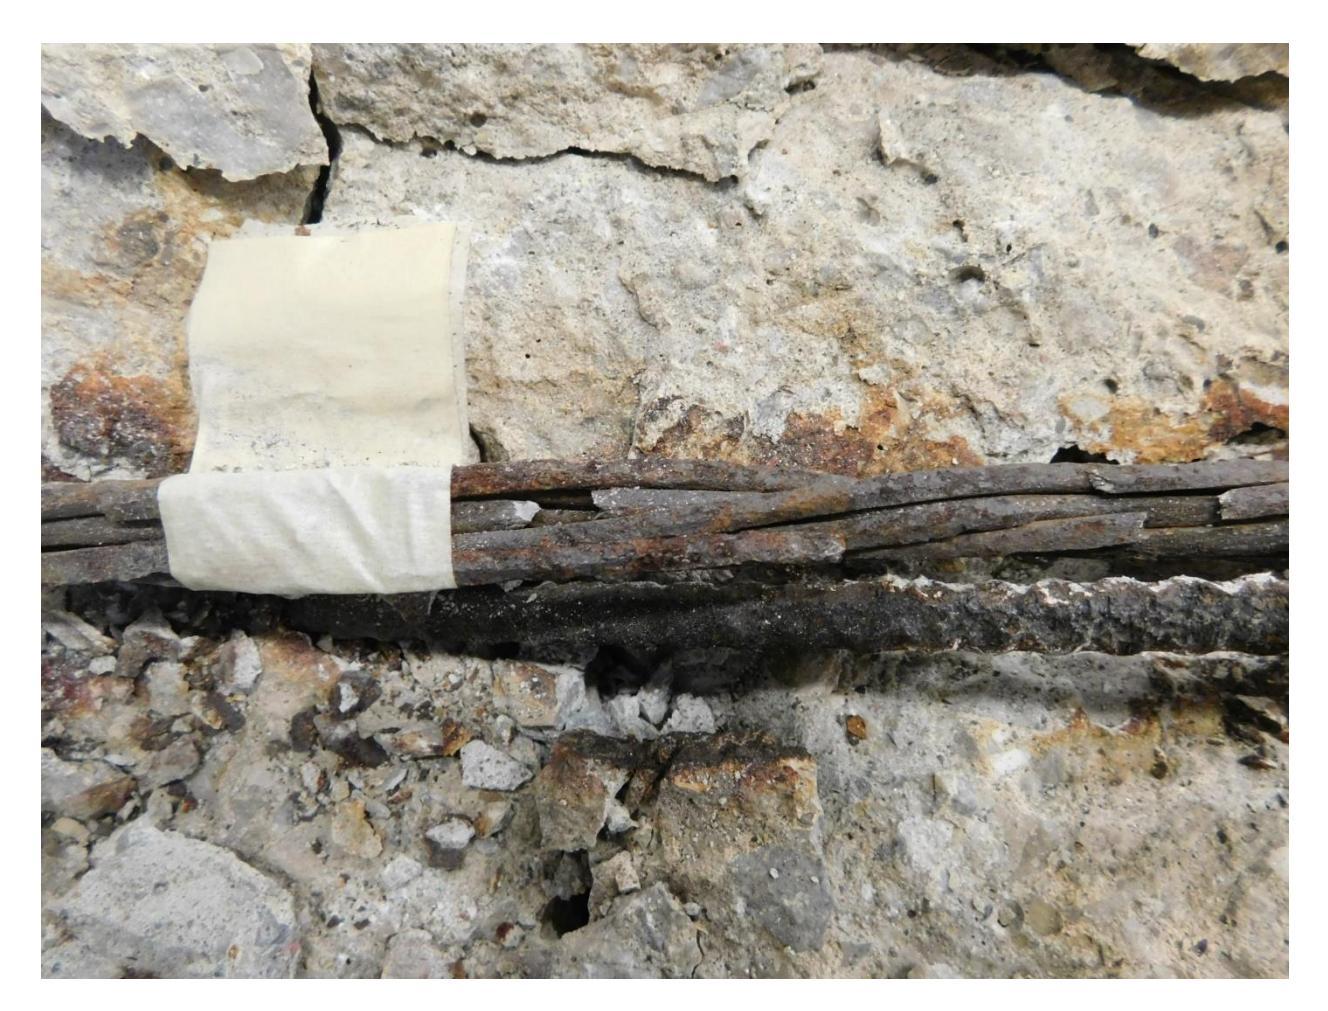
Figure 4.118: Example of Bright Steel at Fracture Interface of Corroded Strand

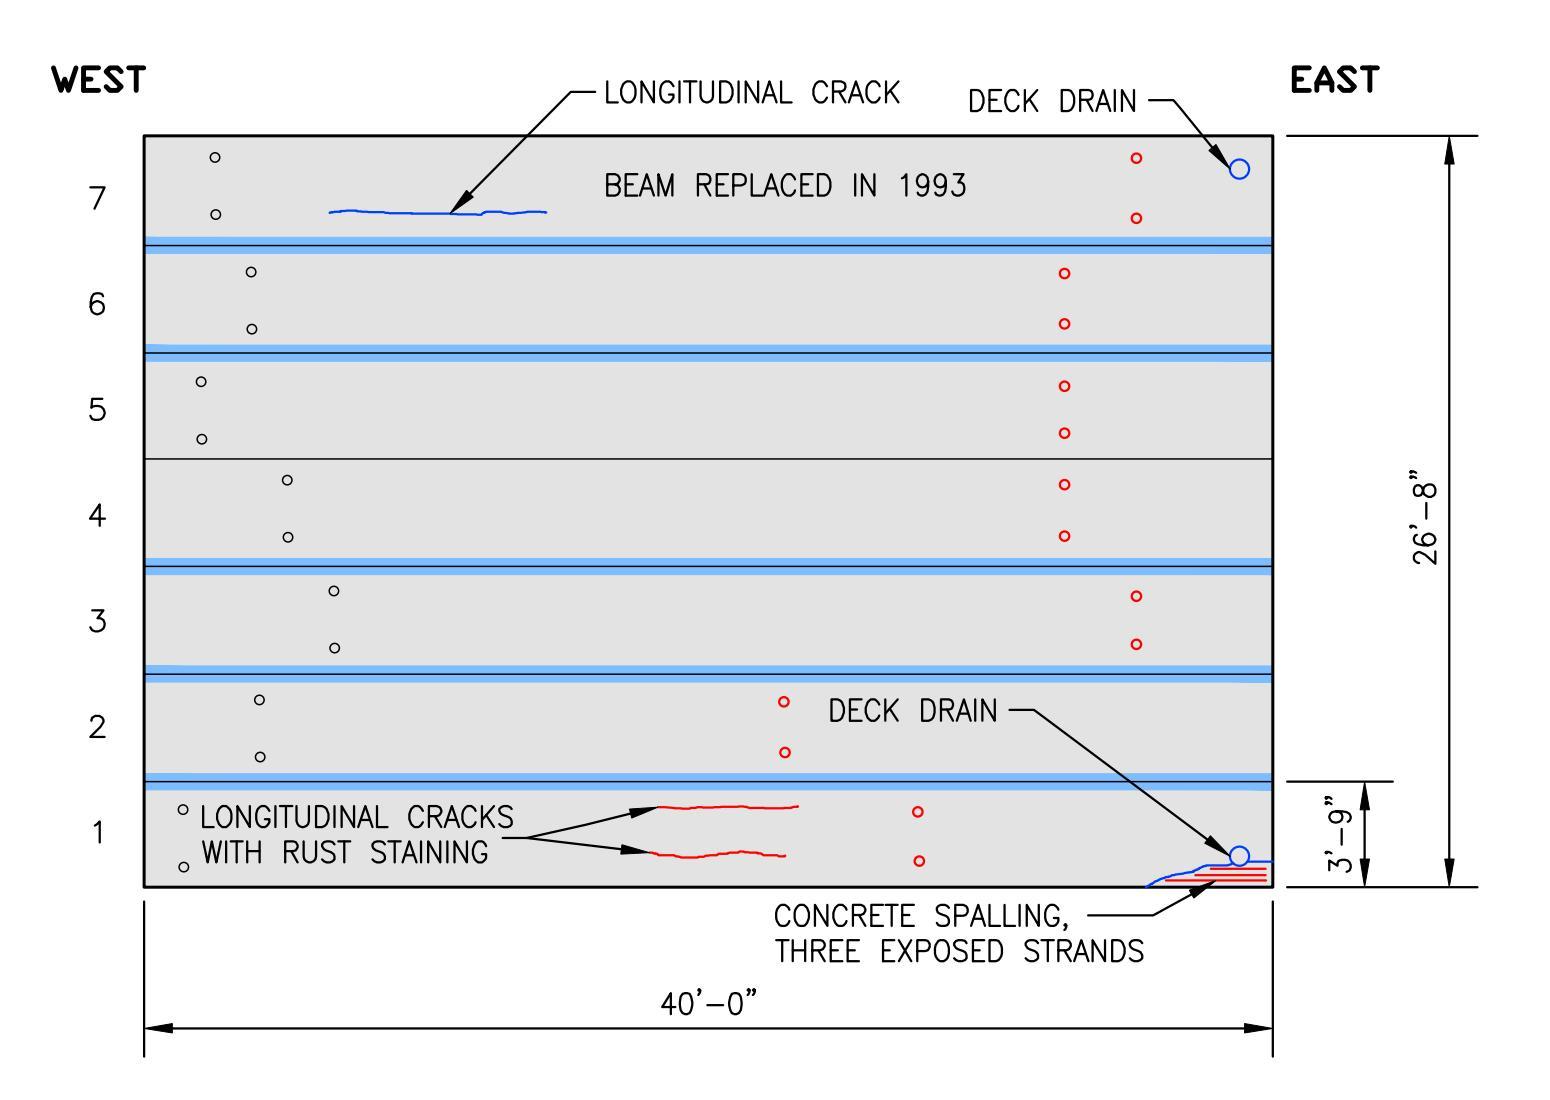
Figure 5.3: Tippecanoe 115 Bottom Flange Deterioration

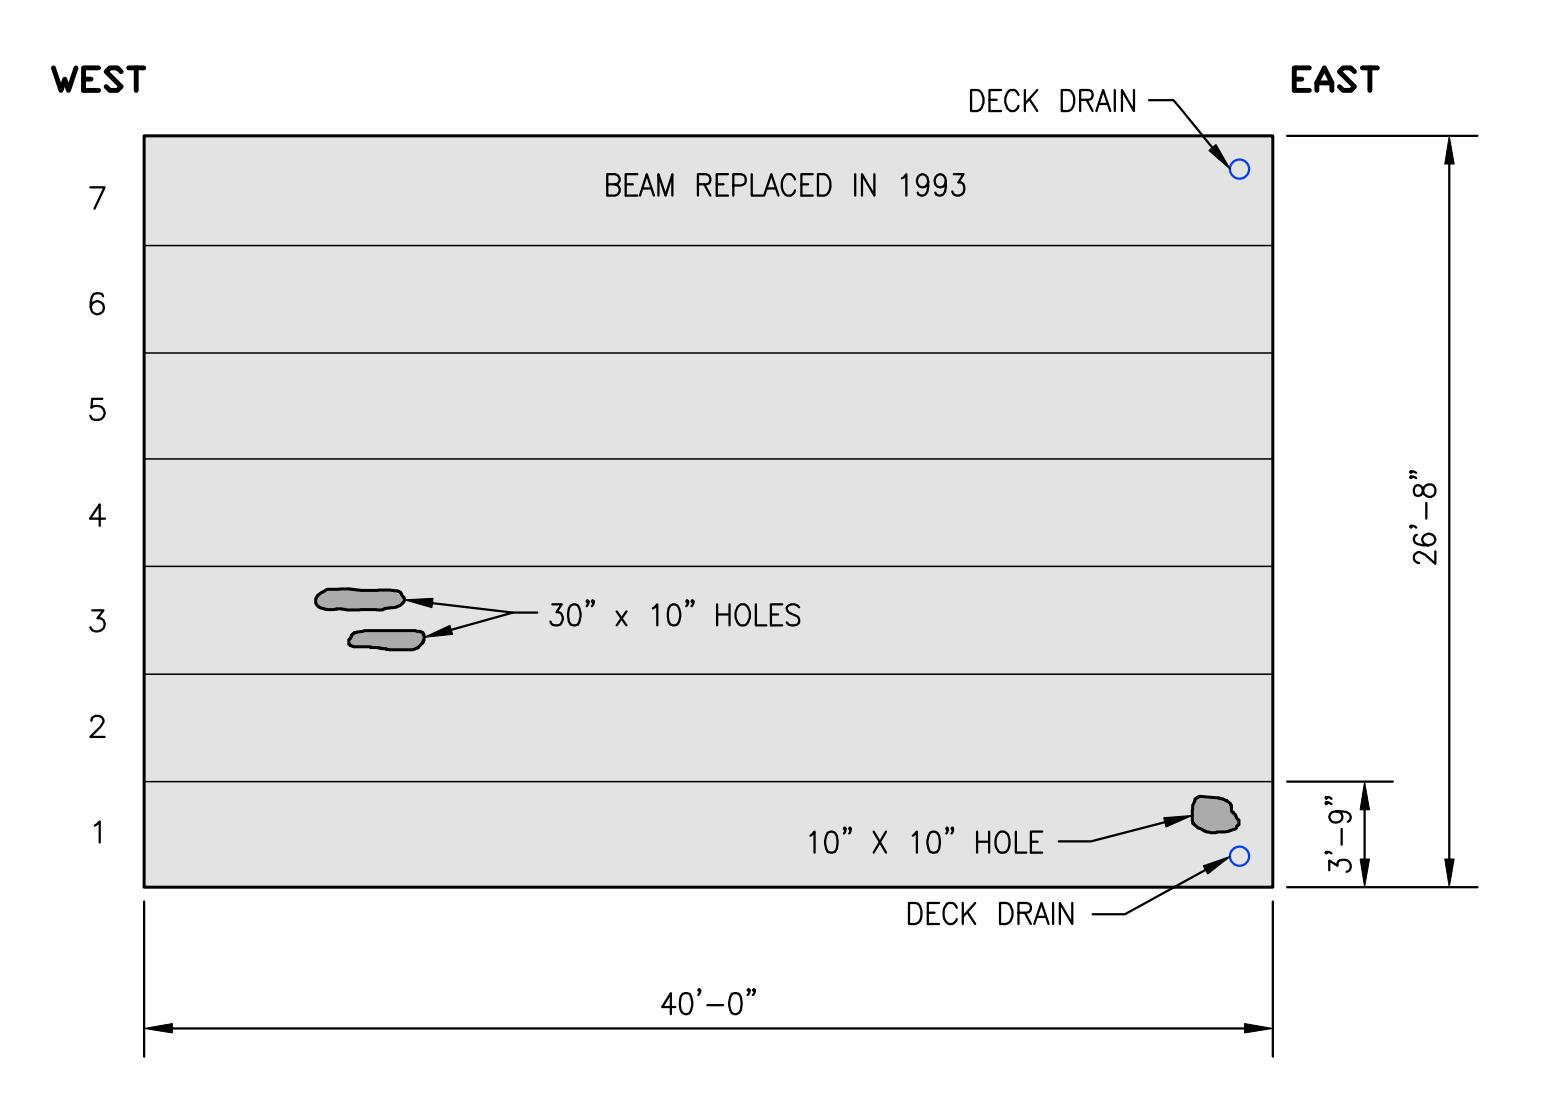
Figure 5.12: Bridge 79-00115 Plan of Top Flange Deterioration

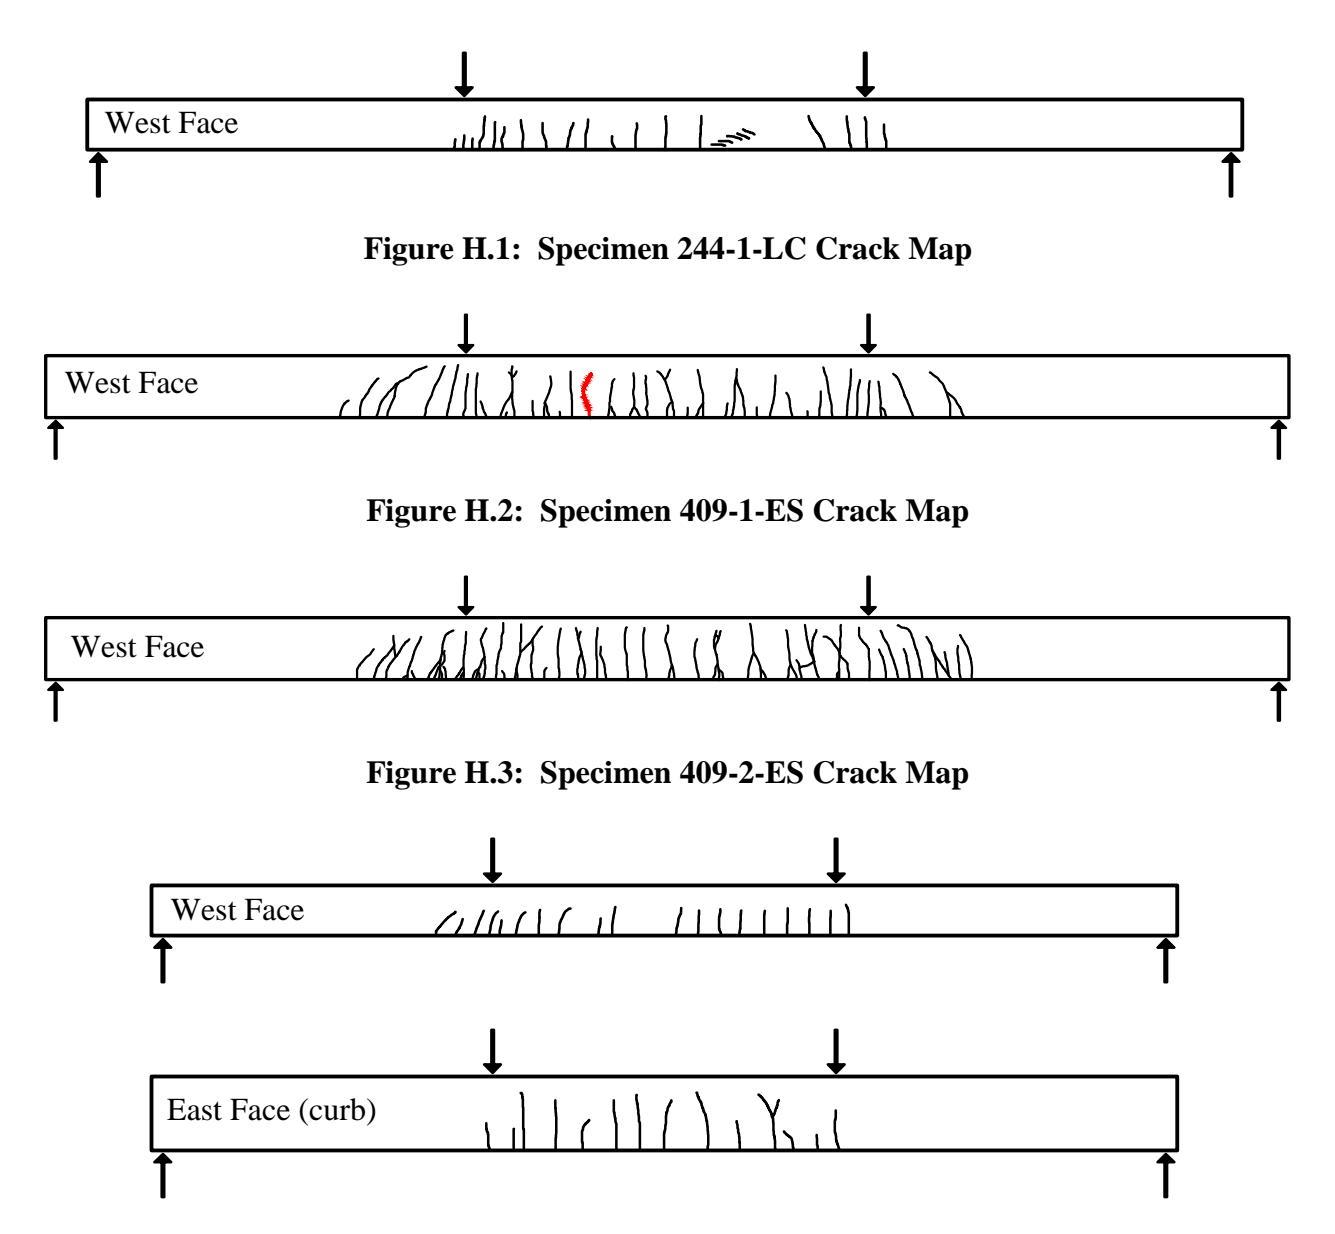
Figure H.4: Specimen K5-1-LC Crack Map

Note: Red cracks indicate the location of strand fracture at collapse.

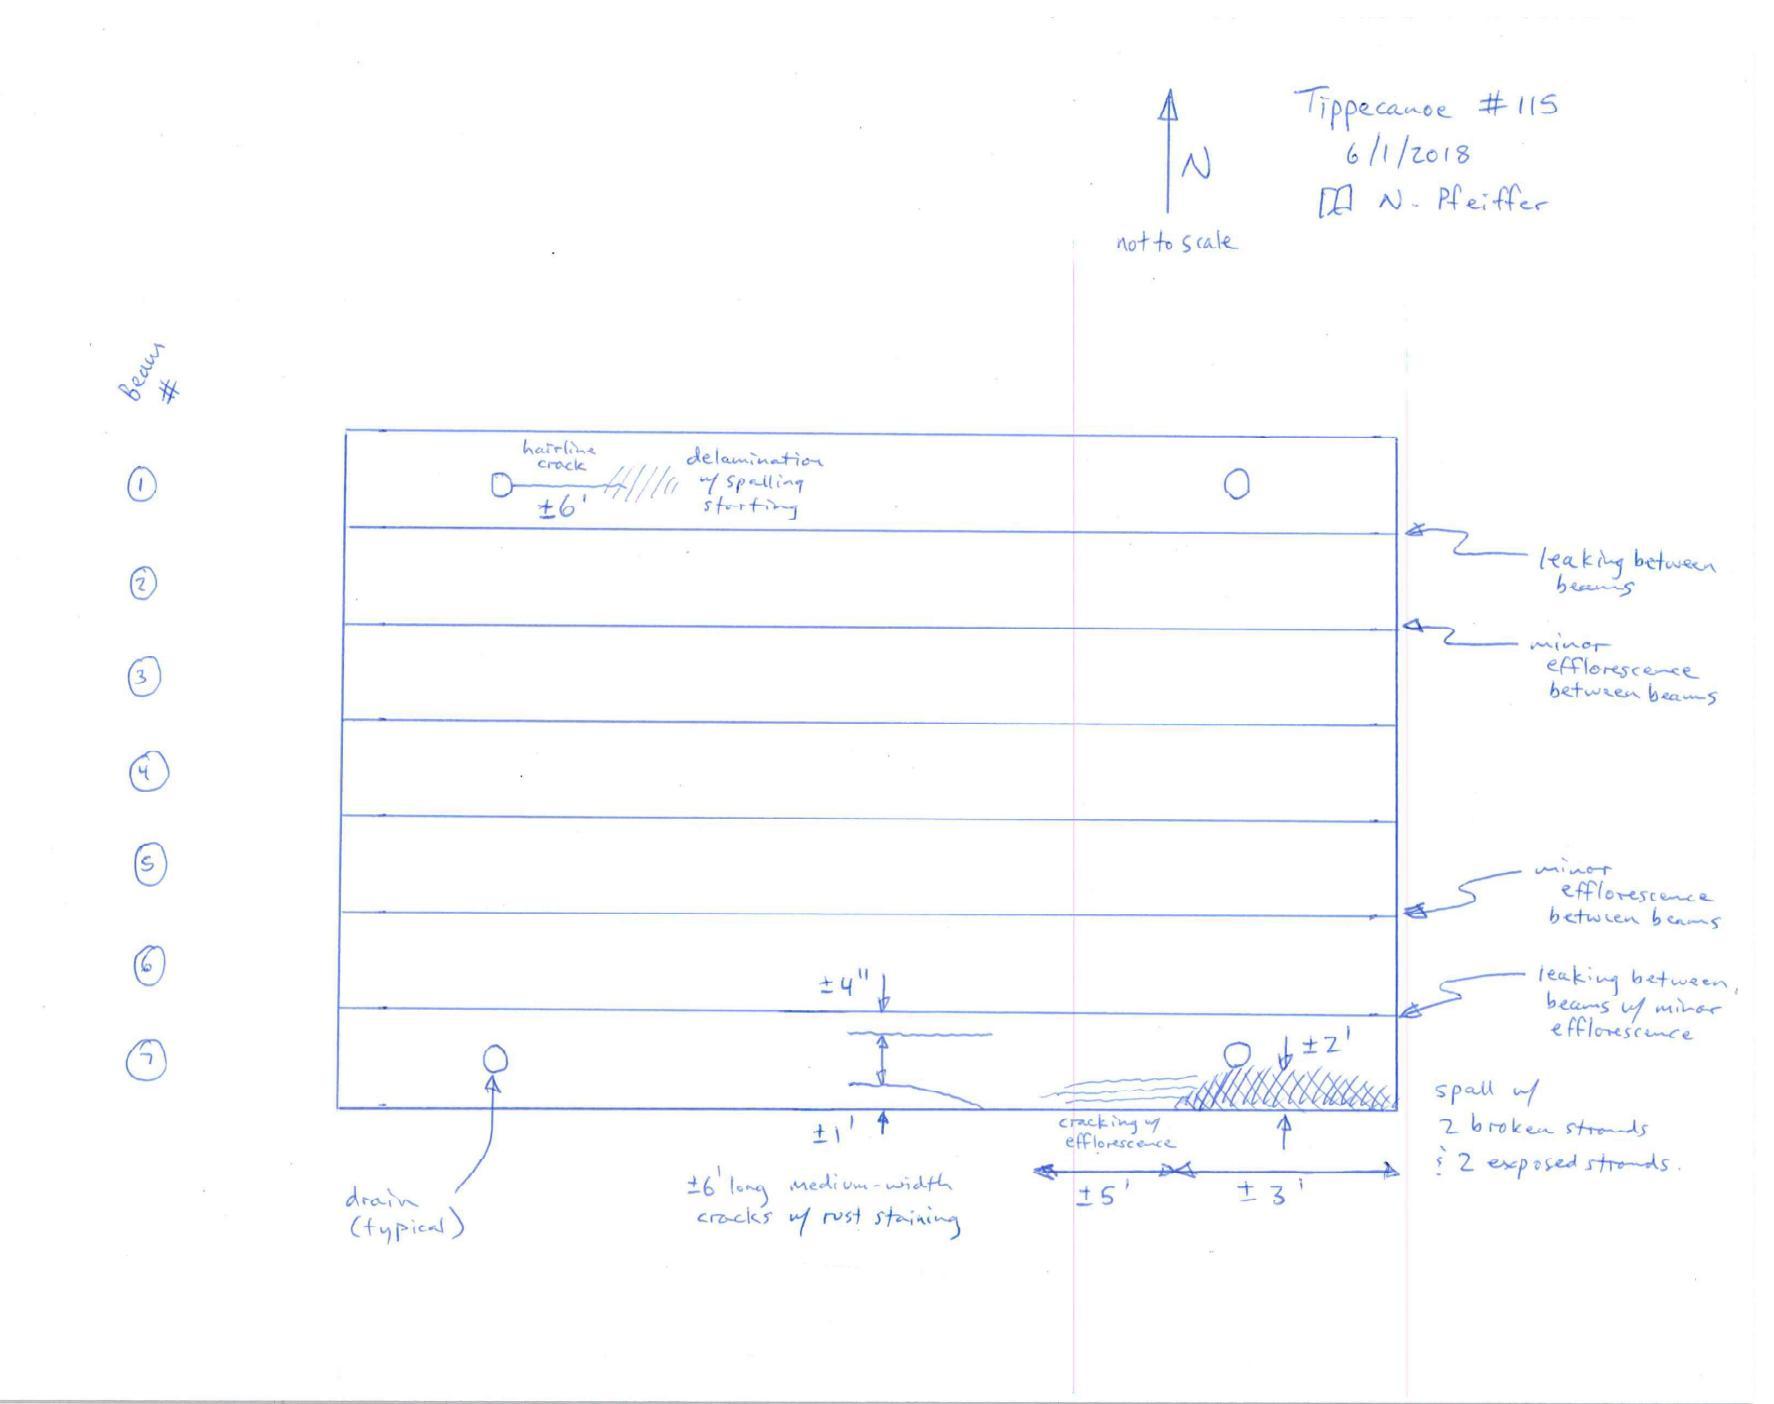
Description 6-7-2018 str 79-00115 - S facia beam crack along S side with rust staining looking W
