**A BENCHMARK FOR EVALUATING PERFORMANCE IN VISUAL
INSPECTION OF STEEL BRIDGE MEMBERS AND STRATEGIES FOR
IMPROVEMENT**

A Dissertation

Lyles School of Civil Engineering
West Lafayette, Indiana
May 2019

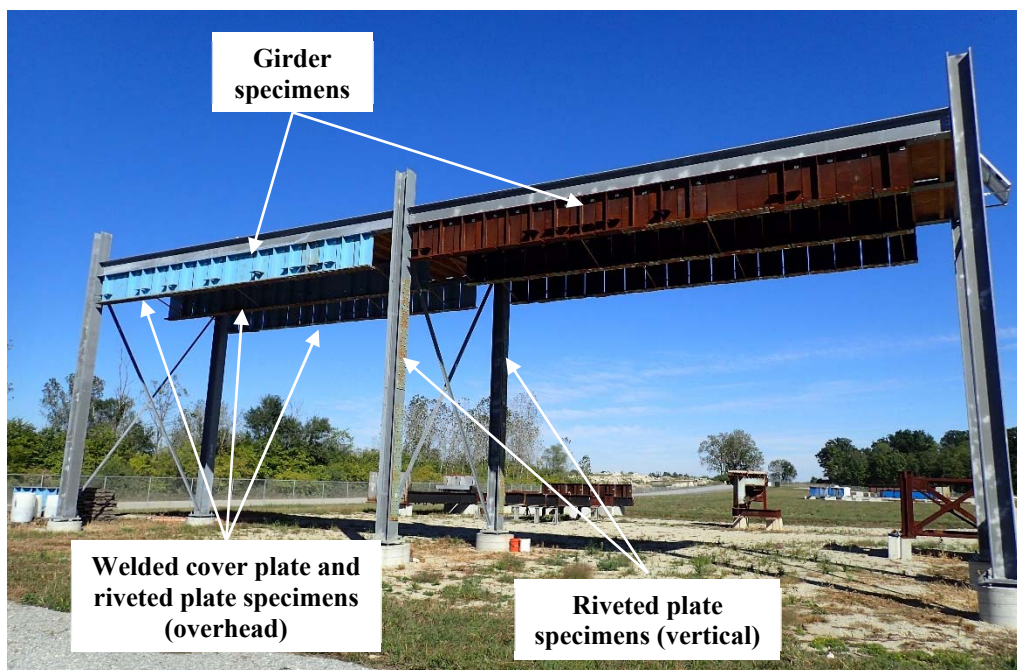
Figure 3.1 Probability of detection training structure with POD specimens

The training structure, shown in Figure 3.1, was designed and constructed at Purdue University's Steel Bridge Research, Inspection, Training, and Engineering (S-BRITE) Center to model a two span, three girder highway bridge. The structure supports 183 full size bridge specimens with known fatigue cracks. Considering the typical spacing of these details on an actual bridge, the test frame represents a bridge of approximately 450 to 500 feet. The specimens are suspended 25 feet above the ground and a timber deck and timber framing were installed to mimic typical access and lighting conditions. Due to time constraints, only a subset of the specimens installed on the training structure were included in the inspection scenario. After eliminating the weathering steel specimens, the inspection included 72 girder specimens, 16 riveted plate specimens (8 mounted overhead and 8 mounted vertically), and 59 welded cover plate specimens. Each inspector inspected the same specimens in the same order.

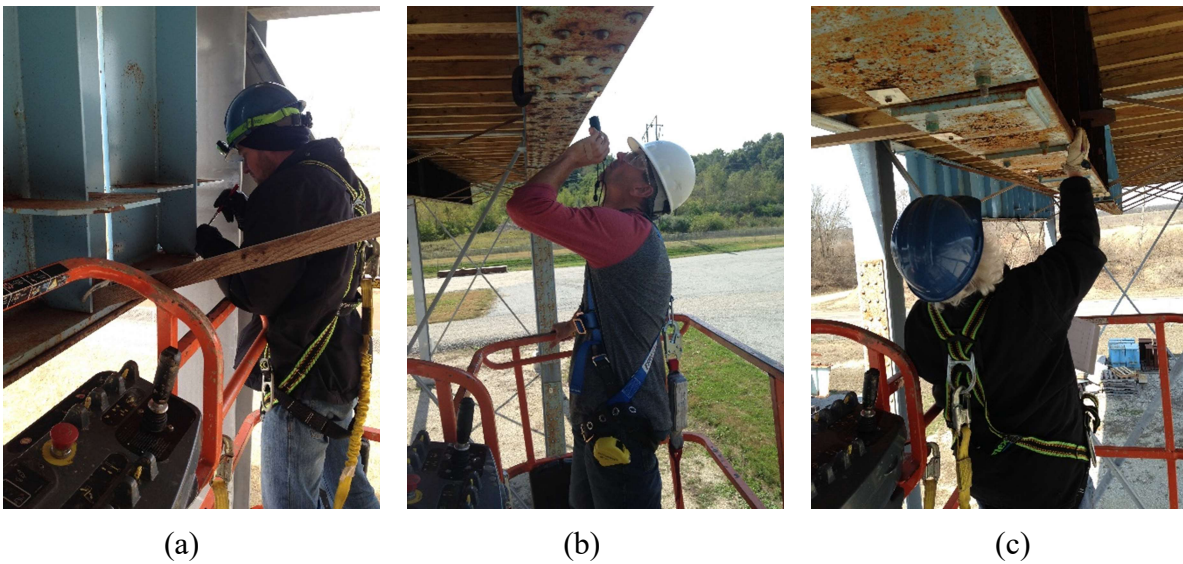
Figure 3.2 Hands-on inspection of the (a) girder, (b) overhead mounted riveted plate, and (c) welded cover plate specimens

plate girder or wide flange sections with out-of-plane distortion induced cracks, welded cover plate terminations with weld toe cracks, and riveted plates with rivet hole cracks. The painted specimens were coated with a typical bridge paint system, excluding the polyurethane top coat. To imitate in-service bridges, all specimens (flawed and unflawed) were subjected to an accelerated weathering process. A combination of salt water, metal shavings, and scratches were applied to simulate typical damage and deterioration. Each specimen had one crack, multiple cracks, or no cracks. Although the specimens were fabricated in a controlled laboratory setting, all cracks were sized, oriented, and located as they typically are in the field. A detailed discussion of the preparation of the specimens is provided in [50].

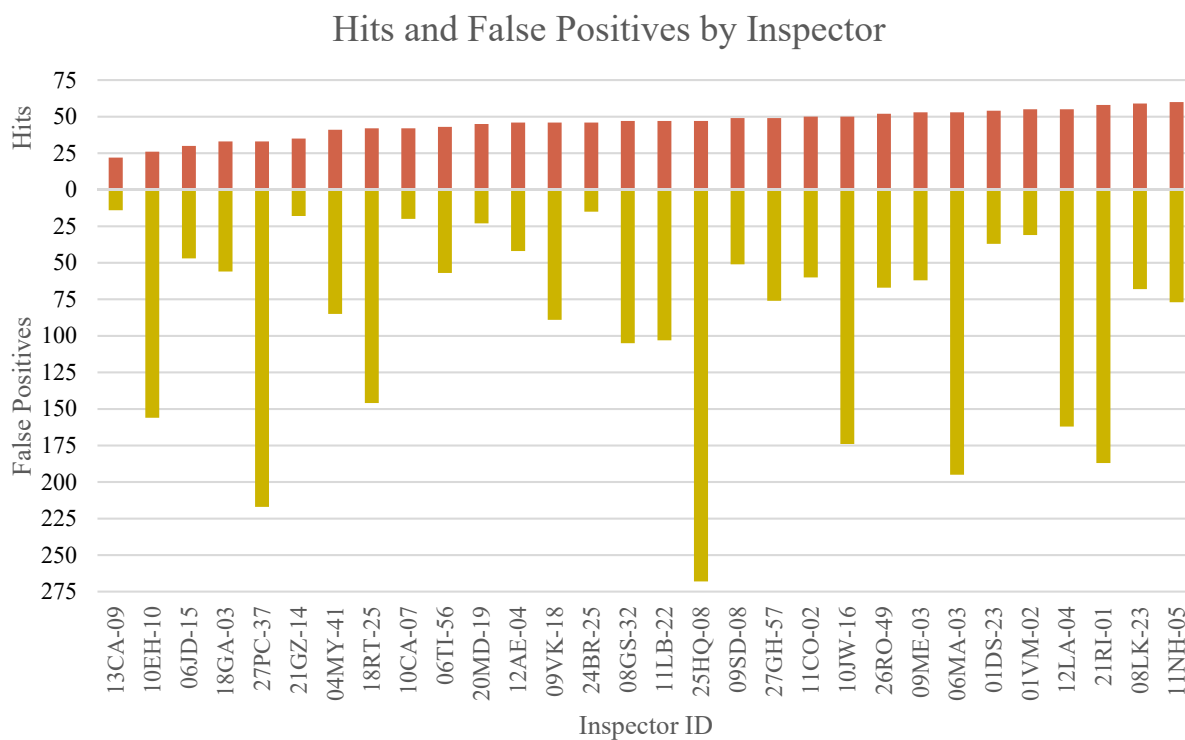
Figure 3.5 Hits and false calls by inspector during the hands-on inspections

the number of hits (positive y-axis). Therefore, inspectors that made more calls did not necessarily locate more cracks.

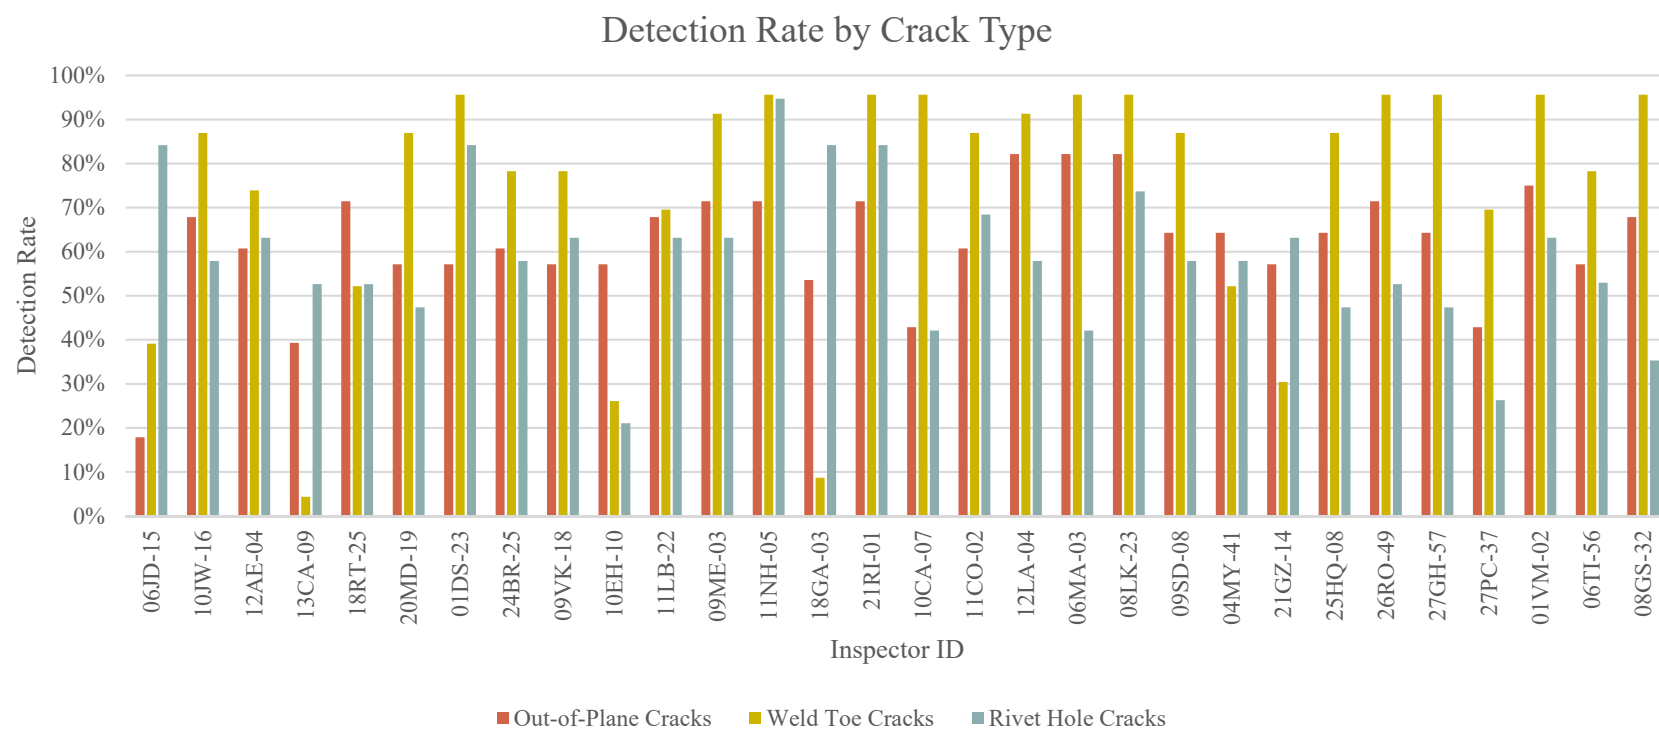
Figure 3.6 Inspector detection rates by crack type

The average detection rates for each specimen type for each inspector were also studied. Twenty-three (23) of the 30 inspectors recorded their highest detection rate on the weld toe cracks. Four inspectors recorded their highest detection rate on the rivet hole cracks and three inspectors recorded their highest detection rate on the out-of-plane cracks.

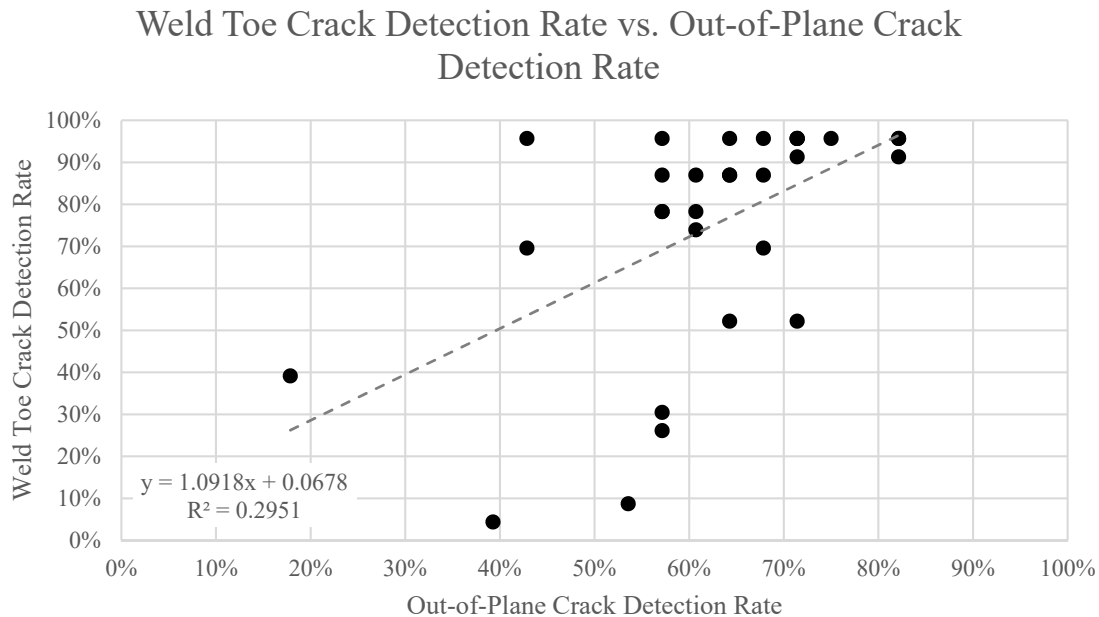
Figure 3.7 Weld toe crack detection rate plotted against out-of-plane crack detection rate

Finally, there was a positive correlation between detection rates of the out-of-plane cracks and the weld toe cracks, meaning that performance on one subset of the inspection could be used to predict performance on another subset. However, there was no correlation between detection rates of the out-of-plane cracks and the rivet hole cracks or between the detection rates of the rivet hole cracks and the weld toe cracks. The relationship between weld toe crack detection rate and out-of-plane crack detection rate is shown in Figure 3.7.

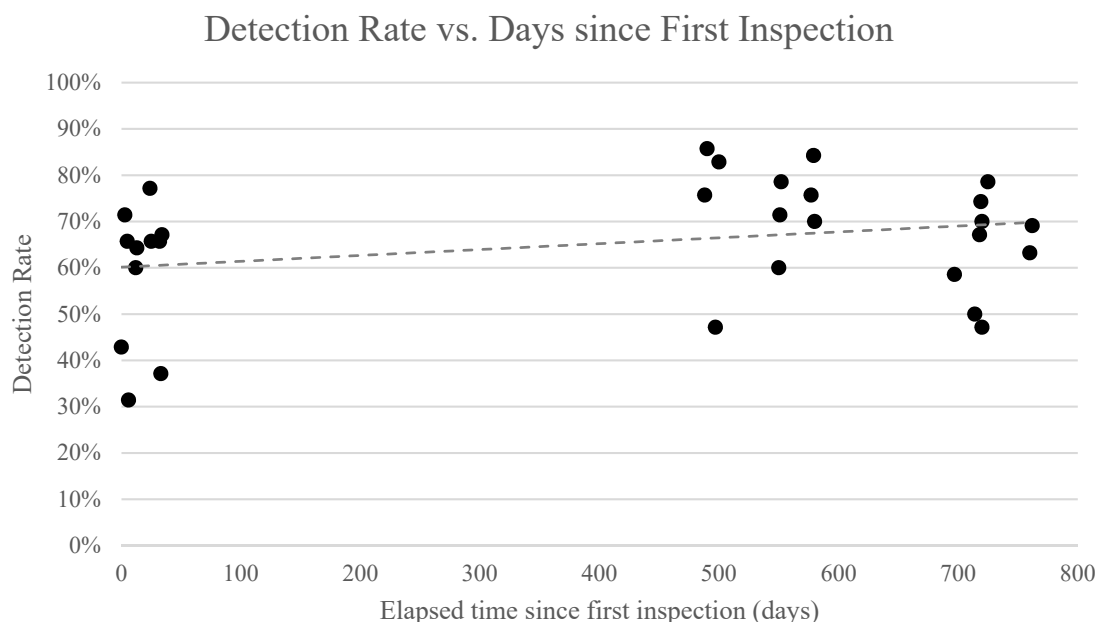
Figure 3.8. Detection rate plotted against the number of days since the first POD inspection

long gap between the 11th and 12th inspections, the conditions of all the specimens were revalidated by Purdue research staff.

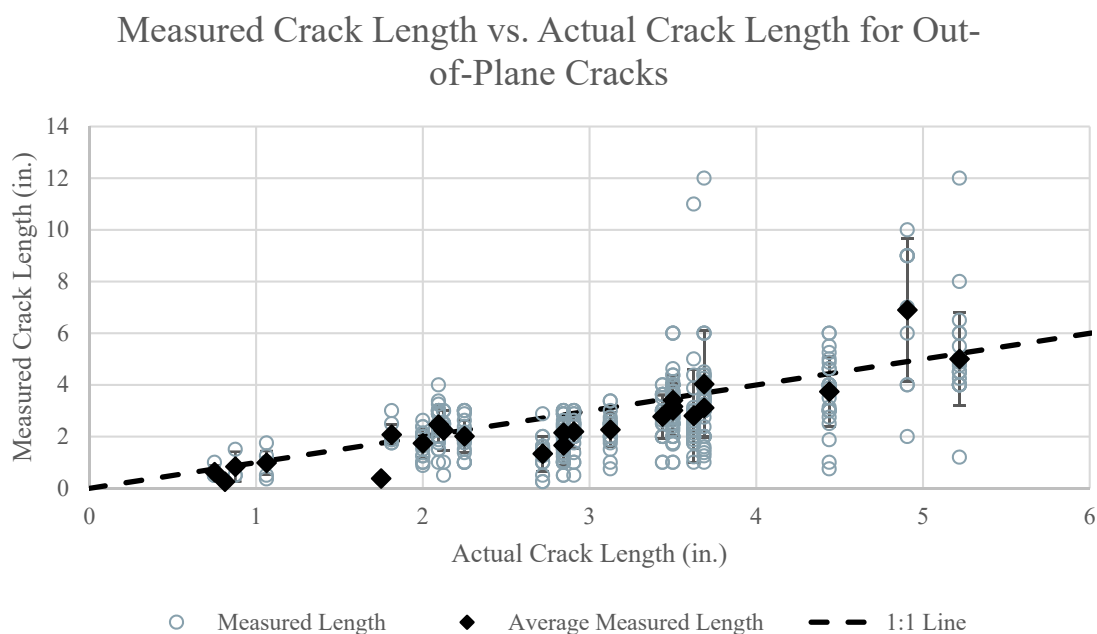
Figure 3.9 Measured crack length versus actual crack length for out-of-plane cracks

the inspectors tended to underestimate the crack length. Since most of these cracks were wrapped around the ends of the stiffeners, it was difficult to accurately measure the length and most inspectors just approximated the length of each leg. The average measurement error was -0.38 inch and the average absolute error was 0.92 inch. The average absolute error increased with crack length and the percent absolute error remained constant with crack length. Table 3.4 shows the error analysis for the reported length measurement for all the cracks in the girder specimens.

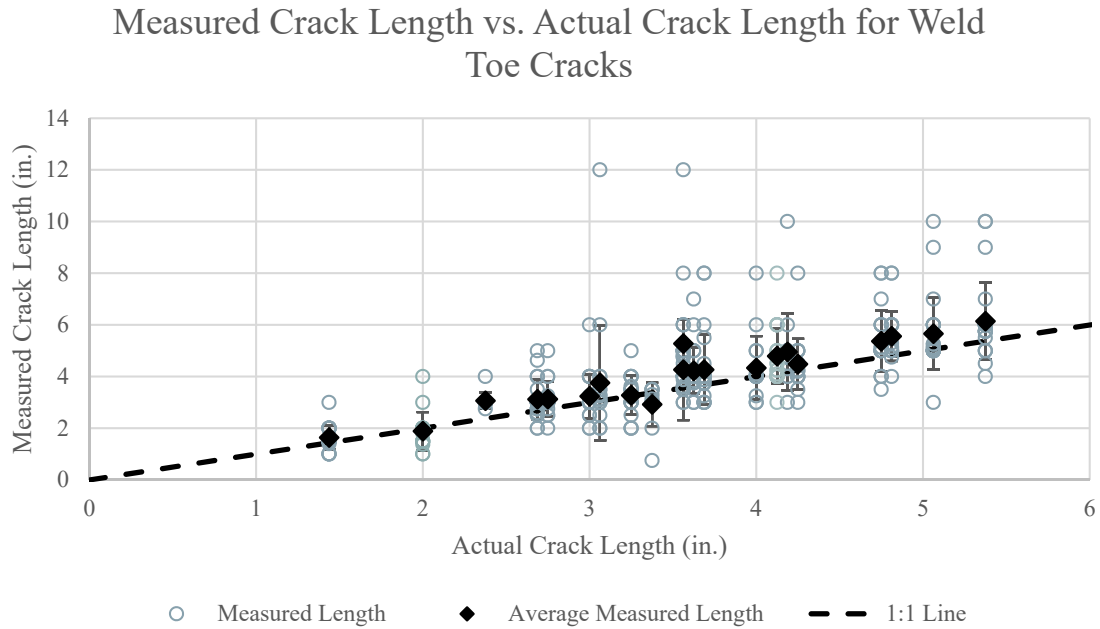
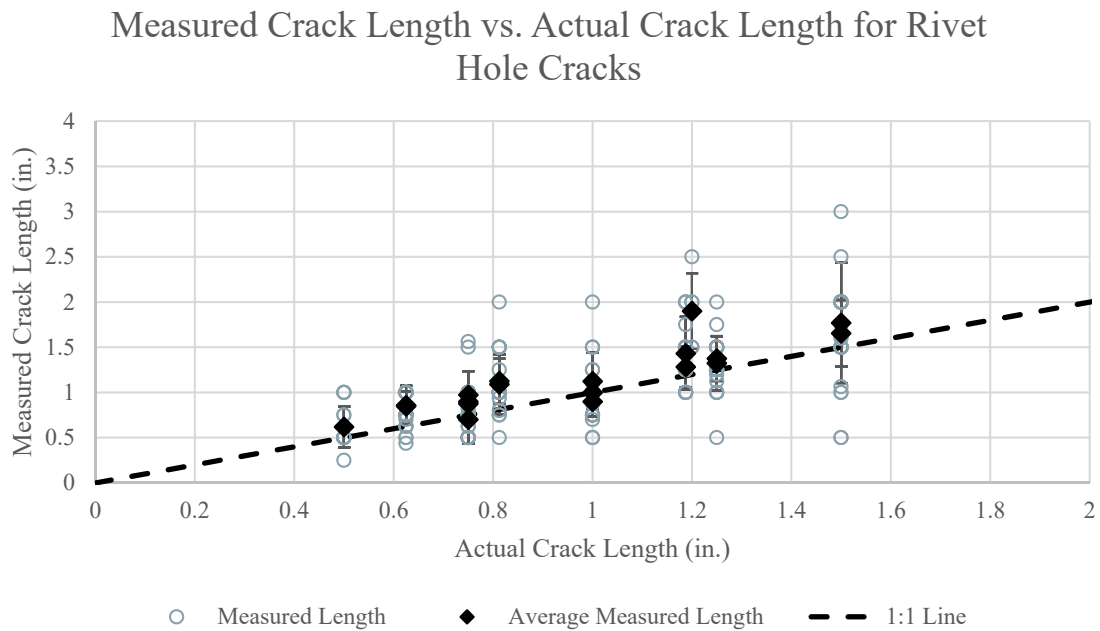
Figure 3.10 and Figure 3.11 present the crack length data for the welded cover plate and riveted plate specimens, respectively. In contrast to the girder specimens, the average of the measured lengths of these cracks is generally above the 1:1 line indicating that the inspectors had a tendency to overestimate the length. For the weld toe cracks, the average measurement effort was 0.51 inch and the average absolute error was 0.76 inch. For the rivet hole cracks, the average measurement error was 0.14 inch and the average absolute error was 0.24 inch. For both crack types, the average absolute error increased with crack length and the percent absolute error decreased with crack length. Table 3.4 shows the error analysis for the reported length measurement for all the cracks in the welded cover plate and riveted plate specimens.

Figure 3.10 Measured crack length versus actual crack length for weld toe cracks

Figure 3.11 Measured crack length versus actual crack length for rivet hole cracks

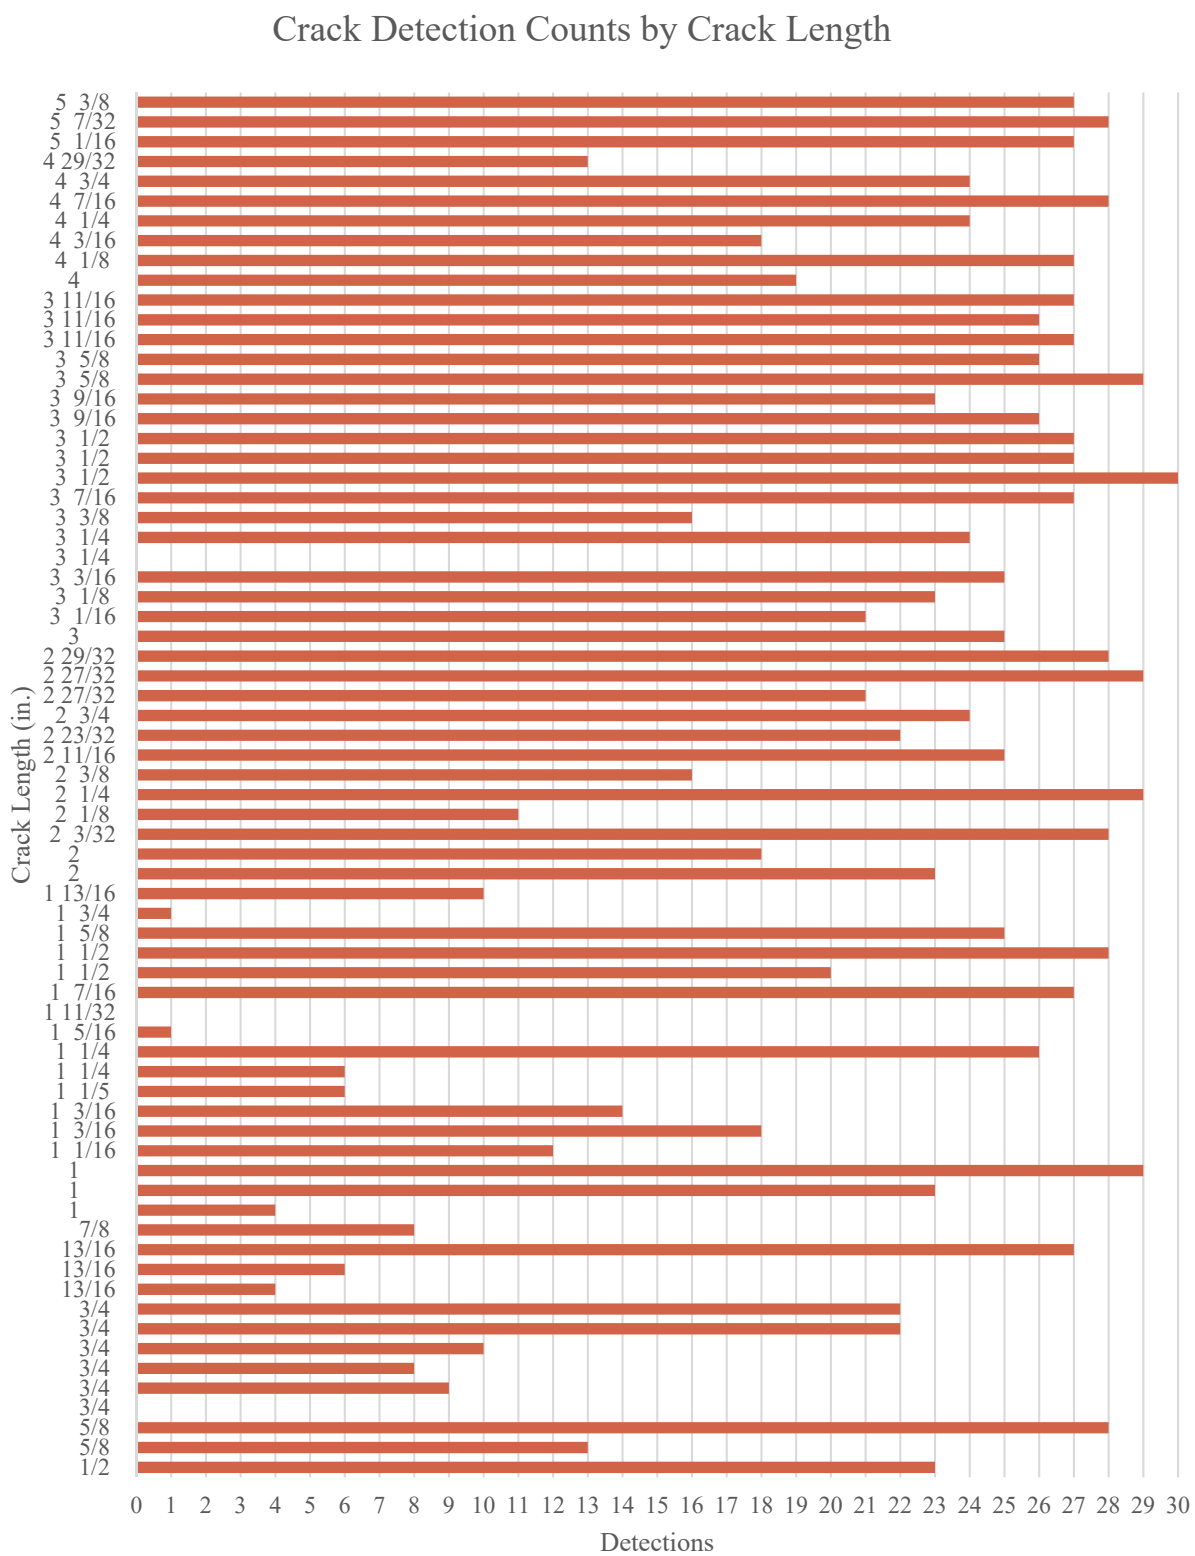
Figure 3.12 Number of crack detections by crack

Each crack had the potential to be detected 30 times, once by each participant. One crack was detected by all 30 inspectors, while three cracks were not detected by any participants. The largest undetected crack was 3-1/4 inches. This undetected crack was located along the weld toe of a tapered cover plate specimen. The other two undetected cracks were out-of-plane cracks in the girder specimens. These cracks were both located in the web gap between a longitudinal stiffener and a transverse stiffener and they were 3/4 inch and 1-11/32 inches in length. The smallest crack, measuring 1/2 inch, was detected by 23 of the 30 inspectors. This crack was located at a rivet hole. Figure 3.12 shows each crack, sorted by length, and the number of times it was correctly identified by an inspector. Visually, it appears that there was a correlation between crack size and number of detections. Generally, the longer cracks were detected more often than the shorter cracks.

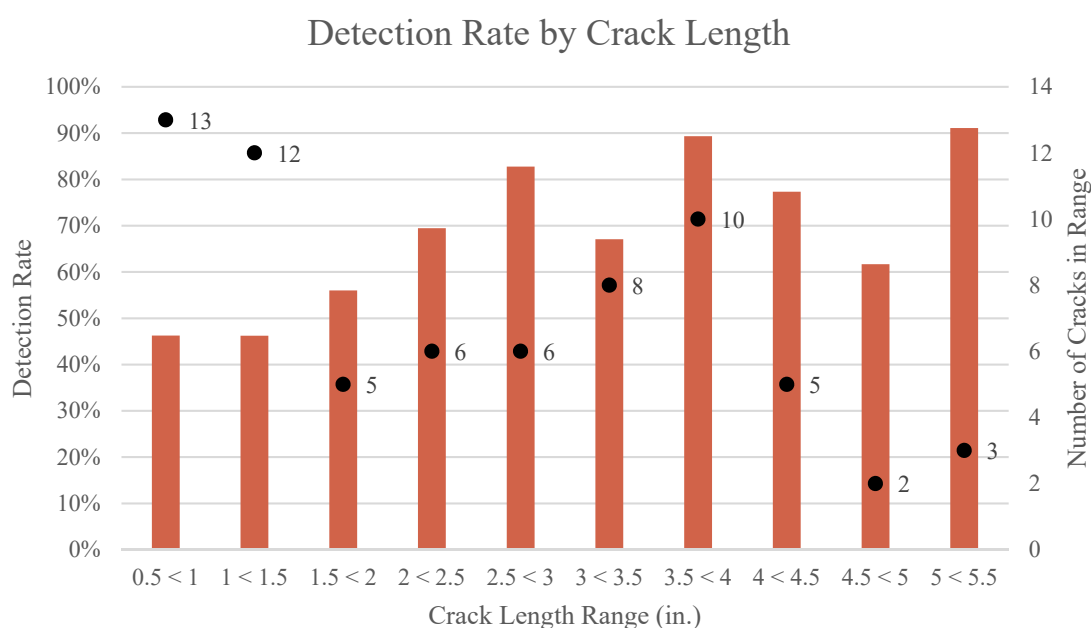
Figure 3.13 Detection rate by crack length

The cracks were grouped into 1/2-inch length increments, beginning at 1/2 inch, and the detection rate for bin was computed. The detection rate was determined by summing the number of hits for each crack in the increment and dividing by the total number of detection attempts made. The smallest crack size ranges, 1/2 to 1 inch and 1 to 1-1/2 inches, had the lowest detection rate, 46%. The largest crack size range, 5 to 5-1/2 inches, had the highest detection rate, 91%. The detection rates for the crack size ranges in between the extremes varied from 56% to 89%. Figure 3.13 shows the detection rates for each length increment. The number of cracks in each bin are shown on the right hand vertical axis.

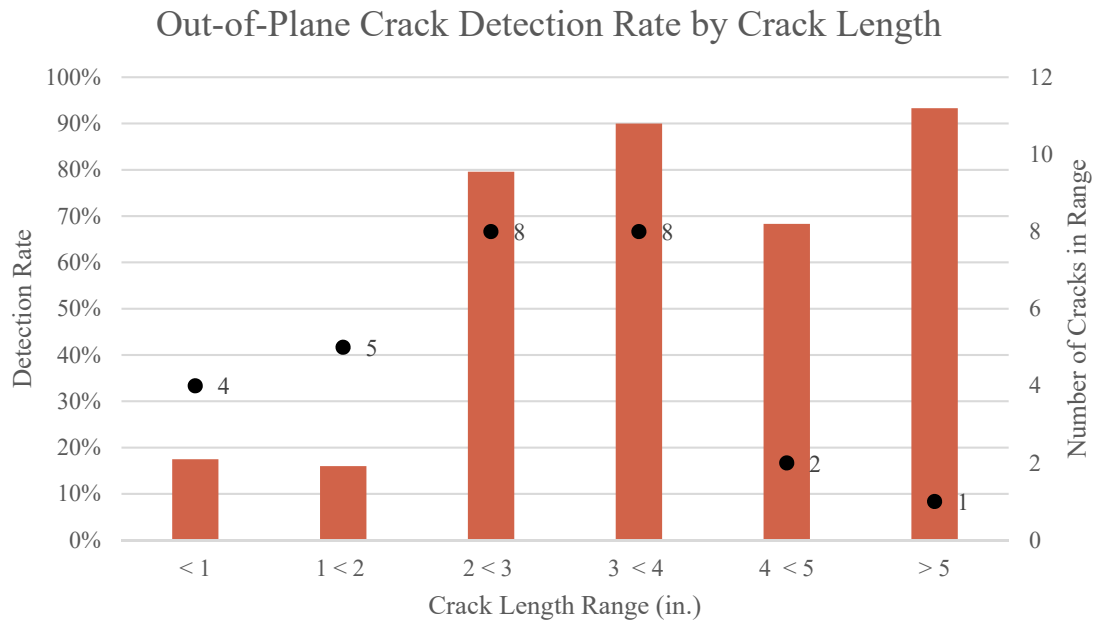
Figure 3.14 Out-of-plane crack detection rate by crack length

The detection results for each crack type were separated from the total data and examined for a relationship between crack length and detection. As shown in Figure 3.14, the detection rate increased with increasing crack length for the out-of-plane cracks. Although the increase is not constant, there is a clear improvement in detection for cracks longer than 2 inches. Figure 3.9 and Figure 3.10 show the relationship between detection rate and crack length for the weld toe cracks and the rivet hole cracks, respectively. Detection rate does not appear to be heavily influenced by crack length for these crack types, although the more limited range in crack lengths may have restricted the relationship.

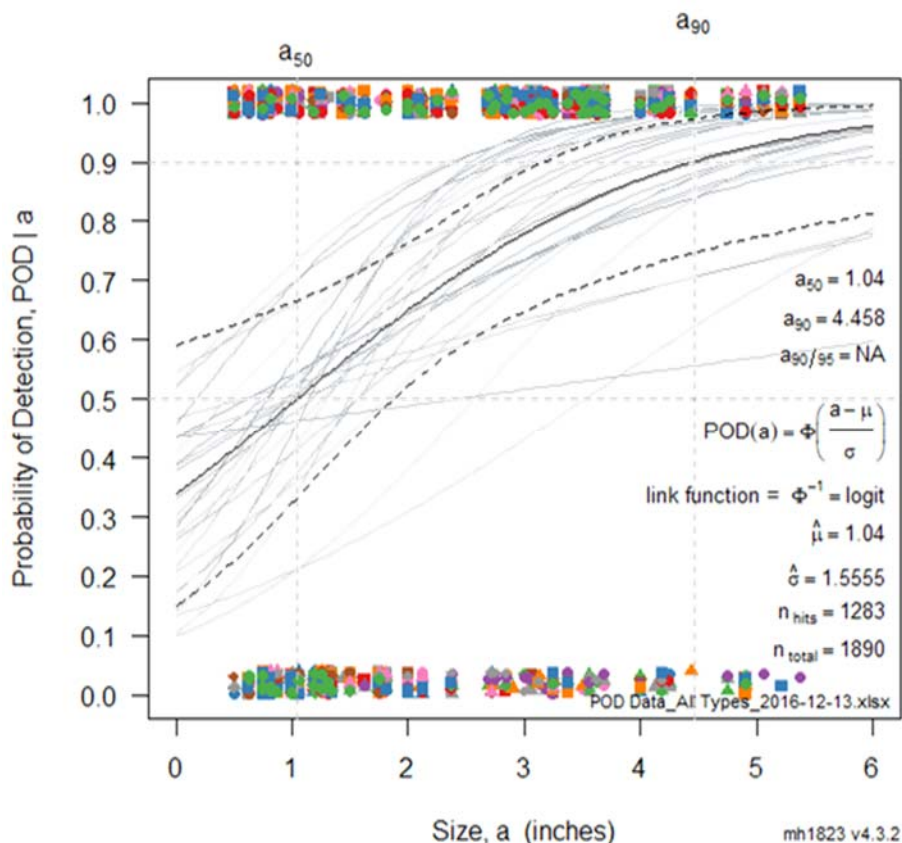
Figure 3.18 Probability of detection curves considering all cracks, excluding inspectors 13CA-09, 06JD-15, and 18GA-03

After removing the results from the three inspectors whose performance did not conform to the assumptions of the POD model (POD increasing with increasing crack length), the average probability of detection curve was regenerated and is shown in Figure 3.18. For the 27 remaining inspectors and all the specimens, a_{50} remained 1 inch, but a_{90} was reduced to 4-1/2 inches. Due to variability, the 95% confidence limits could still not be applied to a_{90} . The average POD curve for all specimens does not appear asymptotic with $\text{POD} = 1.0$, even for large crack sizes. This indicates that there is a residual probability of missing cracks, even when the length is very long. Additionally, the relatively shallow slope of the curve as it transitions from $\text{POD} = 0$ to $\text{POD} = 1.0$ is due to the large variability in performance and suggests that variables other than crack length are affecting the probability of detection.

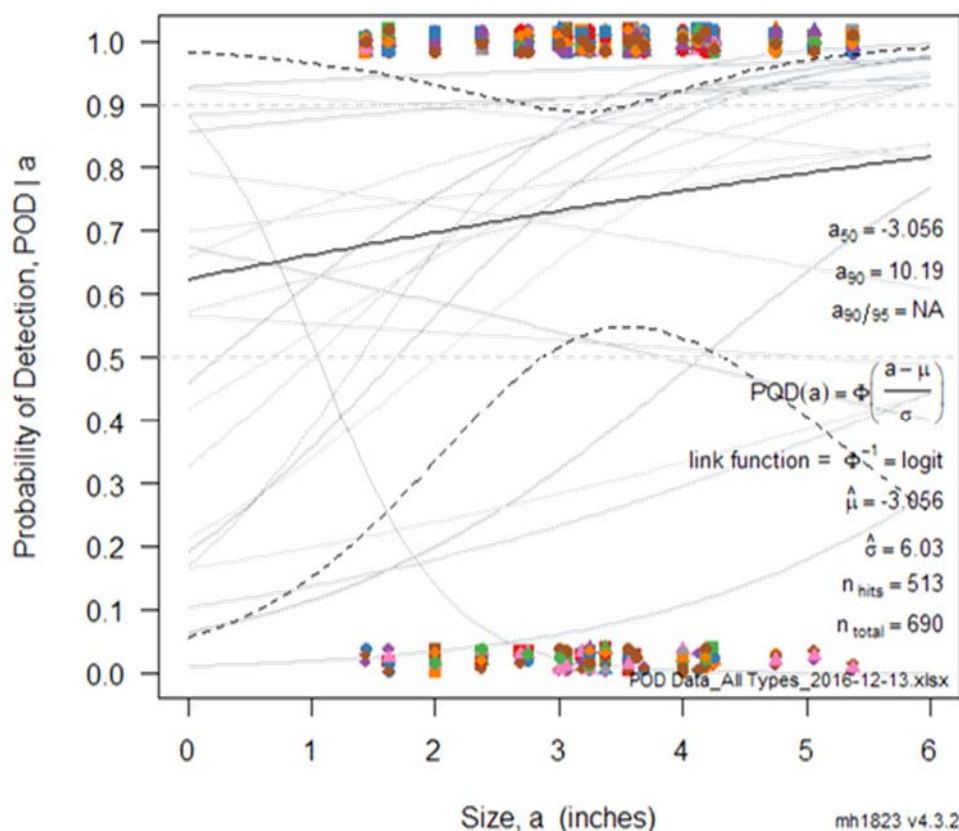
Figure 3.20 Probability of detection curves considering only the weld toe cracks

probability of detection for all lengths of cracks of this type. Inspectors 13CA-09, 18RT-25, 04MY-41, and 25HQ-08 showed a negative relationship between probability of detection and crack length. This was likely due to flawed decision making rather than failure to locate the crack. Based on previous experience, some of the inspectors believed the weld toe cracks to be cracks in the paint, not fatigue cracks in the base metal. This belief was either mentioned to the proctor or noted on the inspection form. In these cases, personal biases or expectations may have had more influence on performance than defect size.

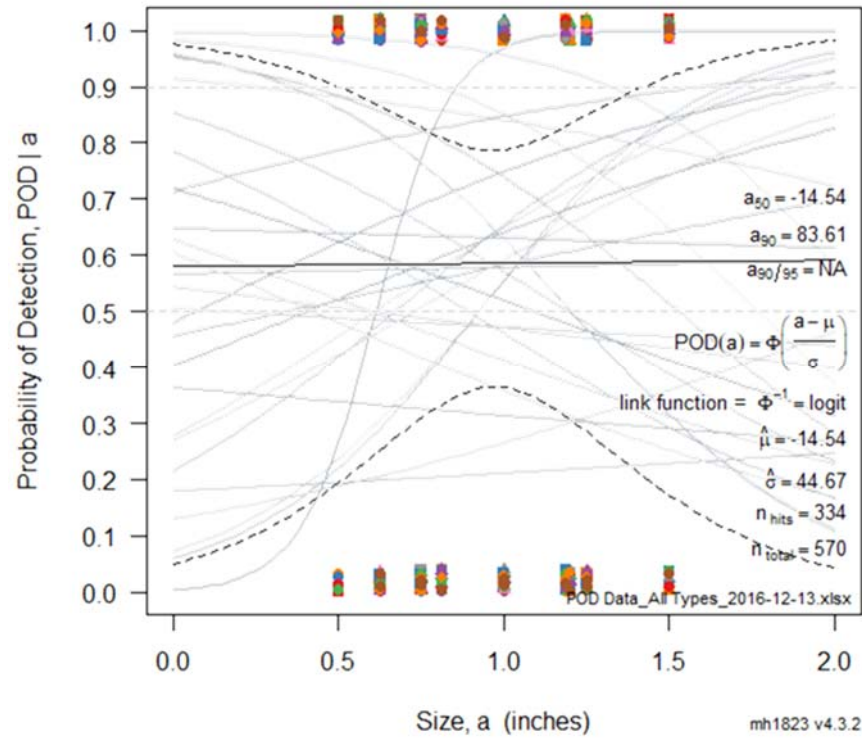
Figure 3.21 Probability of detection curves considering only the rivet hole cracks

1-inch range provided, the probability of detection is nearly constant at approximately $POD = 0.6$. Seventeen of the inspectors had a negative relationship between probability of detection and crack length for the riveted hole cracks. The variability in performance over a very small range of crack lengths suggests that performance is being influenced by factors beyond crack length.

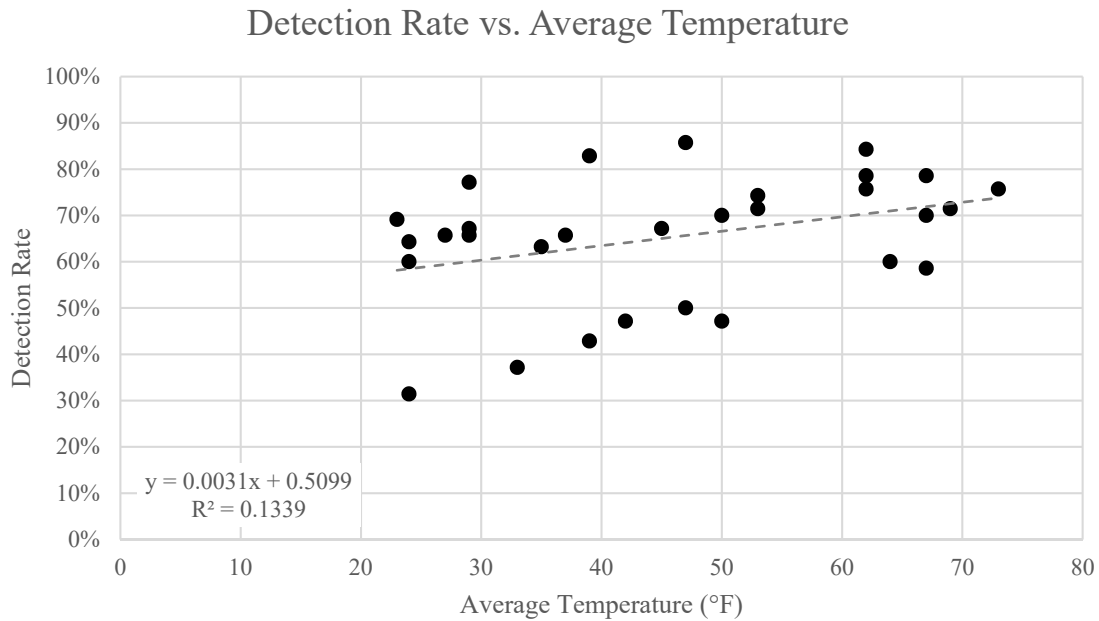
Figure 3.22 Detection rate plotted against average temperature

As shown in Figure 3.22, detection rate increased with increasing temperature, indicating that inspector comfort may influence detection rate. The average daily temperature during the inspections ranged from 23°F to 73°F, with an overall average of 46°F. The *t*-test revealed that inspectors working on days with an average temperature above 51°F ($M = 0.726$, $SD = 0.077$) detected significantly more cracks than inspectors who worked on days with an average temperature below 51°F ($M = 0.610$, $SD = 0.148$), $t(27) = 2.81$, $p = 0.009$. It is likely that an upper bound limit on temperature exists, but it was not noticed in this study because the average daily temperature did not exceed 73°F during any of the inspections.

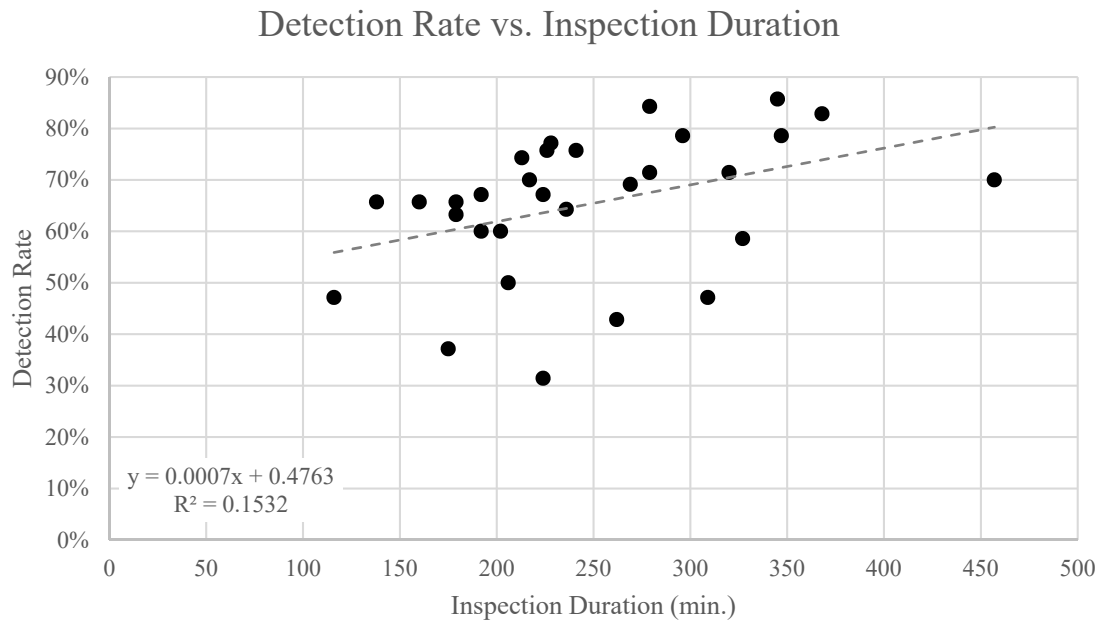
Figure 3.23 Detection rate plotted against inspection duration

The t -test suggests that inspectors should spend at least 90 seconds inspecting each specimen, or detail, since inspectors who spent more than 3.75 hours completing the inspection ($M = 0.708$, $SD = 0.124$) performed significantly better than inspectors who spent less than 3.75 hours ($M = 0.589$, $SD = 0.127$), $t(27) = 2.60$, $p = 0.015$.

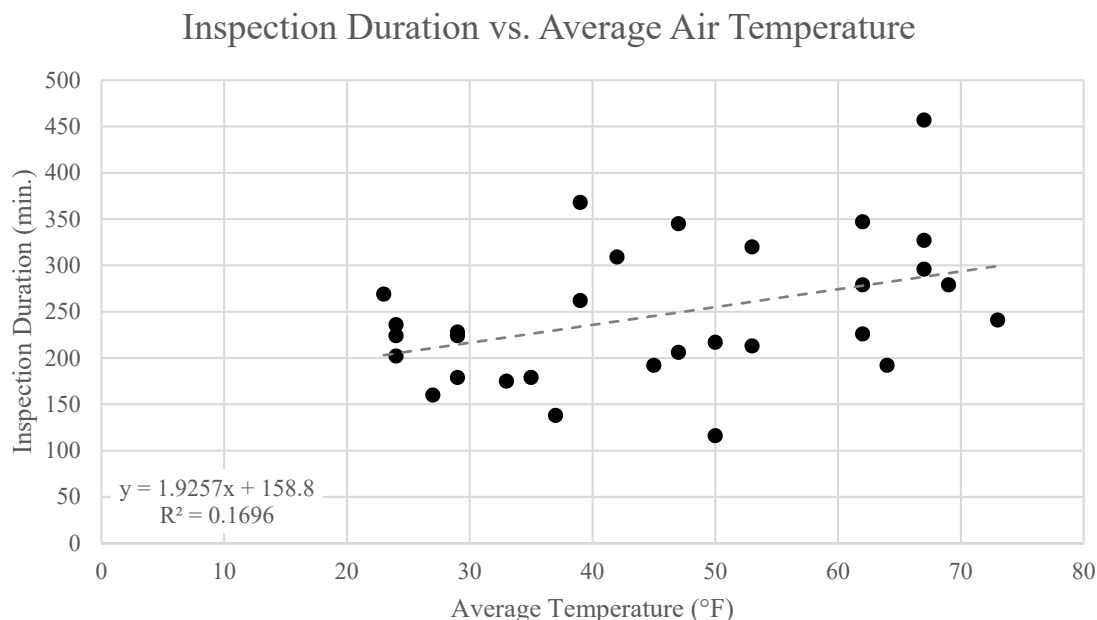
Figure 3.24 Inspection duration plotted against average temperature

Covariance between air temperature and inspection time was investigated to determine whether inspection speed varied significantly with weather conditions. A positive relationship was observed; the inspectors tested on the warmest days tended to spend more time completing the inspection. This suggests that inclement or uncomfortable weather may encourage inspectors to increase inspection speed. The plot of inspection time against air temperature can be found in Figure 3.24.

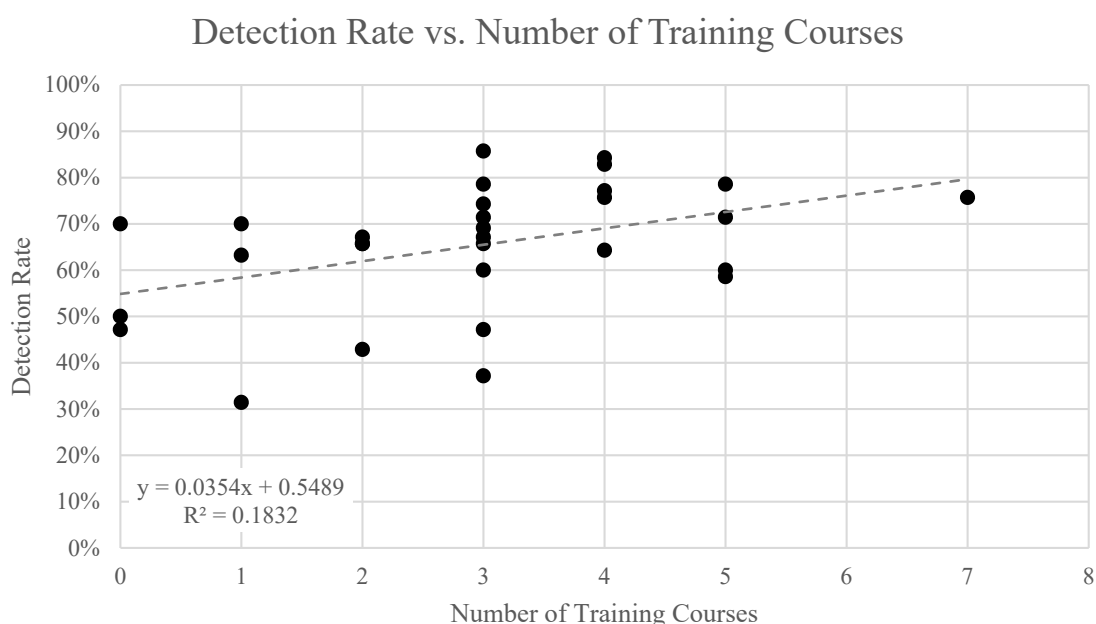
Figure 3.25 Detection rate plotted against the number of training courses taken by the inspector

this study, so the improvement in detection rate is likely due to the completion of more focused or specialized training. In fact, inspectors who had attended at least three training courses ($M = 0.692$, $SD = 0.123$) performed significantly better than inspectors who had attended less than three of the listed training courses ($M = 0.573$, $SD = 0.135$), $t(16) = 2.35$, $p = 0.032$. In addition to the in-depth discussion provided in these courses, they may offer a useful review of the basic principles of inspection. By federal law, inspectors are required to complete refresher training periodically [1, §650.313]. The majority of the inspectors participating in the study had completed one of these trainings within the previous three years, so time since training was not helpful in explaining the variability in detection rate.

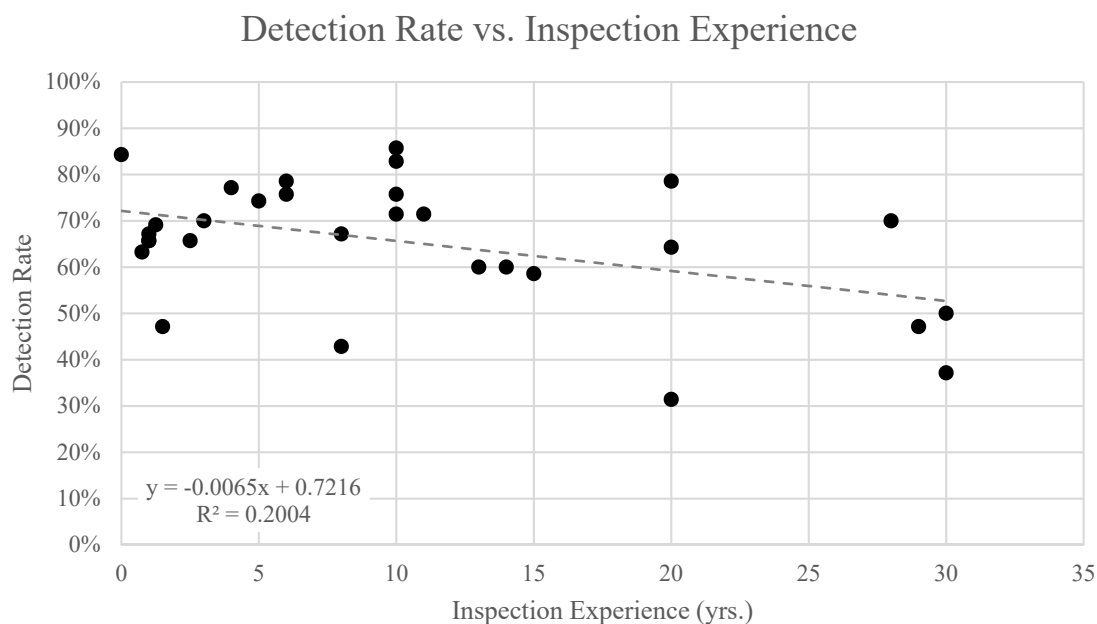
Figure 3.26 Detection rate plotted against inspection experience

Although common sense suggests that inspection performance should increase with experience, previous research presents a varied relationship between performance and experience [29]–[31]. It is possible that unmeasured factors such as physical health, expectations, or motivation are neutralizing the influence of inspection experience. For instance, an inspector with 29 years of experience explained that even though welded cover plate terminations are fatigue prone details, they rarely find fatigue cracks in these locations and instead supposed that the cracklike indications were paint flaws. As a result, this inspector detected only 9% of the fatigue cracks in these specimens. Another similarly experienced inspector made their displeasure in participating known to the proctor, spent less than 3 hours on the inspection, and only detected 37% of the cracks. The *t*-test suggests that inspectors with between 2 years and 14 years of experience ($M = 0.706$, $SD = 0.106$) performed significantly better than inspectors with less than 2 years or more than 14 years of experience ($M = 0.60$, $SD = 0.147$), $t(25) = 2.26$, $p = 0.033$. This group of inspectors may have enough experience to identify likely crack locations and recognize fatigue cracks, but not so much experience that they are overly influenced by attitude or personal biases.

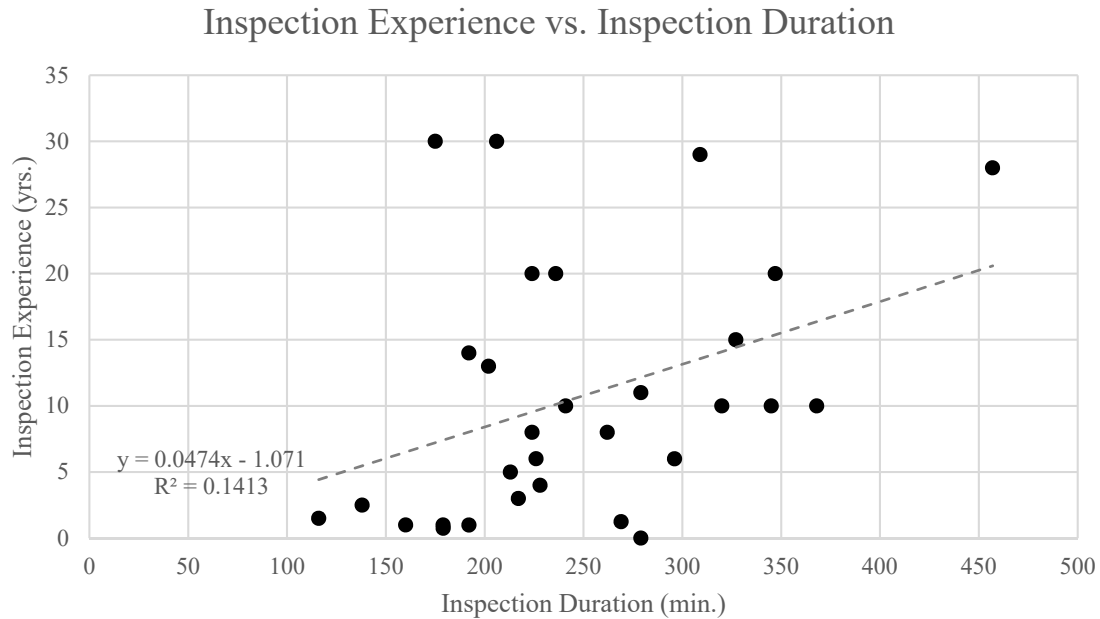
Figure 3.28 Inspection experience plotted against inspection duration

Covariance between inspection duration and experience was also investigated to determine if more experienced inspectors inspect more quickly or more slowly than less experienced inspectors. A positive relationship between inspection experience and inspection duration was observed; more experienced inspectors tended to spend more time completing the inspection. Notably, the inspectors with more than 25 years of experience demonstrated the greatest variability in inspection duration with inspection times ranging from 175 minutes to 457 minutes. The plot of inspection experience against inspection duration can be found in Figure 3.28.

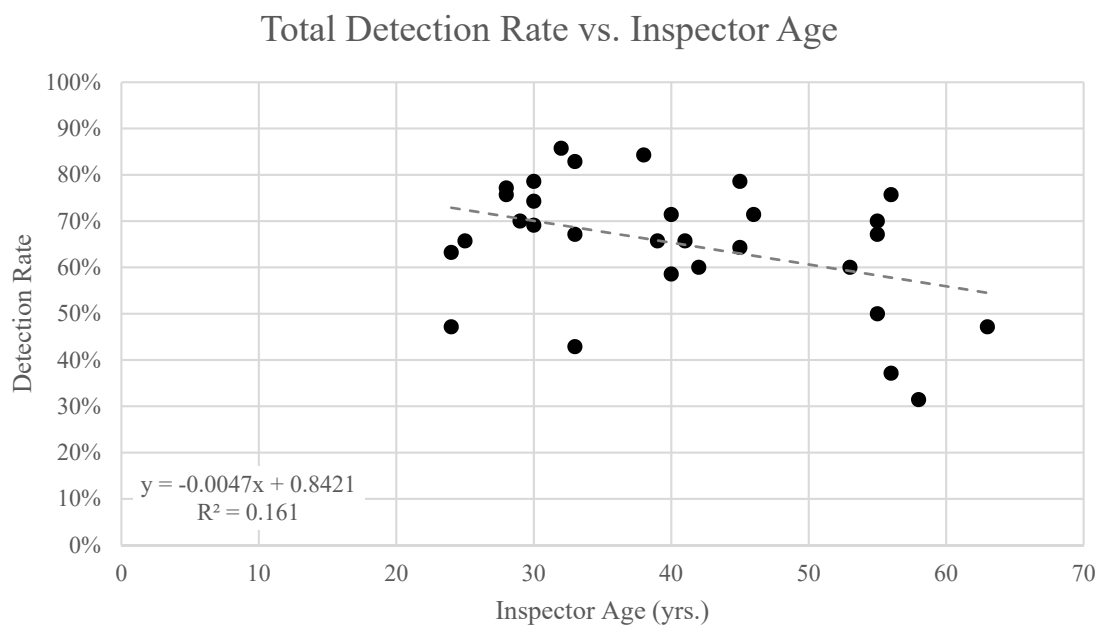
Figure 3.29 Detection rate plotted against inspector age

Similar to experience, there was a slight negative trend between the age of the inspector and detection rate as shown in Figure 3.29. The participants ranged in age from 24 to 63, with an average of 40 years. Once again, this trend is strongest for the welded cover plate specimens. As shown in Figure 3.30, four of the oldest participants had the lowest detection rates on these specimens. In at least three of these cases, the inspectors saw the majority of the cracks, but decided that they were only cracks in the paint, not in the base metal. These decisions were primarily based on previous experience with this detail and they were noted on the inspection forms and/or discussed with the proctor.

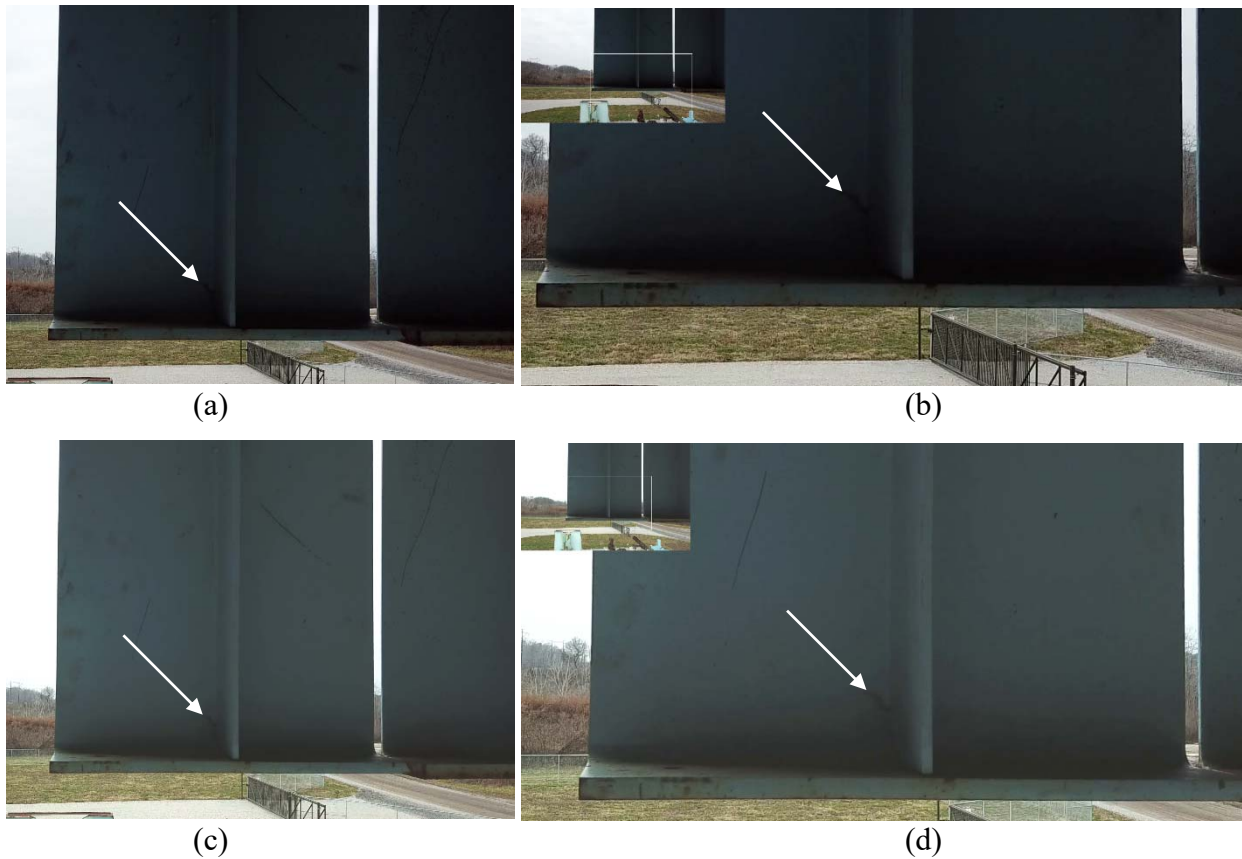
Figure 5.23 Still image from a UAS video (a) uncorrected, (b) zoomed in on the crack-prone region at the bottom of the transverse stiffener, (c) with brightness adjusted, and (d) zoomed in on the crack-prone region with brightness adjusted
