**A BENCHMARK FOR EVALUATING PERFORMANCE IN VISUAL
INSPECTION OF STEEL BRIDGE MEMBERS AND STRATEGIES FOR
IMPROVEMENT**

A Dissertation

Lyles School of Civil Engineering
West Lafayette, Indiana
May 2019

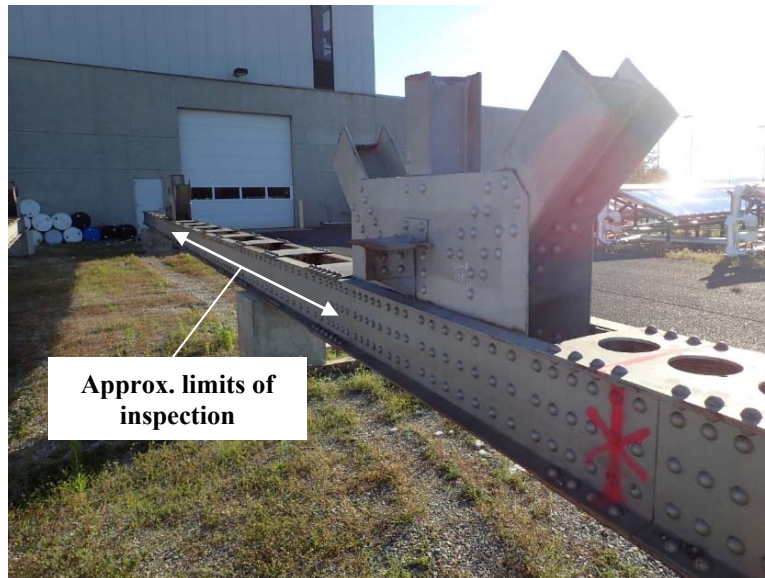
Figure 6.1 Truss chord elevation view (looking from joint L4 to L2)

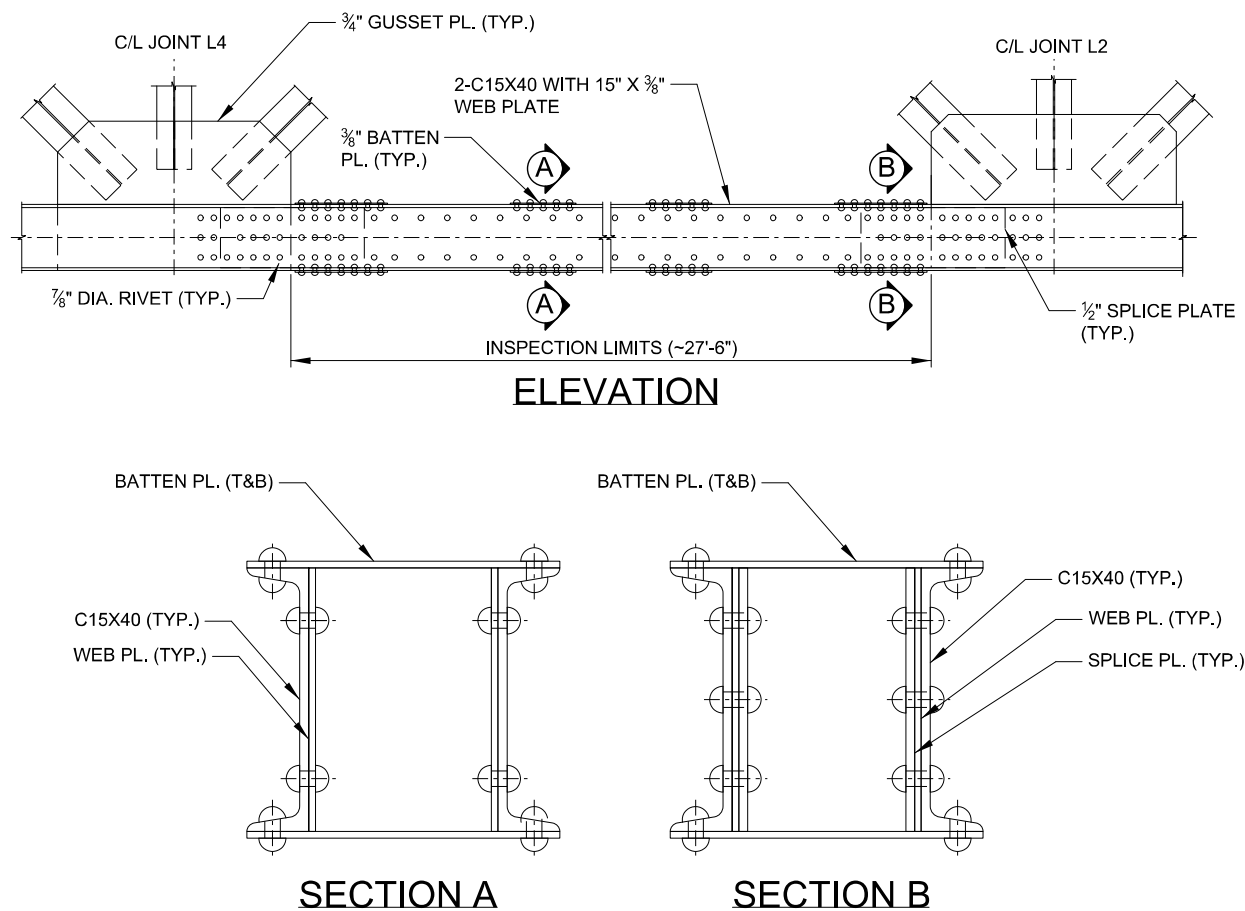
Figure 6.2 Elevation and section views of the truss chord

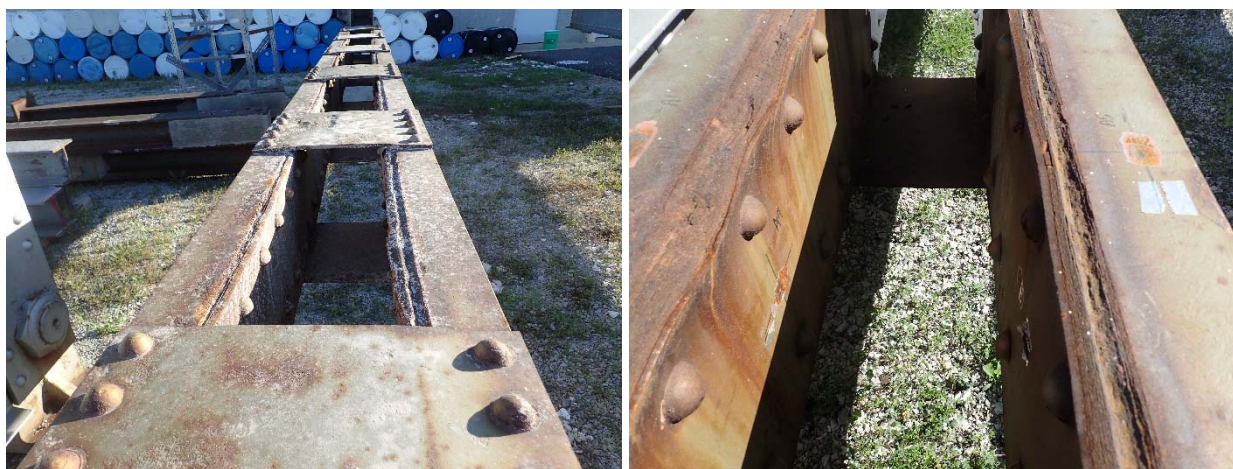
Figure 6.3 View of typical corrosion damage resulting in section loss and pack rust

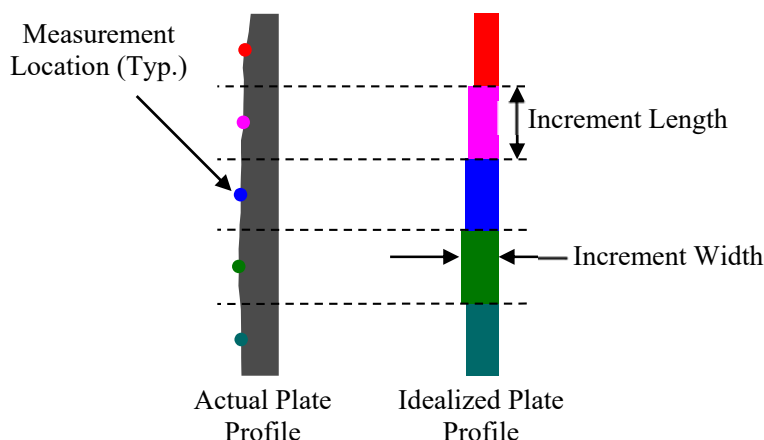
Figure 6.5 Illustration of the method used to calculate remaining member area from field measurements

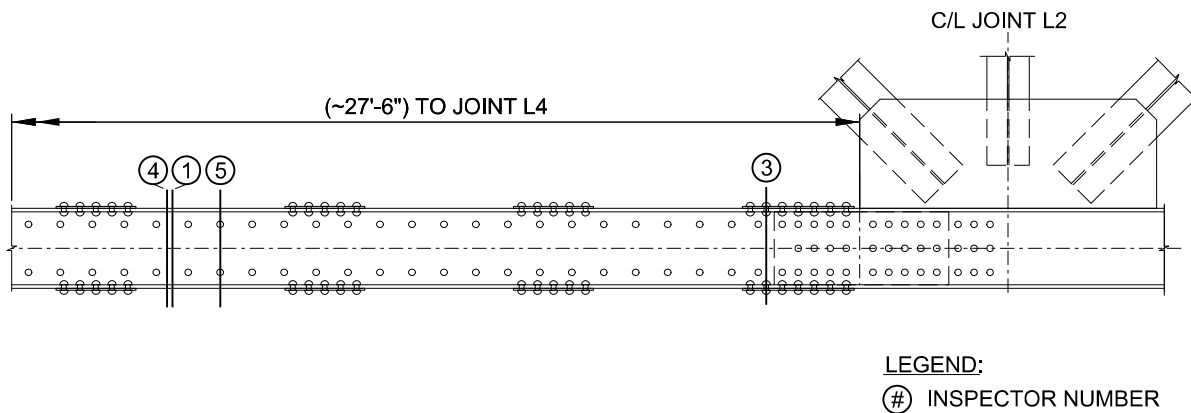
Figure 6.6 Critical section locations identified by the inspectors during Task 1
