THERMAL IMAGE ANALYSIS FOR FAULT DETECTION AND DIAGNOSIS OF PV SYSTEMS

A Thesis

Submitted to the Faculty of Purdue University

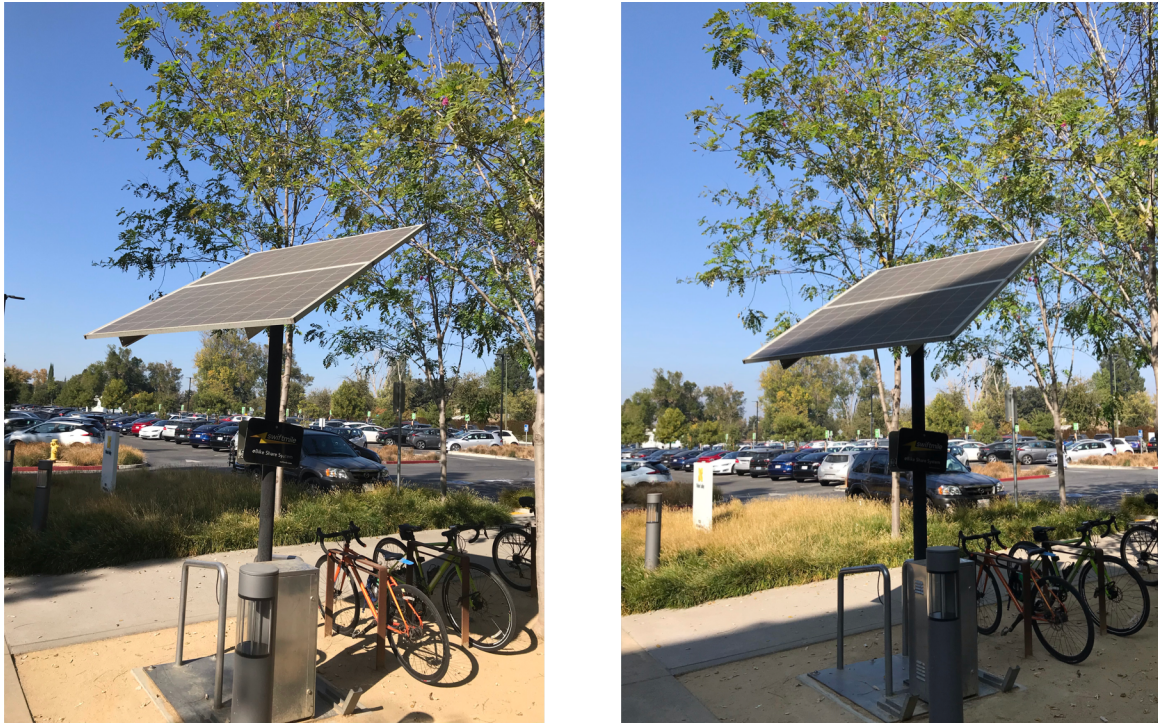
Figure 2.5. Shading Effect on PV modules: No shading (left) and shading (right)

Shadow Effect on PV systems is a common but critical problem. According to Deutsche Gesellschaft für Sonnenenergie (DGS), “in a large number of these systems, shading caused annual yield reductions of between 5 percent and 10 percent. Shading can be classified as temporary, resulting from the location, the building, or caused by the system itself (self-shading)” (Deutsche Gesellschaft für Sonnenenergie (DGS), 2013, p. 173). Shadow effect on PV systems can be categorized into two groups, direct shadows and temporary shadows. In particular, direct shadows can result in a significant impact on the PV module. In the case of temporary shadows, circumstances like snow, leaves, animal droppings, and other objects on PV modules can result in a shading effect (Deutsche Gesellschaft für Sonnenenergie (DGS), 2013). *Figure 2.5* shows an example of a shadow effect on PV modules.

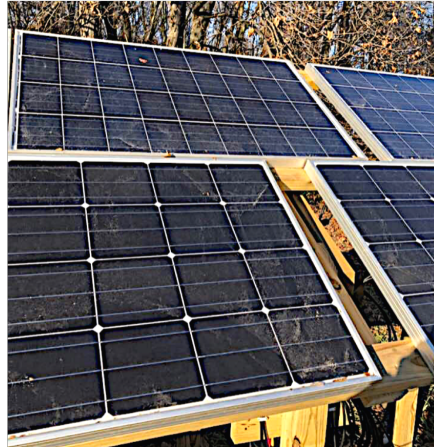
Figure 2.6. Soiling effect

Soiling means an accumulation of dirt on PV module surfaces (Piliougine, Carretero, Sidrach-de Cardona, Montiel, & Sánchez-Friera, 2008). When it comes to soiling, the meaning of ‘dirt’ contains not only dust but also snow, leaves, pollen, animal droppings, and any other object stacked up on PV modules (Maghami et al., 2016). It is considered one of the significant causes of energy losses in PV systems performance. “Soiling is a complex problem that increases uncertainty and drives up the levelized cost of energy through lost energy production, increased operation and maintenance costs, and financing rates” (U.S. Department of Energy, 2018, p. 47). “Soil deposition can result into cementation, which eventually leads to an energy loss of up to 100%” (Fagnani, 2016, para. 5). *Figure 2.6* shows one example of soiling effect on PV modules.

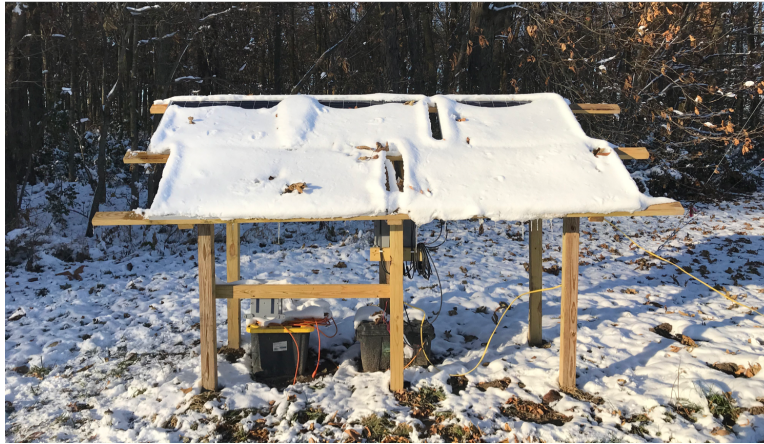
Figure 2.7. Snow effect

Soiling effect can pose serious harm in places where snow accumulates and remains for a long time. “Snow cover can be seen as a special case of soiling applicable in countries with colder climate” (Stridh, 2012, p. 1). In this condition, where snow entirely covers up PV modules, the performance of the PV modules can be badly decreased. An example of the snow effect on PV modules is present in *Figure 2.7*. It is recommended to arrange the PV modules horizontally than vertically to minimize the loss because electrical strings of vertically arranged PV modules will be more affected by the snow effect (Deutsche Gesellschaft für Sonnenenergie (DGS), 2013).

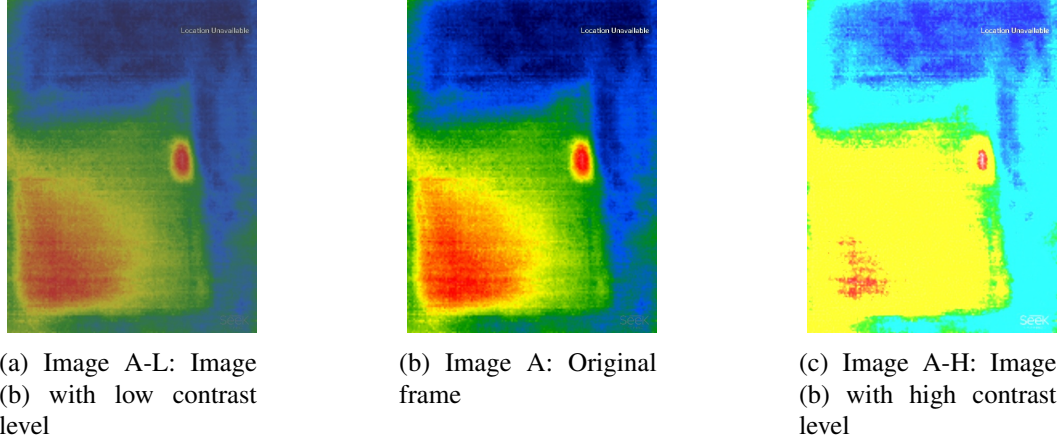
Figure 3.2. Thermal image preprocessing

1. Input a raw image → *Figure 3.2 (b) Image A.*
2. Adjust the image, *Figure 3.2 (b)*, to have a lower contrast level → *Figure 3.2 (a) Image A-L.*
3. Adjust the image, *Figure 3.2 (b)*, to have a higher contrast level → *Figure 3.2 (c) Image A-H.*

Appendix A.1 is an algorithm written in *Python* that used to adjust the contrast level of images. The key feature of the function is using *cv2.convertScaleAbs()* provided by *OpenCV*. The formula of the method is addressed in (3.1). The contrast level was adjusted by using α and β , respectively. α of 3 was used, and to lower the contrast level α of 0.5 was used to increase the contrast level.

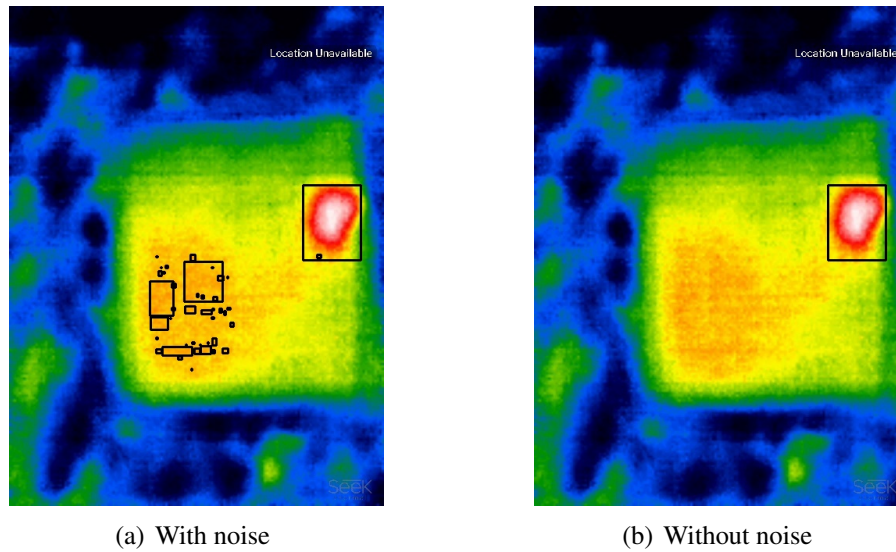
Figure 3.7. Filtering noises

Thus, 250 pixels were selected as the minimum size for measured hot spots in the algorithm to ensure that individual solar cell faults would be detected, while smaller hot pixel noise caused by the camera's measurement inaccuracy was filtered out. The selected measurement distance could be further away, allowing the measurement of multiple PV modules at once with a more accurate thermal camera wingtra (n.d.).

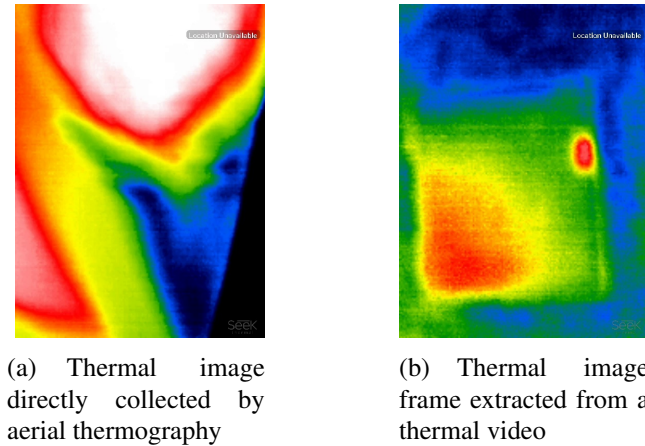
Figure 4.6. Difference in image quality

All three experiments for data acquisition were conducted at an open area with the GPS coordinates of 40.425965,-86.909730 (DD) on the same day (November 26, 2019). The weather was sunny and windy. The temperature range during the experiment was between 50 ° F and 55 ° F. In this stage, video footage was collected instead of images due to image quality issues. When the thermal camera takes images while the UAV is flying, the images collected tend to have poor quality, as shown in *Figure 4.6 (a)*. To improve the quality of the data, the thermal image data was achieved through two steps: (i) collect thermal video data during the experiments, and (ii) extract thermal images from the collected videos using an *OpenCV (n.d.)* model. The thermal image present in *Figure 4.6 (b)* is an example of the thermal frame extracted from a thermal video. This clearly shows the improvement between the two approaches for collecting data.
