**CASE STUDY TO EVALUATE DRIFT ESTIMATION IN NON-DUCTILE
REINFORCED CONCRETE BUILDINGS WITH FOUNDATION LAP-
SPICES: NUMERICAL SIMULATION WORK**

A Thesis

Submitted to the Faculty of Purdue University

Master of Science in Civil Engineering

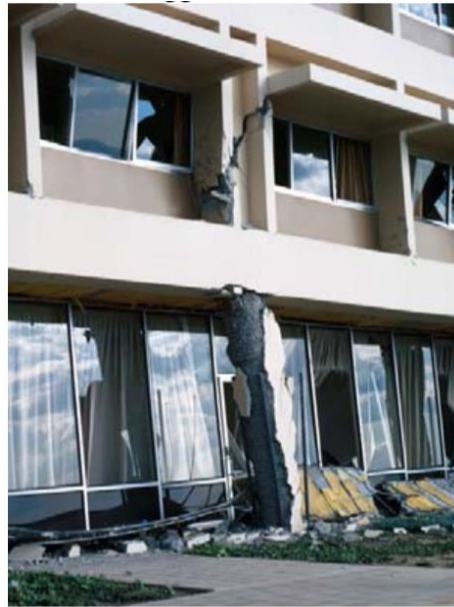
Figure 1.1. Olive View Hospital Medical Treatment Building
1971 San Fernando Earthquake. Damage included soft-story effect due to failure in columns and pounding to neighboring buildings. Source: (Jennings, 1971; Liel, 2008) Photo Credit: USGS Photographic Library

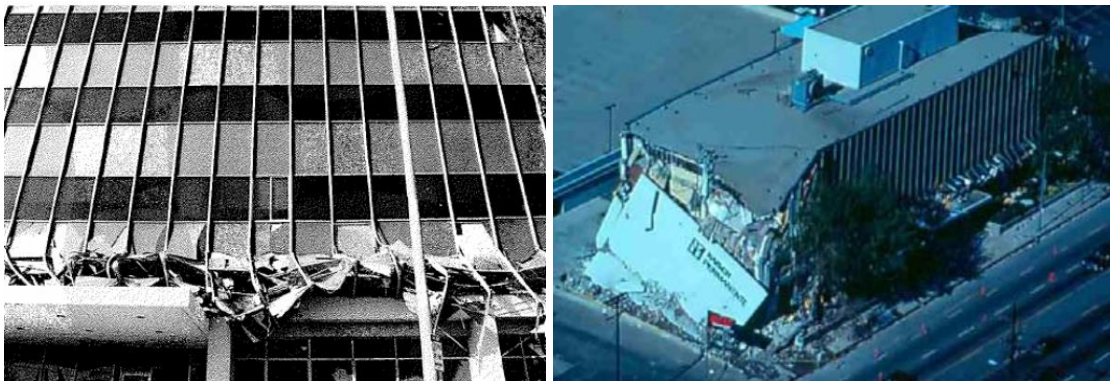
Figure 1.2. Kaiser Permanente Granada Hills Office Building
1994 Northridge Earthquake. Damage included second story collapse due to failure in joints and columns. Source: (Liel, 2008; Mitchell et al., 1995) Photo Credit: Mitchell et al.

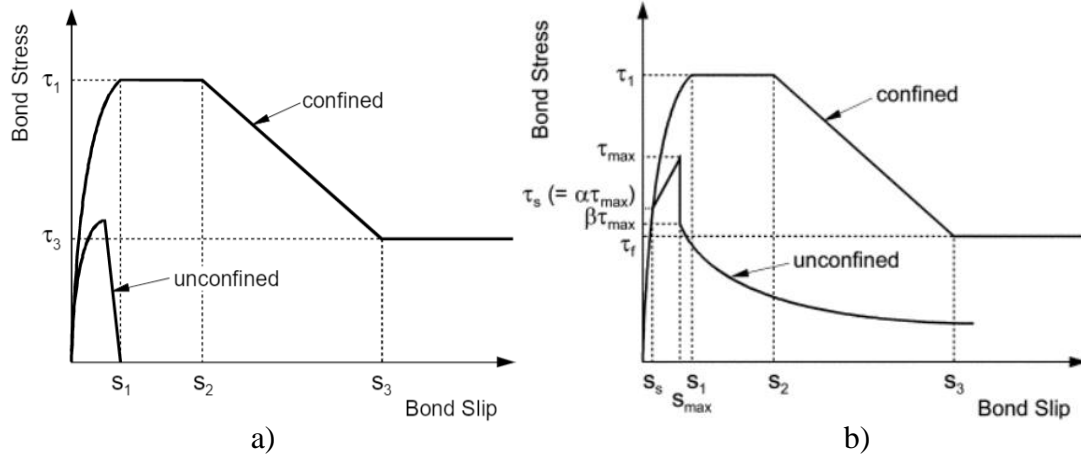
Figure 1.3. a) Local Bond Stress-Slip Relations by Eligehausen et al. (1983) and b) Harajli & Mabsout (2002)

A low number of analytical studies are found in the literature on the modeling of the behavior of a column with short lap splices. Bond-slip relations for single bars have been suggested and generally accepted for lapped splices (J.-Y. Cho & Pincheira, 2004; Chowdhury & Orakcal, 2012). A number of investigators have proposed bond-slip relationships of isolated bars, such as Eligehausen et al. (1983) and Harajli & Mabsout (2002). These are reviewed by Cho & Pincheira (2004) and Chowdhury & Orakcal (2012) as shown in Figure 1.3. The two types of bond failure of the lap splice, as described in the previous studies, are defined by confinement. If considered unconfined or poorly confined versus well confined, normally by transverse reinforcement, bond failure occurs with splitting of concrete versus pullout, respectively (J. Y. Cho & Pincheira, 2006). Both Cho & Pincheira (2006) and Chowdhury & Orakcal (2012) noted that use of the Harajli & Mabsout's (2002) model resulted in better and well agreement between calculated and experimental data from column test results of shear force vs. drift ratio plots. This model will also be used in this study for unconfined concrete.

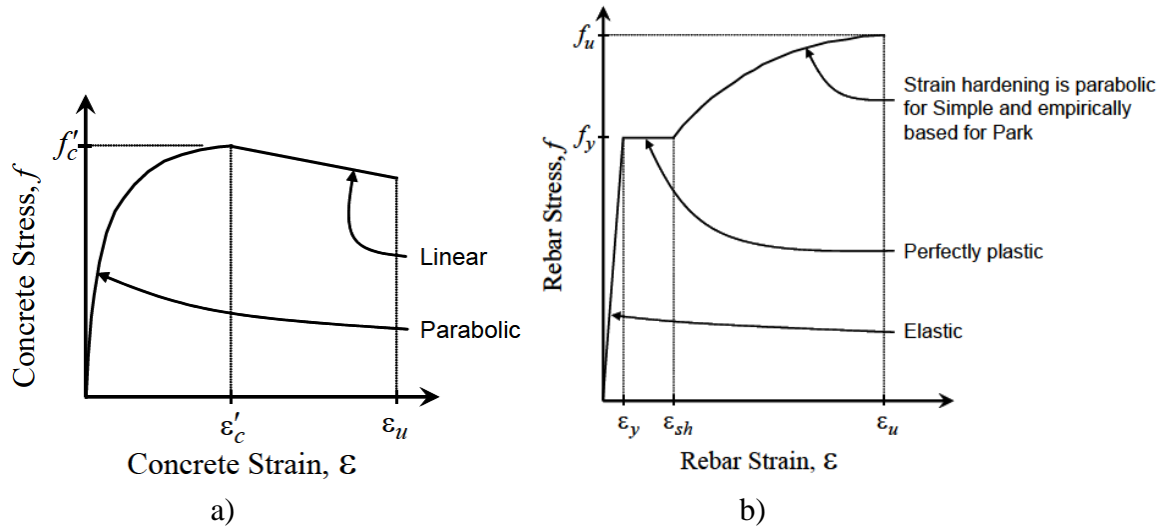
Figure 3.1. a) Concrete Stress-Strain Curve and b) Reinforcement Steel Stress-Strain Curve (Computers and Structures Inc., 2008)

The software SAP2000 has three options for concrete stress-strain models: simple, Mander, and user-defined. The simple stress-strain model, as shown in Figure 3.1a, parabolic portion follows Hognestad parabolic equation and the linear portion follows a linear relationship till $0.2f'_c$ stress reduction and a respective ϵ_u of 0.005 (Computers and Structures Inc., 2008). The tensile yield stress is $7.5\sqrt{f'_c}$. In regards for the reinforcement steel stress-strain model, the options include simple, Park, and user-defined. The simple stress-strain model includes elastic, perfectly plastic, and strain hardening regions as shown in Figure 3.1b. For the research objective needs, simple stress-strain models for both concrete and reinforcement were chosen.

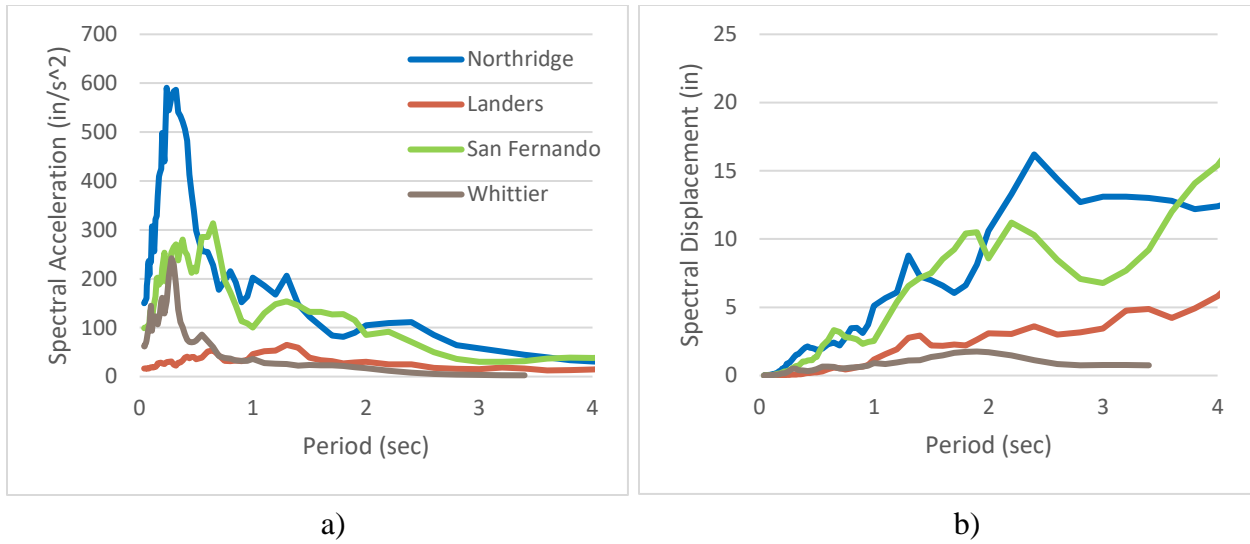
Figure 3.5. a) N-S Frame Acceleration Spectra and b) Displacement Spectra

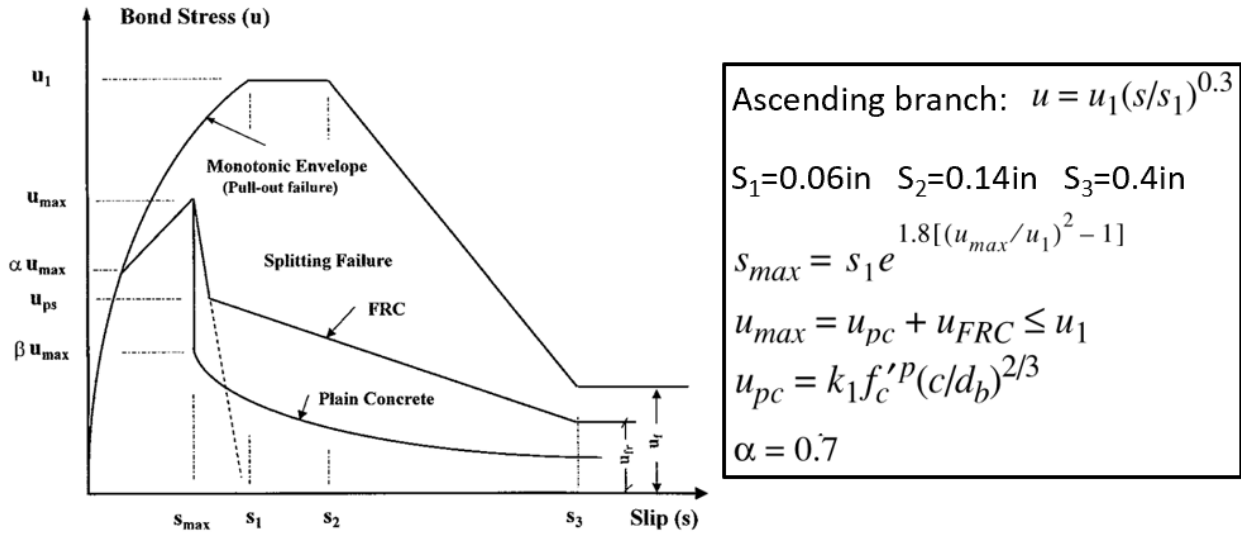
Figure 4.1. Harajli & Mabsout (2002) Local Bond Stress vs. Slip Model

Harajli & Mabsout local bond stress – slip curve is derived empirically. The variables k_1 and p are derived constants. Variable c and d_b are concrete cover and longitudinal bar diameter, respectively. Appendix A provides a few more details and one column results for one frame column. Both moment – curvature and bond stress – slip relationships are required to develop the moment – rotation relationship of a column element. Figure 4.2 displays how to relate slip to rotation, as described by Barin & Pincheira (2002). As previously described, several researchers including Cho & Pincheira (2004) studied the method described and compared against experimental results of 14 column data with short lap splices. Calculations were repeated for one column to check the observed modeling procedure and plot results were actually represented as calculated, results shown in Figure 4.3. In the reference, additional validation of the parameters in this model was conducted in the work of Cho & Pincheira (2004).

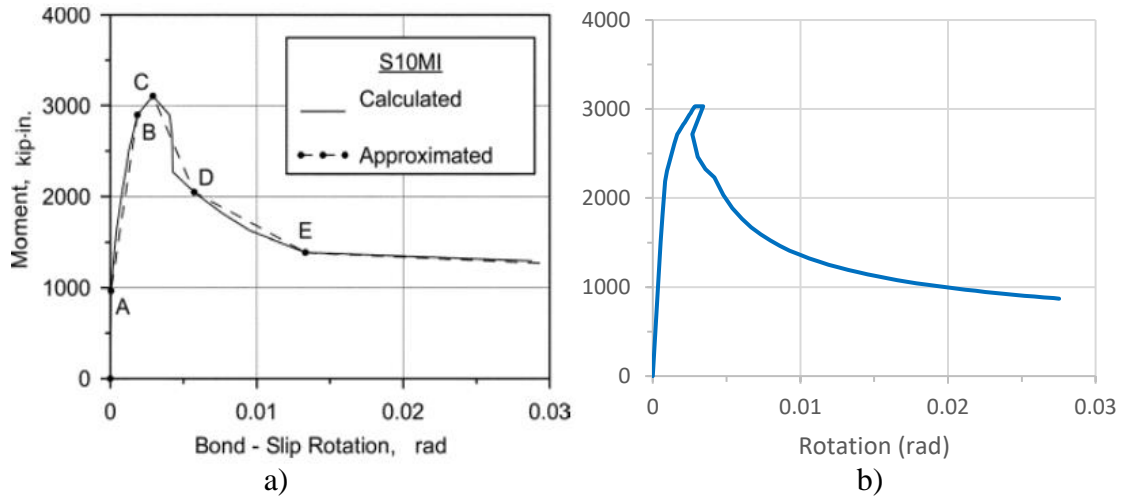
Figure 4.3. a) S10MI Column Moment – Rotation Results from Cho & Pincheira (2004), and b) Calculated Results
