EVALUATION AND STRUCTURAL BEHAVIOR OF DETERIORATED PRECAST, PRESTRESSED CONCRETE BOX BEAMS

A Dissertation

Doctor of Philosophy

Lyles School of Civil Engineering West Lafayette, Indiana December 2019

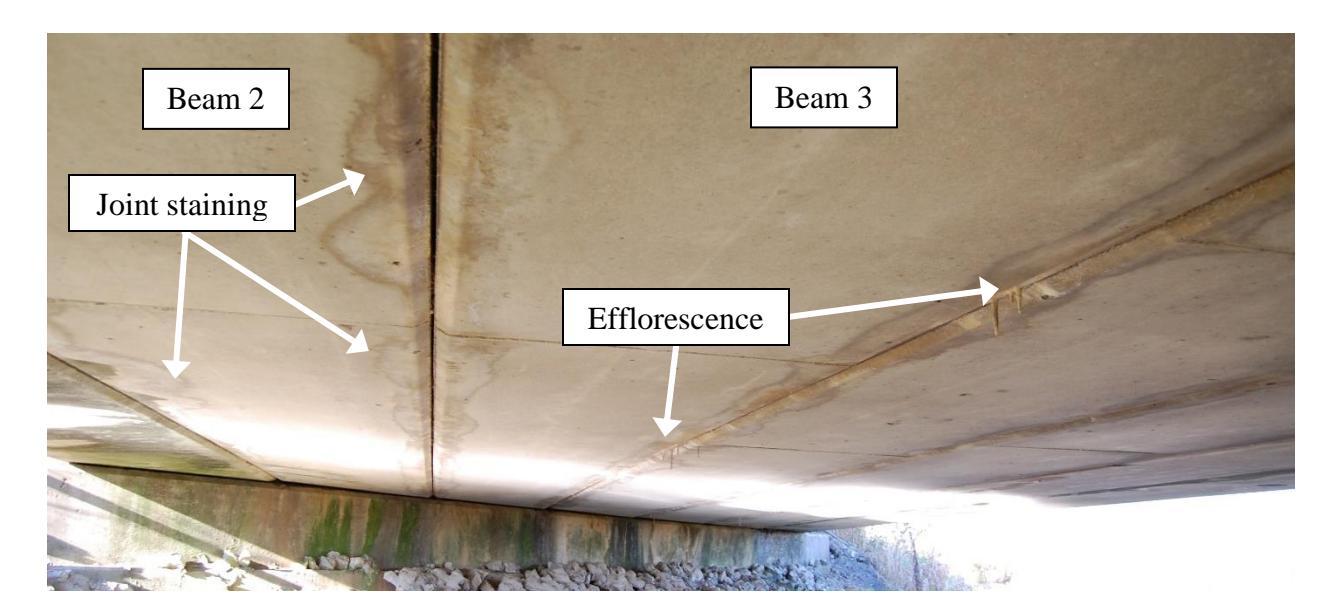
Tippecanoe 244 was inspected by the research team on 8 November 2017. The observed deterioration is summarized in Figure 2.4. Every joint between beams was found with water staining or efflorescence (Figure 2.5). The wearing surface was also observed to have reflective cracks along the length of the bridge. Two large longitudinal cracks were observed in Beam 6 (Specimen 244-6-LC). The crack at midspan was observed to be leaking during the inspection (Figure 2.6). Green staining covered most of the bottom flanges of Beam 1 (Figure 2.7) and Beam 7. The stain also partially extended onto the flange of Beam 6. In addition, spider web cracks were observed on the southeast corner of the bridge on the side of Beam 1 at the abutment (Figure 2.8). No drain holes were found in any of the beams.

Figure 2.5: Joint Staining and Efflorescence

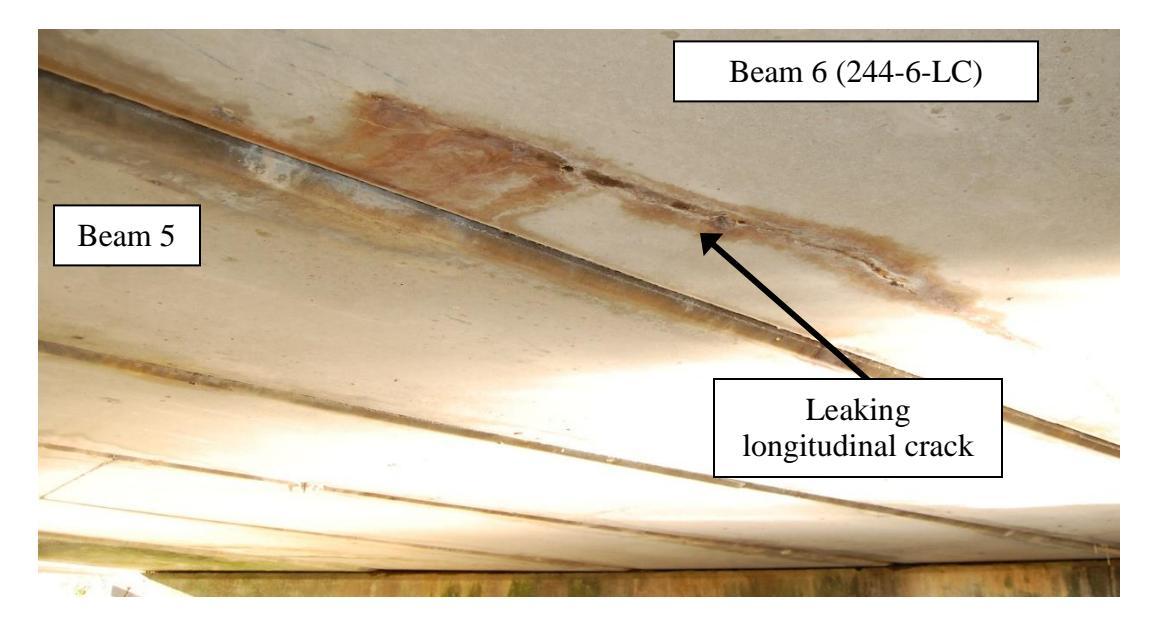
Figure 2.6: Leaking Longitudinal Crack in Beam 6 (244-1-LC)

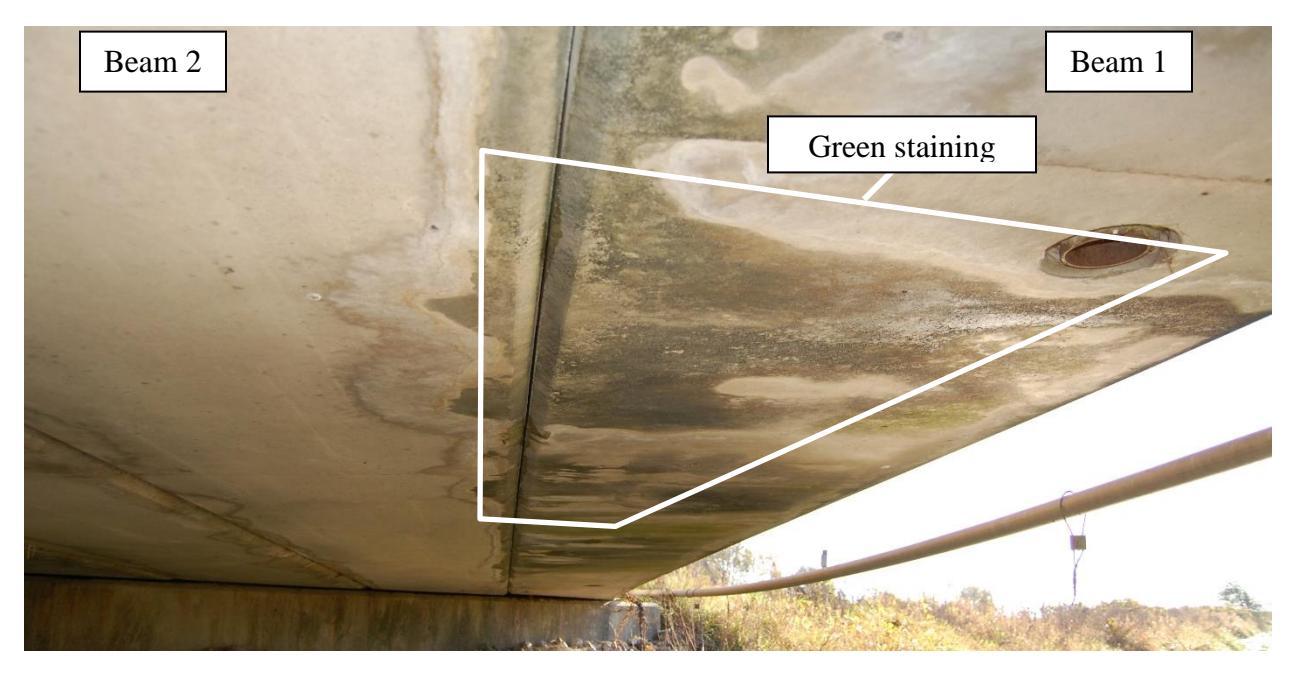
Figure 2.7: Green Staining on Beam 1

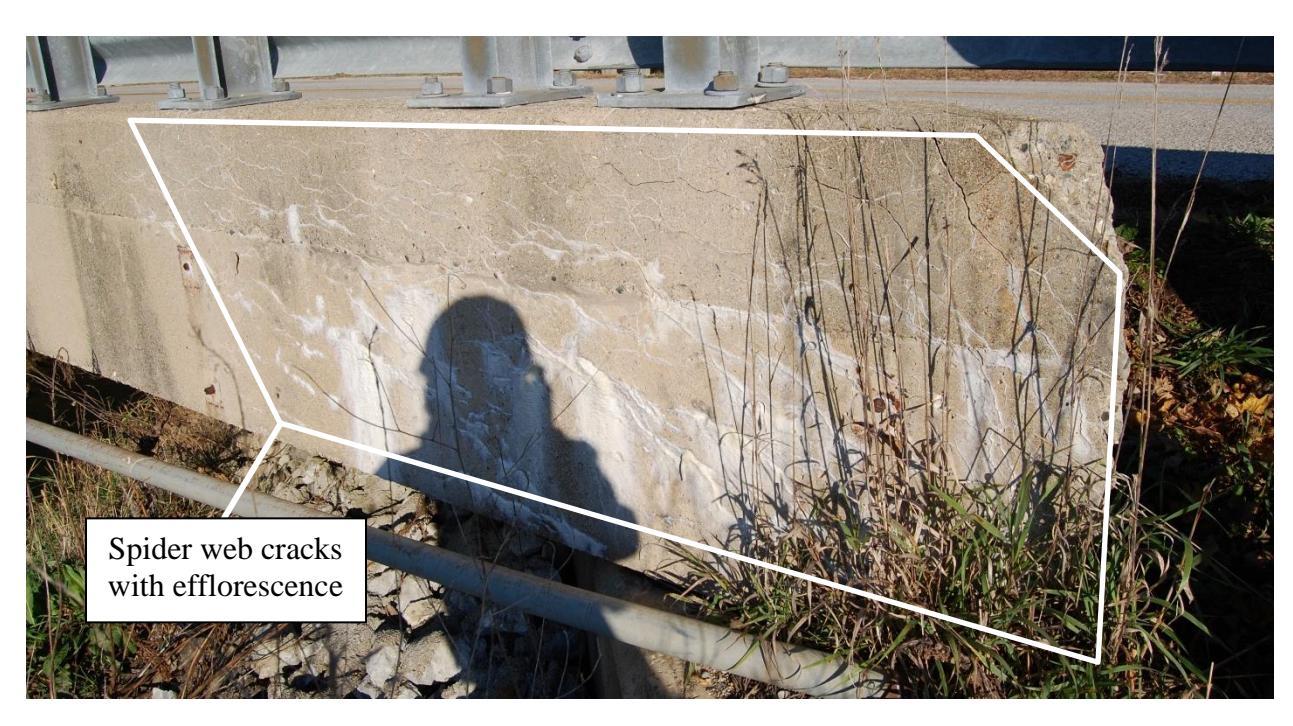
Figure 2.8: Spider Web Cracking on East End of Beam 1

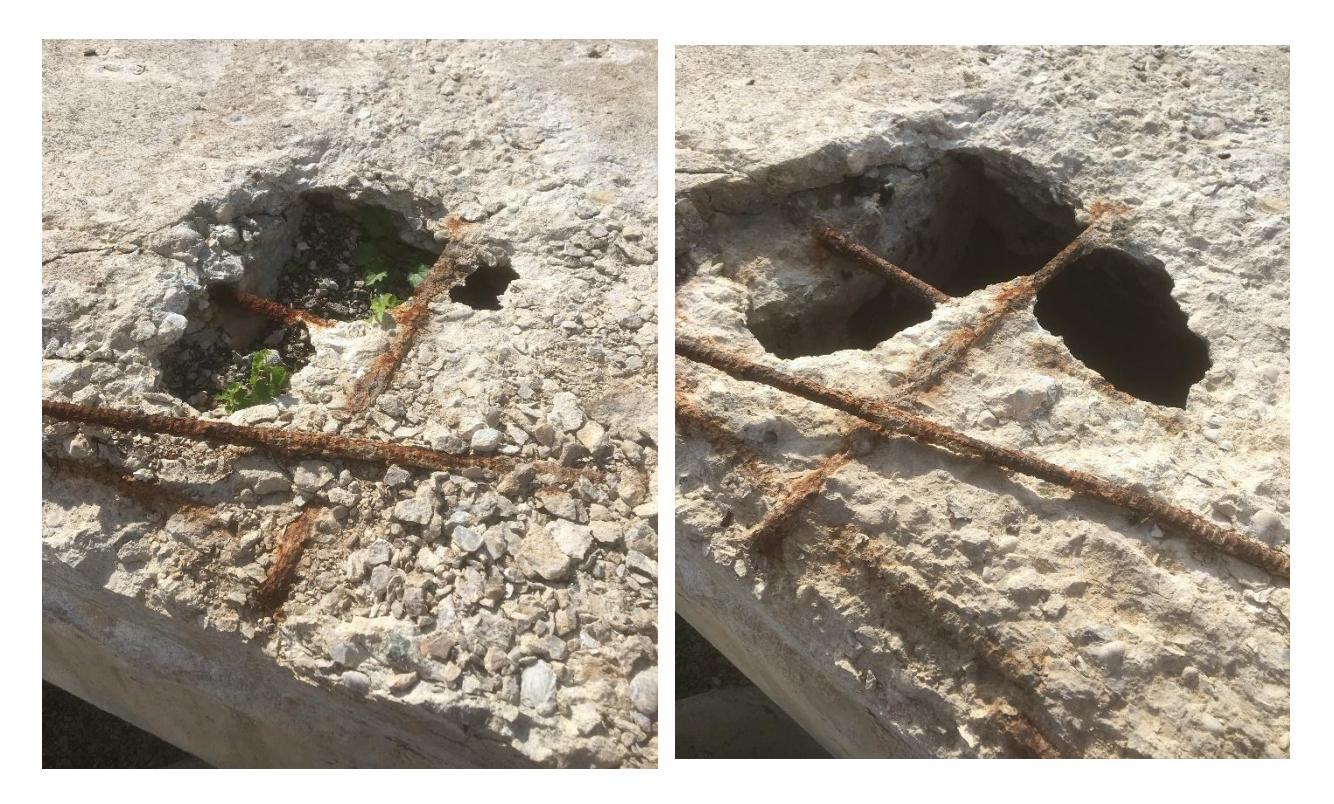
In 2018, the bridge was replaced with a new adjacent box beam bridge. As part of the bridge replacement, Beam 6 (Specimen 244-1-LC) was salvaged and transported to the Bowen Laboratory. During the salvage process, the bituminous wearing surface was removed, and a large hole was found in the top flange of Specimen 244-1-LC at midspan. The hole was approximately 14 in. long and 12 in. wide after removal of the gravel in and around the hole (Figure 2.9). No additional deterioration was observed after the beam was transported to the laboratory. Drain holes were drilled into each of the voids with a 5/8 in. concrete drill bit. Two drain holes were installed approximately 3 ft from each end of the beam. Once the drain holes were cleared, water drained from three of the four drain holes for approximately two to five minutes (Figure 2.10).

(a) Before removal of gravel(b) After removal of gravelFigure 2.9: Hole in Top Flange of Specimen 244-1-LC (Beam 6)

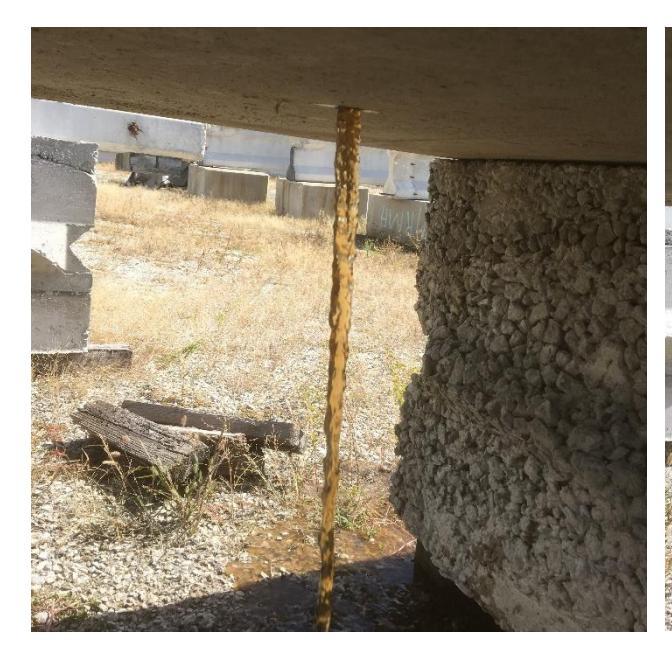
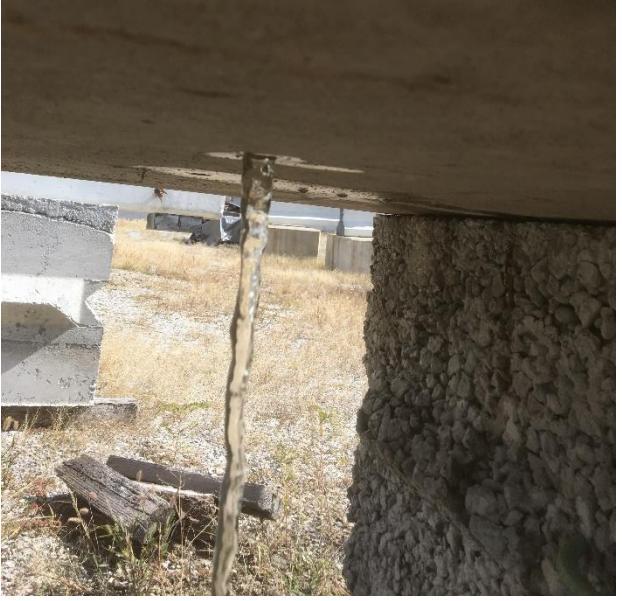
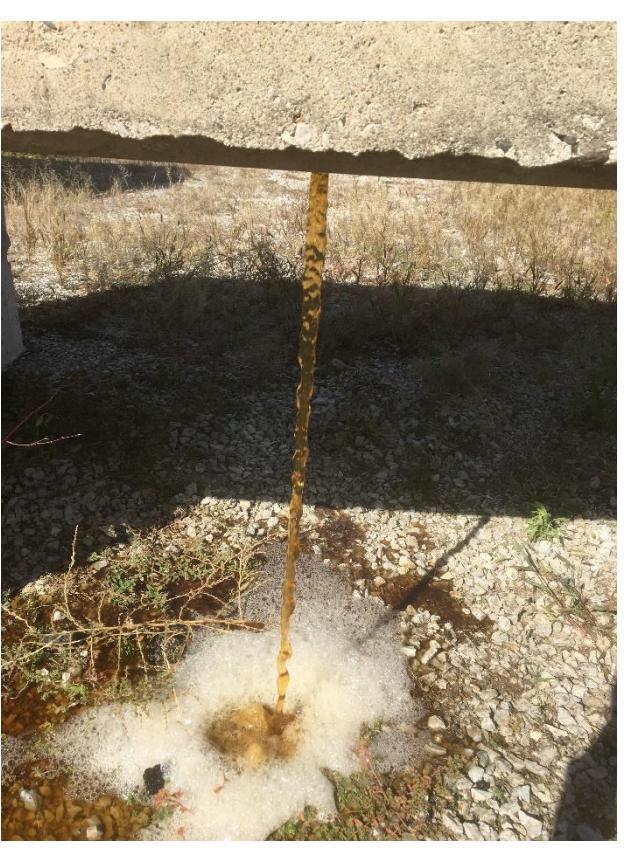
(a) Northeast drilled drain hole

(b) Southeast drilled drain hole

(c) Southwest drilled drain hole Figure 2.10: Water Filled Voids in Specimen 244-1-LC (Beam 6)

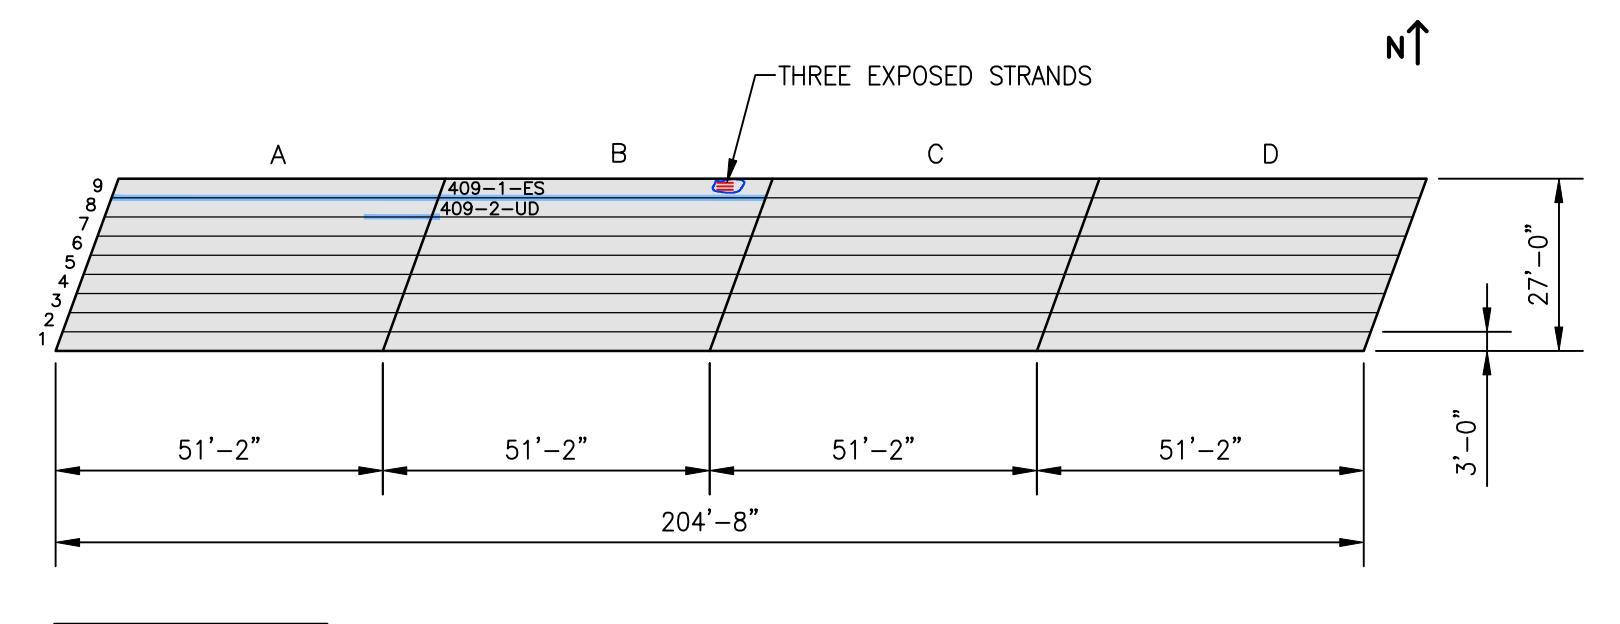
Figure 2.12: Elkhart 409 Deterioration Map

The bridge was inspected by the research team on 27 January 2017. The observed deterioration is summarized in Figure 2.12. Due to access restrictions, photos of the deteriorated sections could not be taken, and only a small portion of the bridge could be inspected. Much of the information presented in Figure 2.12 is based on the official inspection report.

NOTE: NO DRAIN HOLES WERE OBSERVED DURING INSPECTION

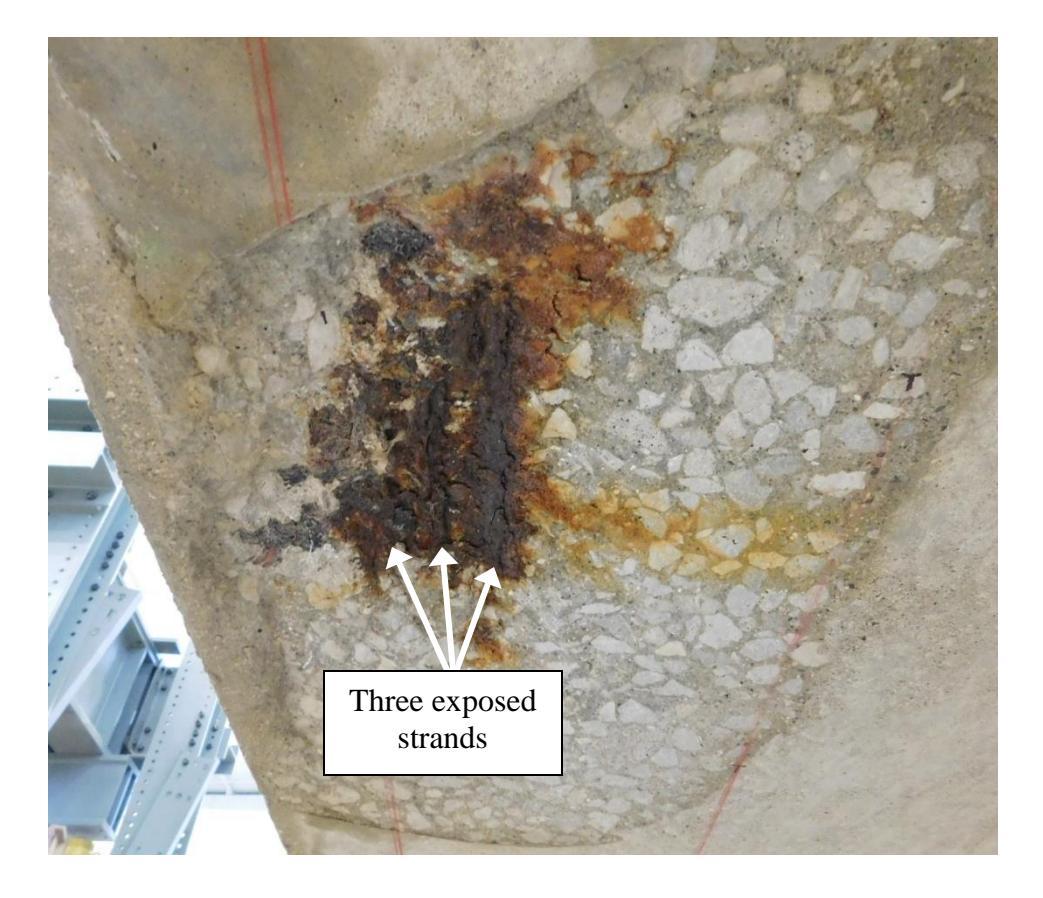
Figure 2.14: Exposed Strands in Specimen 409-1-ES

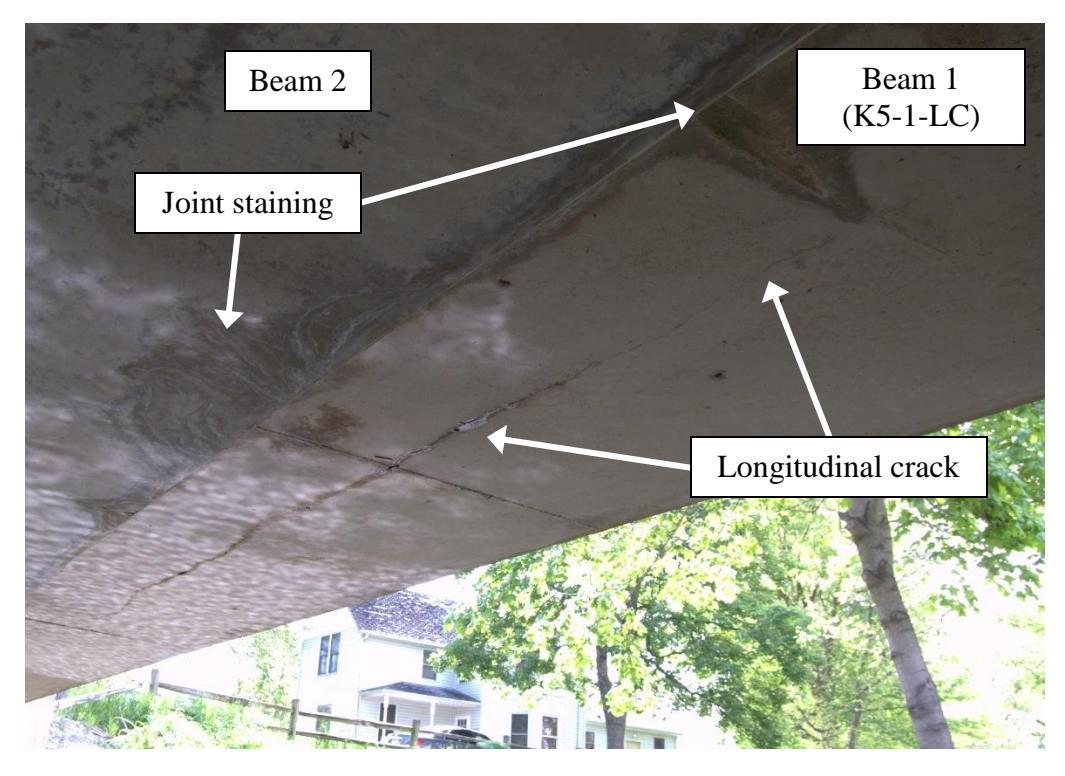
Newton K5 was inspected by the research team on 8 May 2017. A summary of the observed deterioration is provided in Figure 2.16. Two longitudinal cracks and joint staining were found in and around Beam 1 (Specimen K5-1-LC) with one of the longitudinal cracks extending from near the west support into midspan (Figure 2.17). Three rust-stained longitudinal cracks were observed in Beam 7 (Specimen K5-2-LC) along with spalling around the drain holes (Figure 2.18). In addition, reflective cracking was found in the wearing surface across the bridge (Figure 2.19). Please note that thin black lines have been drawn to the right of the actual cracks in Figure 2.19 to highlight the location of the cracks in the wearing surface.

Figure 2.17: Beam 1 (Specimen K5-1-LC) Deterioration

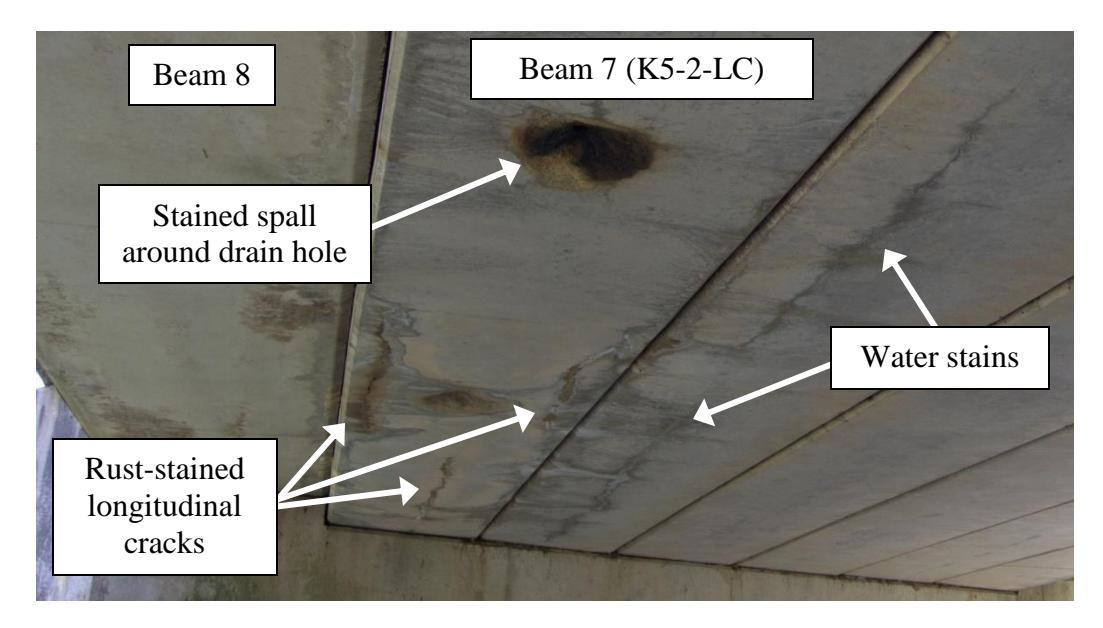
Figure 2.18: Beam 7 (Specimen K5-2-LC) Deterioration

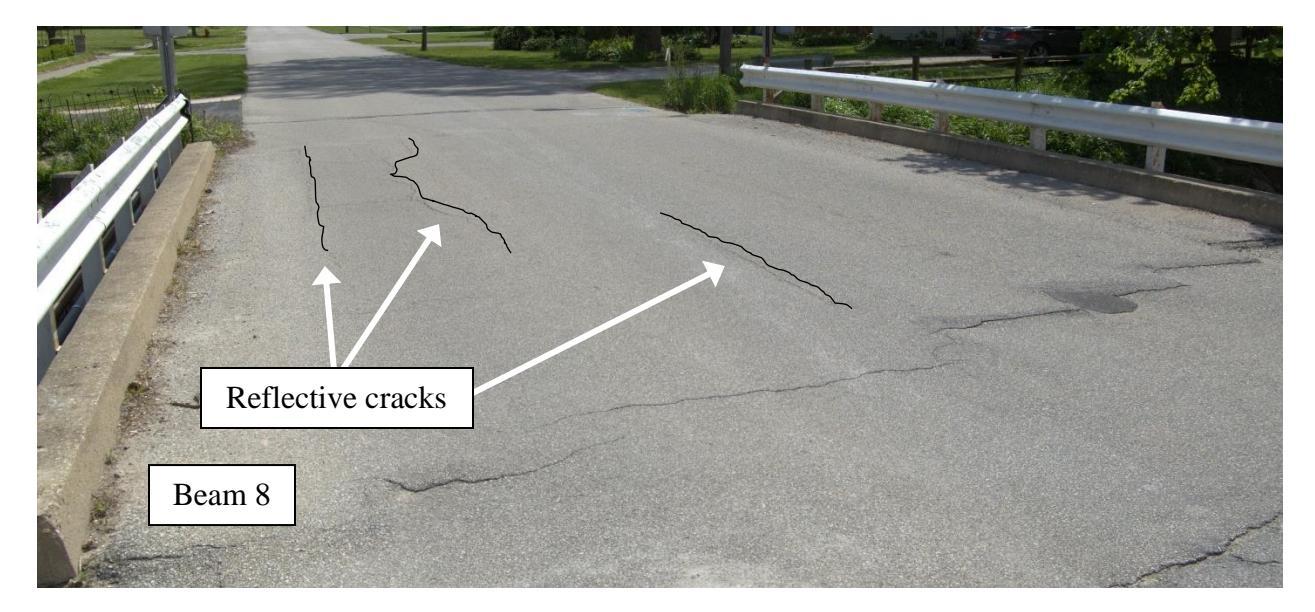
Figure 2.19: Reflective Cracks in Wearing Surface

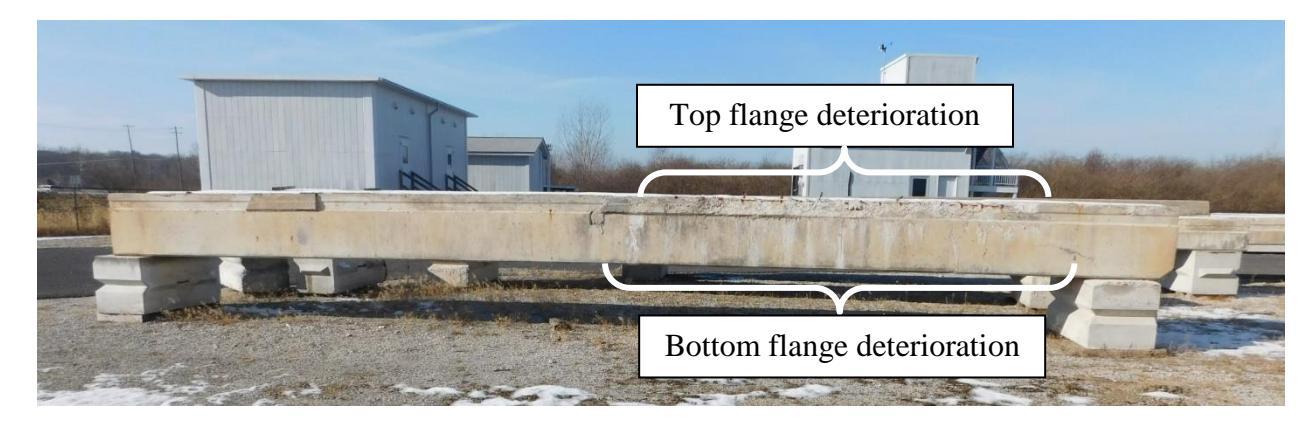
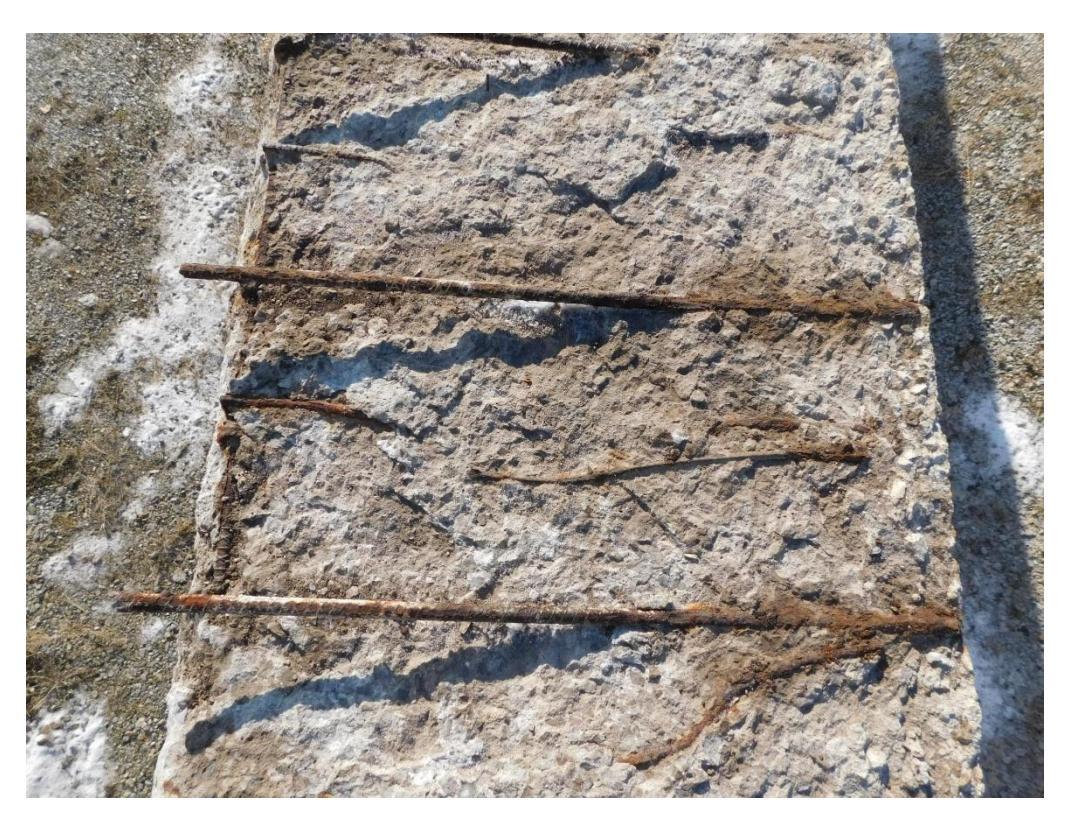
In 2018, the bridge was replaced with a new adjacent box beam bridge. As part of the bridge replacement, Beam 1 (Specimen K5-1-LC) and Beam 7 (Specimen K5-2-LC) were salvaged and transported to the Bowen Laboratory. During the salvage process, the wearing surface was removed, and scaling of the top flange of Specimen K5-2-LC (Beam 7) was observed (Figure 2.20). The top flange deterioration location corresponded with the locations of the three longitudinal cracks in the bottom flange. No additional deterioration was observed in Specimen K5-1-LC (Beam 1), but no drain holes were found in the bottom flange. Drain holes were drilled into the bottom flange of each void using a 5/8 in. concrete drill bit at approximately 3 ft from both ends of the beam. After the drain holes were drilled into the east end of the beam, water drained from the south drain hole for approximately two minutes (Figure 2.21).

(a) Location of the flange deterioration

(b) Concrete scaling and corroded reinforcement Figure 2.20: Specimen K5-2-LC (Beam 7) Top Flange Deterioration

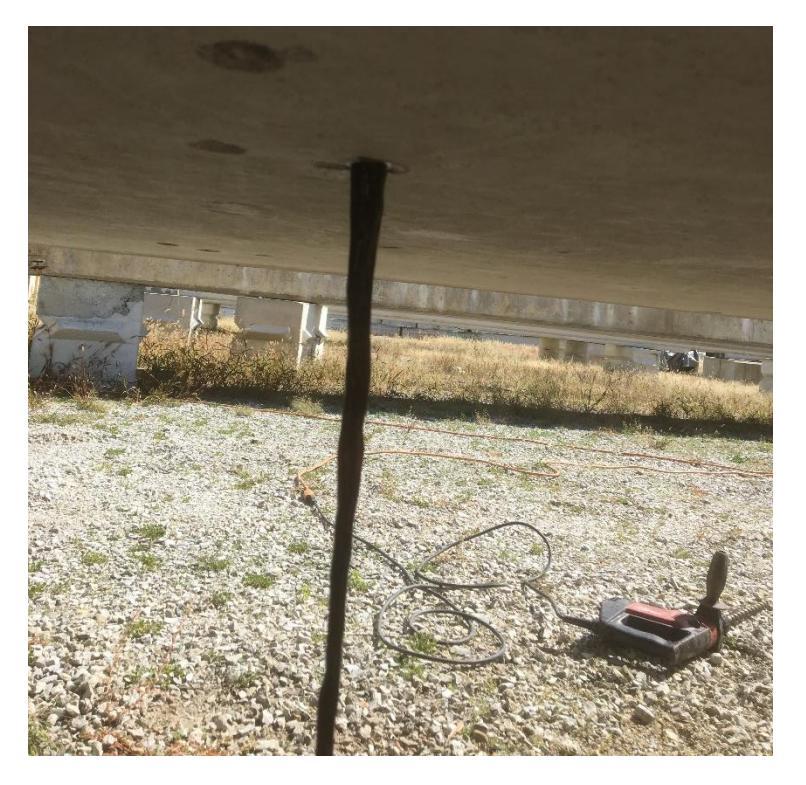
Figure 2.21: Water Draining from K5-1-LC (Beam 1)

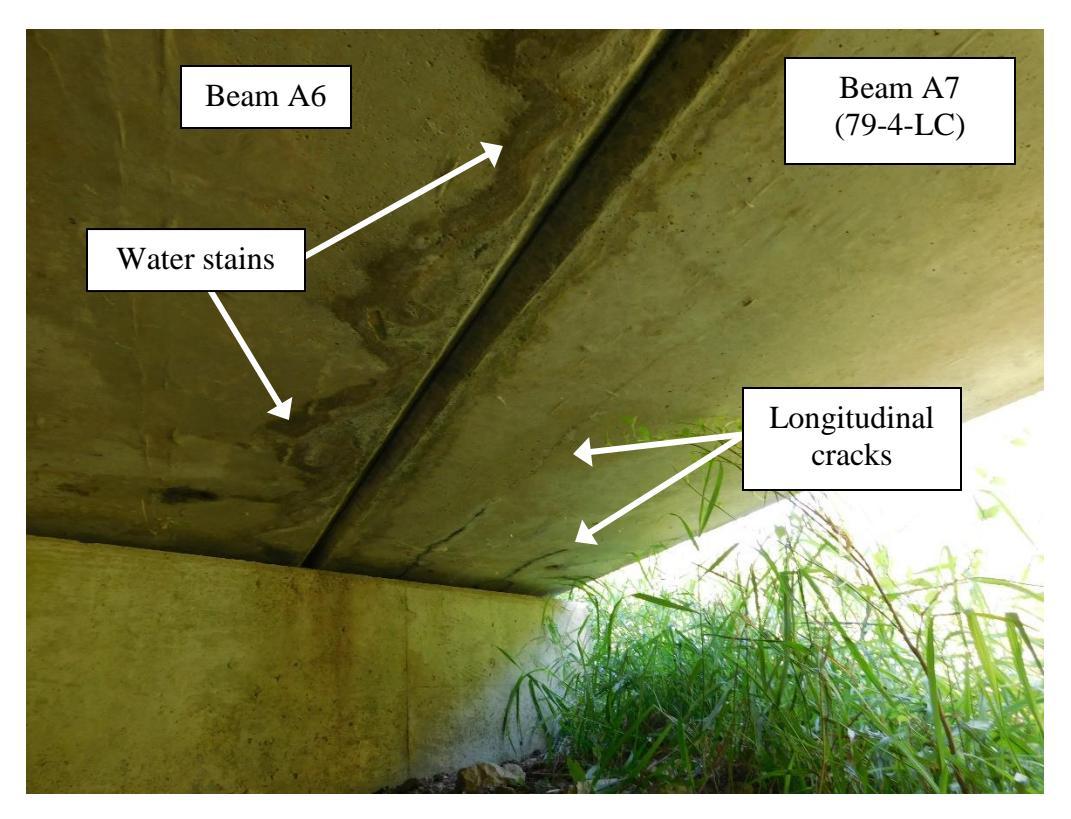
Wells 79 was inspected by the research team on 27 July 2016. The observed deterioration is summarized in Figure 2.23. Longitudinal cracks were found in six beams. The longitudinal cracks in Beam A7 (Specimen 79-4-LC) and Beams C2 and C6 were localized to the ends of the beams supported by the abutments (Figure 2.24 and Figure 2.25). The cracks in Beams B6 and C7 extended from the east support of each beam into midspan (Figure 2.26 and Figure 2.27). The crack in Beam C7 covered almost the entire length of the beam. When the wearing surface was inspected, a hole was found in the top flange of Beam C1 (Figure 2.28). The hole was filled with water, and vegetation was growing around the hole. When the bottom flange was inspected, no drain holes were present. In addition, reflective cracks were found in the wearing surface. The location of the reflective cracks corresponded with the joint between the adjacent beams below.

Figure 2.24: Beam A7 (specimen 79-4-LC) Deterioration

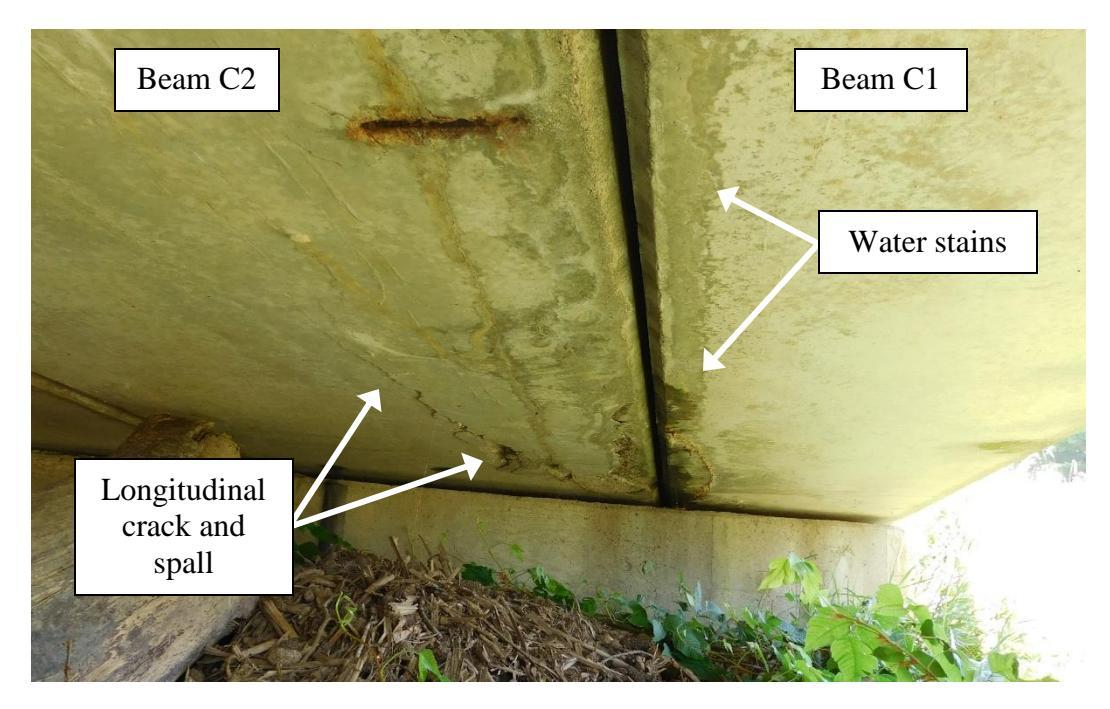
Figure 2.25: Beam C2 Deterioration

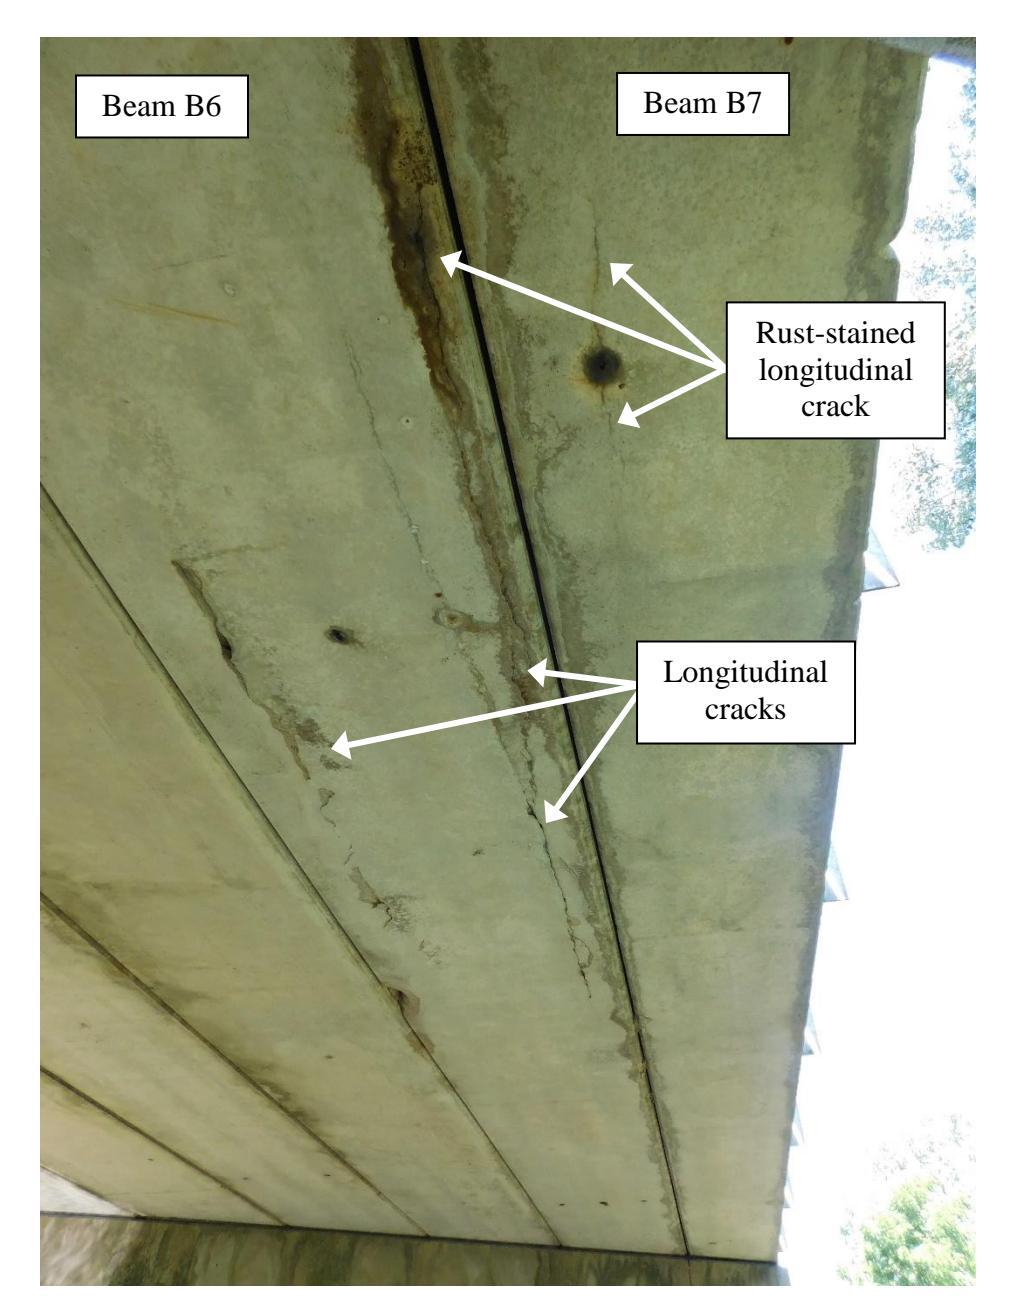
Figure 2.26: Beam B6 Deterioration

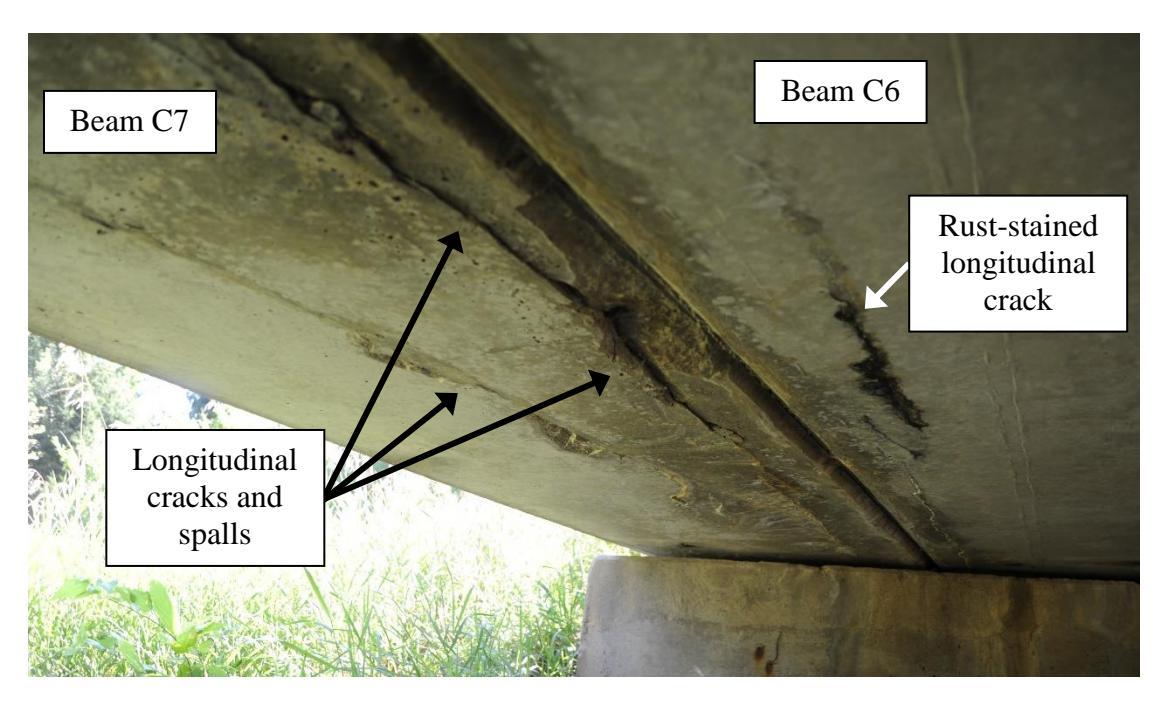
Figure 2.27: Beams C6 and C7 Deterioration

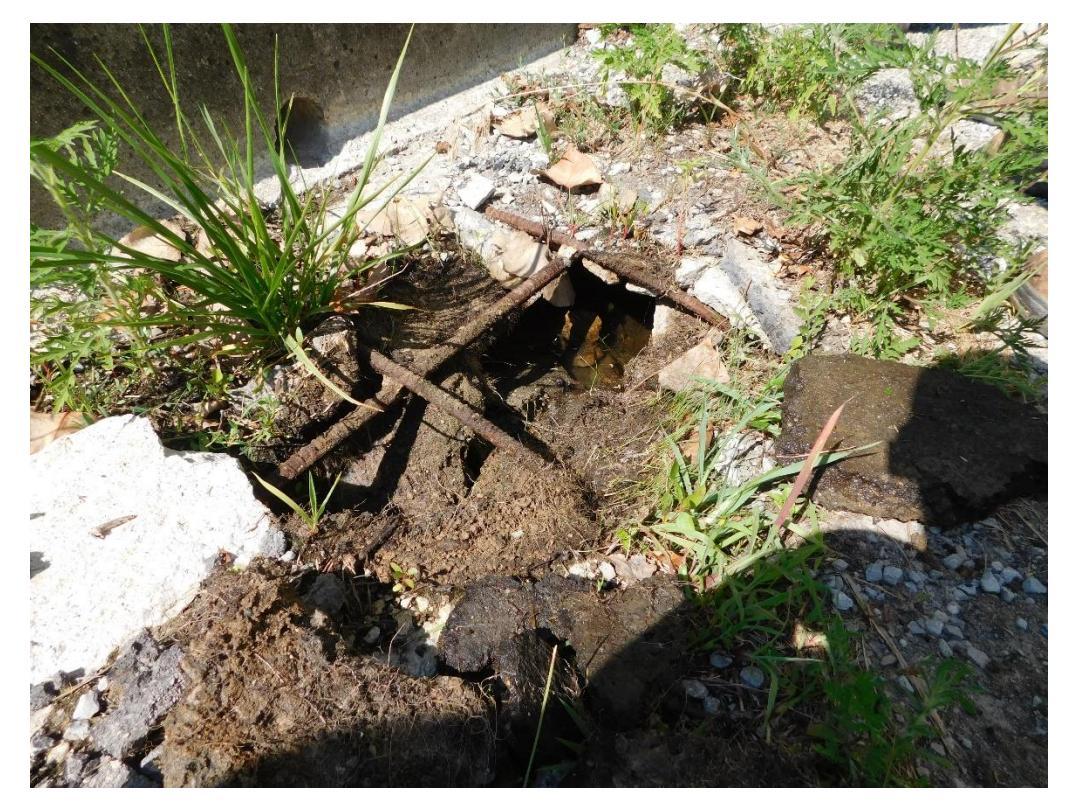
Figure 2.28: Hole in Top Flange of Beam C1

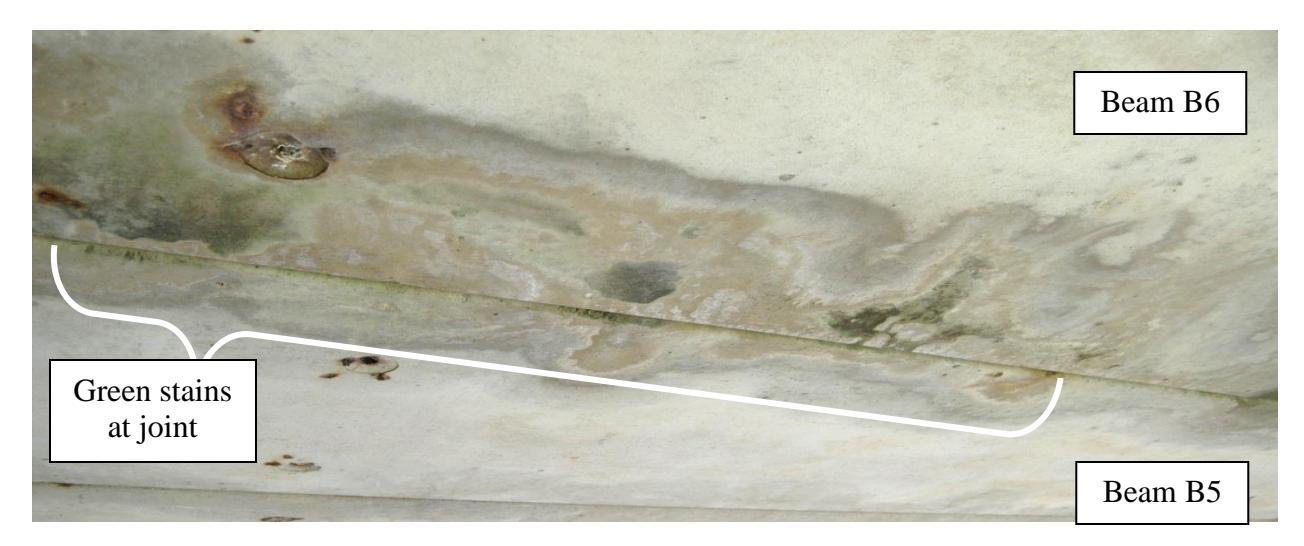
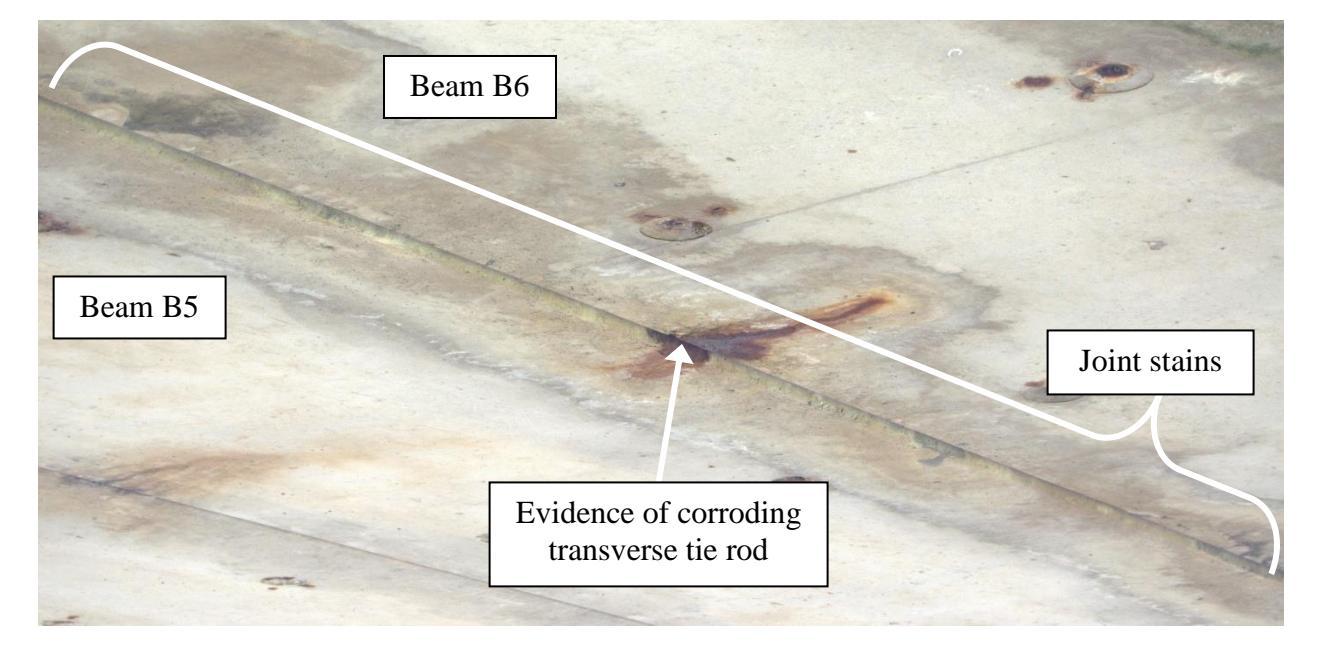
The bridge was inspected by the research team on 8 May 2017. The observed deterioration is summarized in Figure 2.30. Many of the joints showed signs of water leakage as staining around the joints between many of the beams. Examples of the observed staining is provided in Figure 2.31. The joint between Beams B5 and B6 had a large rust stain located near midspan. Because no spalling was observed on the bottom flanges of either beam, the rust was assumed to have originated from the transverse tie rod. A short longitudinal crack was observed in Beam A6 (Specimen 56-1-LC) at the west support (Figure 2.32). Beam B1 (Specimen 56-2-ES) was the most heavily deteriorated; nearly the entire exterior side of the beam had spalled off (Figure 2.33). Many stirrups were exposed, and a single strand was exposed at midspan (Figure 2.34). As shown in Figure 2.30, a majority of the drain holes were found to be rust stained or clogged (Figure 2.35). In addition, reflective cracking was observed in the bituminous wearing surface (Figure 2.36). Please note that a thin black line has been drawn to the right of the crack to highlight the location.

(a) Joint stains between Beams B5 and B6

(b) Joint stains between Beams B5 and B6 Figure 2.31: Joint Staining

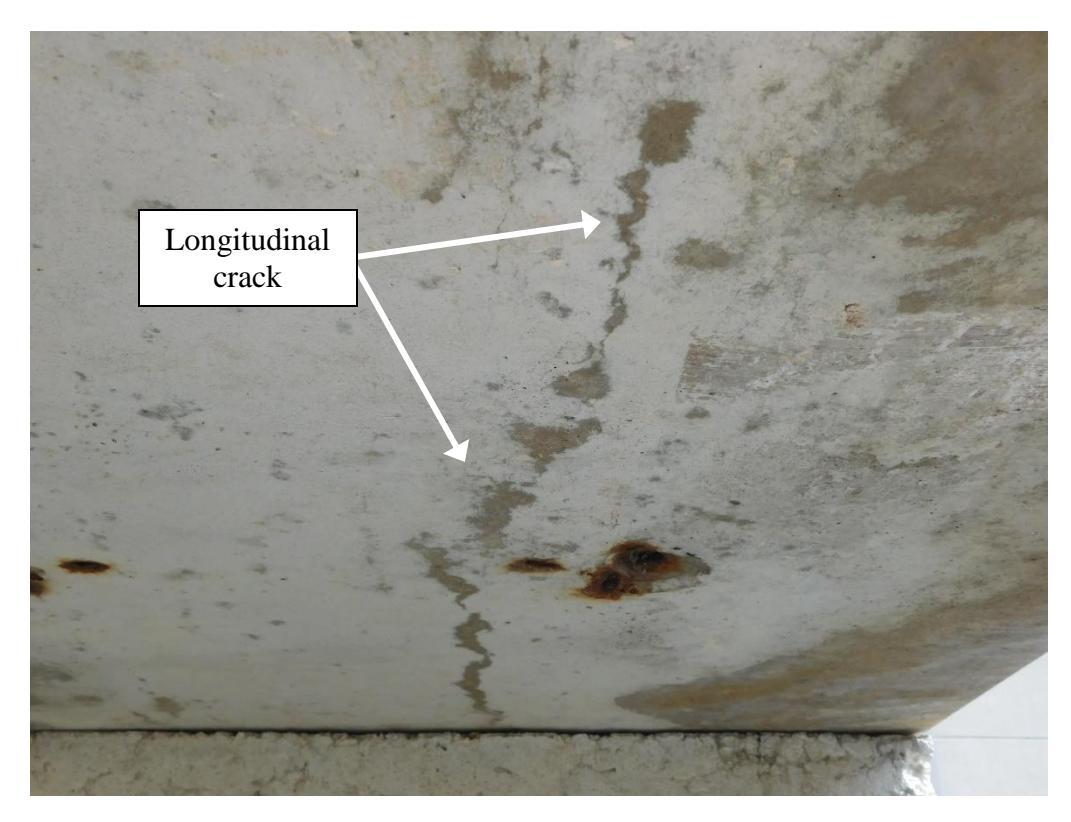
Figure 2.32: Longitudinal Crack in Beam A6 (Specimen 56-1-LC)

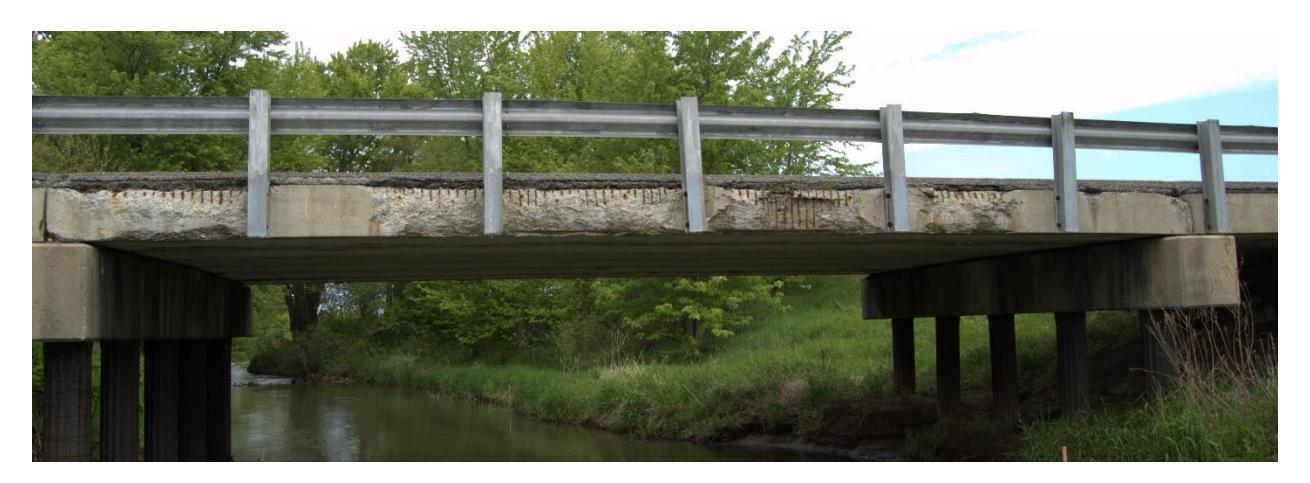
Figure 2.33: Spalling on Beam B1 (Specimen 56-2-ES)

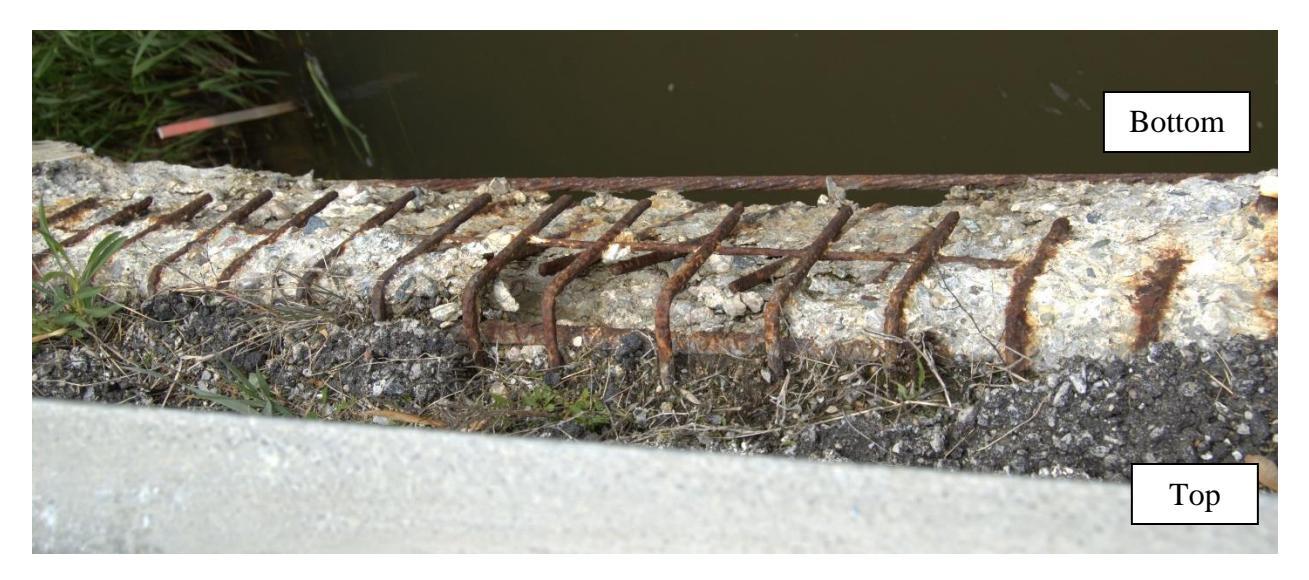
Figure 2.34: Photo looking from above on the exterior side of Beam B1 (specimen 56-2-ES)
