EVALUATION AND STRUCTURAL BEHAVIOR OF DETERIORATED PRECAST, PRESTRESSED CONCRETE BOX BEAMS

A Dissertation

Doctor of Philosophy

Lyles School of Civil Engineering West Lafayette, Indiana December 2019

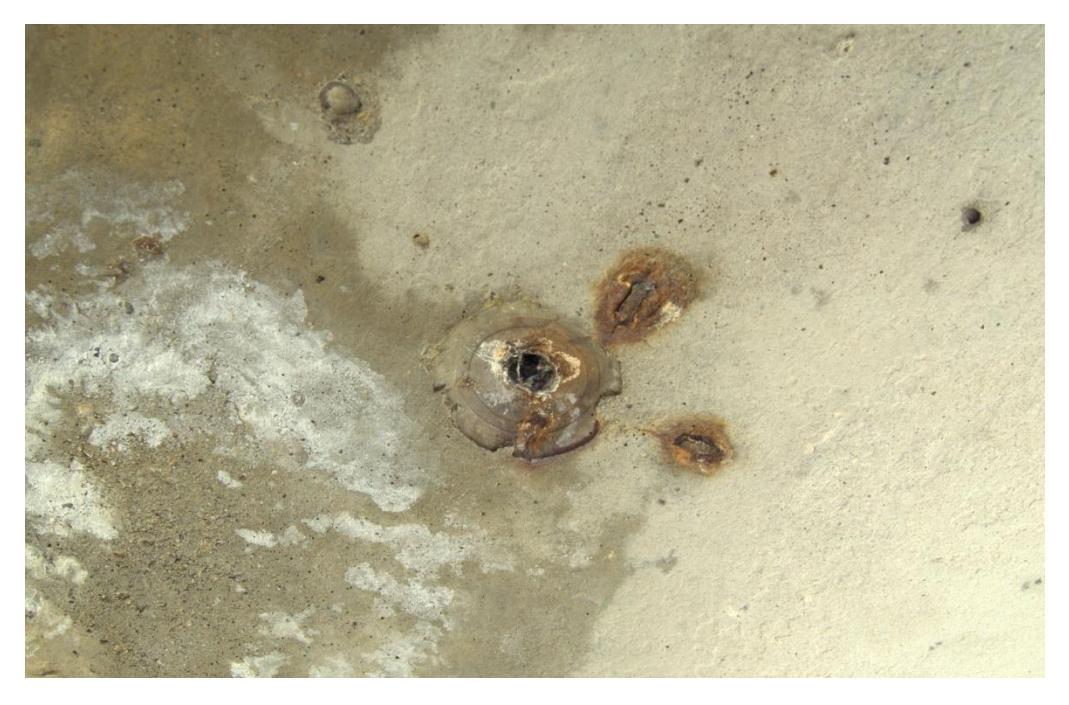
Figure 2.35: Rust-Stained and Clogged Drain Hole

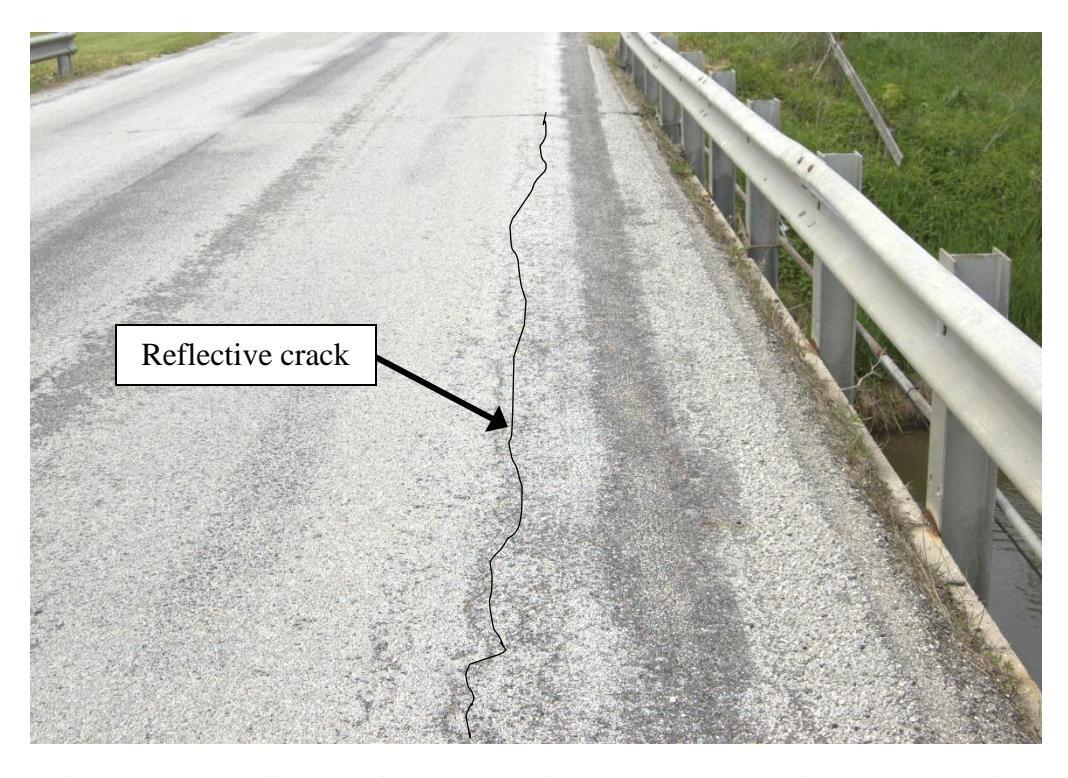
Figure 2.36: Reflective Cracks at Joint between Beam A5 and Beam A6 (Specimen 56-1-LC)

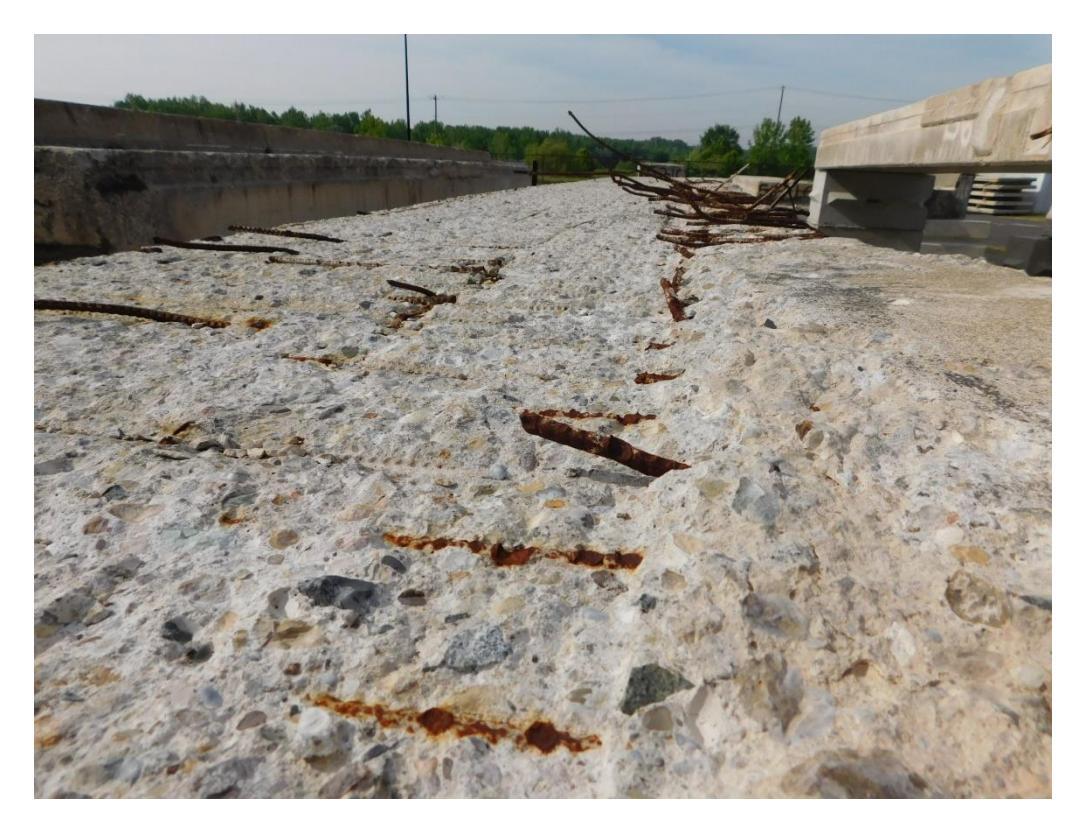
In 2018, the bridge was replaced with a new adjacent box beam bridge. As part of the demolition of the bridge, Beam A6 (Specimen 56-1-LC) and Beam B1 (Specimen 56-2-ES) were salvaged and transported to Bowen Laboratory. To salvage the beams, the wearing surface had to be removed. The milling machine used to remove the wearing surface ground off approximately 2 in. of the top flange of Specimen 56-2-ES (Beam B1) (Figure 2.37). The research team was informed by the bridge contractor that deteriorated concrete is nearly as easy to mill as bituminous materials, and the similarity in hardness causes milling machine operators to have difficulty when determining where the bituminous wearing surface ends and the deteriorated concrete begins. As such, the bridge contractor believed that the top 2 in. of Specimen 56-2-ES (Beam B1) was deteriorated.

Figure 2.37: Top Flange Removed by Milling Machine

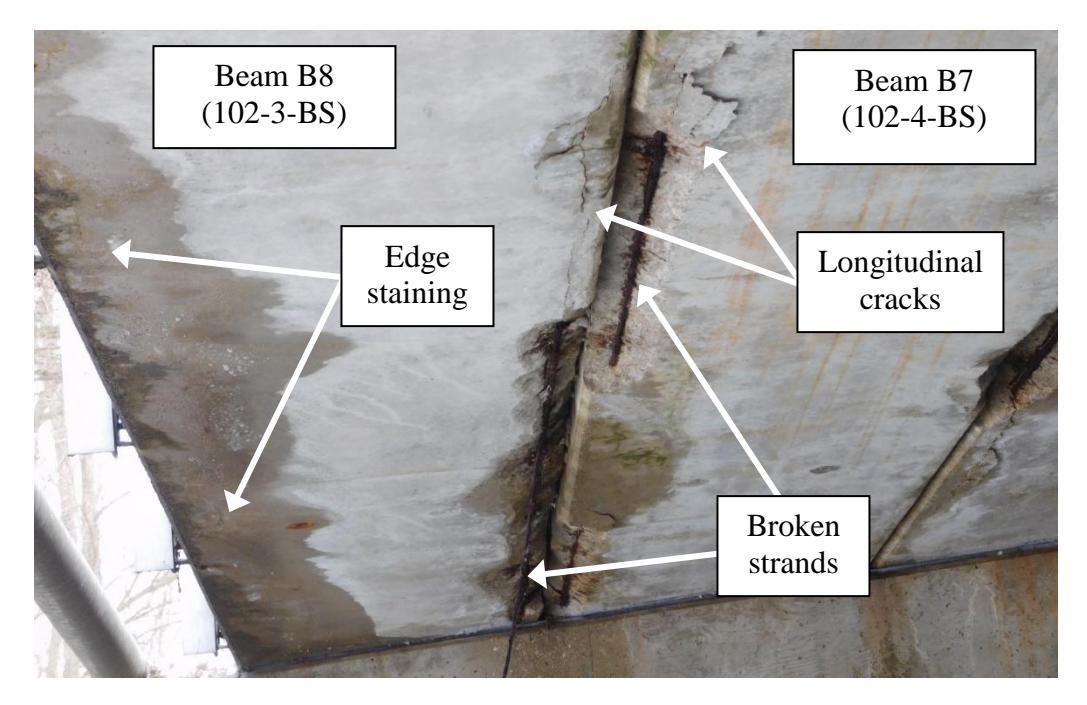
Figure 2.40: Deterioration of Beams B7 and B8 (Specimens 102-3-BS and 102-4-BS)

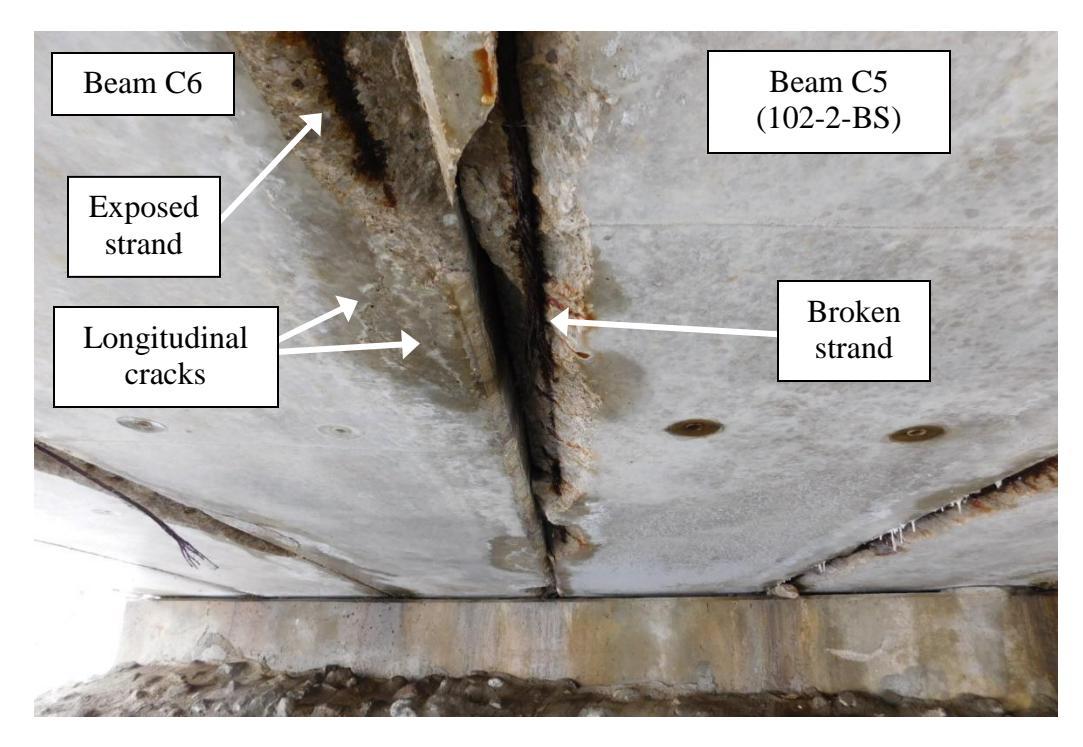
Figure 2.41: Deterioration of Beam C5 and Beam C6 (Specimen 102-2-BS)

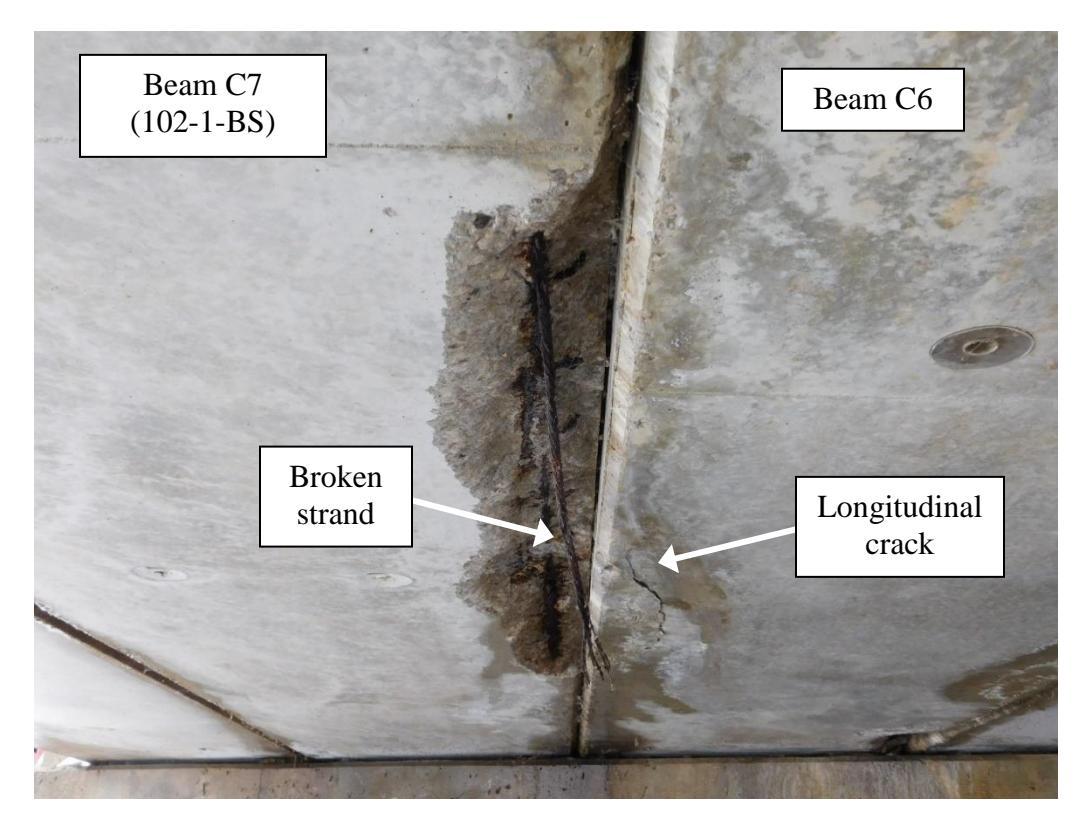
Figure 2.42: Deterioration of Beam C6 and Beam C7 (Specimen 102-1-BS)

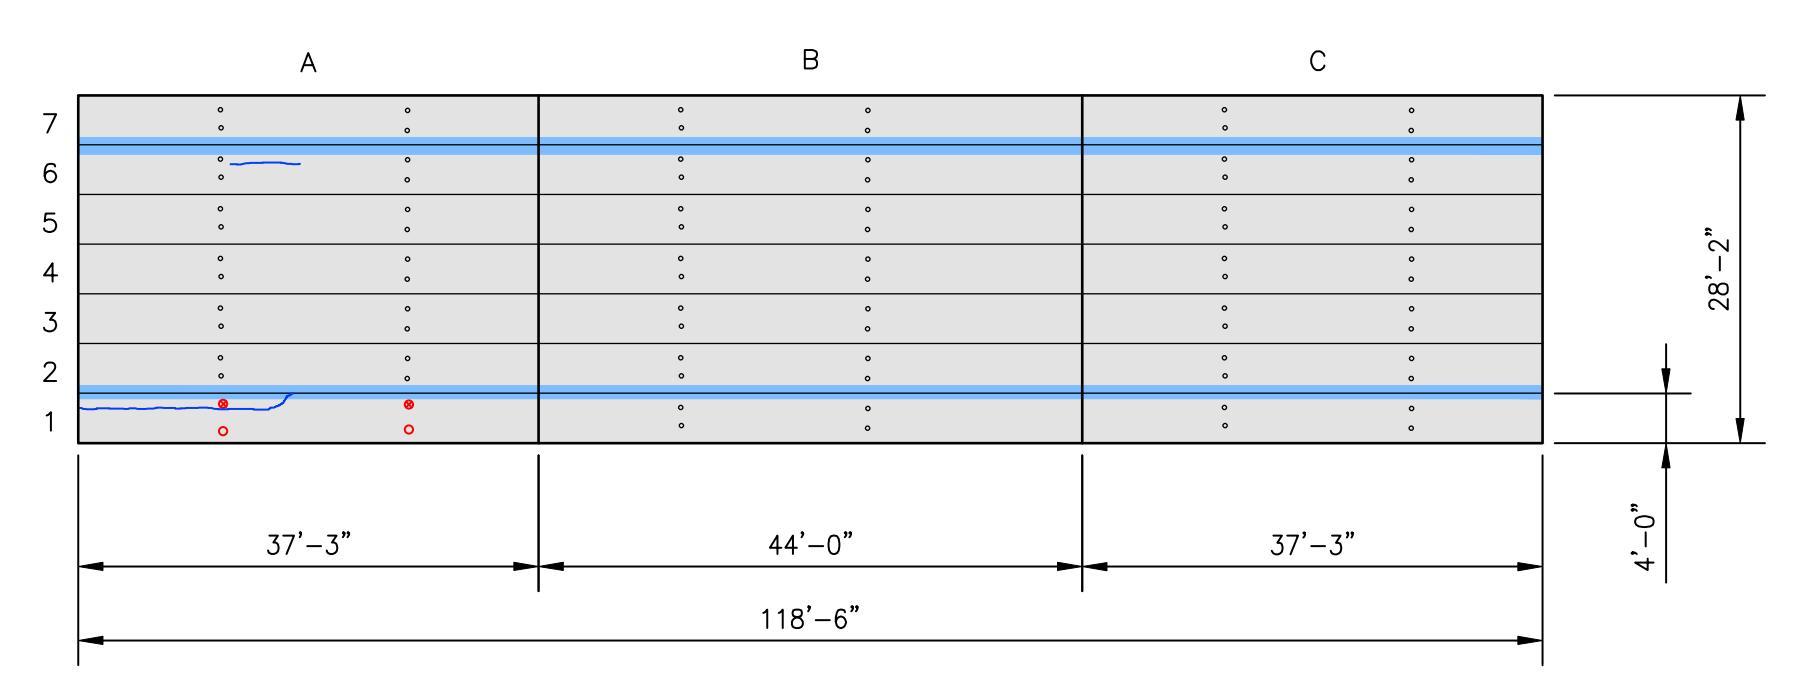
Figure 2.45: Daviess 95 Deterioration Map

Daviess 95 was visited by the research team on 24 January 2017. The observed deterioration is summarized in Figure 2.45. A longitudinal crack in Beam A1 extended from the west beam support into the middle portion of the beam and showed signs of water leaking through the crack (Figure 2.46). Beam A1 also showed signs of clogged drain holes (Figure 2.47). A hairline longitudinal crack was found in Beam A6 in the middle third of the span. Staining was observed between the exterior beam and first interior beam on both sides of the bridge along the length of all three spans. The staining was characterized by a greenish color and efflorescence (Figure 2.48). Longitudinal reflective cracks were also observed in the wearing surface (Figure 2.49). Please note that a black line has been drawn next to the reflective crack to highlight the crack location in Figure 2.49.

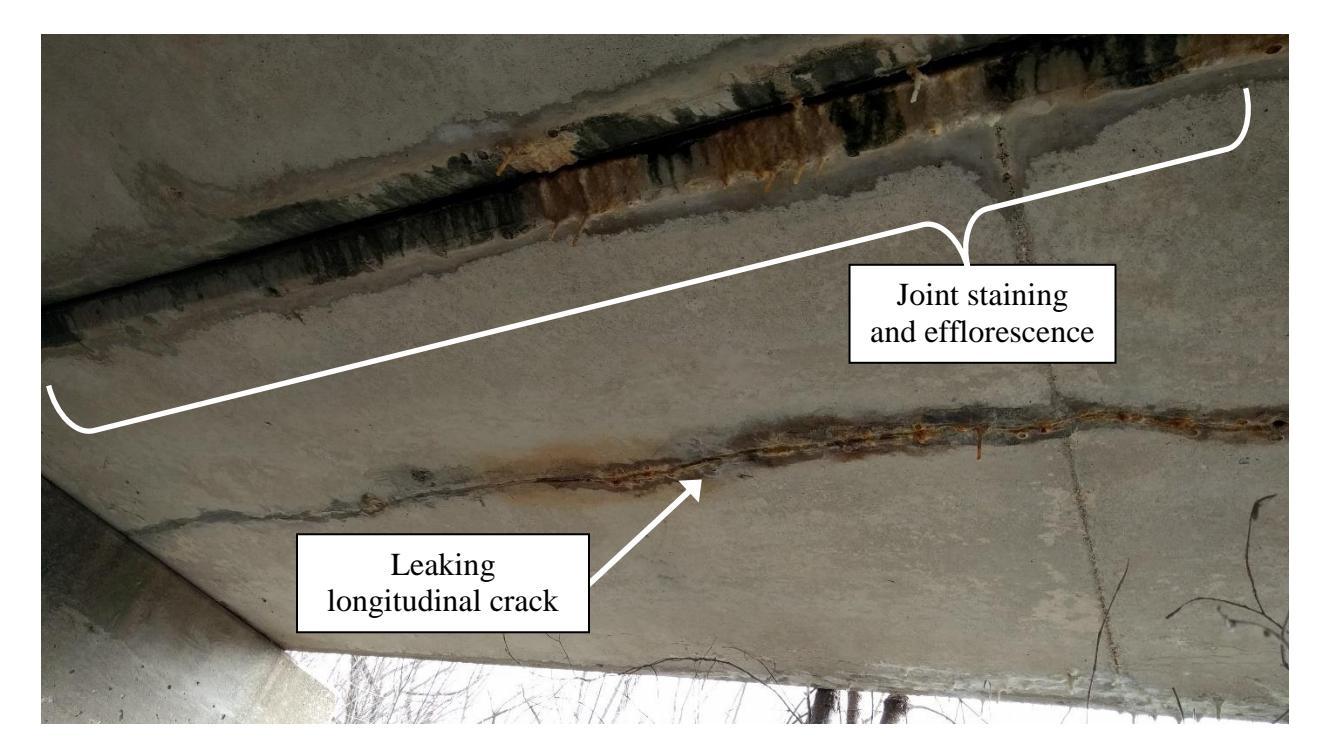
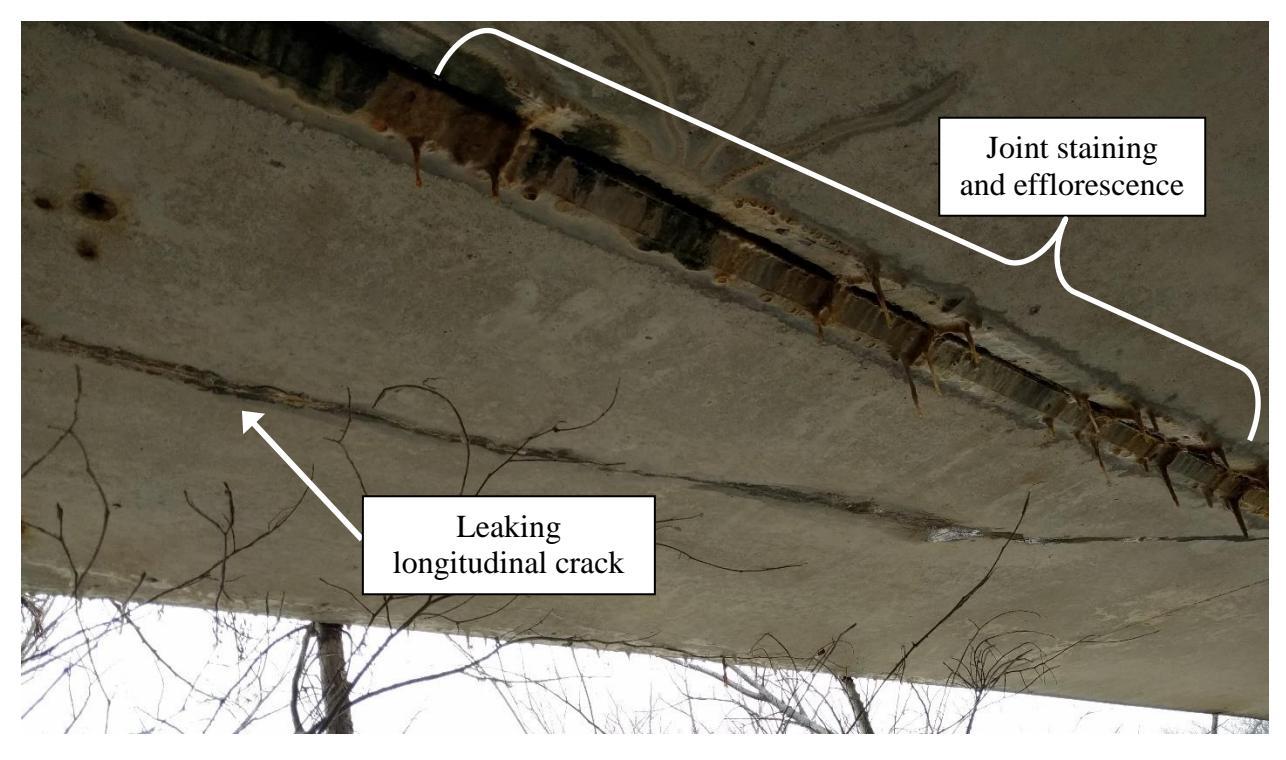
(a) West portion of the longitudinal crack on Beam A1

(b) East portion of the longitudinal crack on Beam A1 Figure 2.46: Beam A1 Deterioration

The shear key deterioration mechanism does not address the formation of longitudinal cracks in the middle of the bottom flange away from the support as observed in Tippecanoe 244 (Figure 2.6), Newton K5 (Figure 2.17 and Figure 2.18), Wells 79 (Figure 2.26 and Figure 2.27), Daviess 95 (Figure 2.46), Daviess 160 (Figure 2.52 and Figure 2.53), Elkhart 385 (Figure 2.57), and Elkhart 410 (Figure 2.69(a)). If the longitudinal crack forms away from the edge of the section and the support, it is theorized that the source of the cracking is the void.

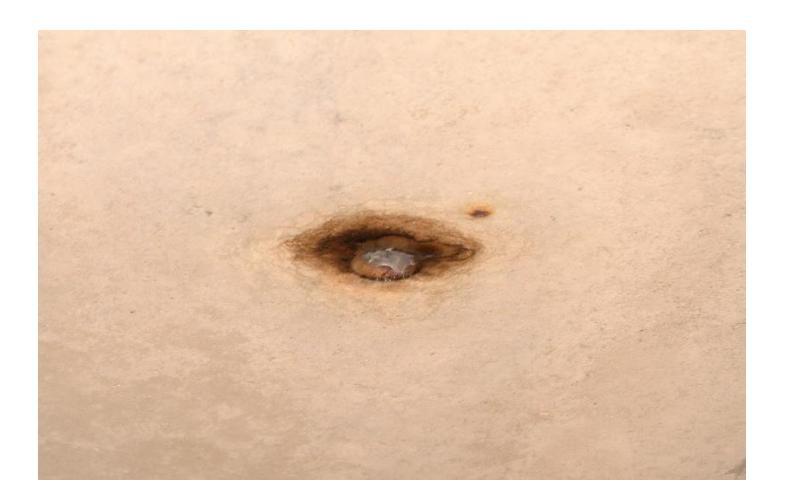
Figure 2.47: Clogged Drain Hole in Beam A1

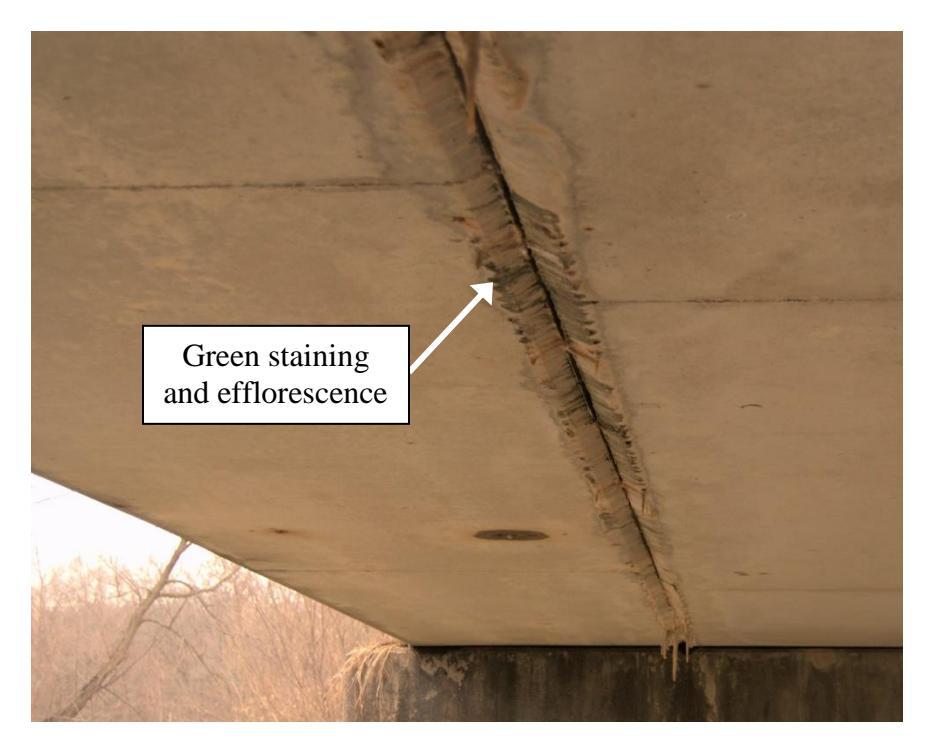
Figure 2.48: Staining between Beam A1 and A2

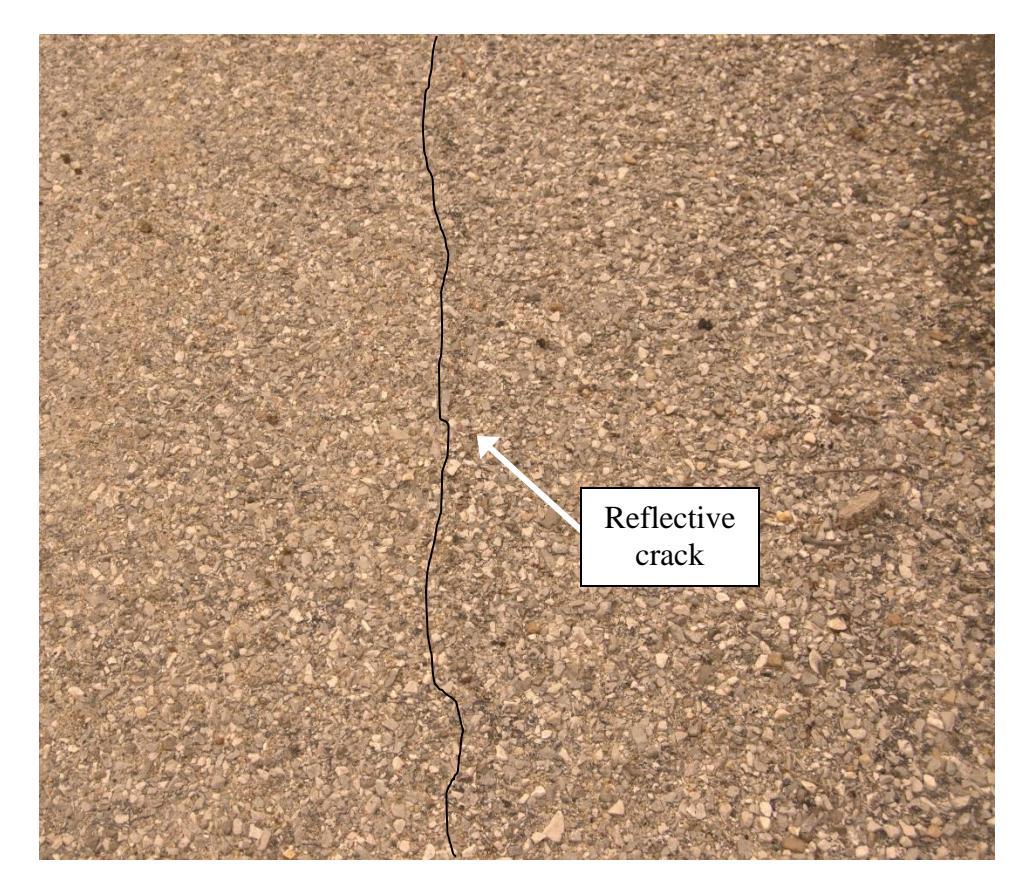
Figure 2.49: Reflective Crack through Wearing Surface

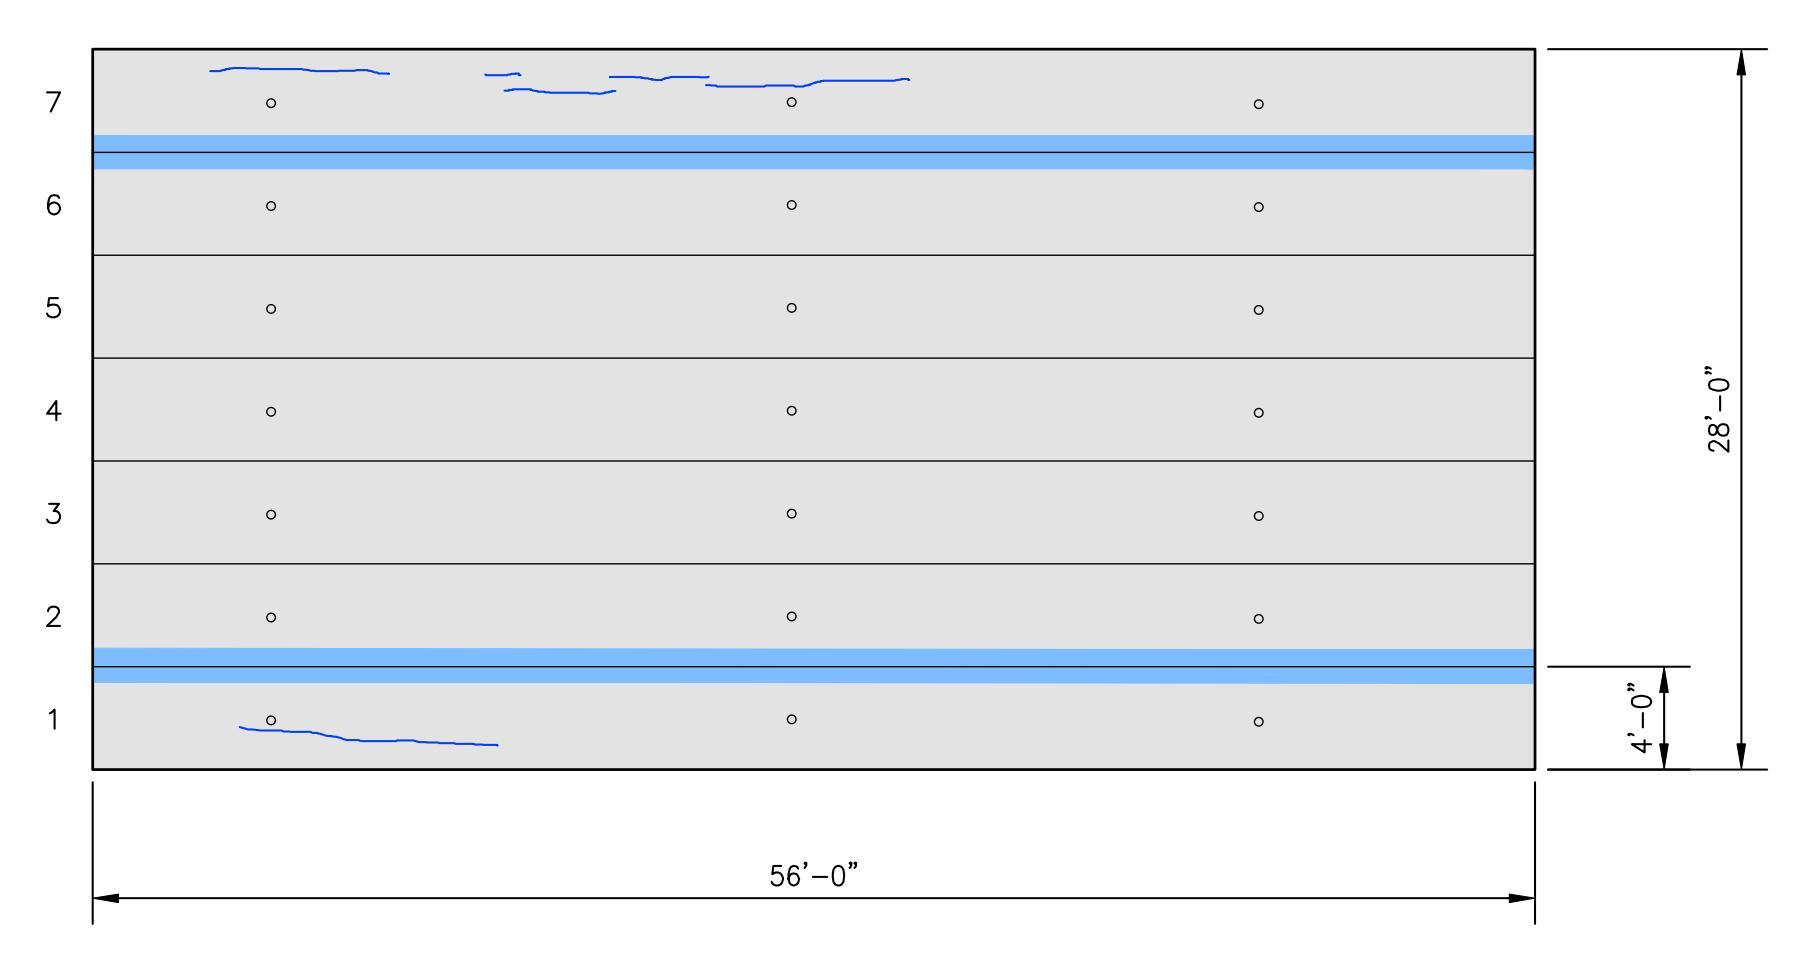
Figure 2.51: Daviess 160 Deterioration Map

Daviess 160 was inspected by the research team on 24 January 2017. The observed deterioration is summarized in Figure 2.51. Beam 1 was observed to have a longitudinal crack on the bottom flange and green staining at the joint (Figure 2.52). Beam 7 had similar deterioration to Beam 1 but exhibited more extensive longitudinal cracking and green staining at the joint (Figure 2.53). The wearing surface was also observed to have reflective cracks between Beams 2 and 3 (Figure 2.54). A black line has been drawn on Figure 2.54 next to the reflective crack to highlight the crack's location.

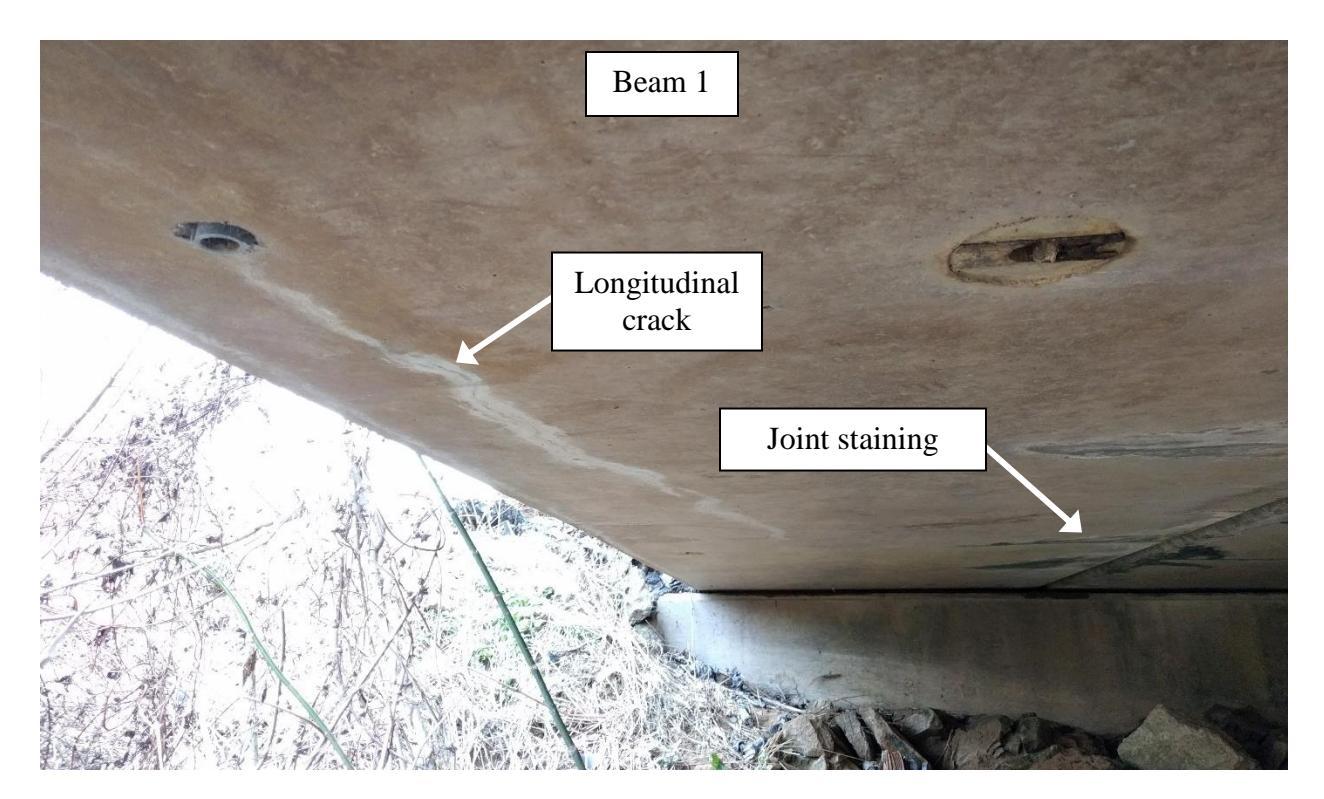
Figure 2.52: Beam 1 Deterioration

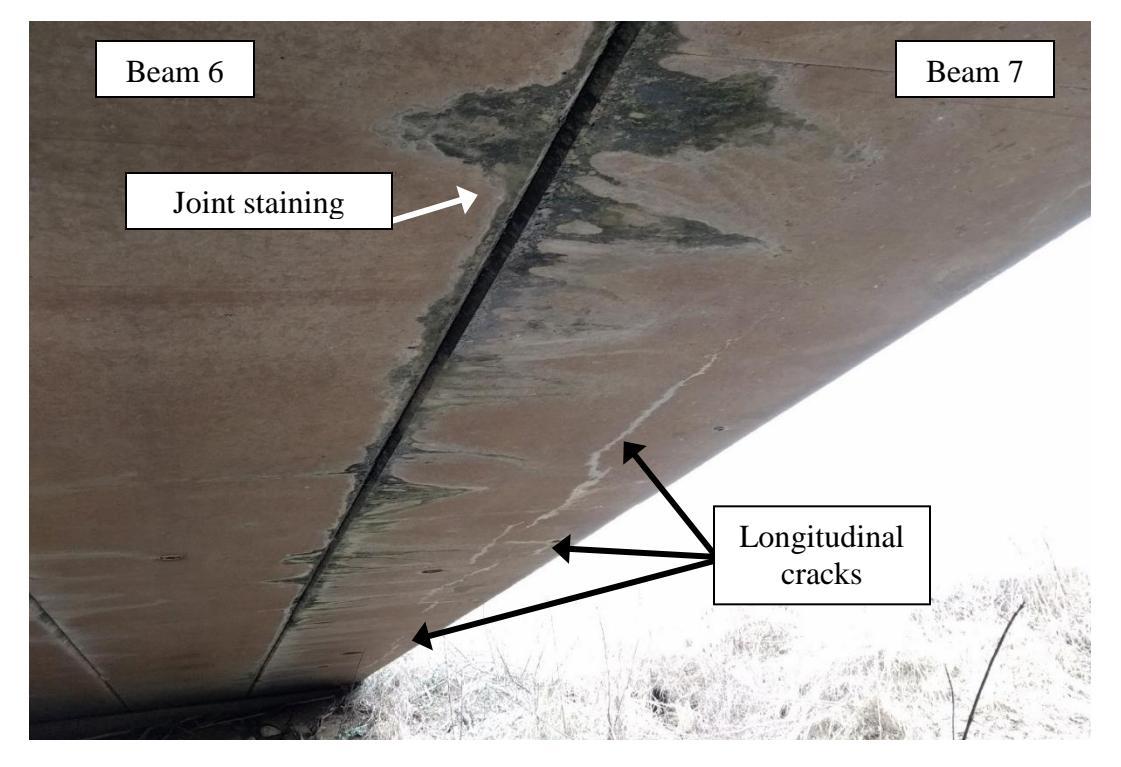
Figure 2.53: Deterioration of Beams 6 and 7

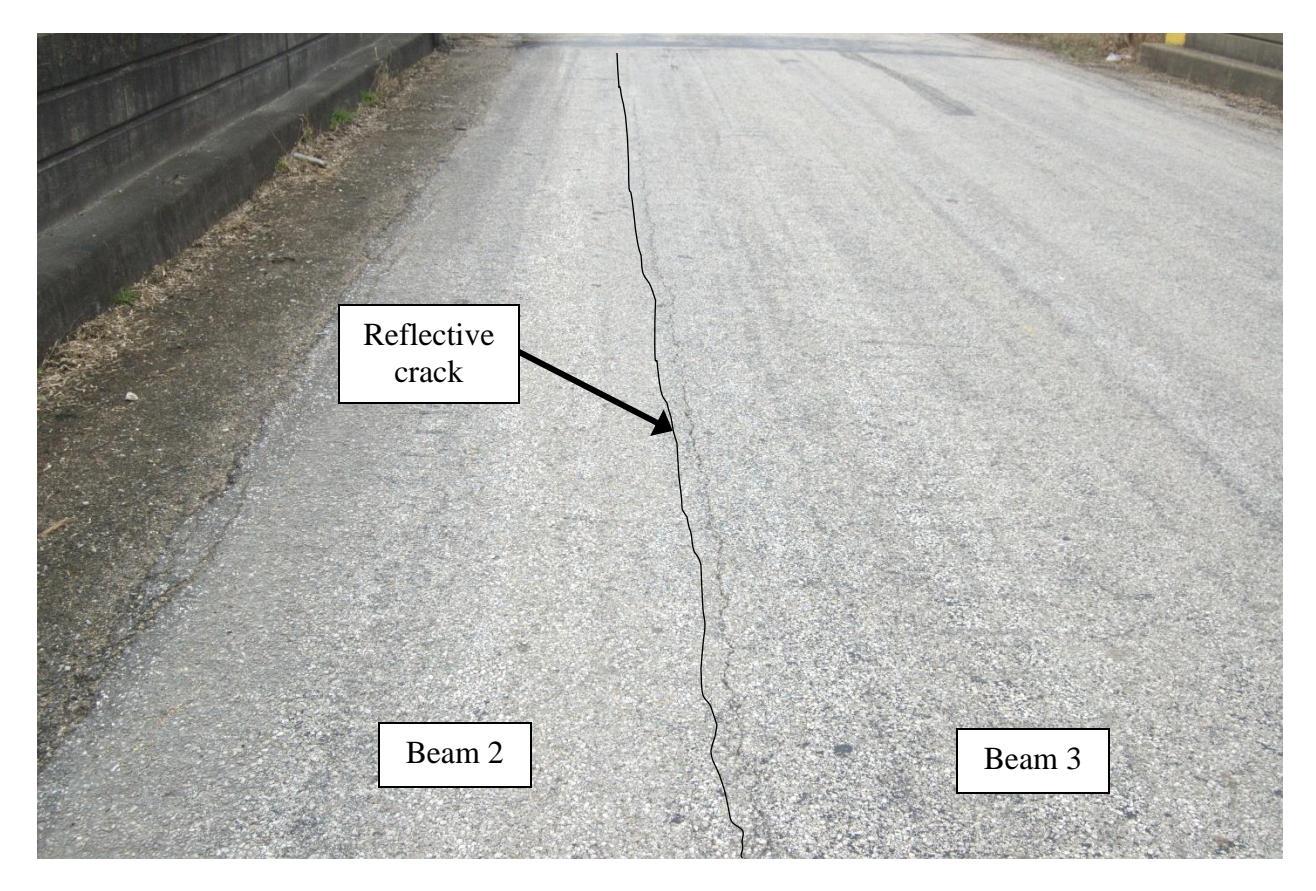
Figure 2.54: Reflective Crack in the Wearing Surface between Beams 2 and 3

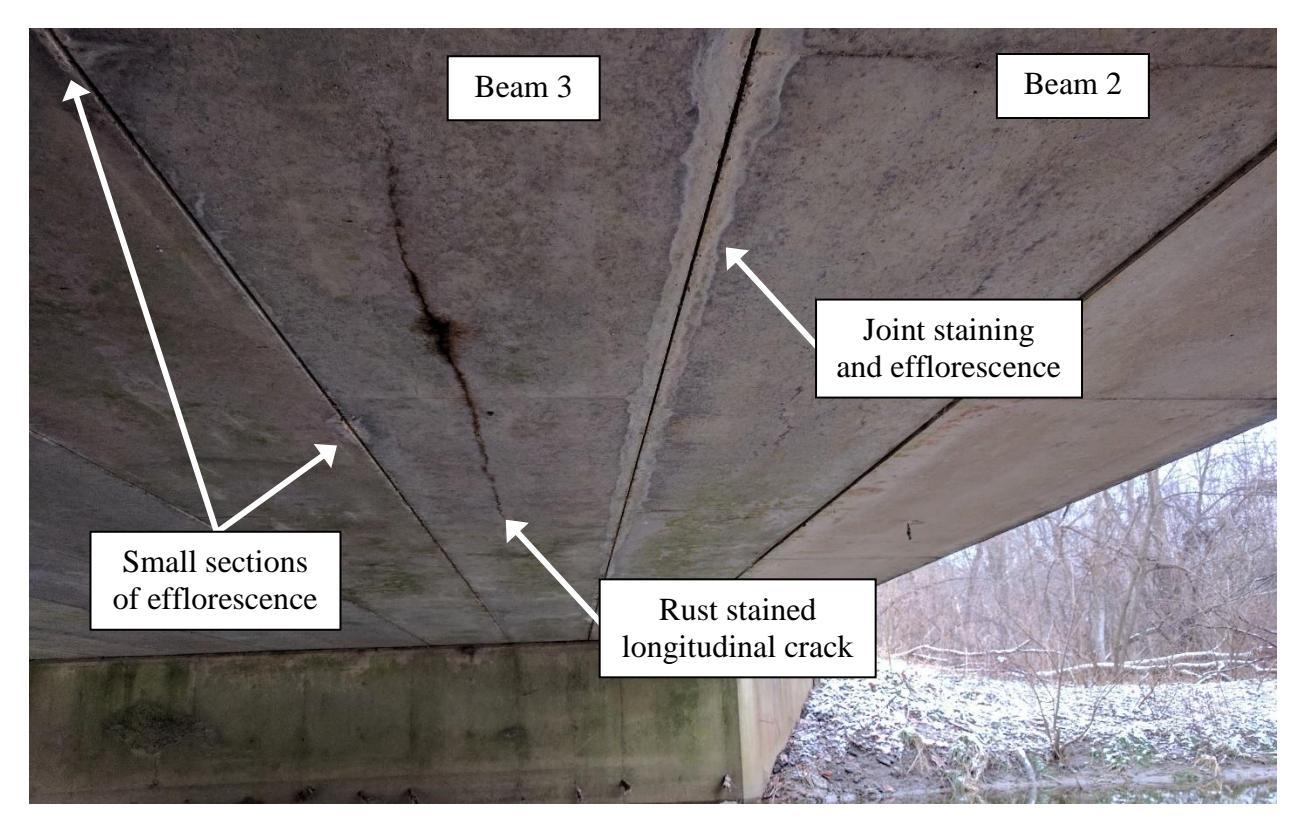
Elkhart 385 was inspected by the research team on 27 January 2017. The observed deterioration is summarized in Figure 2.56. A rust stained longitudinal crack was found at midspan on Beam 3 (Figure 2.57). The joints between Beams 2 and 3 and Beams 7 and 8 were stained from water leaking through the shear key. These locations are interesting as they are the locations of the first joint in the original configuration of the bridge prior to the addition of the new exterior beams. Small sections of efflorescence were also observed at the joint between Beams 3 and 4. No reflective cracks were observed in the wearing surface or concrete deck.

Figure 2.57: Elkhart 385 Deterioration

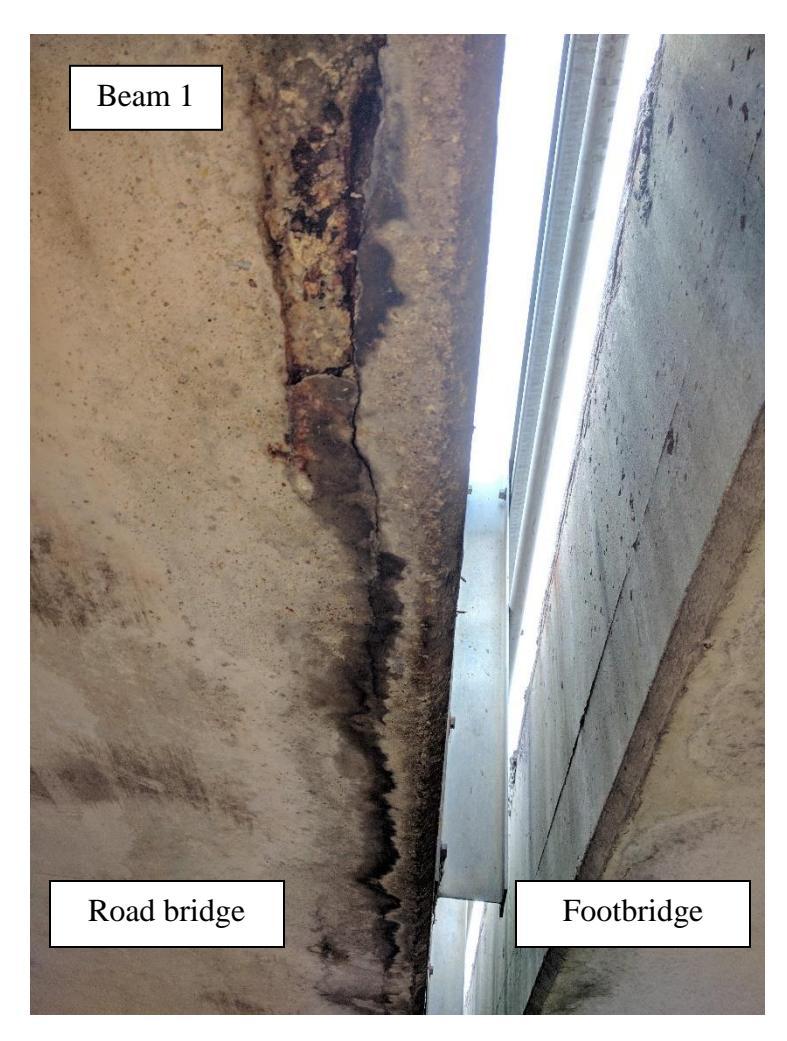
Elkhart 404 was inspected by the research team on 27 January 2017. The observed deterioration is summarized in Figure 2.59. As shown in Figure 2.58, the bridge was constructed with a sidewalk south of Beam 1. The sidewalk was placed on a beam separated from the road bridge (Figure 2.60). A single exposed strand on the west end of Beam 1 and staining on the exterior edge of Beam 1 were the only deterioration found (Figure 2.61). No reflective cracks in the wearing surface were observed by the research team, but hairline cracks were noted in the official inspection report.

Figure 2.60: Separation between Road Bridge and Footbridge

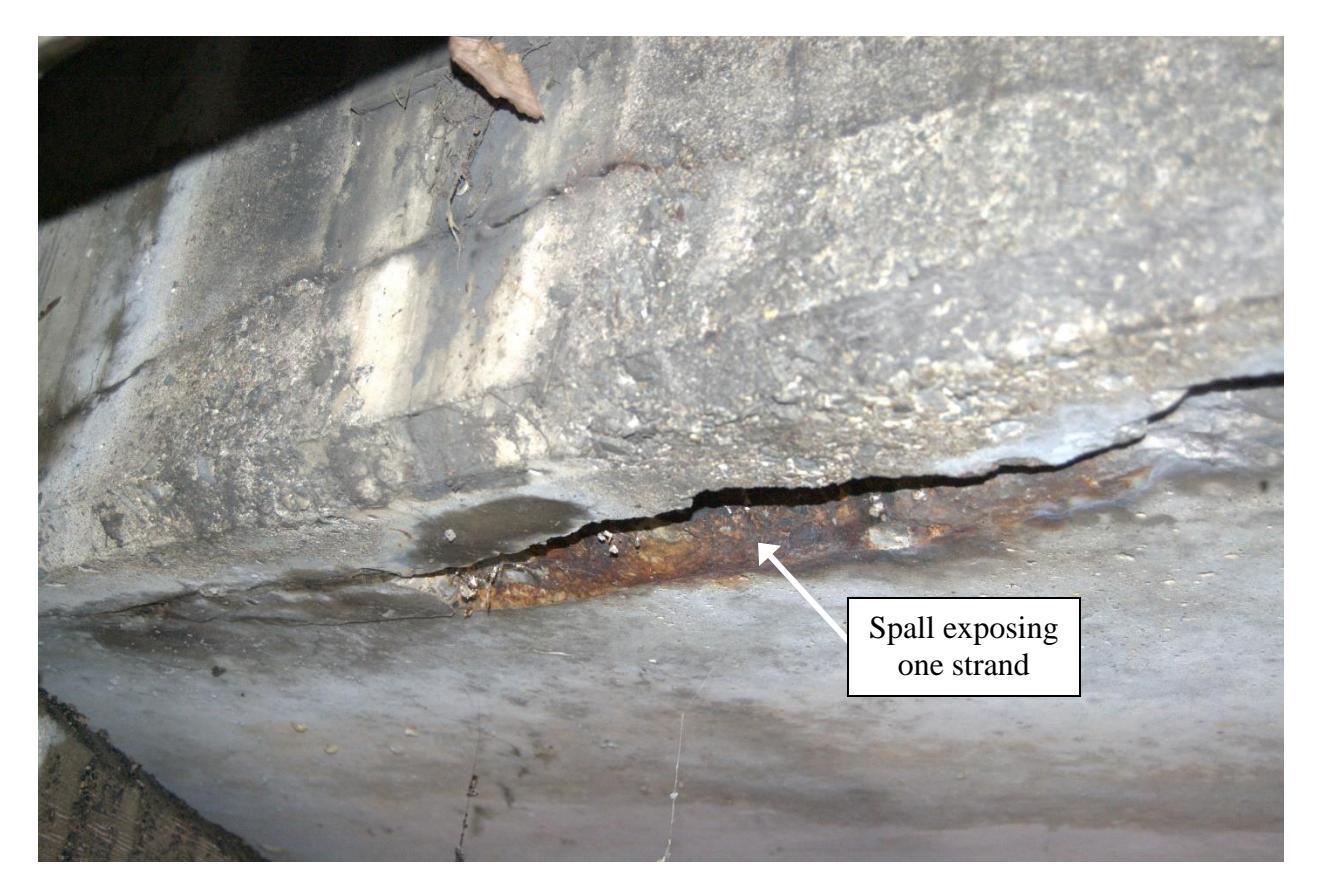
Figure 2.61: Beam 1 Deterioration

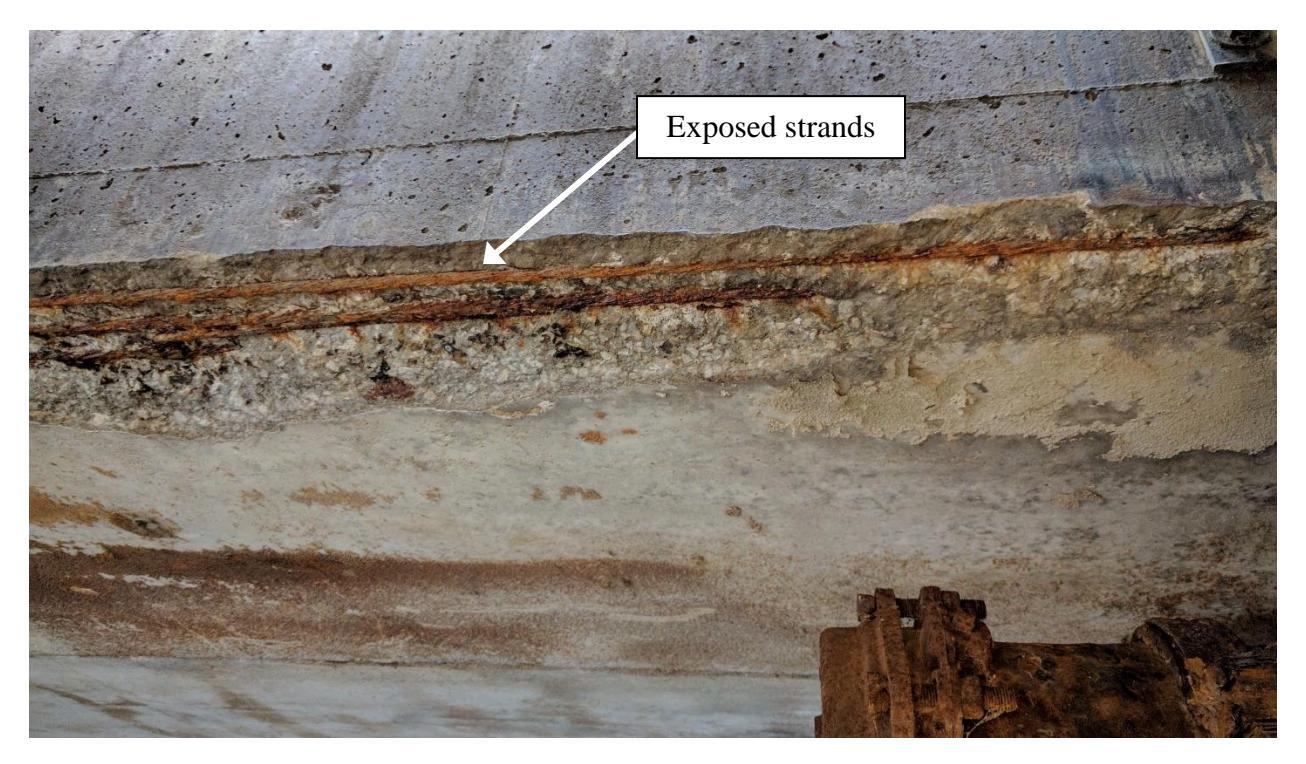
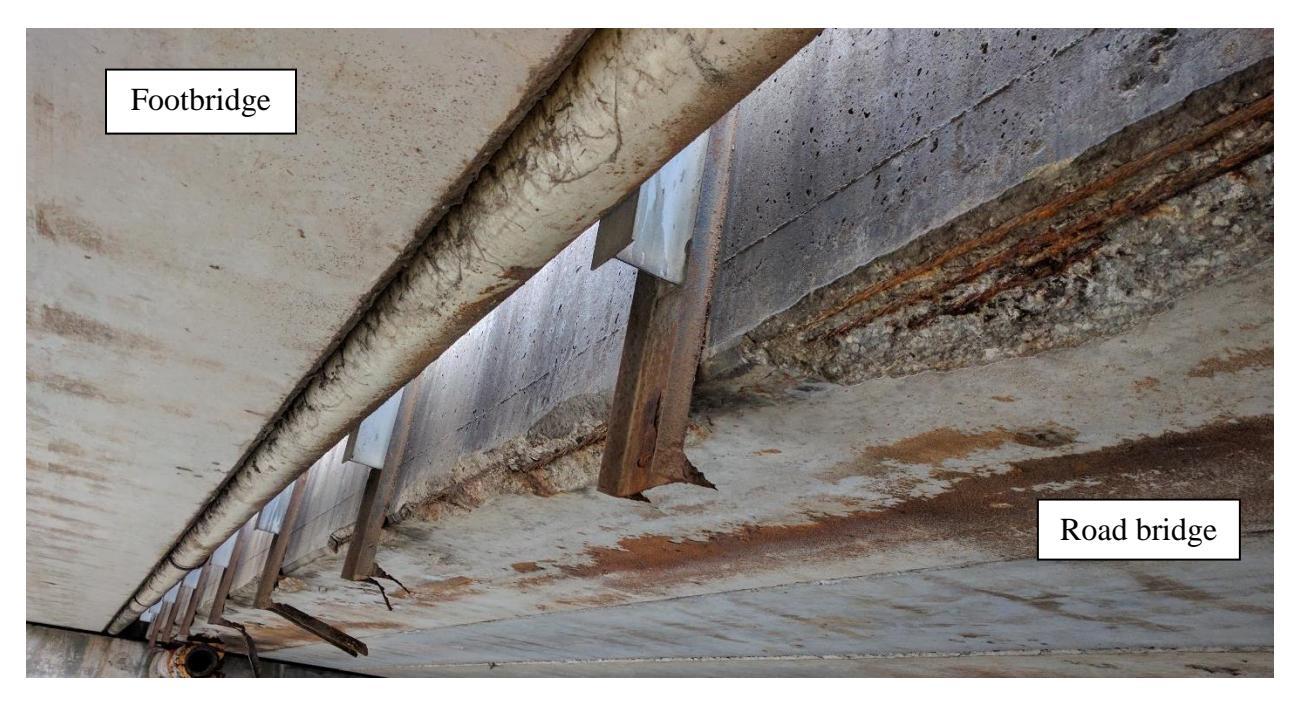
Elkhart 406 was visited by the research team on 27 January 2017. The observed deterioration is summarized in Figure 2.63. The deterioration of Elkhart 406 is localized to the exterior beams. Beam 1 and Beam 8 were both observed to have spalling with an exposed strand. A spall extending from the north support to midspan on Beam 1 exposed three strands (Figure 2.64), and a spall on Beam 8 exposed a single strand near the north support (Figure 2.65). No longitudinal cracks were found in the concrete deck. In addition, the footbridge beams on either side of the bridge were in excellent condition. Neither were found with any deficiencies.

(a) Spalling on Beam 1 with three exposed strands

(b) Strands exposed up to midspan of Beam 1 Figure 2.64: Deterioration of Beam 1

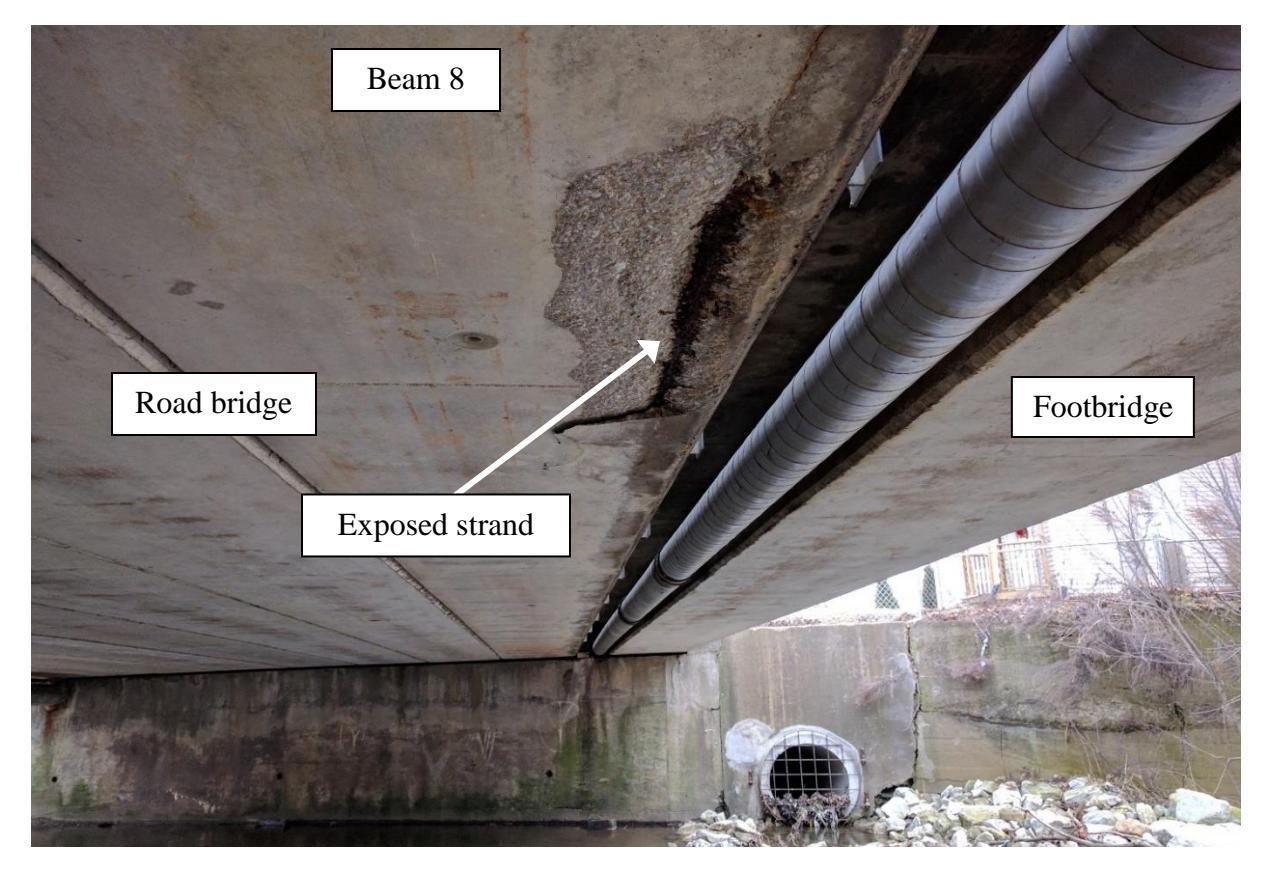
Figure 2.65: Beam 8 Deterioration
