EVALUATION AND STRUCTURAL BEHAVIOR OF DETERIORATED PRECAST, PRESTRESSED CONCRETE BOX BEAMS

A Dissertation

Doctor of Philosophy

Lyles School of Civil Engineering West Lafayette, Indiana December 2019

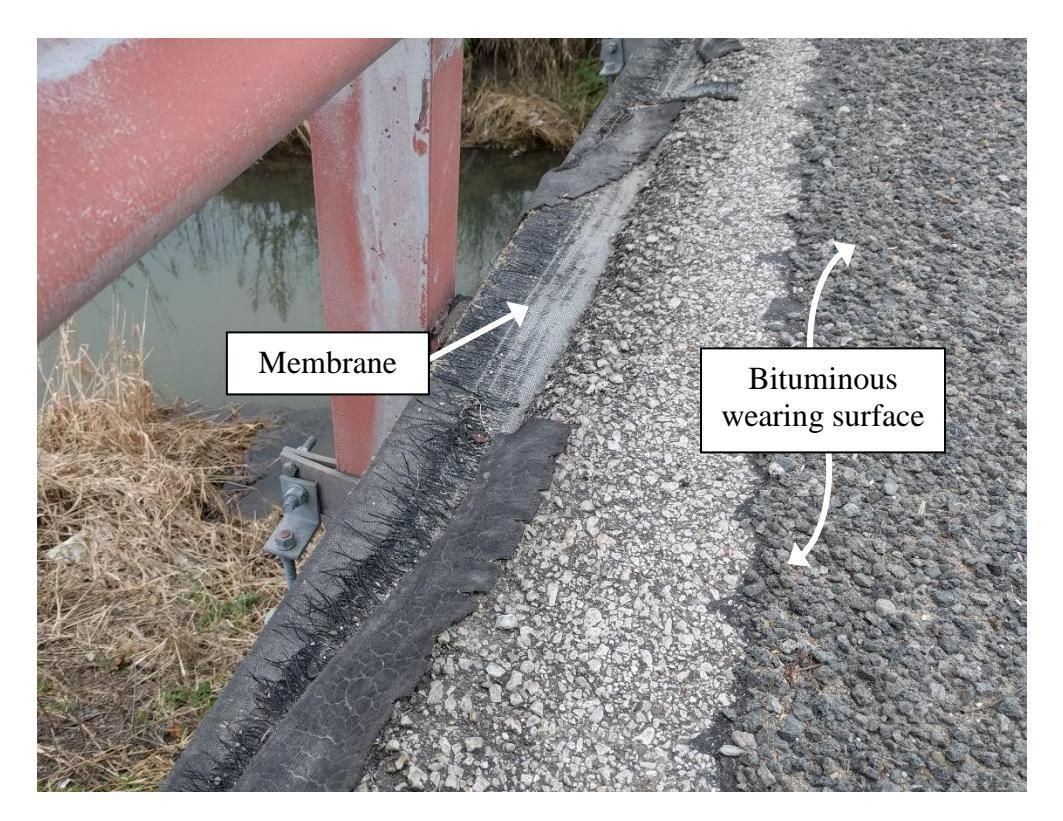
Figure 2.67: Membrane under the Bituminous Wearing Surface

A comparison between the 1959 beams and 1973 beams (Figure 2.68) revealed that more of the 1973 beams were deteriorated. The direct cause of this discrepancy in deterioration is unknown, but the roadway is only two lanes (24 ft wide) which creates a very wide shoulder that is carried by the beams added during the 1973 reconstruction (Figure 2.71). During the winter there is potential for plowed snow to accumulate on the edges of the bridge. When the snow is removed from the traffic lane, road salts may be carried with the snow onto the edge of the bridge. If the snow is not removed from the bridge, the resulting chloride laden snow melt could be carried through the shear keys to the beams below. Over time, chlorides in the snow melt could reach the strand and induce corrosion. The described mechanism of deterioration implies, however, that the membrane between the wearing surface and the beams has failed and is not effective.

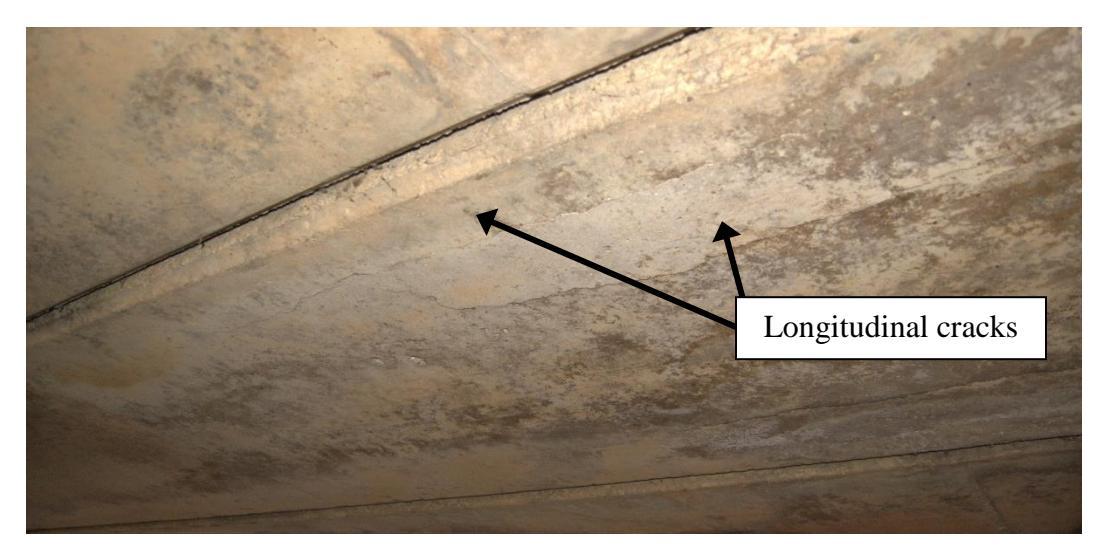
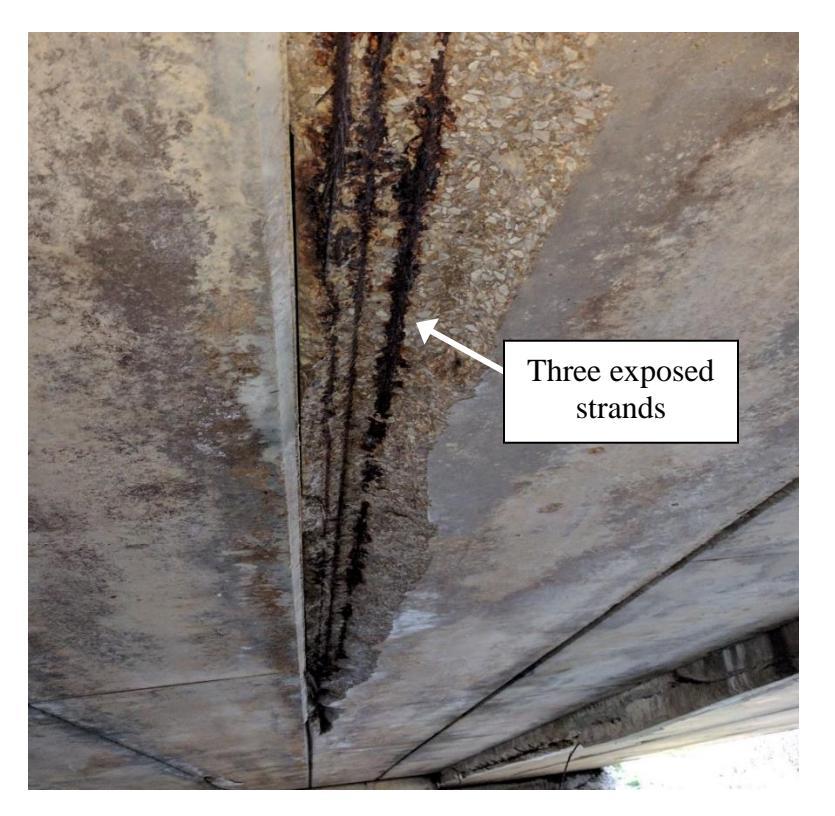
Elkhart 410 was inspected by the research team on 27 January 2017. A summary of the observed deterioration is provided in Figure 2.68. Overall, the bridge exhibited extensive deterioration in the form of longitudinal cracking and spalling which exposed strand. Examples of this deterioration are provided in Figure 2.69 and Figure 2.70.

(a) Beam 5 (1959) deterioration

(b) Beam 11 (1959) deterioration

Figure 2.69: 1959 Construction - Example Longitudinal Cracking and Exposed Strands

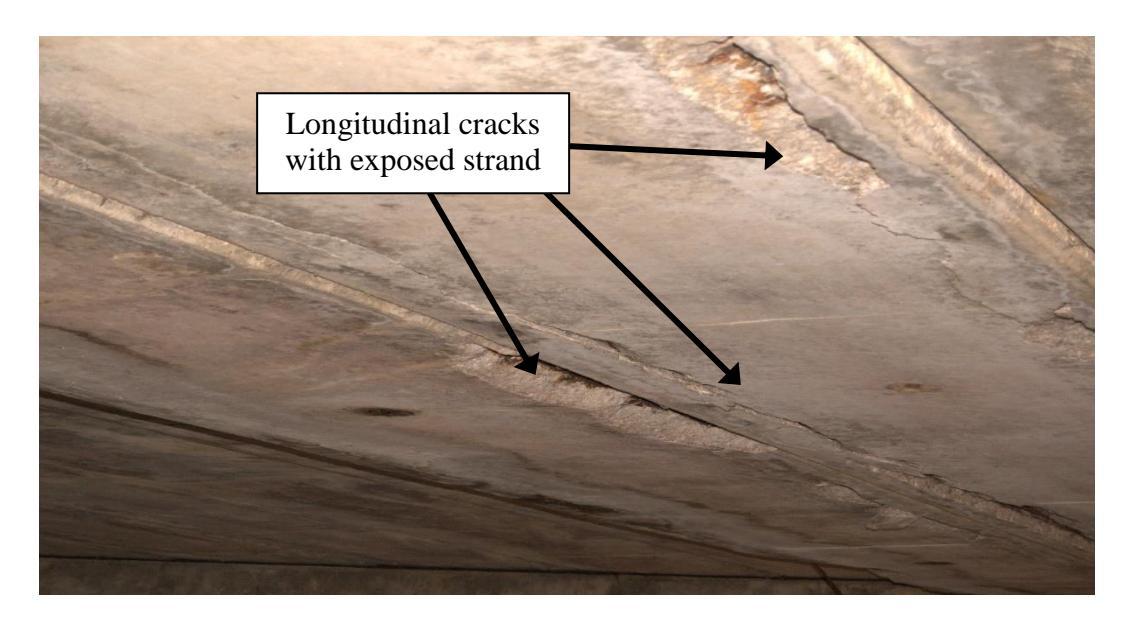
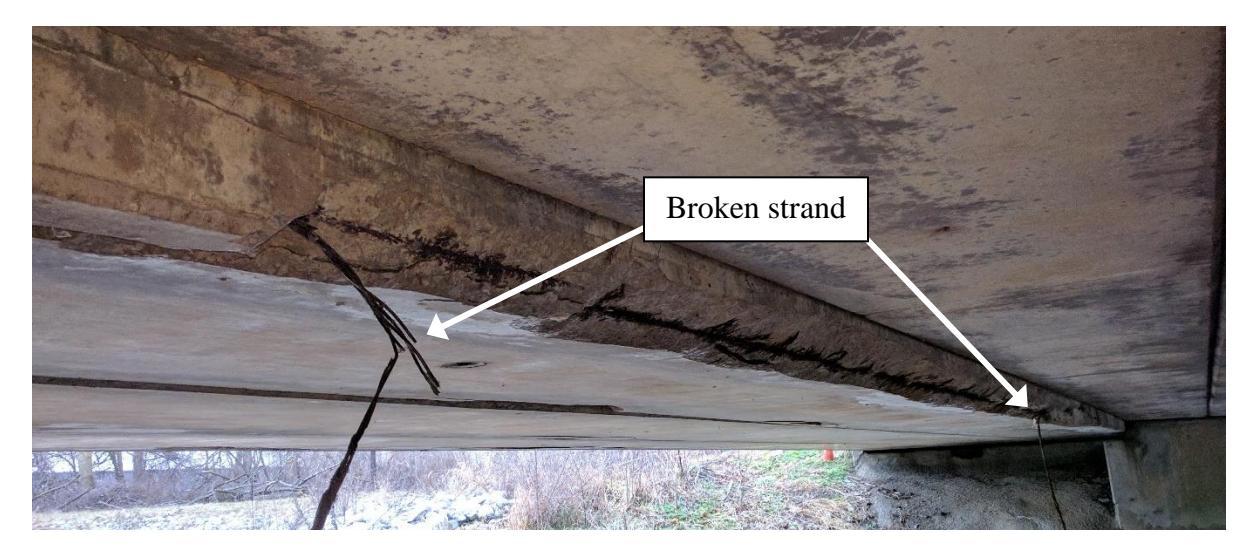
(a) Beam 2 (1973) deterioration

(b) Beam 15 (1973) deterioration

Figure 2.70: 1973 Reconstruction - Example Longitudinal Cracking with Exposed Strand

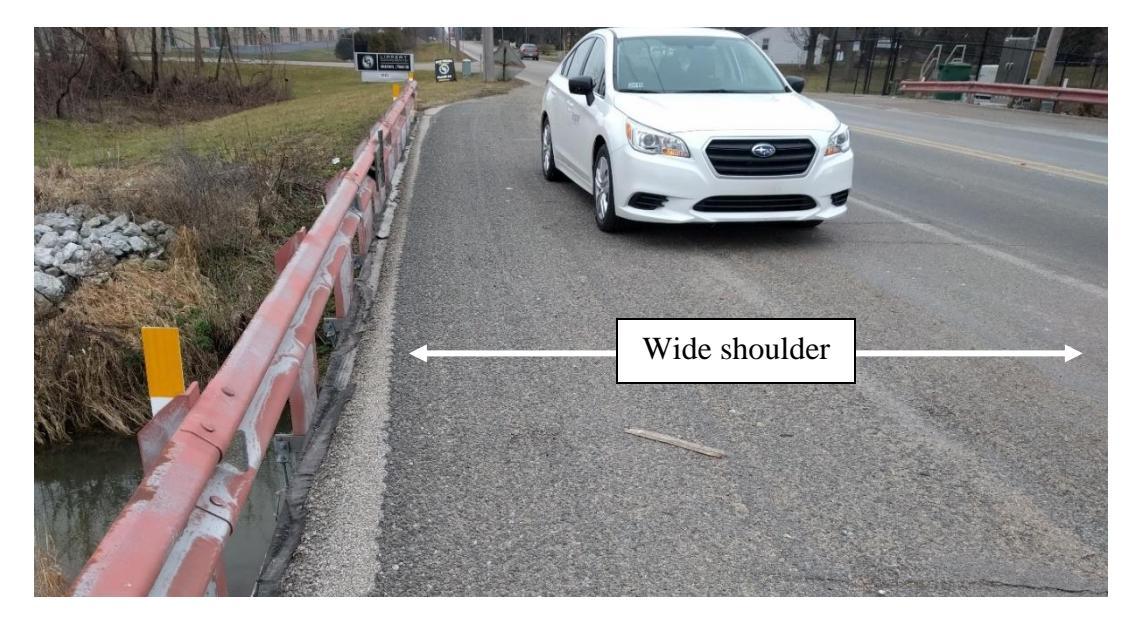
Figure 2.71: Large shoulder Width Carried by the 1973 Beams

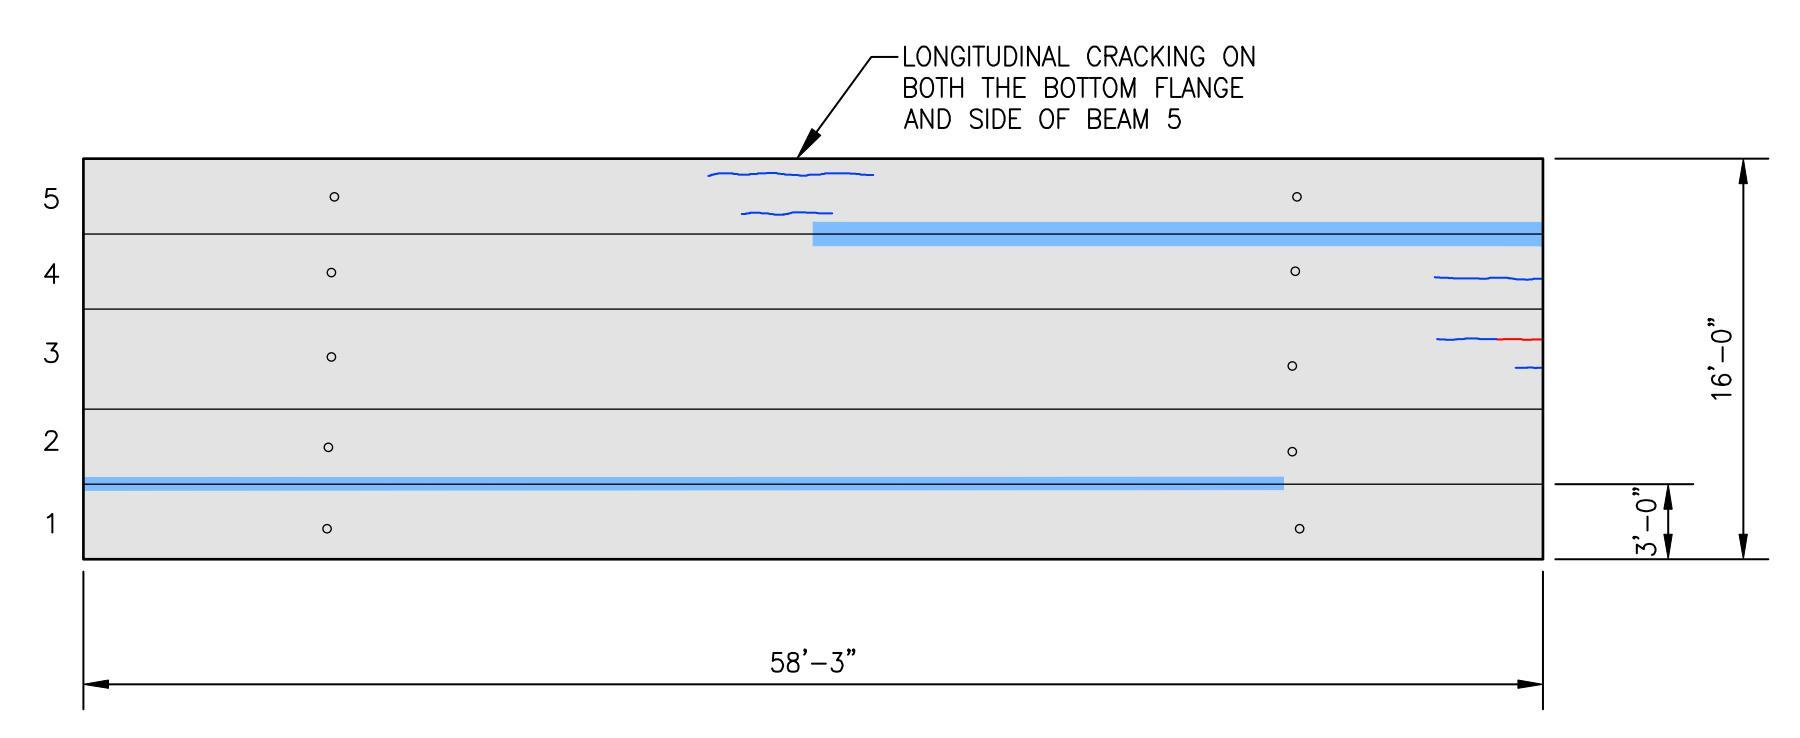
Figure 2.73: Greene 8 Deterioration Map

The bridge was inspected by the research team on 24 January 2017. The observed deterioration is summarized in Figure 2.73. Staining was observed at each of the exterior joints (Figure 2.74). One of the longitudinal cracks extending from the end of Beam 3 was rust stained for a length of approximately 1 ft (Figure 2.75). Two longitudinal cracks were observed in Beam 5 at midspan. The longitudinal crack on the west side of Beam 5 is believed to extend through the corner of the section to join the corner crack that was observed on the exterior of Beam 5 (Figure 2.76).

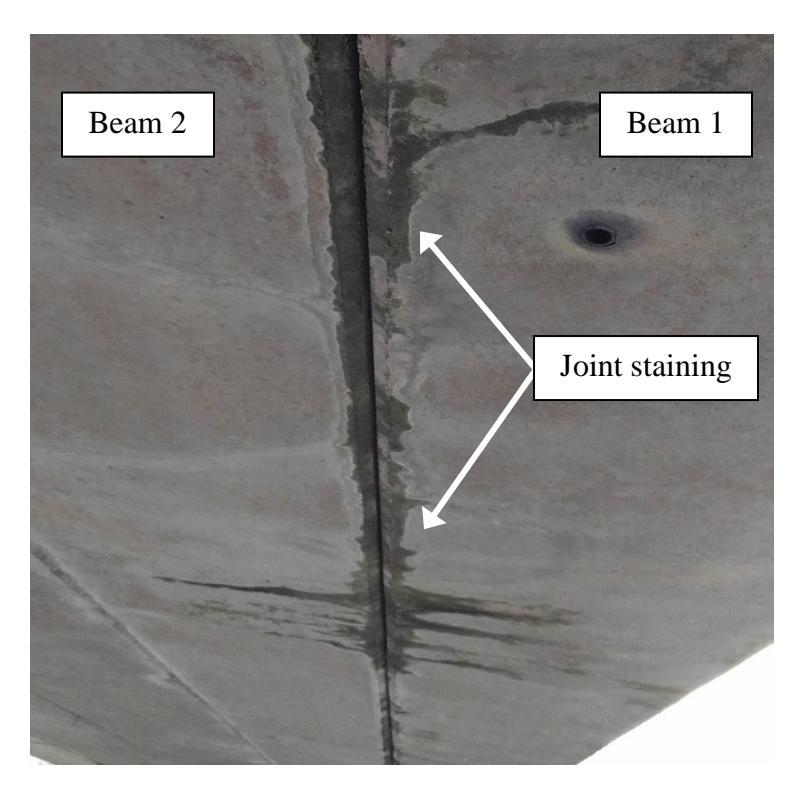
Figure 2.74: Stained Joint between Beams 1 and 2

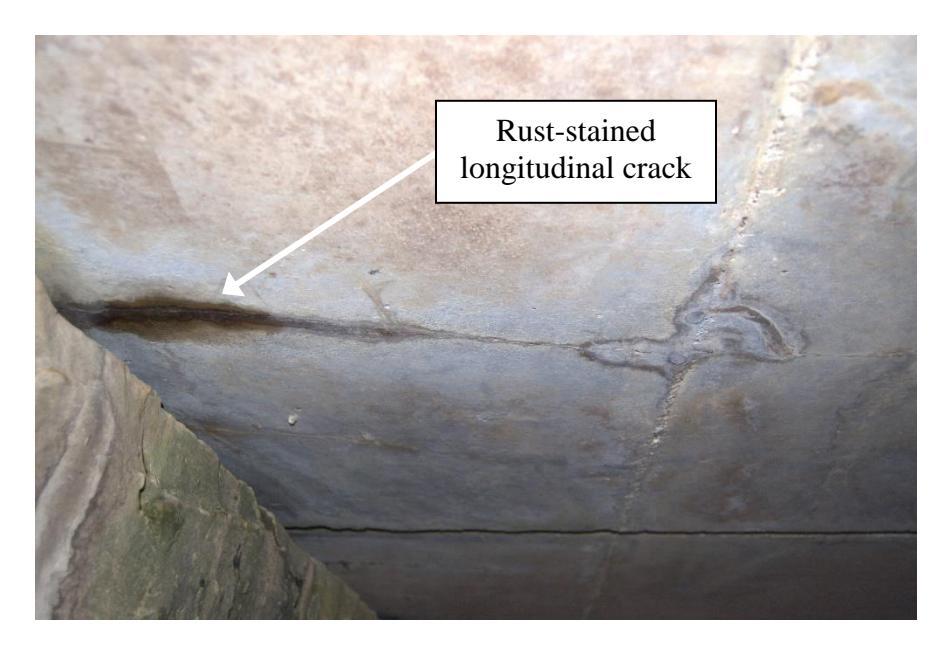
Figure 2.75: Stained Longitudinal Crack in Beam 3

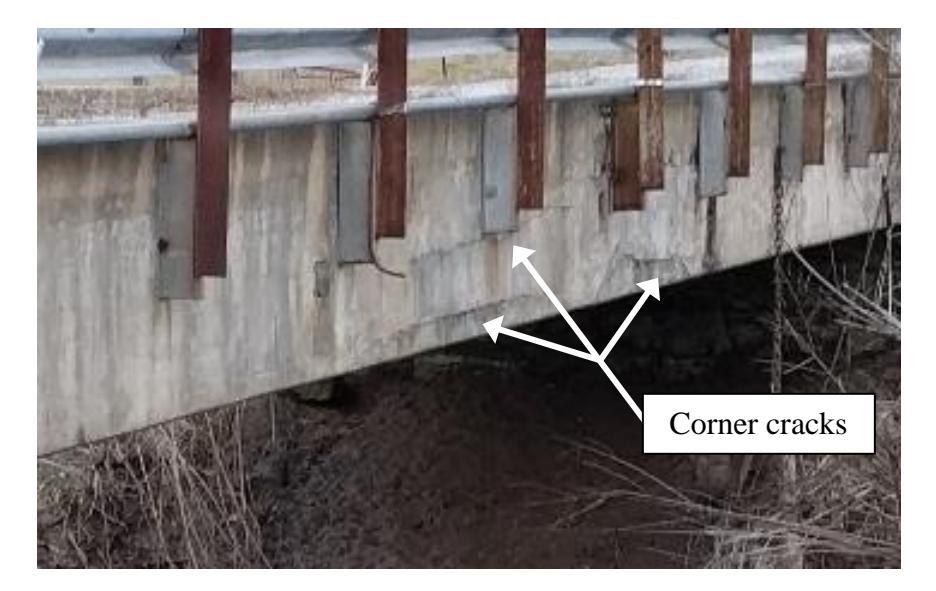
Figure 2.76: Corner Cracks in Beam 5

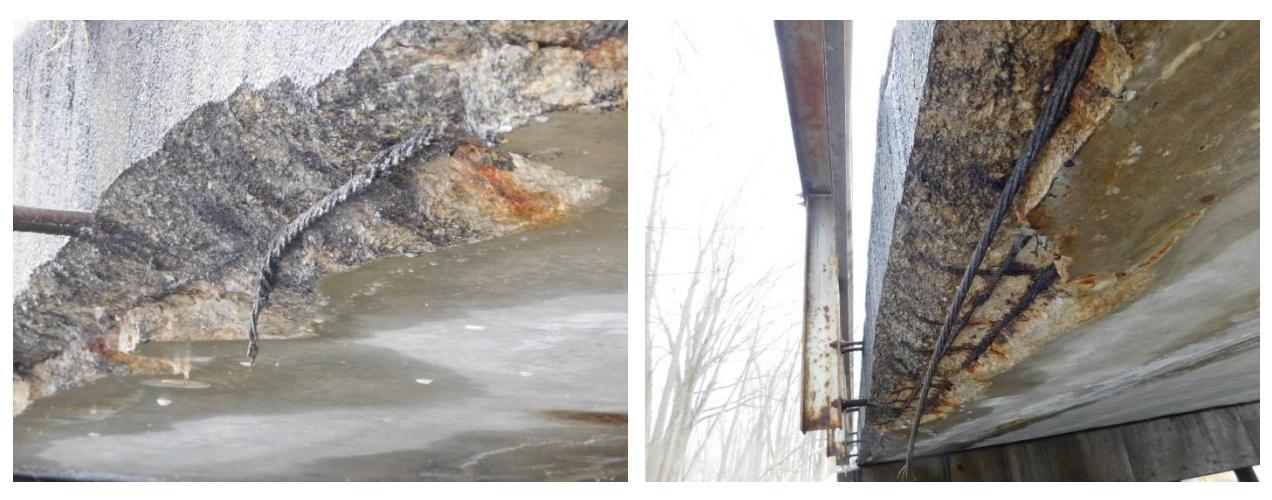
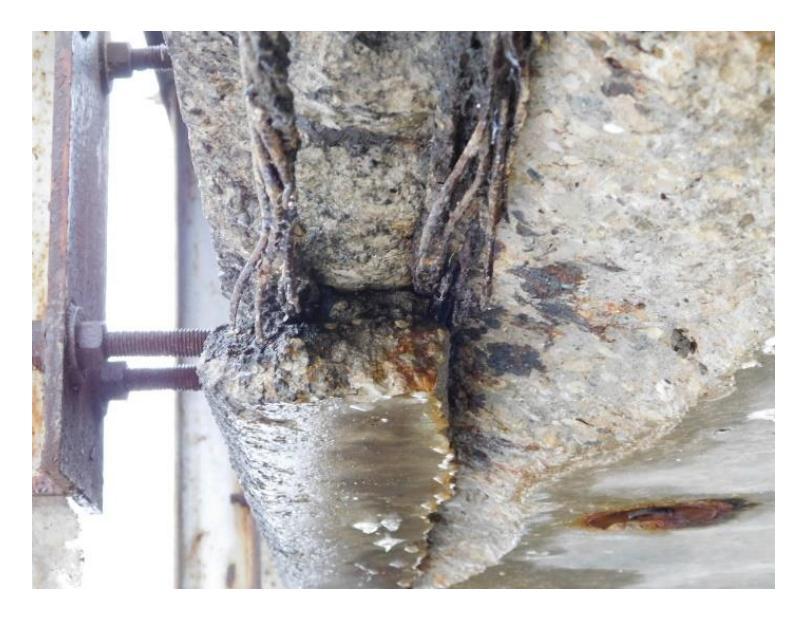
The research team inspected Kosciusko 18 on 9 January 2018. A summary of the deterioration is provided in Figure 2.78. Beams A1, A7, and B1 were all found to have exposed and broken strands located on the exterior corner of the respective sections (Figure 2.79). Longitudinal cracks were observed in Beams A1 and C6 (Figure 2.80). Melting frost was observed at the joint between Beams 1 and 2 over the pier between Spans A and B (Figure 2.81). The melting frost at the joint indicated that water from the bridge deck above was leaking into the joint and curling onto the bottom flange of the beams.

(a) Broken strand Beam A1

(b) Broken strand Beam A7

(c) Broken strands Beam B1 Figure 2.79: Deterioration of Beams A1, A7, and B1

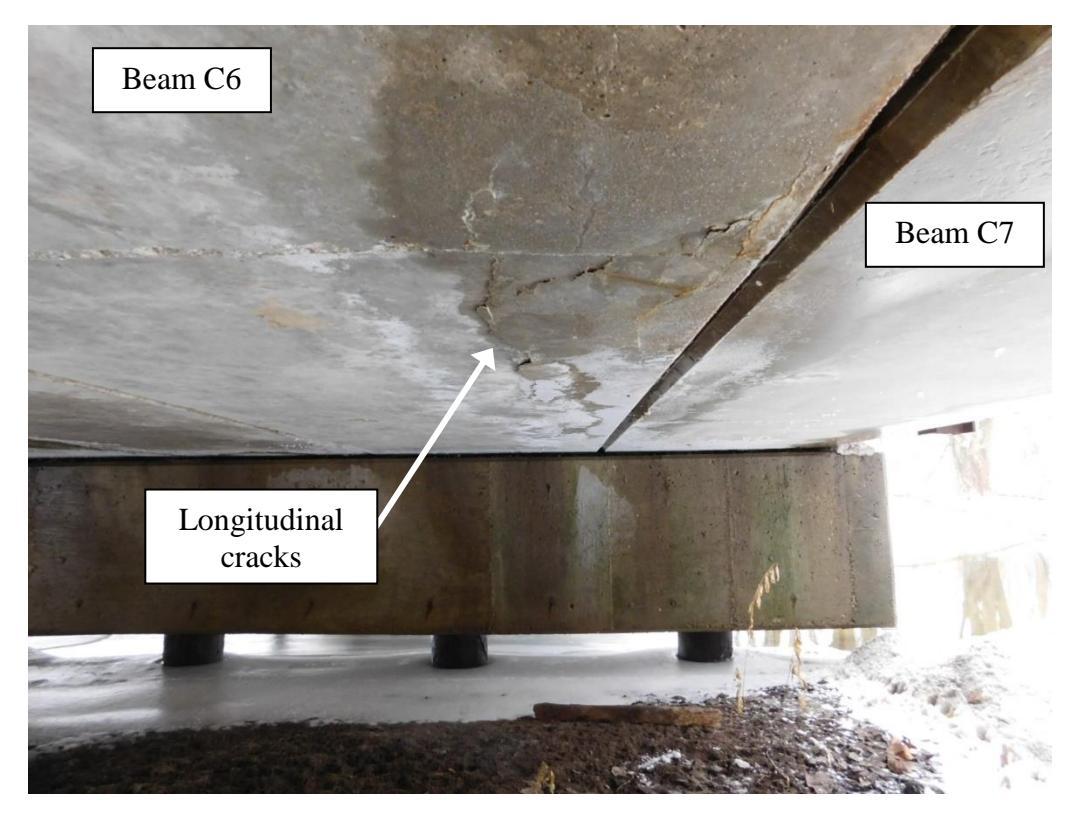
Figure 2.80: Beam C6 Deterioration

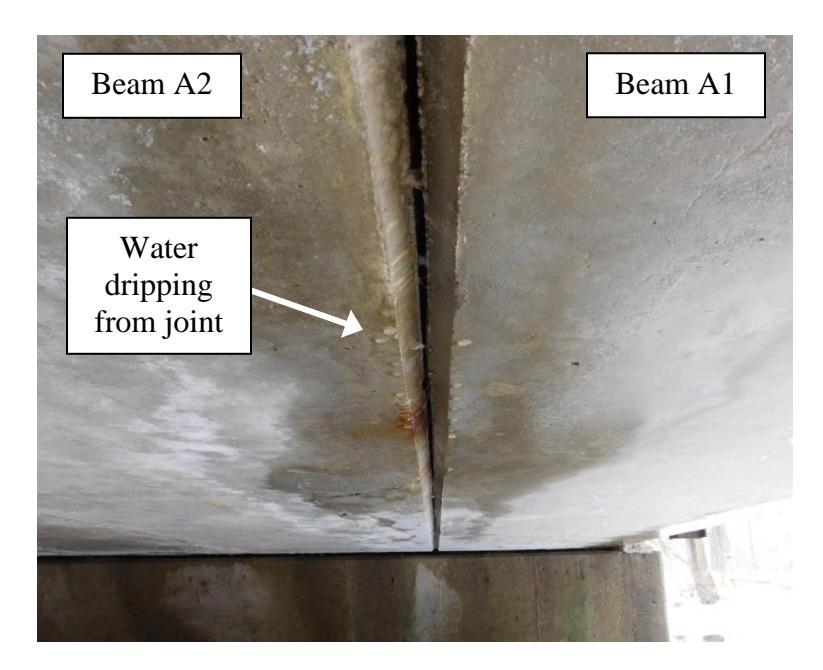
Figure 2.81: Leaking Shear Key between Beams A1 and A2

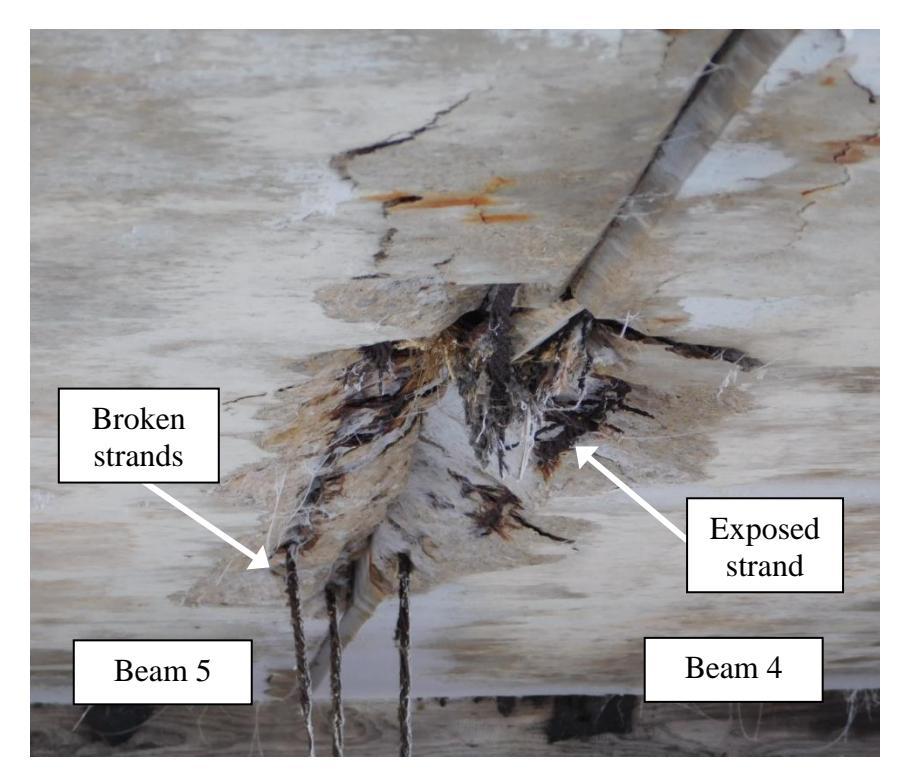
Figure 2.84: Deterioration of Beams 4 and 5

Lake 61 was inspected by the research team on 9 January 2018. A summary of the observed deterioration is provided in Figure 2.83. As shown, Beams 4 and 5 were found with multiple exposed and broken strand in addition to longitudinal cracks near the corners of the beams (Figure 2.84). Longitudinal cracks were also observed in Beams 1, 3, and 7 near the edges of the beams. Beam 1 exhibited a rust stained crack and spall next to a stained joint near the west support (Figure 2.85). Large drain pipes were cast into the beams for drainage. A single hole approximately 6 in. in diameter was also observed at midspan of Beam 7 (Figure 2.86). The shape of the hole indicates that a coring machine was used to create the hole. No explanation or documentation of this work was available in the official inspection reports.

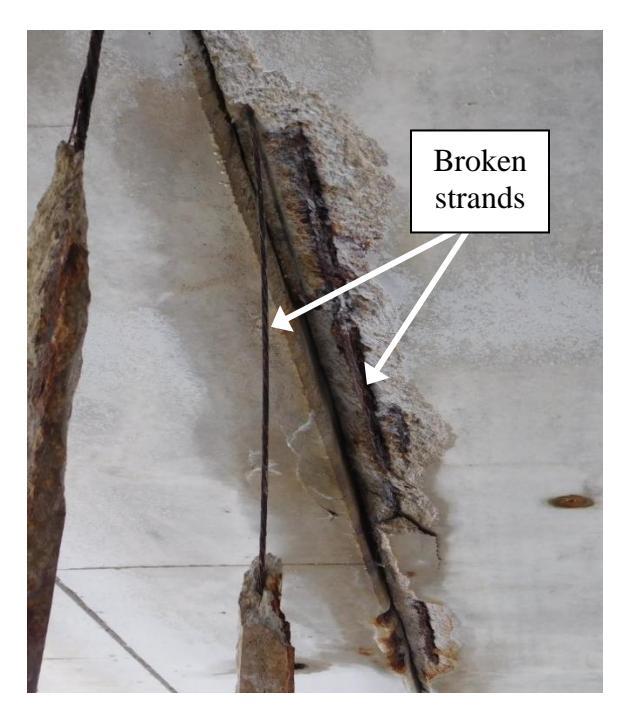
The research team visited Lake 264 on 9 January 2018. A summary of the observed deterioration is presented in Figure 2.88. Beams 3, 4, 9, and 10 were found with exposed edge strands, and Beams 3 and 9 were both found with broken strands (Figure 2.89). In addition to the exposed corner strand, Beam 10 was found with a large spall around the deck drain (Figure 2.90). Longitudinal cracks were observed in Beams 5, 6, 7, and 8. The longitudinal crack in Beam 5 was rust stained (Figure 2.91). Clogged drain holes in Beams 2 and 3 were also noted.

(b) Broken strands in Beam 9

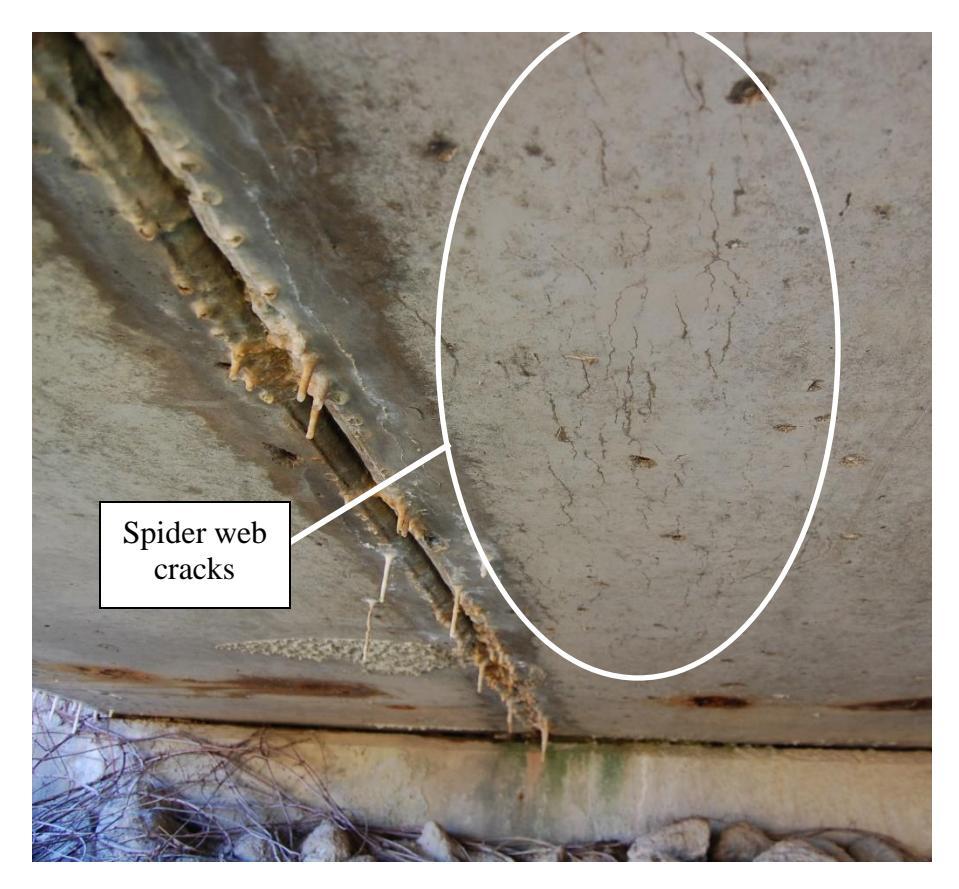
Figure 2.94: Beam 2 Deterioration

Tippecanoe 504 was inspected by the research team on 8 November 2018. A summary of the observed deterioration is presented in Figure 2.93. All beams in the bridge exhibited some form of longitudinal cracking with the exception of Beam 7. Beams 2 and 6 were observed to have spider web cracks at the south support of each beam (Figure 2.94). In addition to the spider web cracking, portions of the west edge of Beam 6 had spalled without exposing strand (Figure 2.95). Efflorescence was common at the exterior and first interior joints from both sides of the bridge (Figure 2.96).

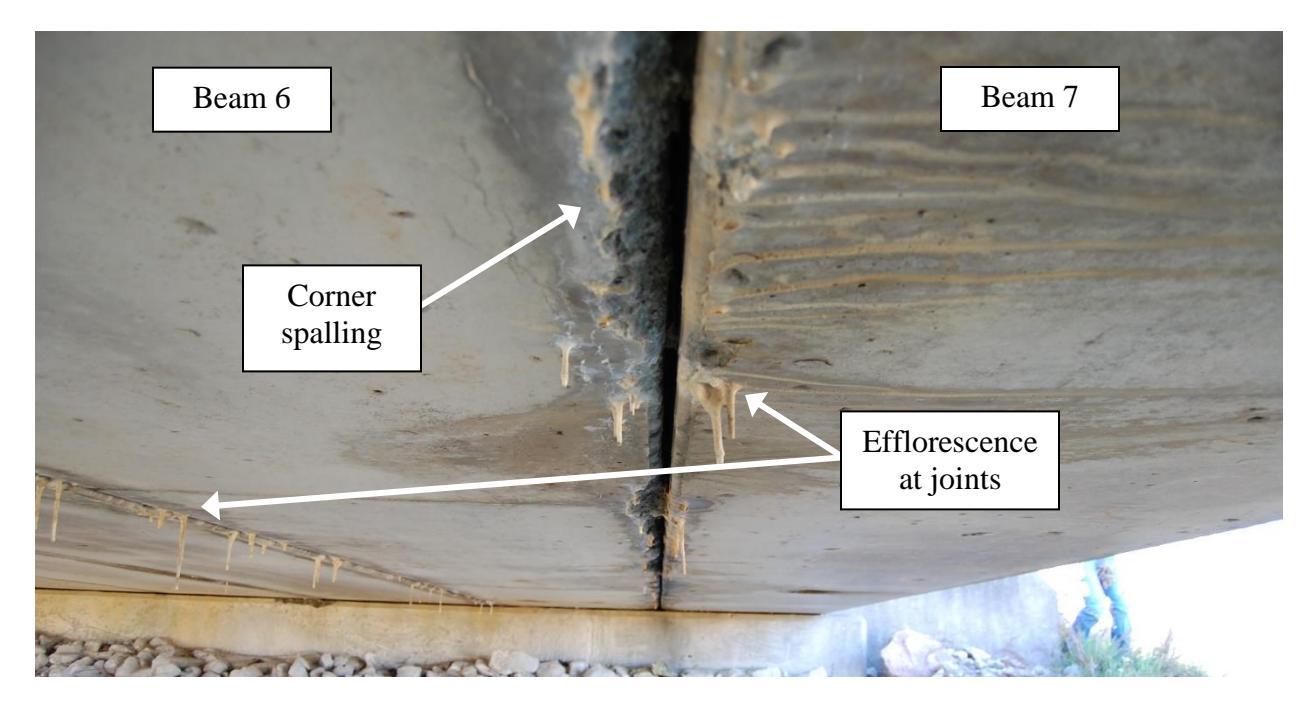
Figure 2.95: Spalling on West Side of Beam 6

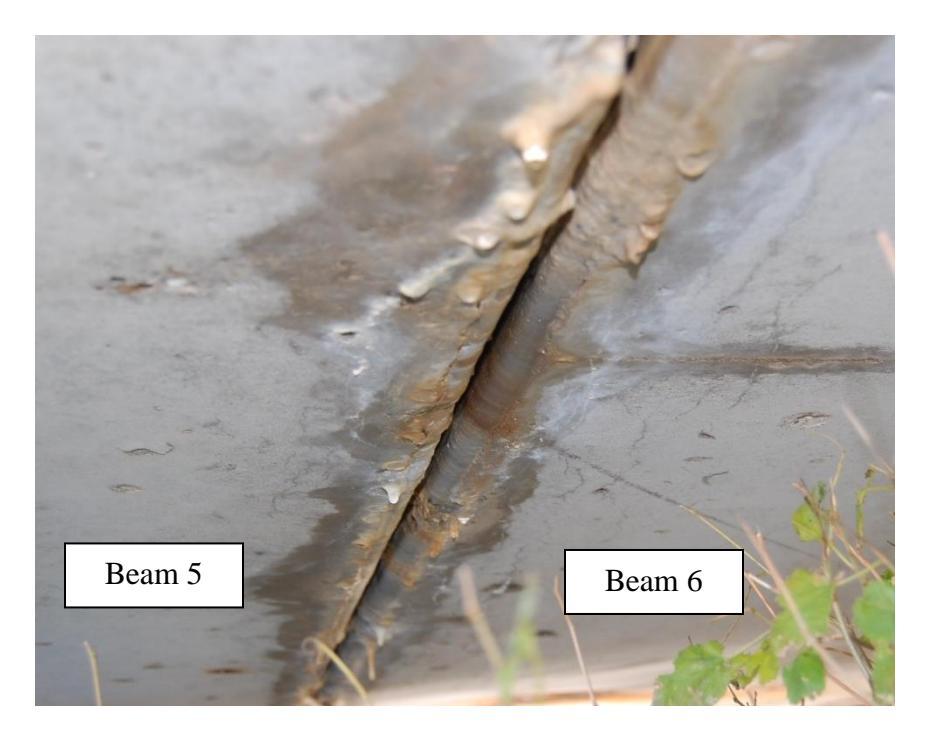
Figure 2.96: Efflorescence at joint between Beams 5 and 6

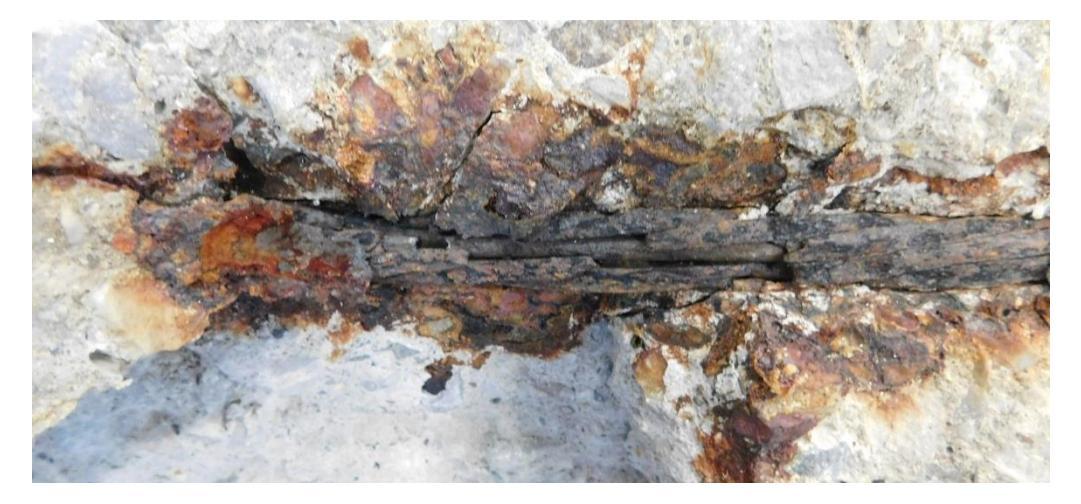
Figure 2.99: Heavily Pitted and Ruptured Strand

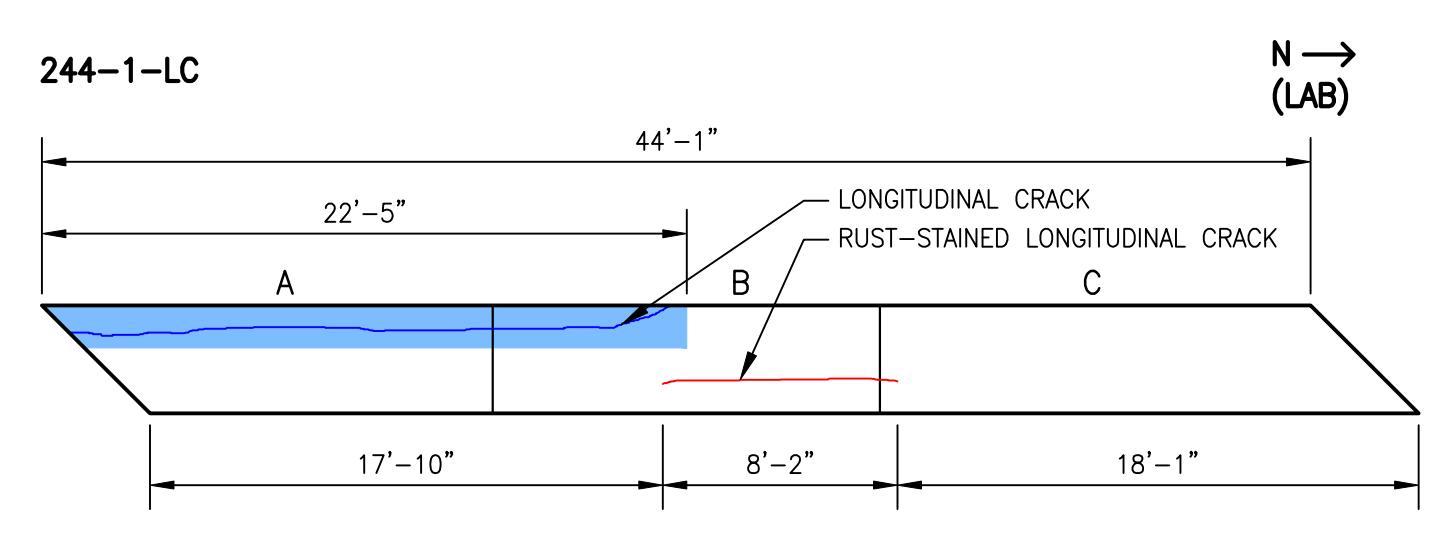
Figure 3.1: Specimen 244-1-LC Visual Deterioration Map

GREEN STAINING AROUND SOUTH LONGITUDINAL CRACK EXTENDS 10 IN. FROM BEAM EDGE.

As shown in Figure 3.1, 244-1-LC had two large longitudinal cracks located away from the edges of the bottom flange. A section taken through each crack revealed that the cracks formed through the thickness of the bottom flange (Figure 3.47). In addition, the cardboard used to form the void was found to have disintegrated (Figure 3.48).

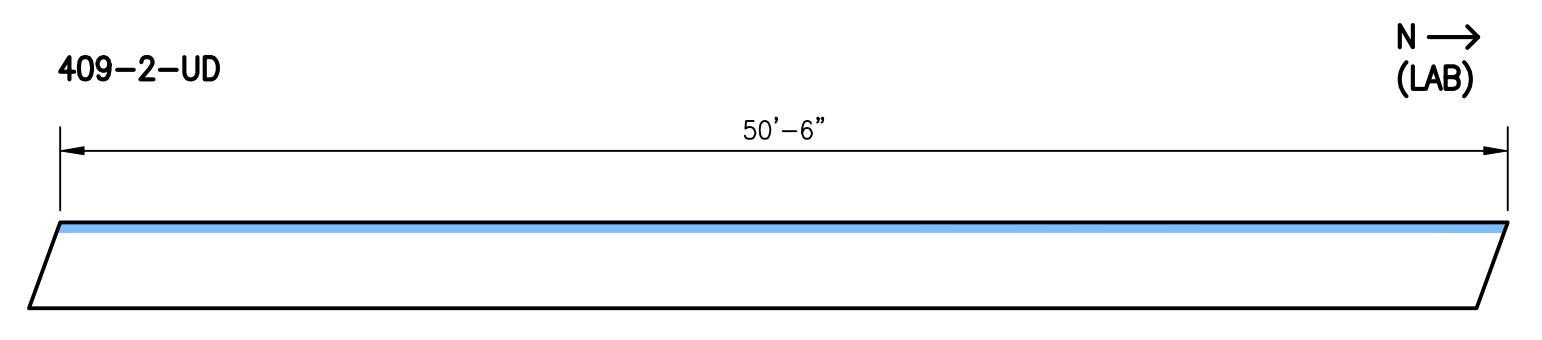
WATER STAINS EXTEND 0-2 IN. FROM BEAM EDGE.

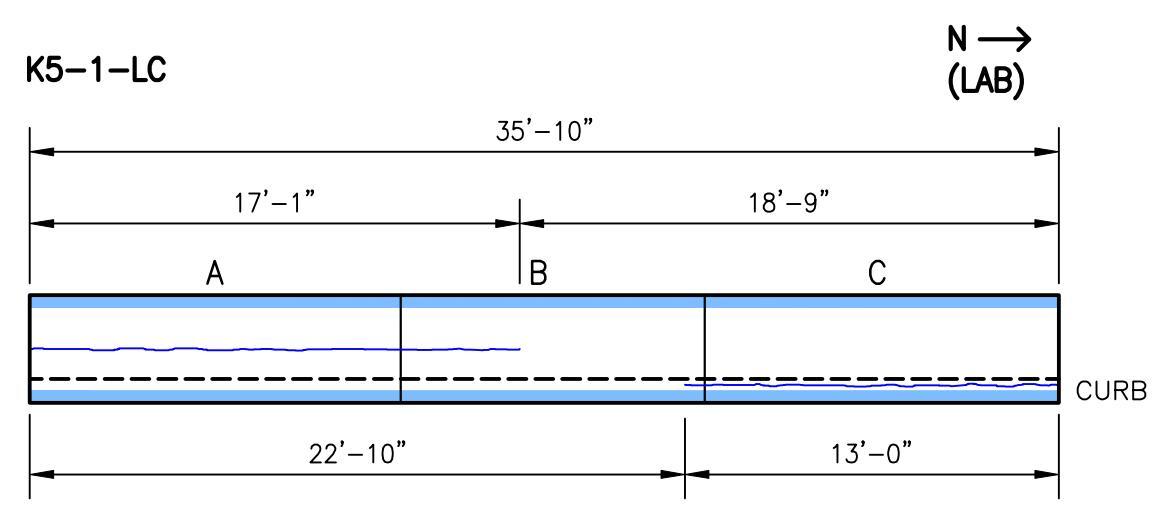
WATER STAINING ON BEAM EDGES 2-4 IN. WIDE

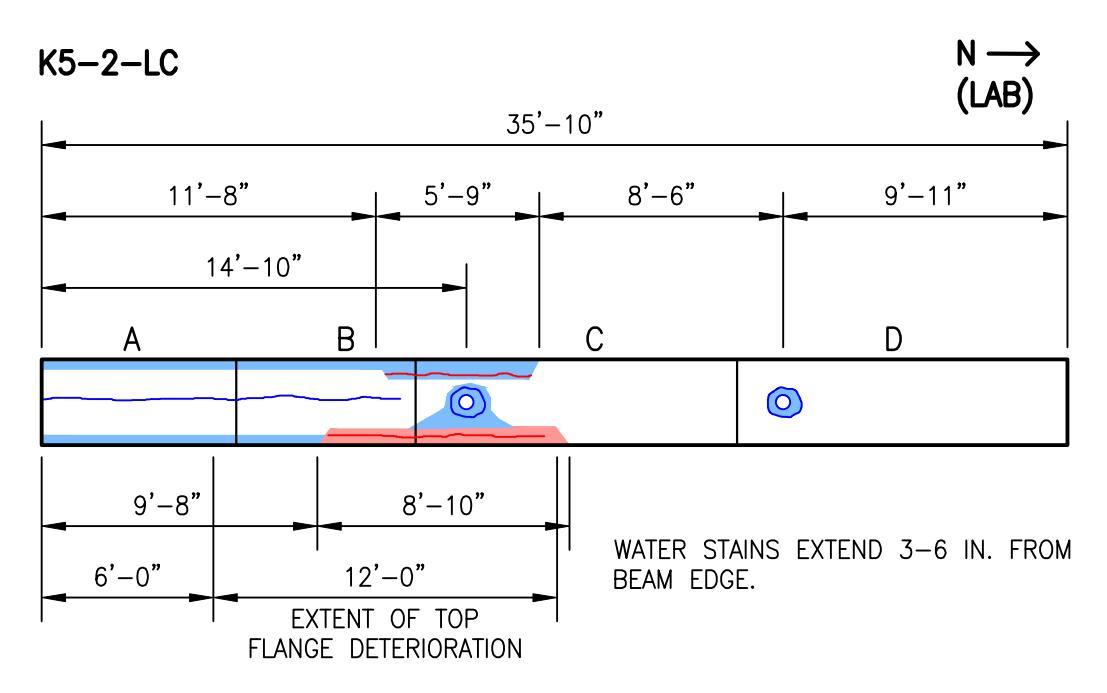
Figure 3.5: Specimen K5-2-LC Visual Deterioration Map

The deterioration of the bottom flange included three longitudinal cracks (Figure 3.5). Each of the longitudinal cracks were observed to extend through the thickness of the flange into the void (Figure 3.57).

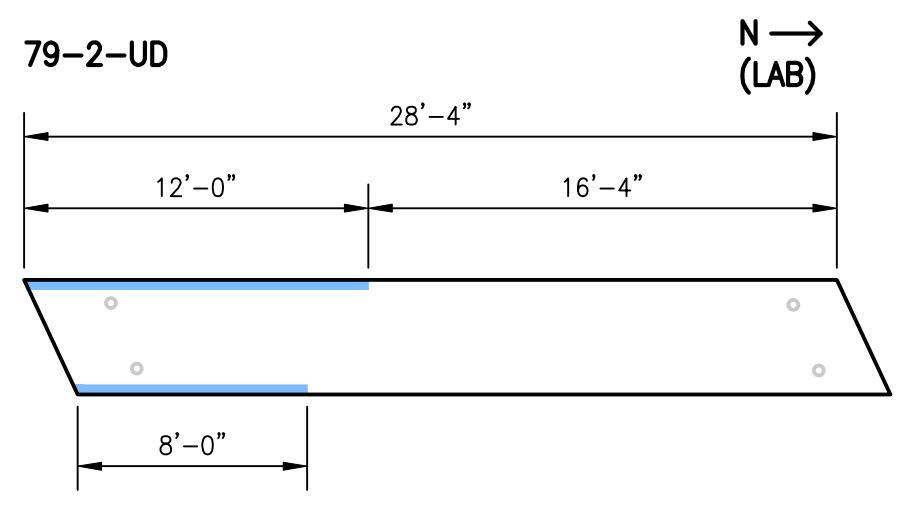
Figure 3.7: Specimen 79-2-UD Visual Deterioration Map

WATER STAINS EXTEND 2-4 IN. FROM BEAM EDGES

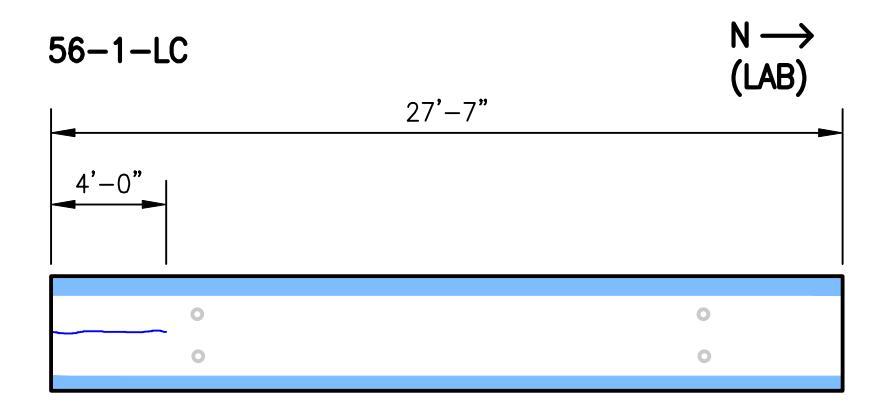
Figure 3.10: Specimen 56-1-LC Visual Deterioration Map

WATER STAINS EXTEND 6-8 IN. FROM EITHER EDGE

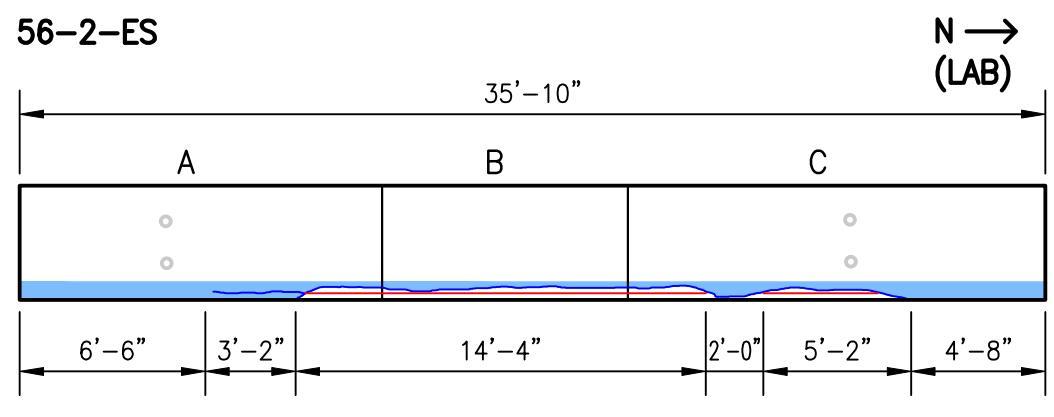
Figure 3.11: Specimen 56-2-ES Visual Deterioration Map

WATER STAINS EXTEND APPROXIMATELY 6 IN. FROM EXTERIOR EDGE.

All deterioration of Specimen 56-2-ES was concentrated on the east side of the specimen (Figure 3.11). In service, Specimen 56-2-ES was an exterior beam with no curbs or other deck drains. The east side of the beam corresponds to the exterior side of the beam while in service. Figure 3.28 shows the representative condition of the strands adjacent to the exposed strand. As shown, Strand 12 (the strand adjacent to the exposed strand (Strand 13)) shows a small amount of surface corrosion but no pitting. The location of the exposed strand in Figure 3.28(b) is provided as a dashed white line for reference. Strand 11, shown in Figure 3.28(c) and located 6 in from Strand 12, was found without any observable corrosion. The measured bottom cover for all strands was 1-3/8 in.

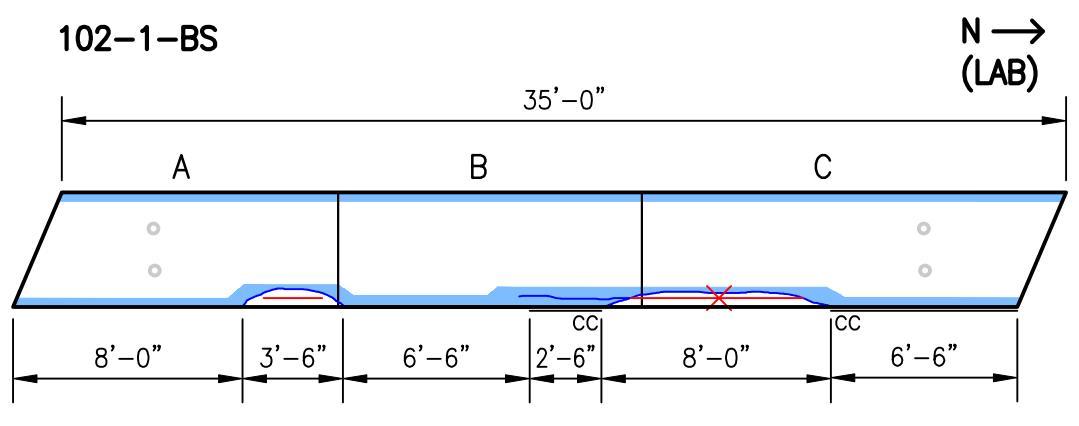
WATER STAINS EXTEND 4-8 IN. FROM BEAM EDGES. CORNER CRACKING AT MIDSPAN.

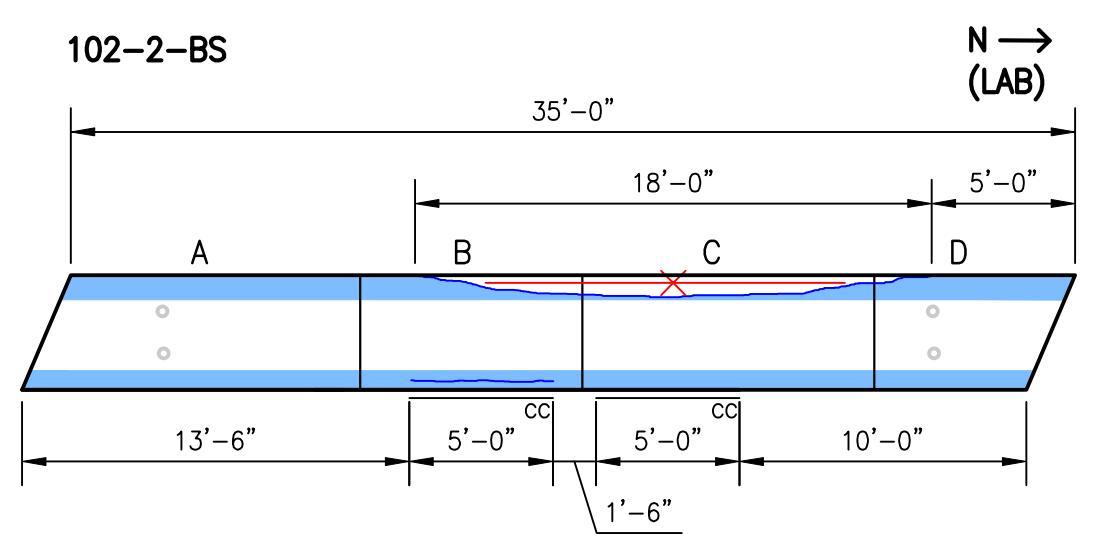
WATER STAINS EXTEND APPROXIMATELY 8 IN. FROM BEAM EDGE. LONGITUDINAL CORNER CRACKING AT MIDSPAN.

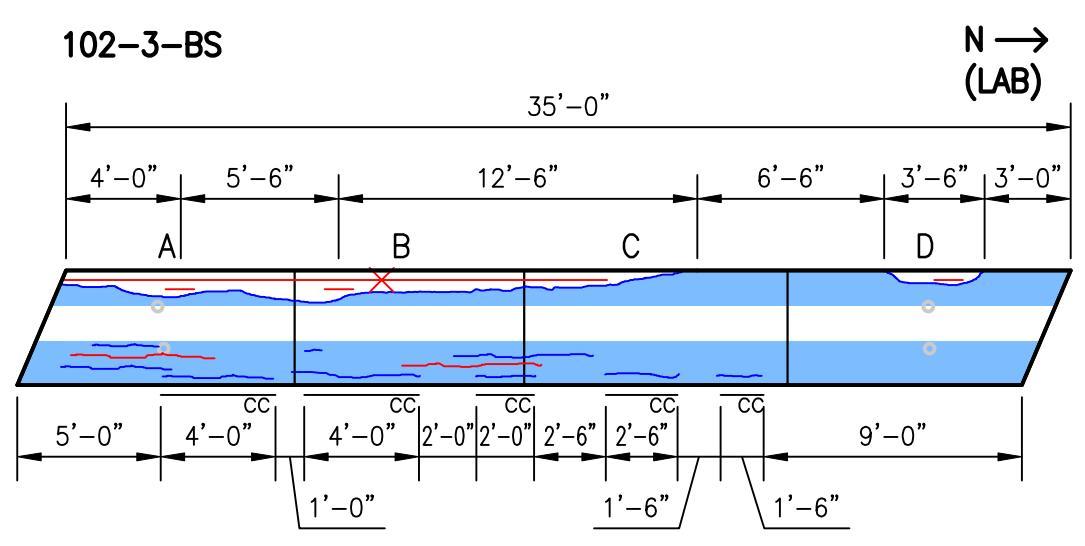
WATER STAINS EXTEND 6-18 IN. FROM BEAM EDGE. LONGITUDINAL CORNER CRACKS ON WEST SIDE CORRESPOND TO LONGITUDINAL CRACKS IN BOTTOM FLANGE.

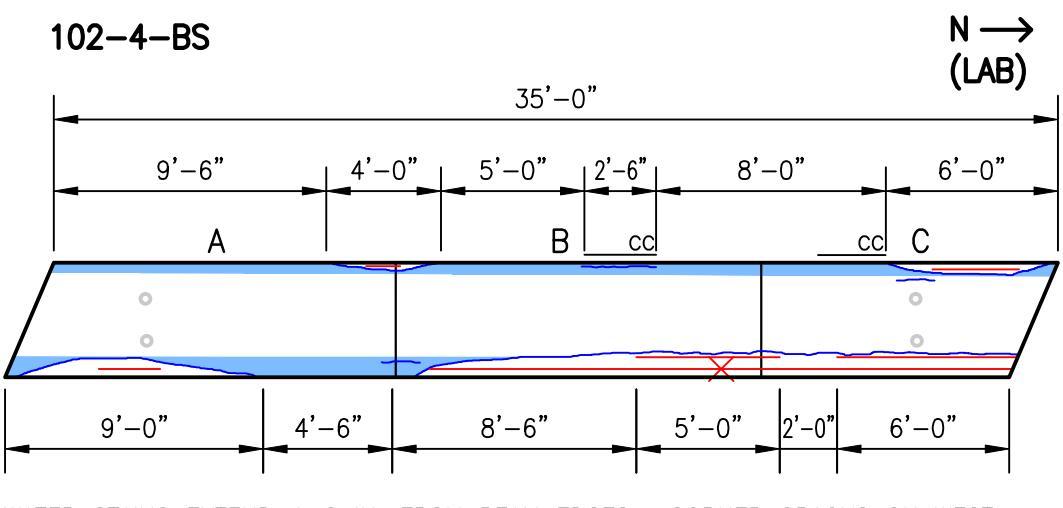
Figure 3.15: Specimen 102-4-BS Visual Deterioration Map

WATER STAINS EXTEND 4-8 IN. FROM BEAM EDGES. CORNER CRACKS ON WEST SIDE OF BEAM.

Specimen 102-4-BS was an interior beam while in service. In Figure 3.15, Specimen 102-4-BS is shown with longitudinal cracks and exposed strands the west and east edges of the bottom flange. A broken strand is also located on the east side of the bottom flange. The representative condition of the strands at the location of deterioration is provided in Figure 3.40 to Figure 3.46.
