EVALUATION AND STRUCTURAL BEHAVIOR OF DETERIORATED PRECAST, PRESTRESSED CONCRETE BOX BEAMS

A Dissertation

Doctor of Philosophy

Lyles School of Civil Engineering West Lafayette, Indiana December 2019

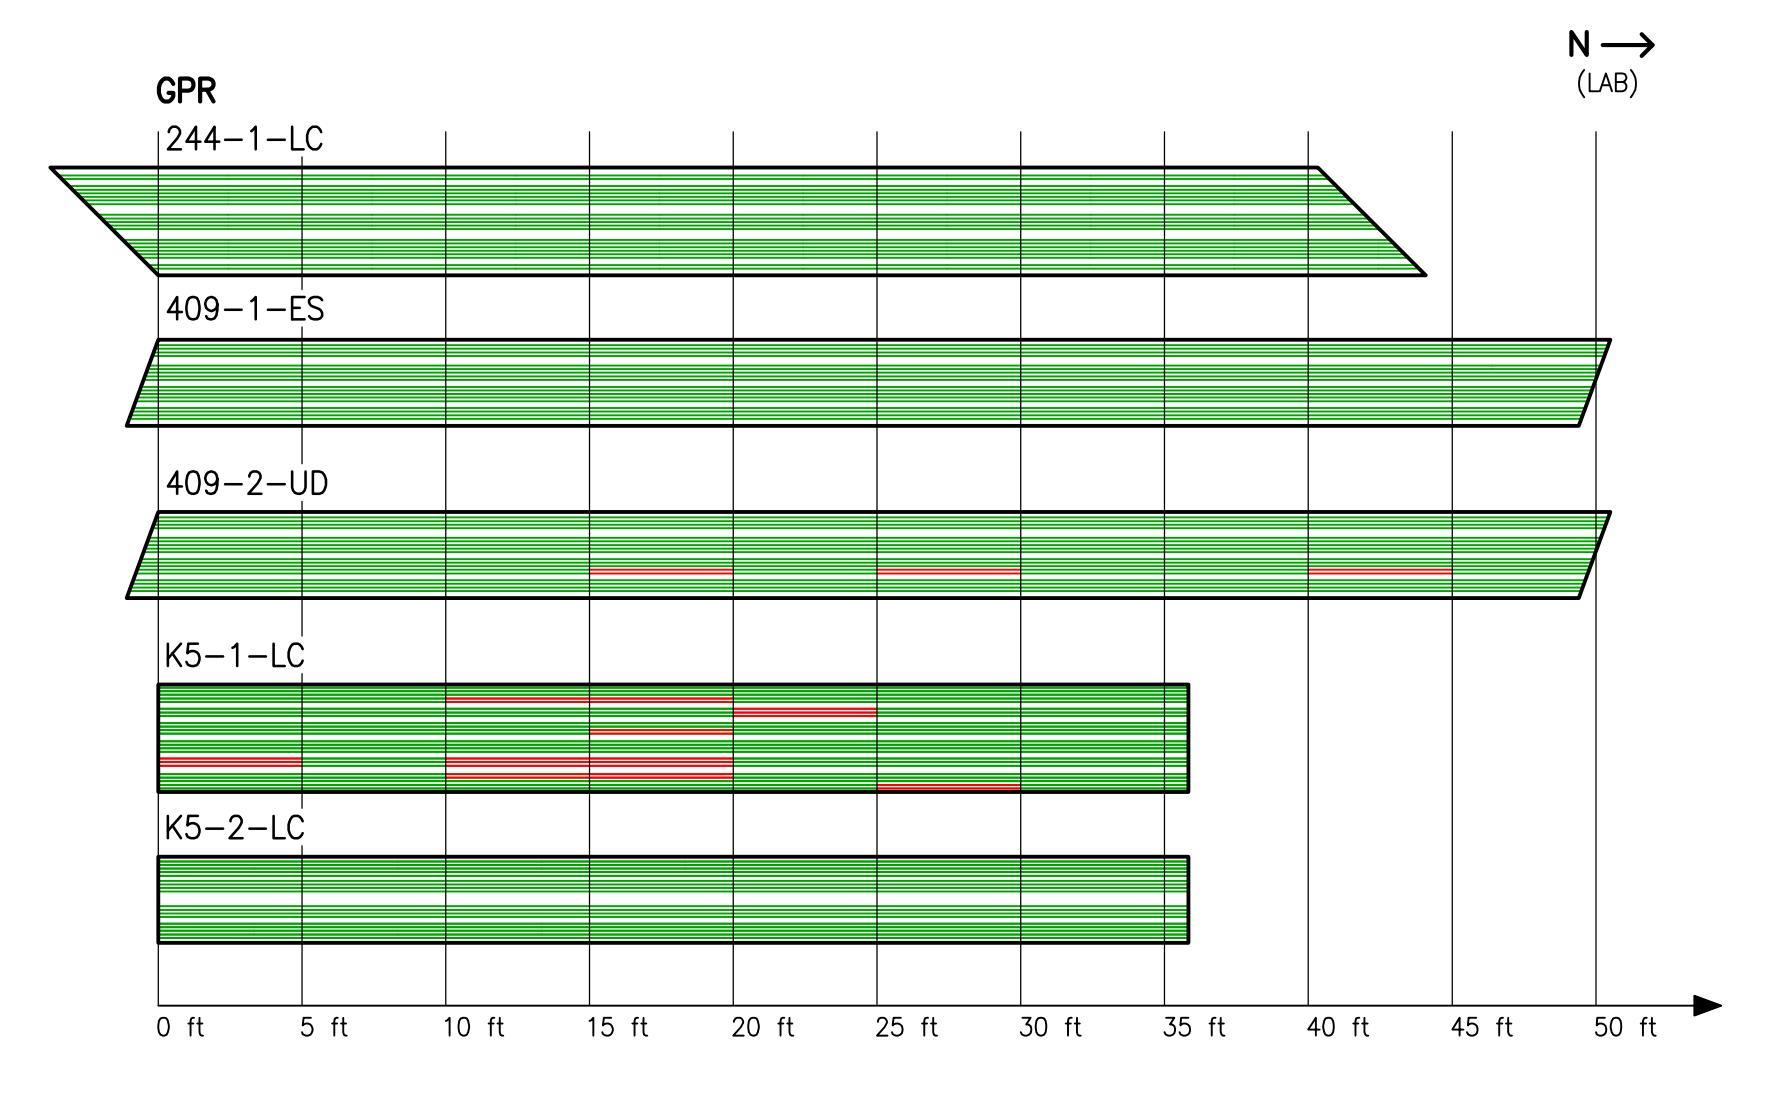
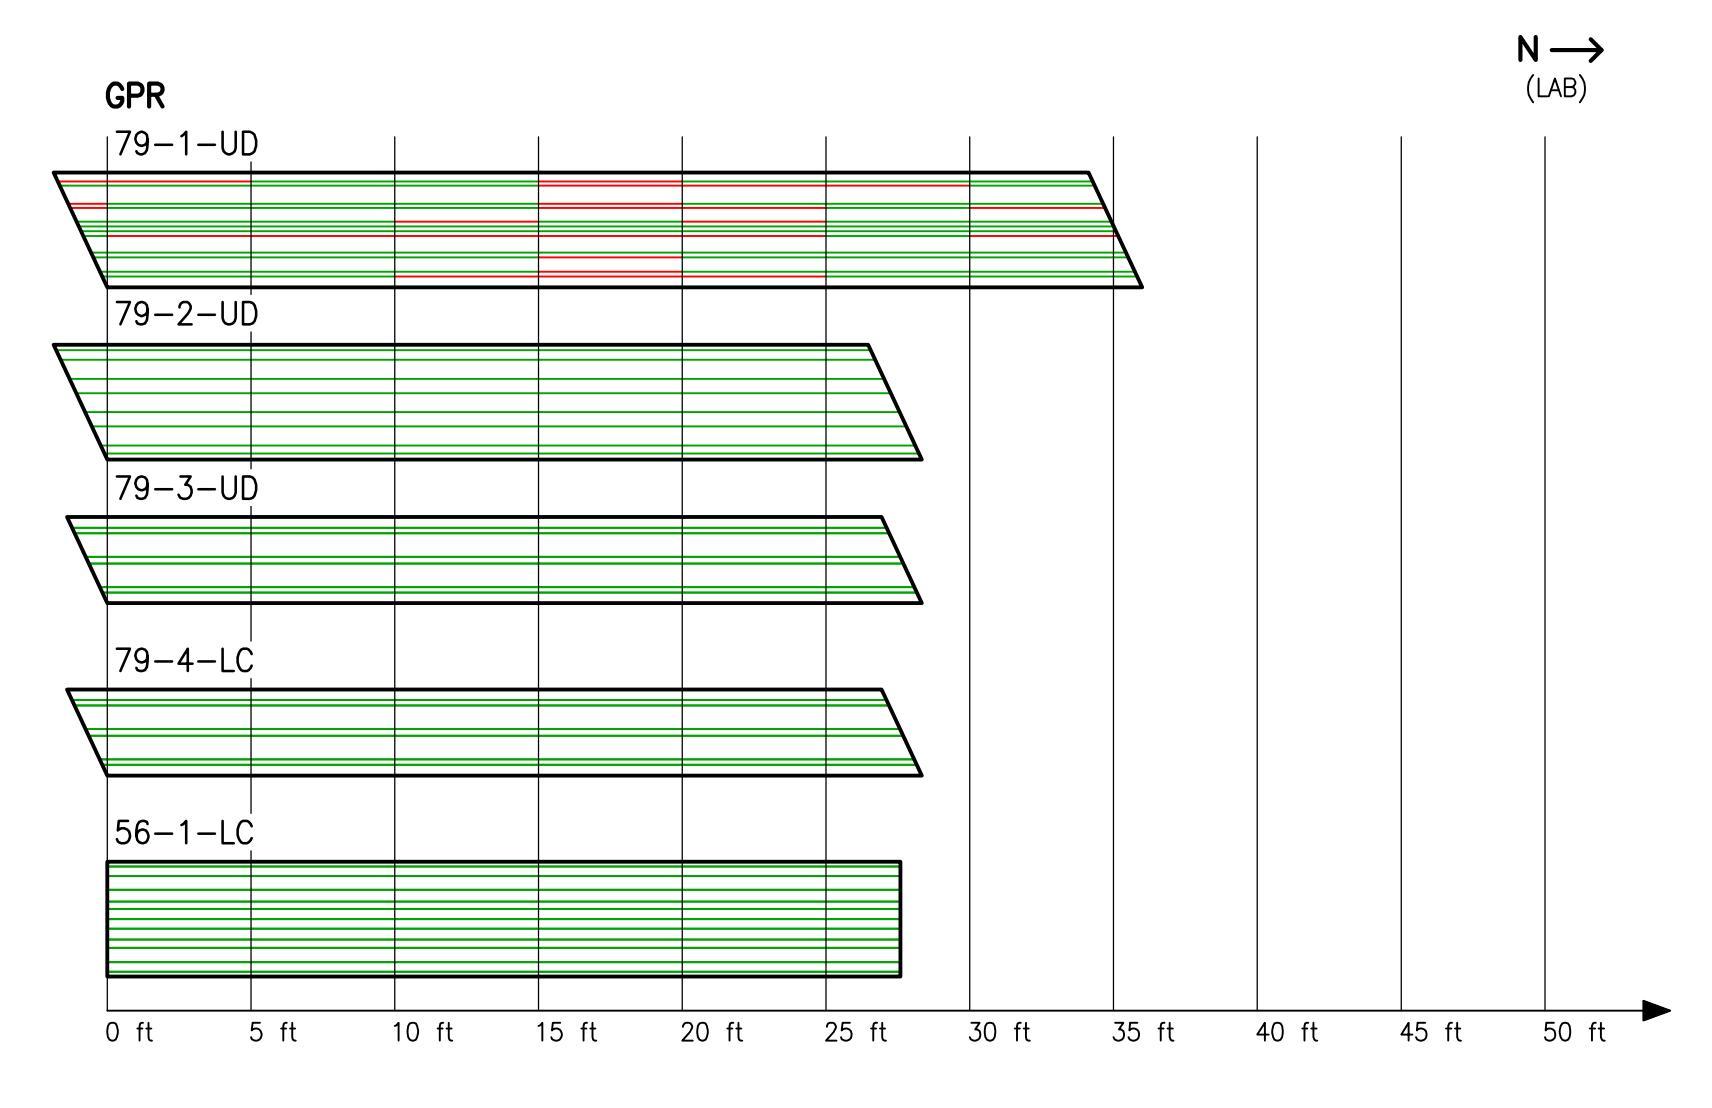
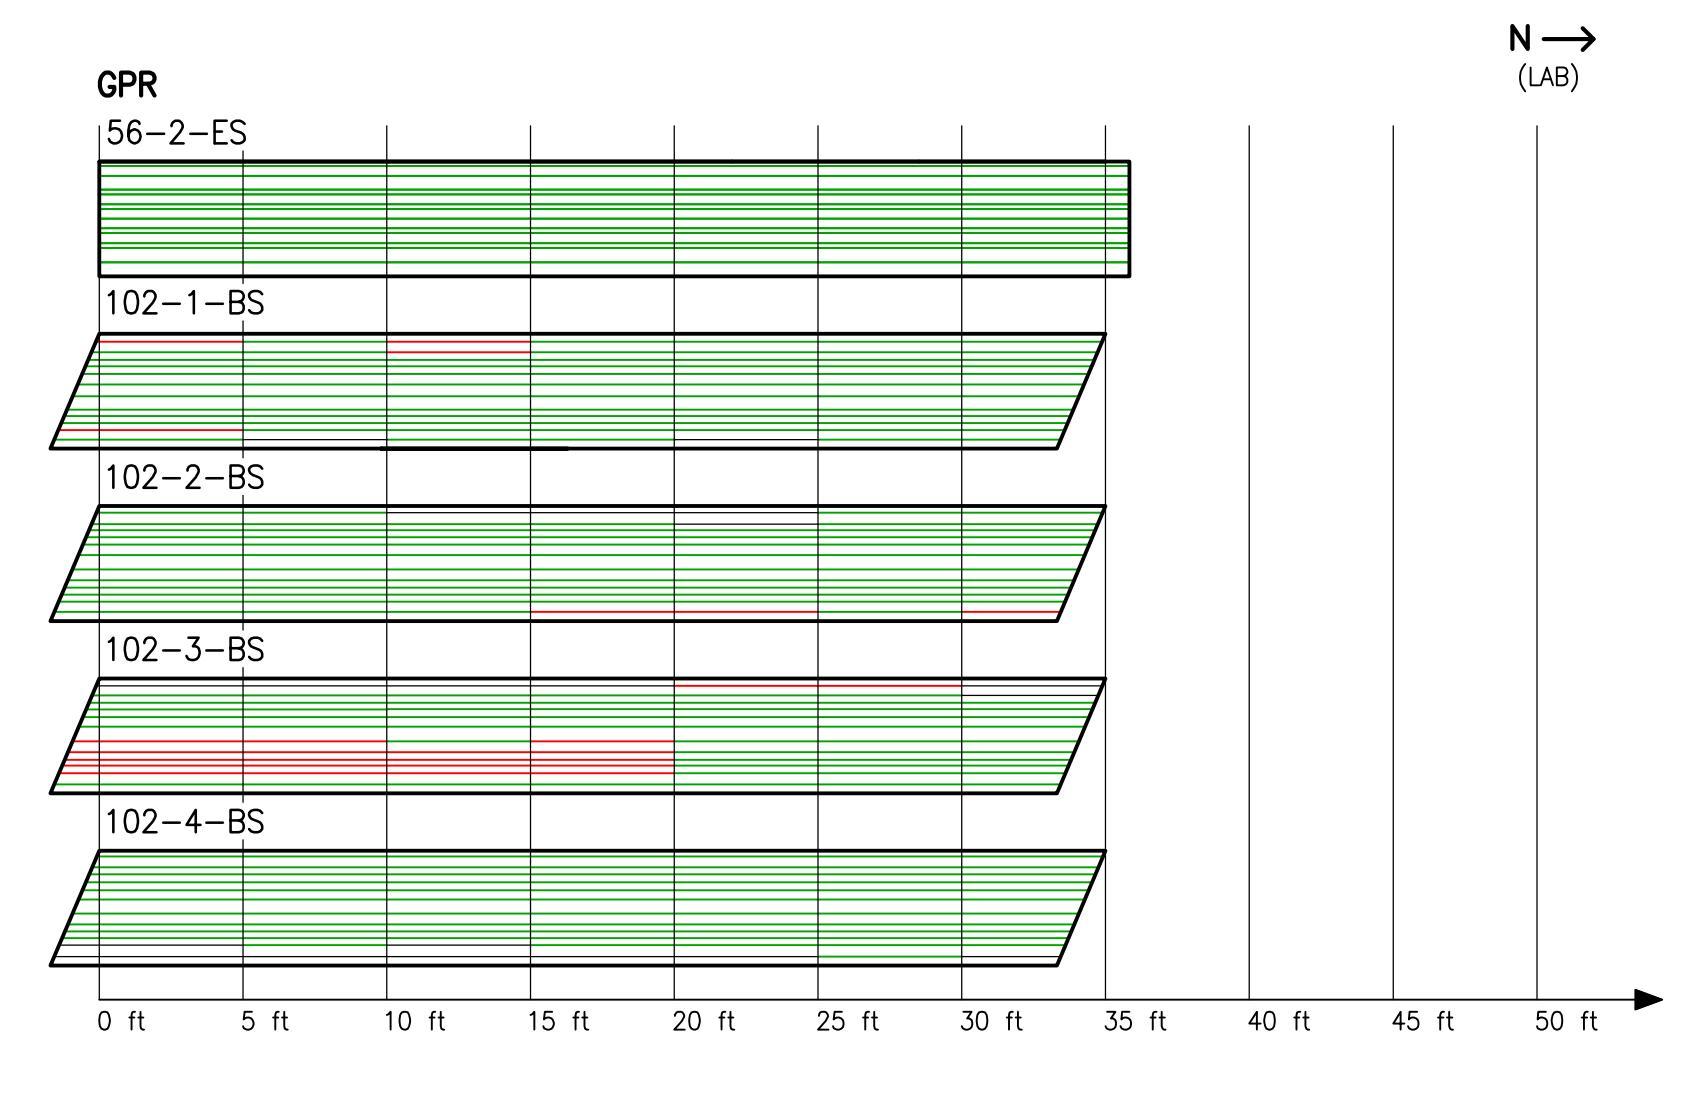
Figure 3.23: GPR Results

The GPR deterioration mapping results are provided in Figure 3.23. The results are displayed using the color coding from Table 3.4. Scans taken over exposed or broken strands were not processed. The unprocessed length of strand for Specimens 56-2-ES, 102-1-BS, 102-2-BS, 102-3-BS, and 102-4-BS are shown as black lines in Figure 3.23. The concrete spall in Specimen 409-1-ES was not directly scanned, but the area of the beam adjacent to the spall was scanned. A comparison of the GPR results and the results from the strand extraction is provided in Section 3.5

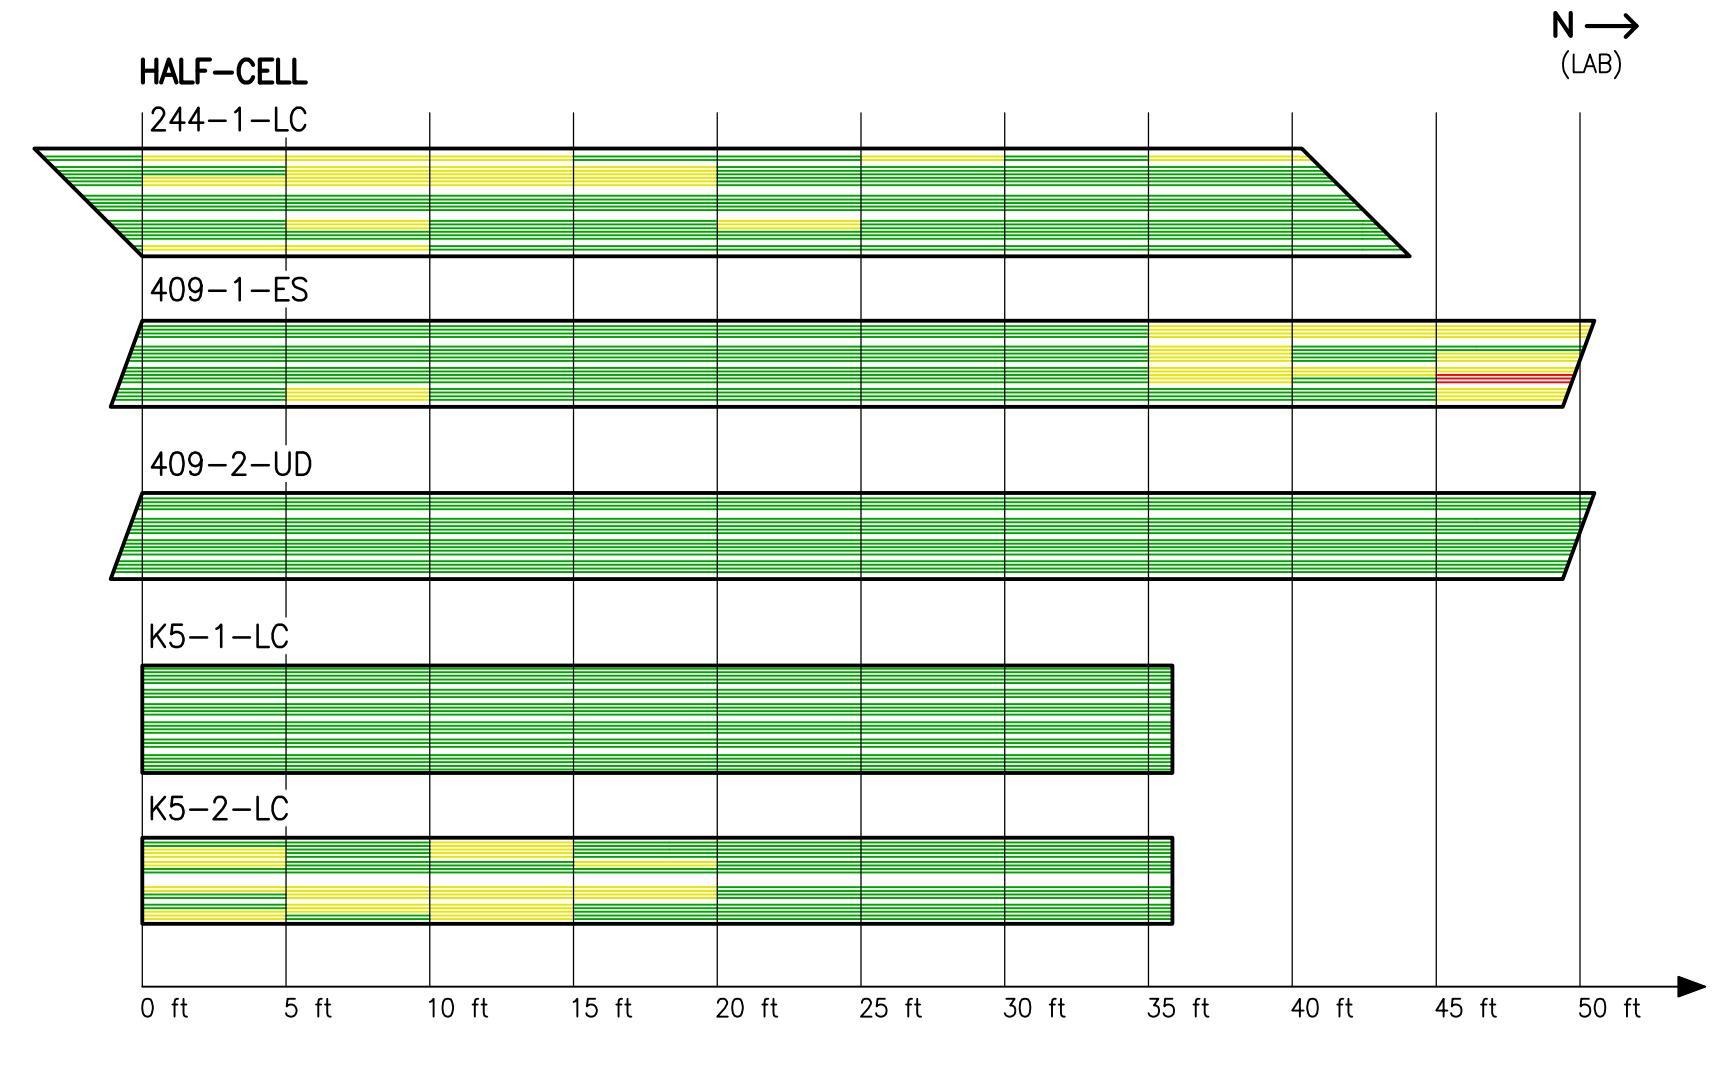
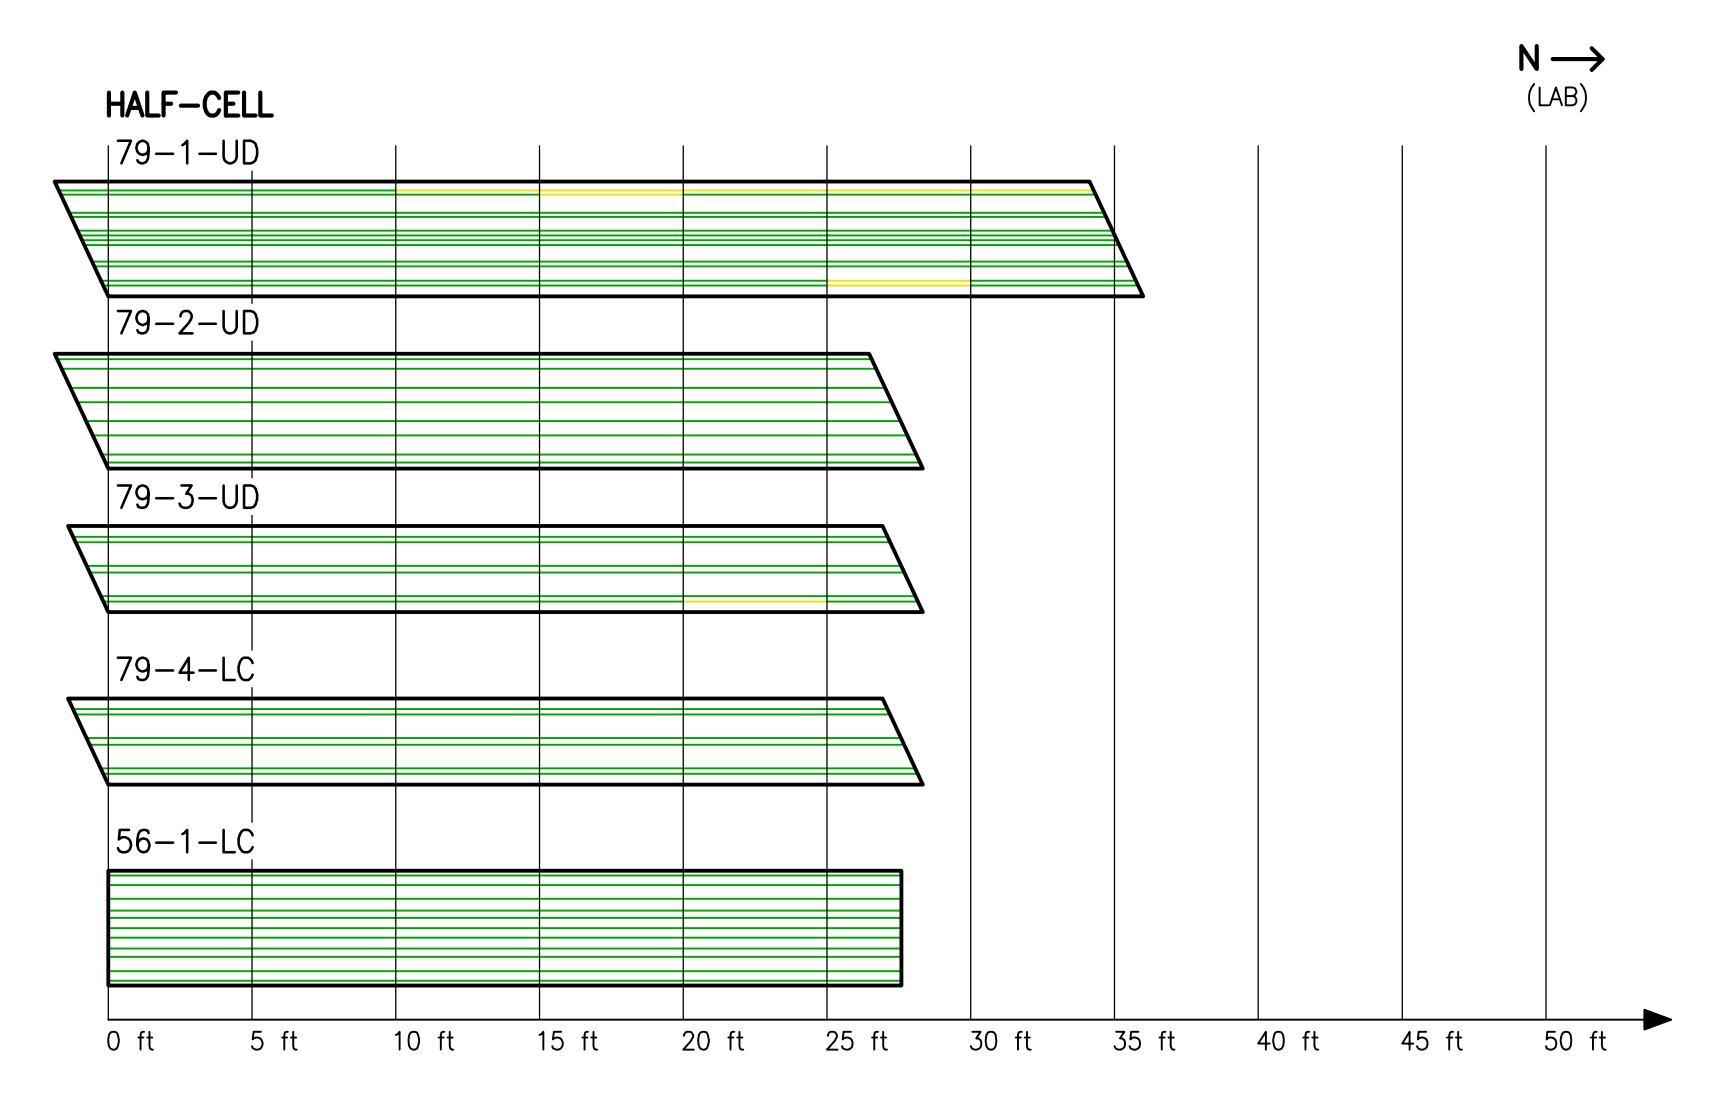
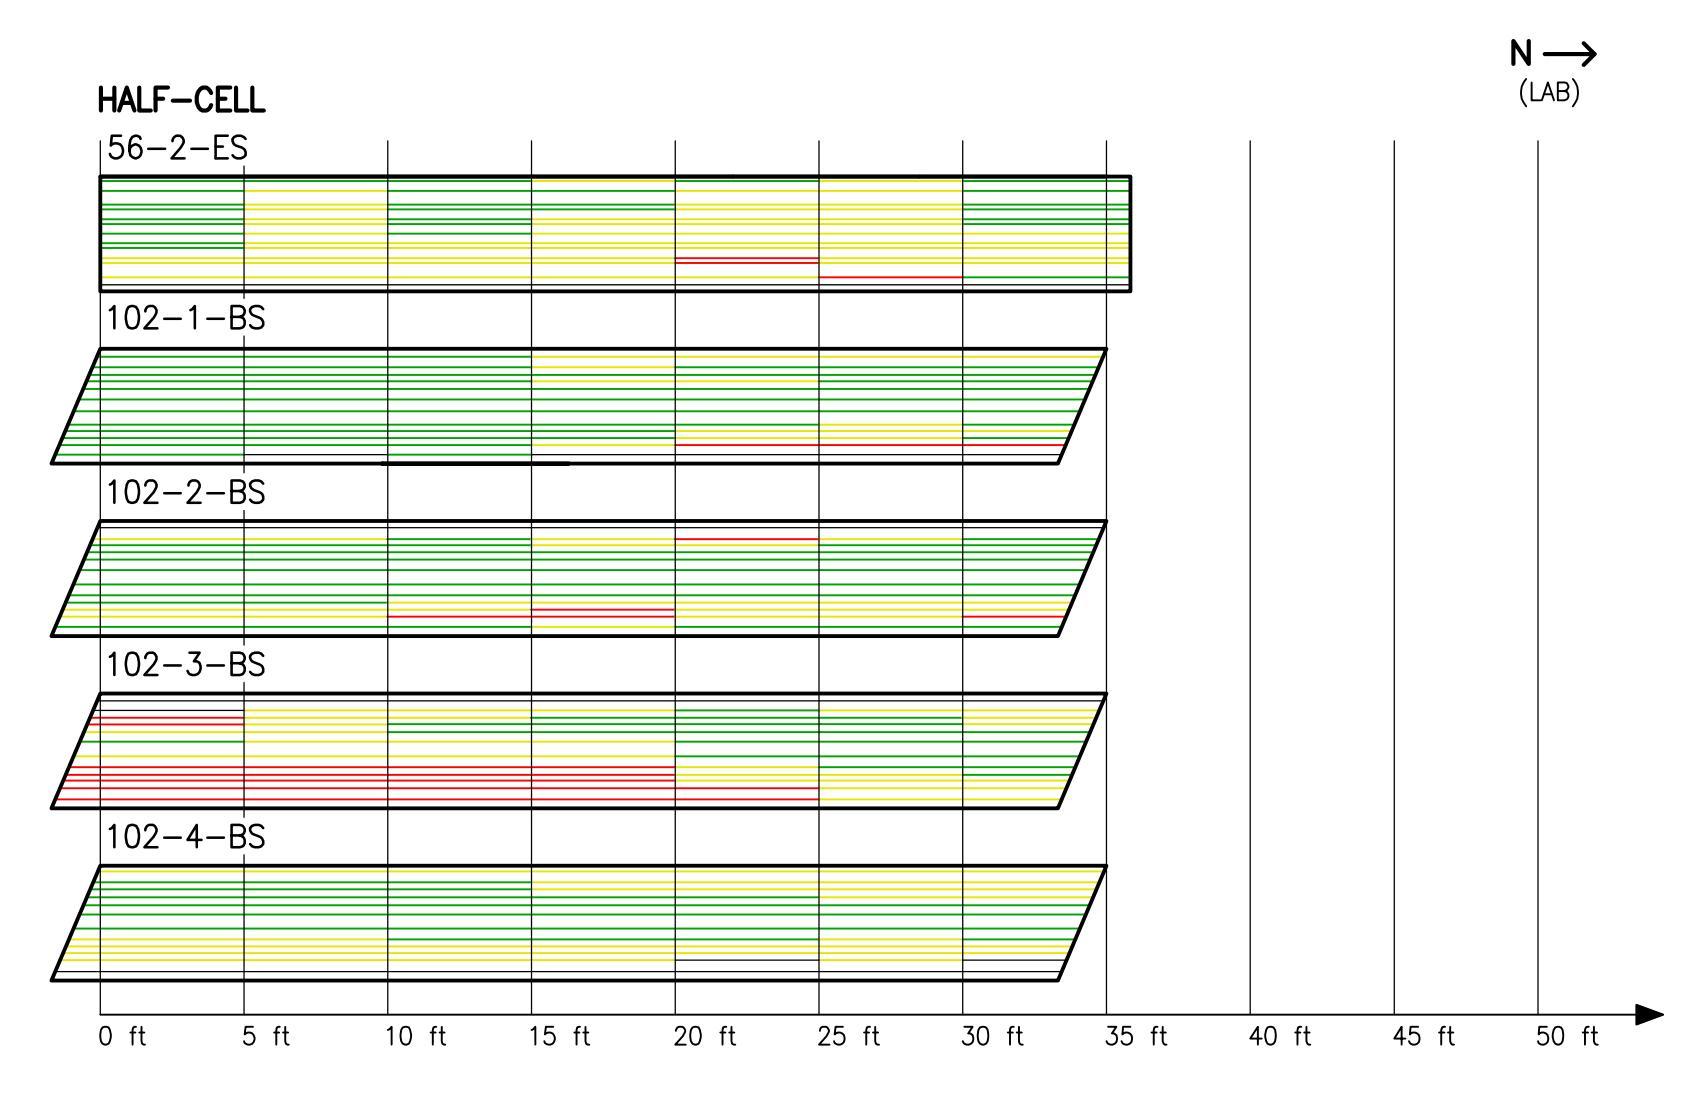
Figure 3.25: Half-Cell Potential Results

The half-cell potentials results are provided in Figure 3.25. The results are displayed using the color coding from Table 3.5. The exposed strands in Specimens 409-1-ES, 56-2-ES, 102-1-BS, 102-2-BS, 102-3-BS, and 102-4-BS were not directly scanned. If the area adjacent to the exposed strand was not spalled, the strand was scanned. Results for Specimen 409-1-ES include the results from the area adjacent to the exposed strands. No suitable areas for scanning were available in portions of Specimens 56-2-ES, 102-1-BS, 102-2-BS, 102-3-BS, and 102-4-BS. The locations where no scan could be taken are indicated in Figure 3.25 by coloring the strand black.

In general, the half-cell potential results correlate well with the visual deterioration observed. A complete comparison between the half-cell potentials results and the results from the strand extraction is provided in Section 3.5.

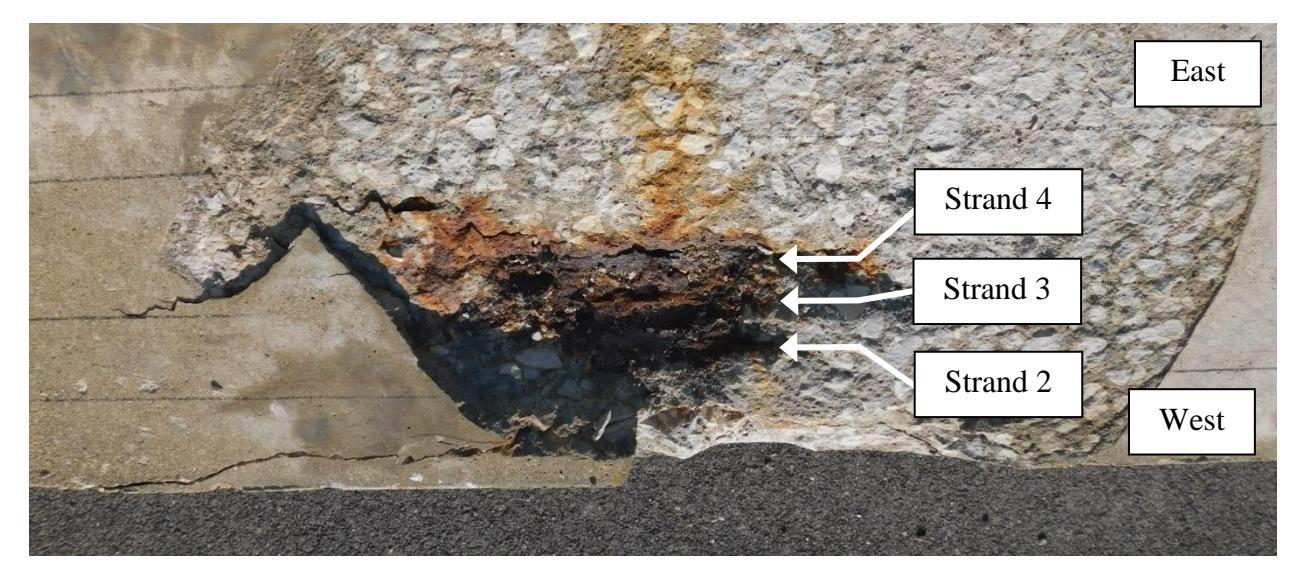
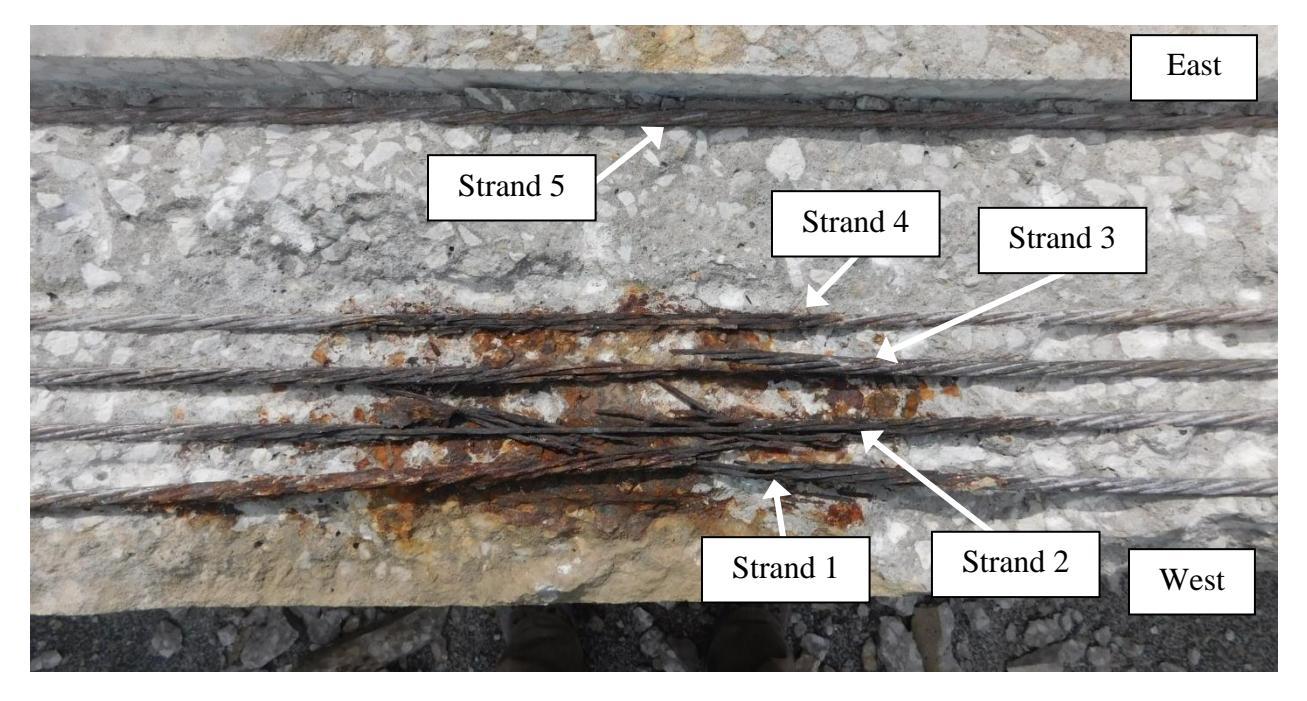
Figure 3.26: Strand Condition at Spall in Specimen 409-1-ES

In service, Specimen 409-1-ES was an exterior beam. The west side of the beam noted in Figure 3.26 corresponds to the side of the beam that faced the exterior. The region of deterioration shown corresponds to the location of a scupper drain where water drained from the bridge deck onto the side of the beam and curled onto the bottom flange. In Figure 3.2, the beam is shown with a spall and three exposed strands. Figure 3.26 shows the condition of the strands adjacent to the three exposed strands (Strands 2 to 4).

As shown in Figure 3.26(b), Strand 1 is completely corroded in addition to the exposed strands. Strand 1 was not exposed by the concrete spall, but deterioration was indicated by longitudinal cracking shown in Figure 3.26(a) and corner cracking shown in Figure 3.27. The corrosion of Strands 1 to 4 extended approximately 6 in. to the north and south of where the strands were exposed. Strand 5, located 4 in. east of Strand 4, has no observable corrosion. The measured bottom cover for all the strands was 1 in.

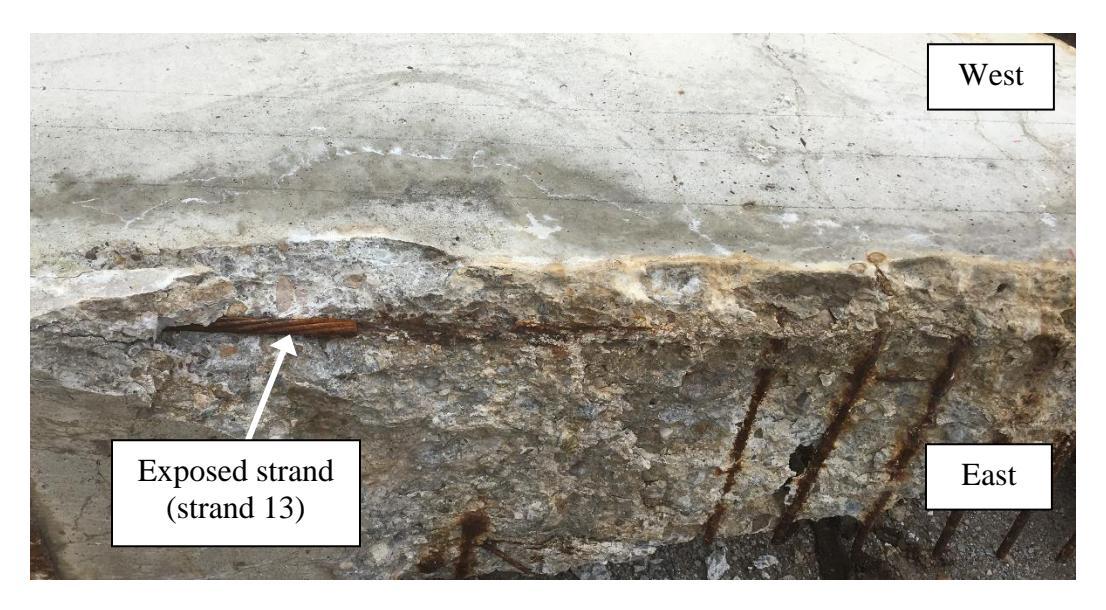
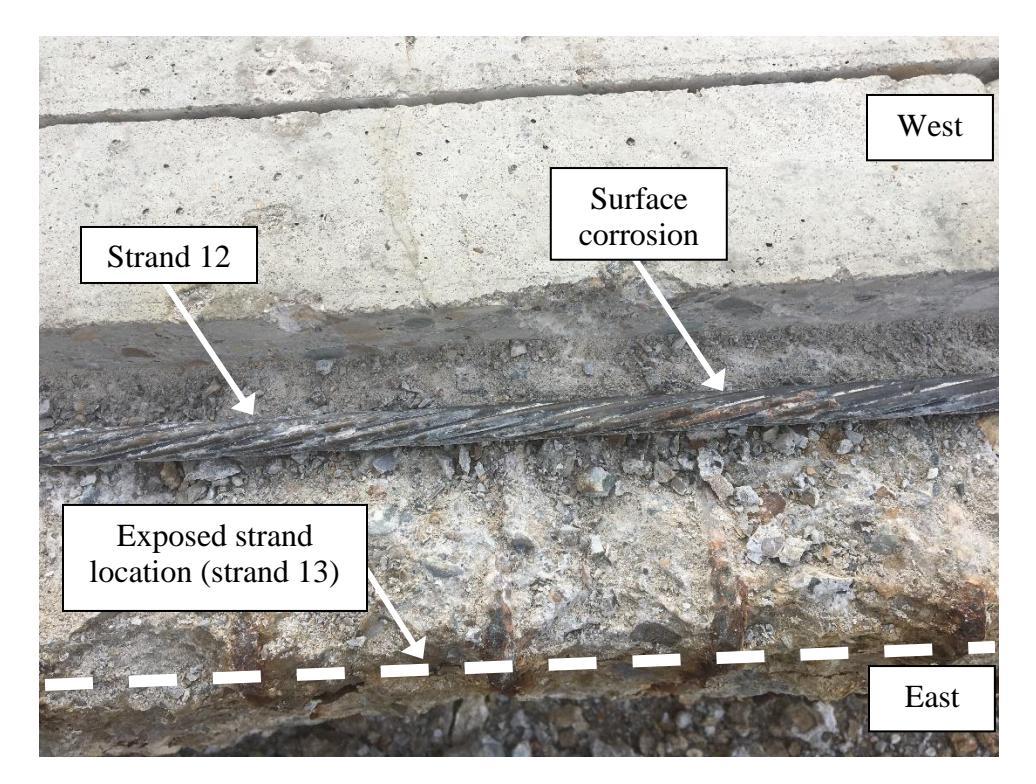
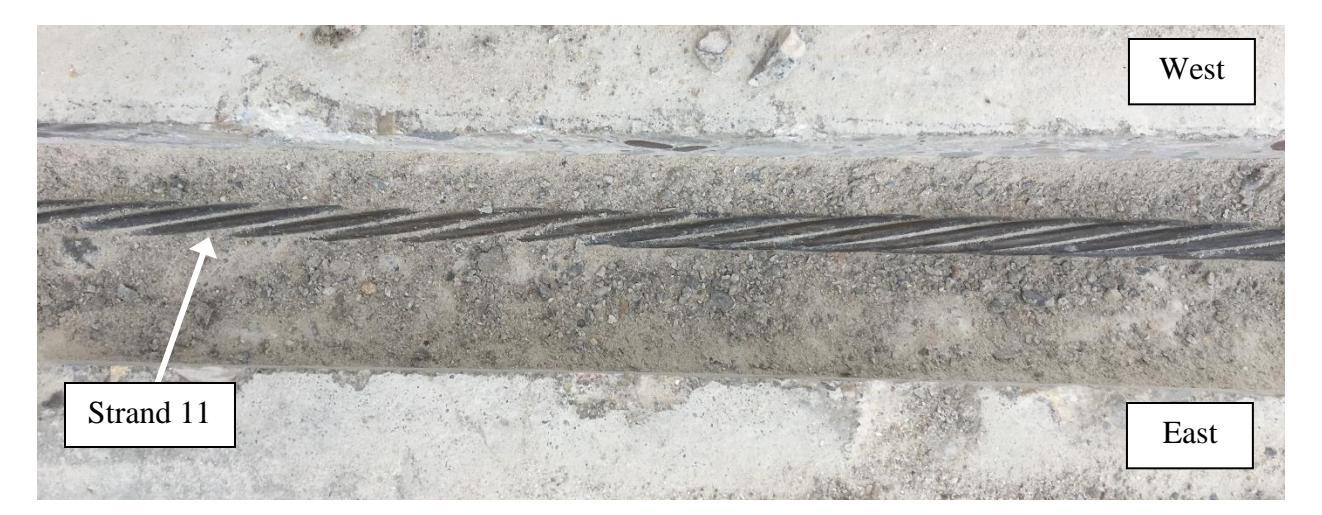
Figure 3.28: Representative Condition of Strands Adjacent to the Exposed Strand in Specimen 56-2-ES

All deterioration of Specimen 56-2-ES was concentrated on the east side of the specimen (Figure 3.11). In service, Specimen 56-2-ES was an exterior beam with no curbs or other deck drains. The east side of the beam corresponds to the exterior side of the beam while in service. Figure 3.28 shows the representative condition of the strands adjacent to the exposed strand. As shown, Strand 12 (the strand adjacent to the exposed strand (Strand 13)) shows a small amount of surface corrosion but no pitting. The location of the exposed strand in Figure 3.28(b) is provided as a dashed white line for reference. Strand 11, shown in Figure 3.28(c) and located 6 in from Strand 12, was found without any observable corrosion. The measured bottom cover for all strands was 1-3/8 in.

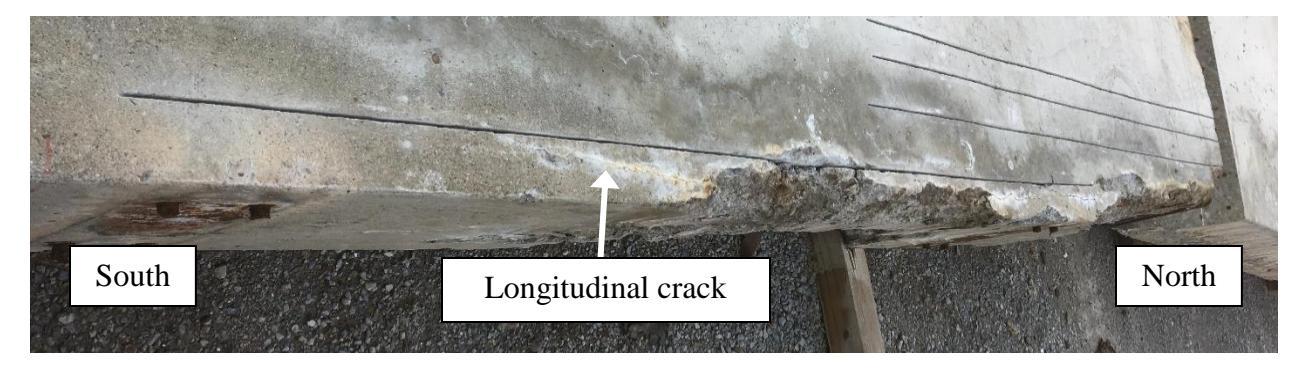
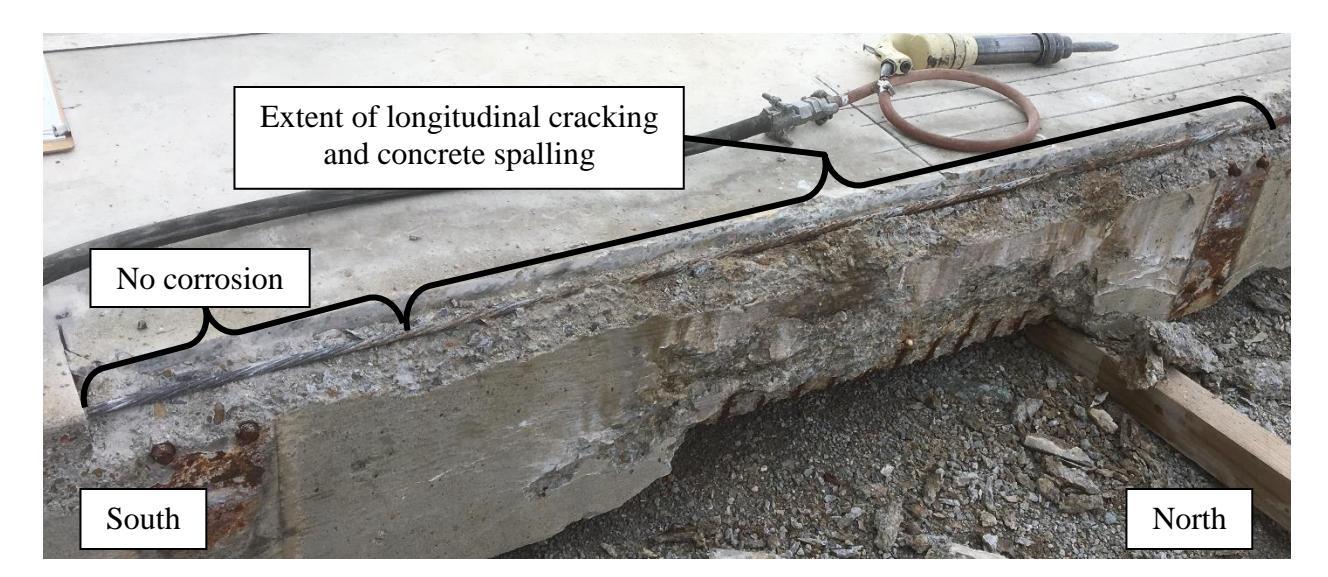
Corrosion was observed on Strand 13 outside of the exposed region of the strand where a longitudinal crack extended from the concrete spall (Figure 3.29). Where the longitudinal crack ended, no corrosion of Strand 13 was observed. Only the length of strand at the longitudinal crack was corroded. No corrosion of Strand 13 was observed where no cracking or concrete spalling was observed.

(b) After cover was removed Figure 3.29: Extent of Corrosion in Exposed Strand in Specimen 56-2-ES

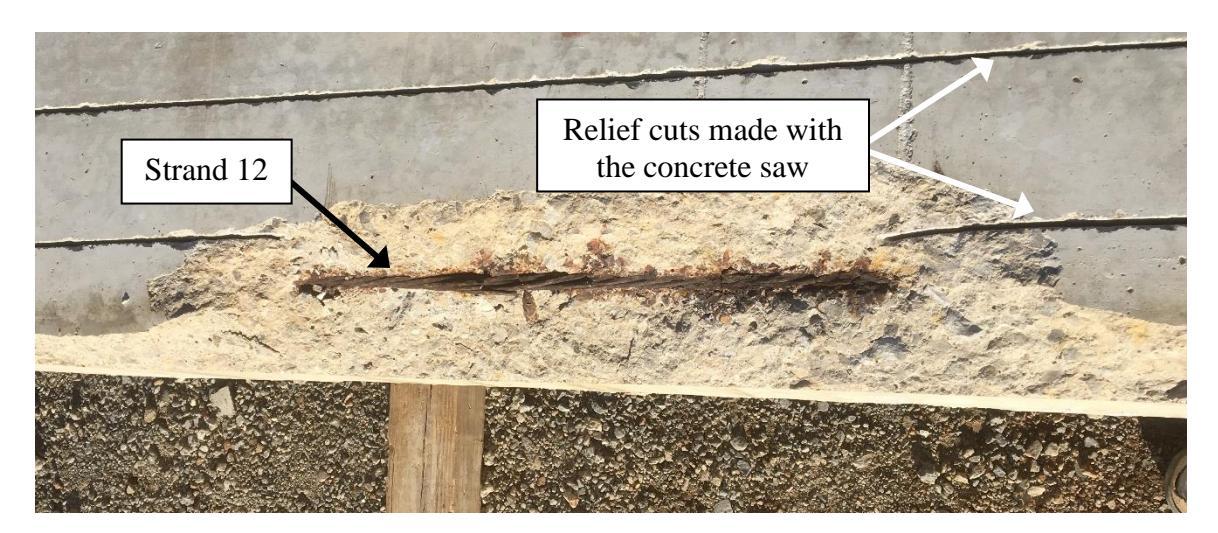
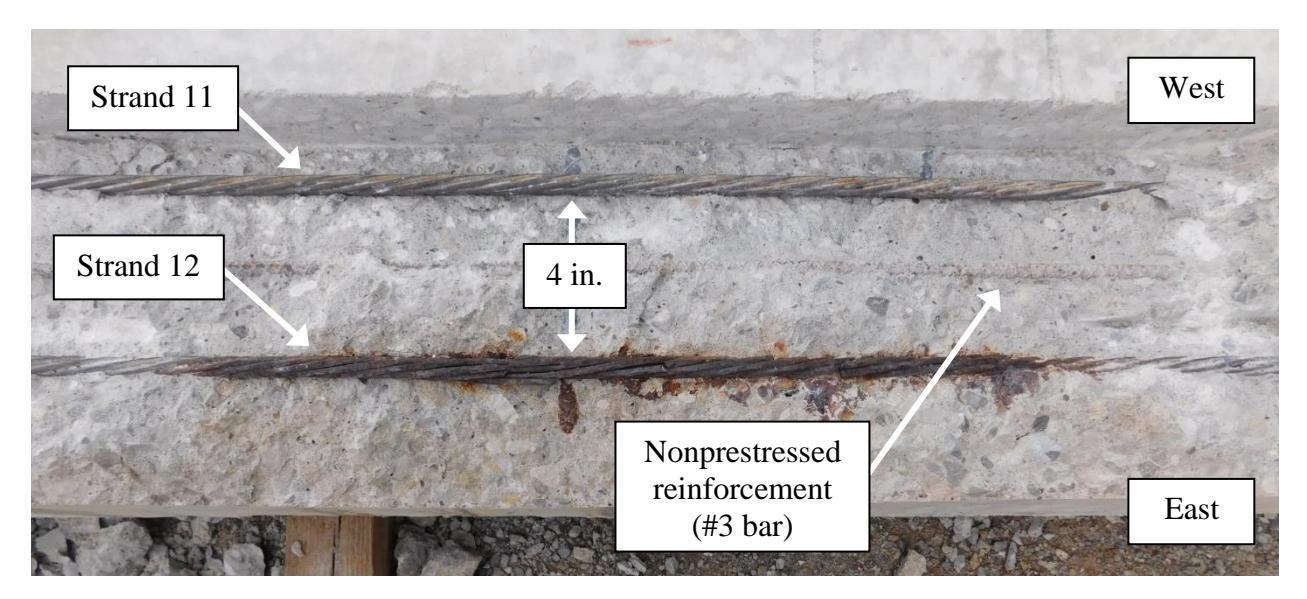
Figure 3.30: Strand Condition at Exposed Strand in Segment A of Specimen 102-1-BS

Figure 3.30 to Figure 3.32 show the condition of Strand 11 which is adjacent to the corroded edge strand. As shown in Figure 3.30(a), the corrosion on Strand 12 in Segment A extended approximately 2 in. from the exposed region of the strand. In Figure 3.32, a dashed white line represents the original location of the broken strand (Strand 12). Corrosion of Strand 11 was only observed in Segment C, where the strand was adjacent to the broken portion of Strand 12. In addition, at the location of the broken strand, no corrosion was observed on Strand 10. The corrosion on Strand 12 in Segment C was limited to the length of the longitudinal cracks and corner cracks extending north and south from the exposed region of Strand 12 (Figure 3.12). Notably, Strand 11 was located 4 in. from Strand 12, and Strand 10 was located 3 in. from Strand 11.

As shown in Figure 3.30 to Figure 3.32, a nonprestressed #3 bar was found at each location of deterioration. The bar was assumed to have been used during construction of the beam to support the transverse reinforcement. The location of the bar in Figure 3.31 indicates that the lack of side cover at that location (1 in.) may have resulted in premature deterioration of Strand 12. In the other locations, however, the bar was located between Strands 11 and 12 and had adequate side cover. The measured bottom cover for all strands and nonprestressed reinforcement was 1-1/2 in.

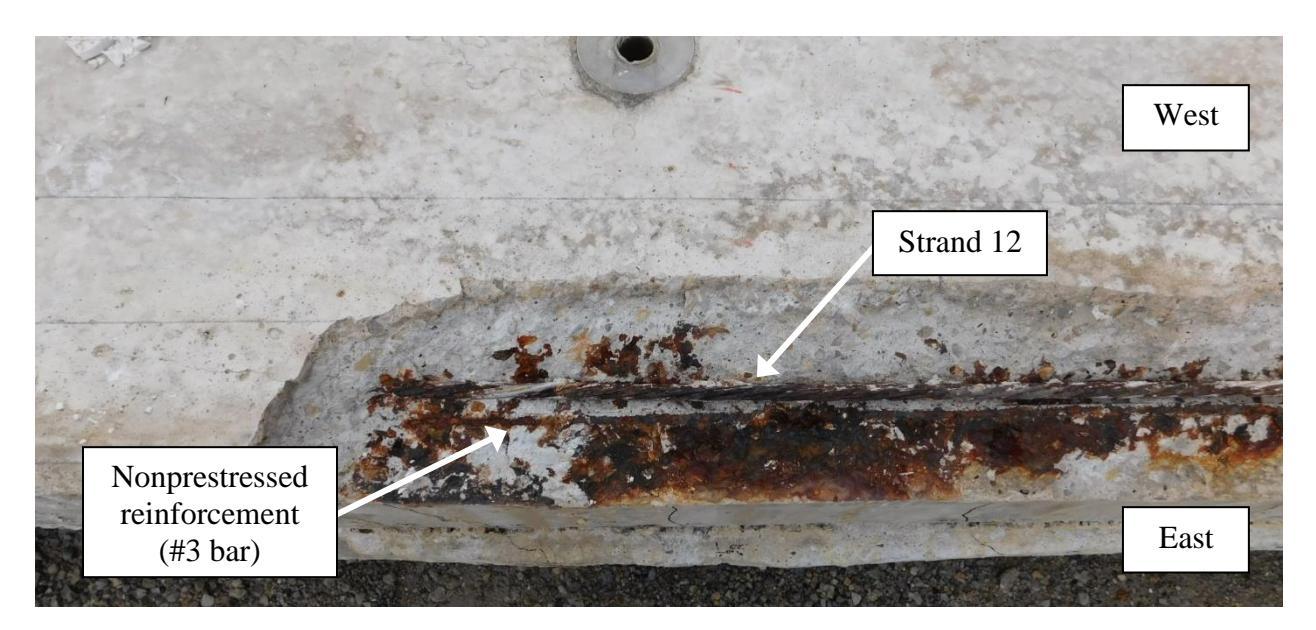
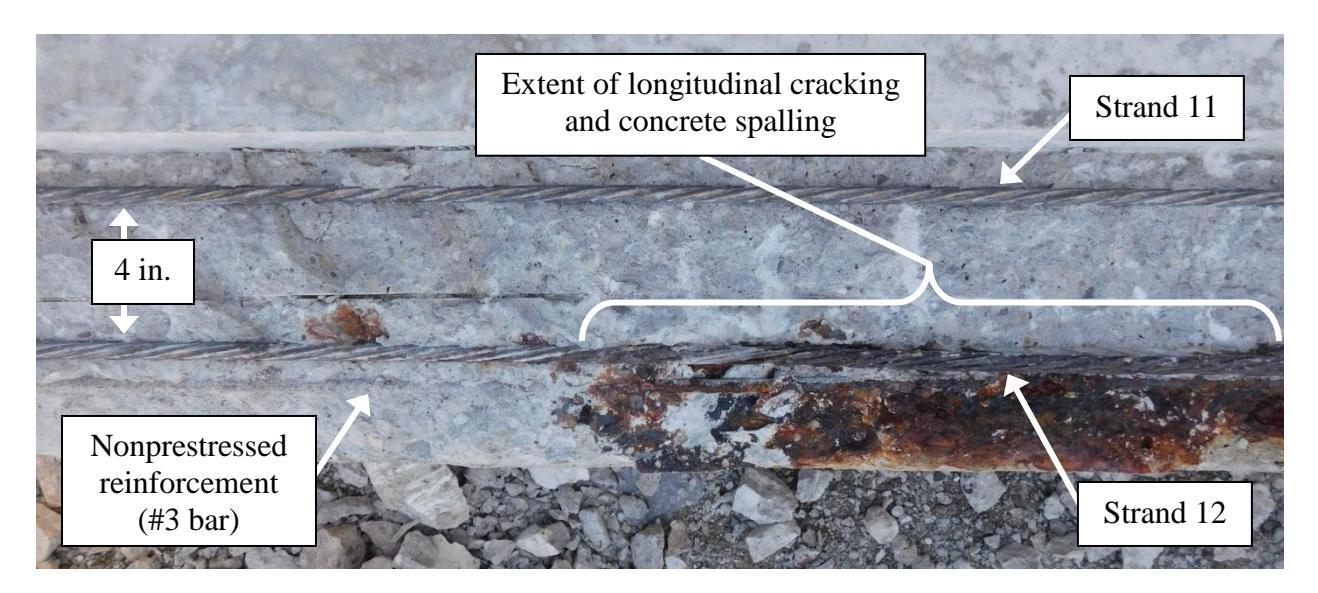
Figure 3.33: Strand Condition at Longitudinal Cracks in Segment B of Specimen 102-2-BS

Specimen 102-2-BS was an interior beam in-service. In Figure 3.13, 102-2-BS is shown with a broken strand on the west beam edge and longitudinal cracks on the east beam edge. The condition of the strands at the locations of deterioration are shown in Figure 3.33 for longitudinal cracking in Segment B and Figure 3.34 for the exposed and broken strand in Segment C. In Segment B, Strand 12 was observed with severe corrosion while Strand 11, located 4 in. from Strand 12, was found with no corrosion. Strand 2 in Segment C was located 5 in. from Strand 1 (the broken strand) and was observed to have no corrosion. The measured bottom cover of all the reinforcement was 1-5/8 in.

The longitudinal extent of the corrosion of Strand 1 was limited to the exposed length of the broken strand. Similar to Strand 1, the extent of corrosion along the length of Strand 12 was limited to the extent of the longitudinal cracking shown in Figure 3.13 (Figure 3.33(b)).

Where the CEPRA corrosion rate indicated "visible" corrosion (orange strand in figures), the strands were often found with no corrosion, or surface rust and no pitting. In Specimens 102-1-BS and 102-2-BS, "visible" corrosion was indicated on many of the strands adjacent to exposed strand (Figure 3.94 and Figure 3.95). For Specimen 102-1-BS, "visible" corrosion was detected on Strand 11 and at the locations where the strands were adjacent to exposed strands (adjusted four-part scale between 15 ft and 30 ft in Figure 3.94), but no corrosion was observed in Strand 11, as shown in Figure 3.30(b) and Figure 3.31(b), or in Strand 10, as shown in Figure 3.32(b). In addition, corrosion was detected on Strand 11 in Specimen 102-2-BS (adjusted four-part scale between 10 ft and 25 ft in Figure 3.95), but no corrosion was observed as shown in Figure 3.33(b).
