EVALUATION AND STRUCTURAL BEHAVIOR OF DETERIORATED PRECAST, PRESTRESSED CONCRETE BOX BEAMS

A Dissertation

Doctor of Philosophy

Lyles School of Civil Engineering West Lafayette, Indiana December 2019

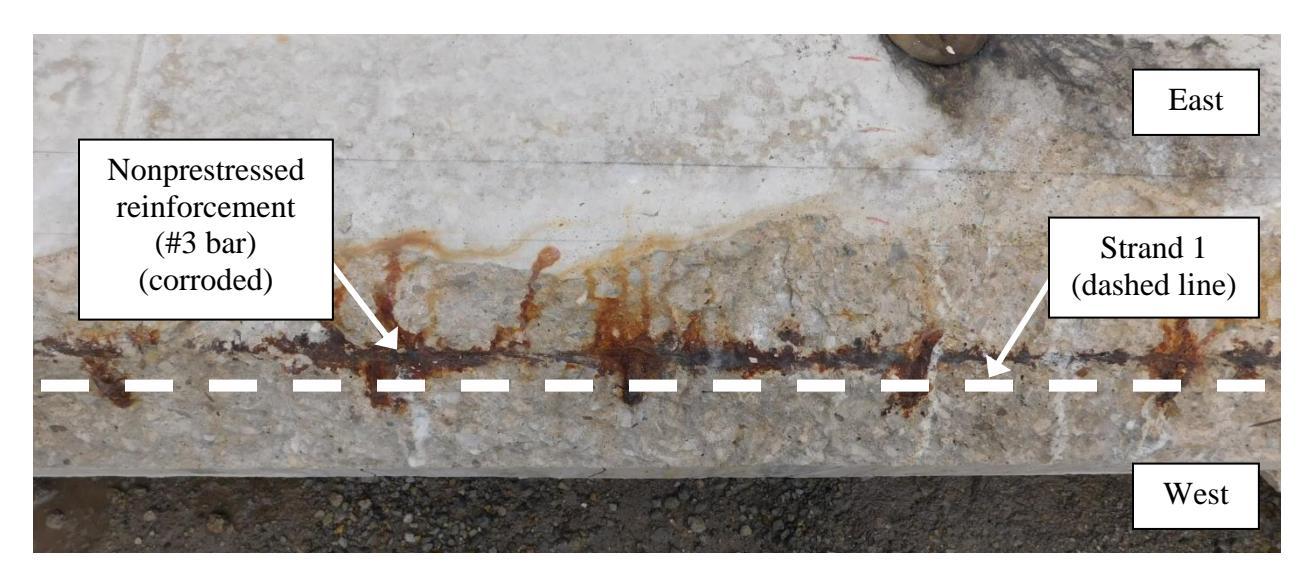
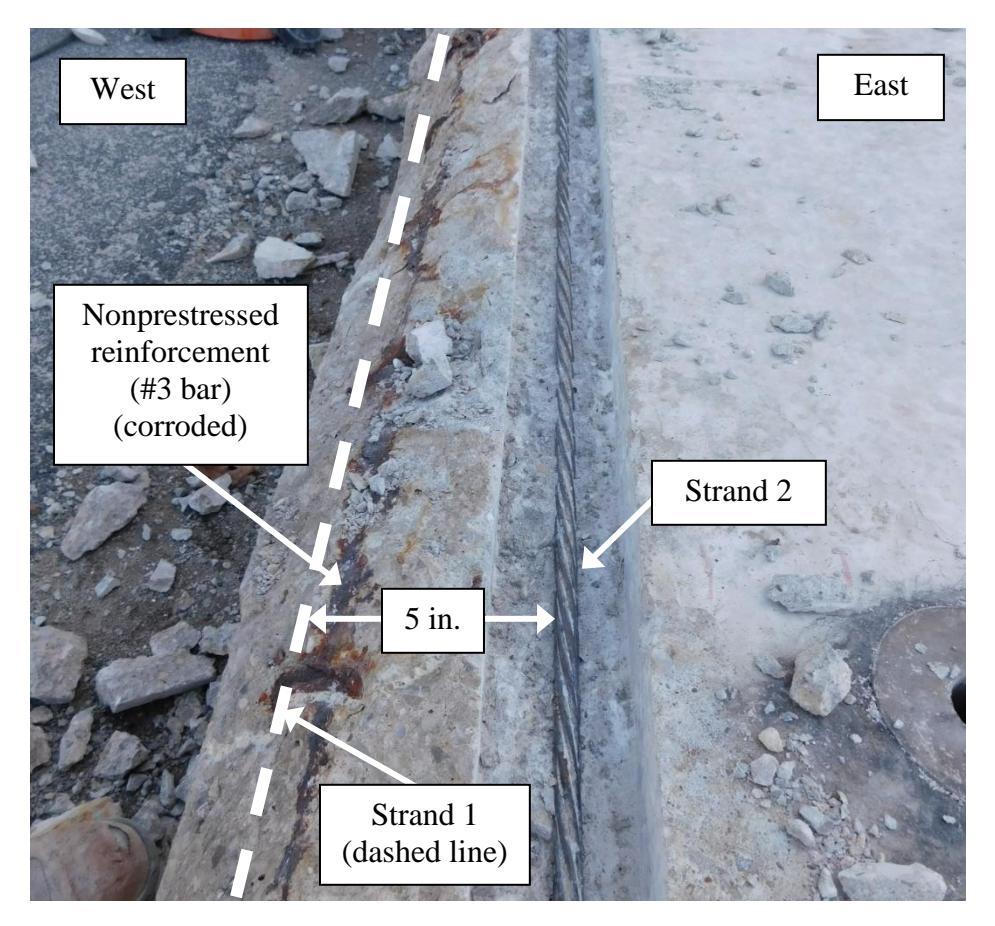
Figure 3.34: Strand Condition at Broken Strand in Segment C of Specimen 102-2-BS

Specimen 102-2-BS was an interior beam in-service. In Figure 3.13, 102-2-BS is shown with a broken strand on the west beam edge and longitudinal cracks on the east beam edge. The condition of the strands at the locations of deterioration are shown in Figure 3.33 for longitudinal cracking in Segment B and Figure 3.34 for the exposed and broken strand in Segment C. In Segment B, Strand 12 was observed with severe corrosion while Strand 11, located 4 in. from Strand 12, was found with no corrosion. Strand 2 in Segment C was located 5 in. from Strand 1 (the broken strand) and was observed to have no corrosion. The measured bottom cover of all the reinforcement was 1-5/8 in.

The longitudinal extent of the corrosion of Strand 1 was limited to the exposed length of the broken strand. Similar to Strand 1, the extent of corrosion along the length of Strand 12 was limited to the extent of the longitudinal cracking shown in Figure 3.13 (Figure 3.33(b)).

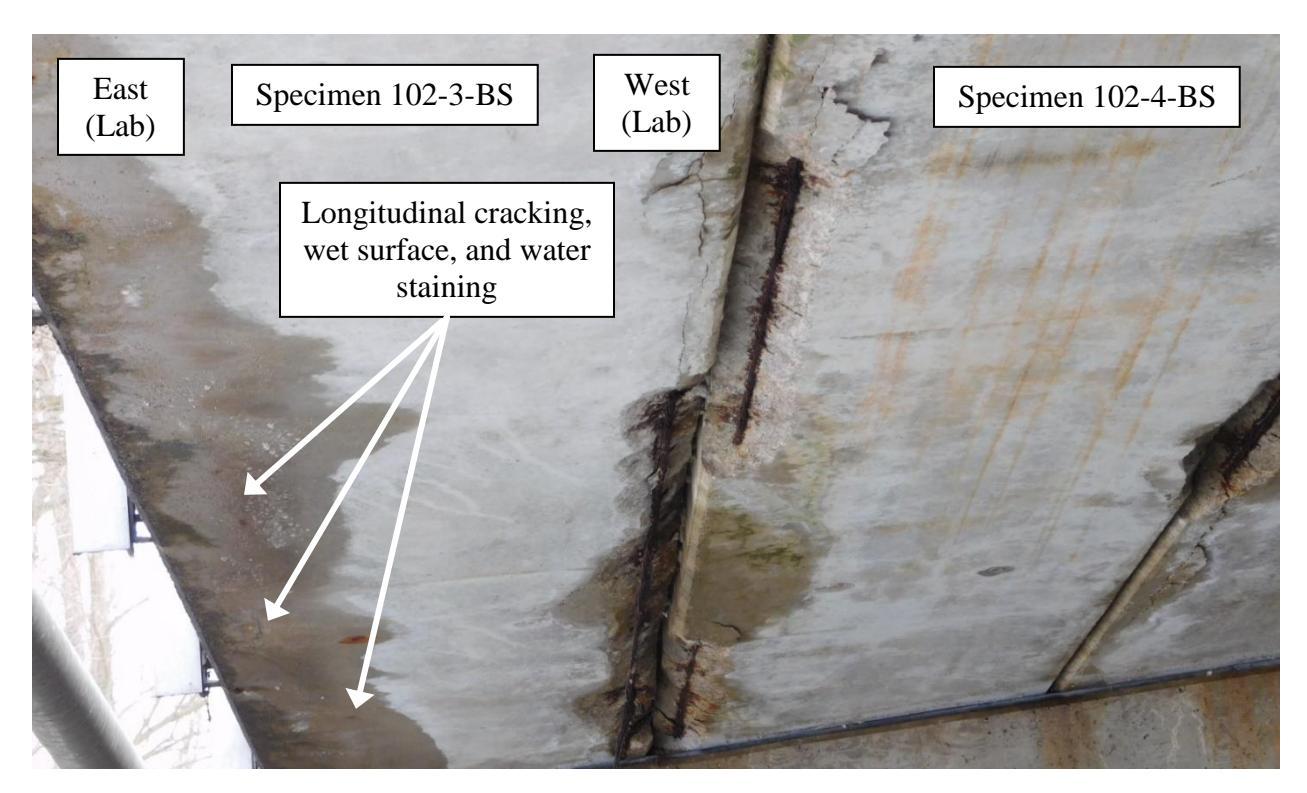
Figure 3.35: Condition of Specimen 102-3-BS in Service

In service, 102-3-BS was an exterior beam without a curb or other drainage system. The deterioration shown in Figure 3.14 consists of exposed and broken strands on the west side of the beam and longitudinal cracking on the east side of the beam. The east side of the beam corresponds to the exterior side of the beam while in service. During the bridge inspection, the exterior side of the beam was wet while the interior side was dry (Figure 3.35). In Figure 3.36, longitudinal cracks were observed prior to structural testing within the wet region shown in Figure 3.35. The representative condition of the strands at the locations of deterioration is provided in Figure 3.37 to Figure 3.39.

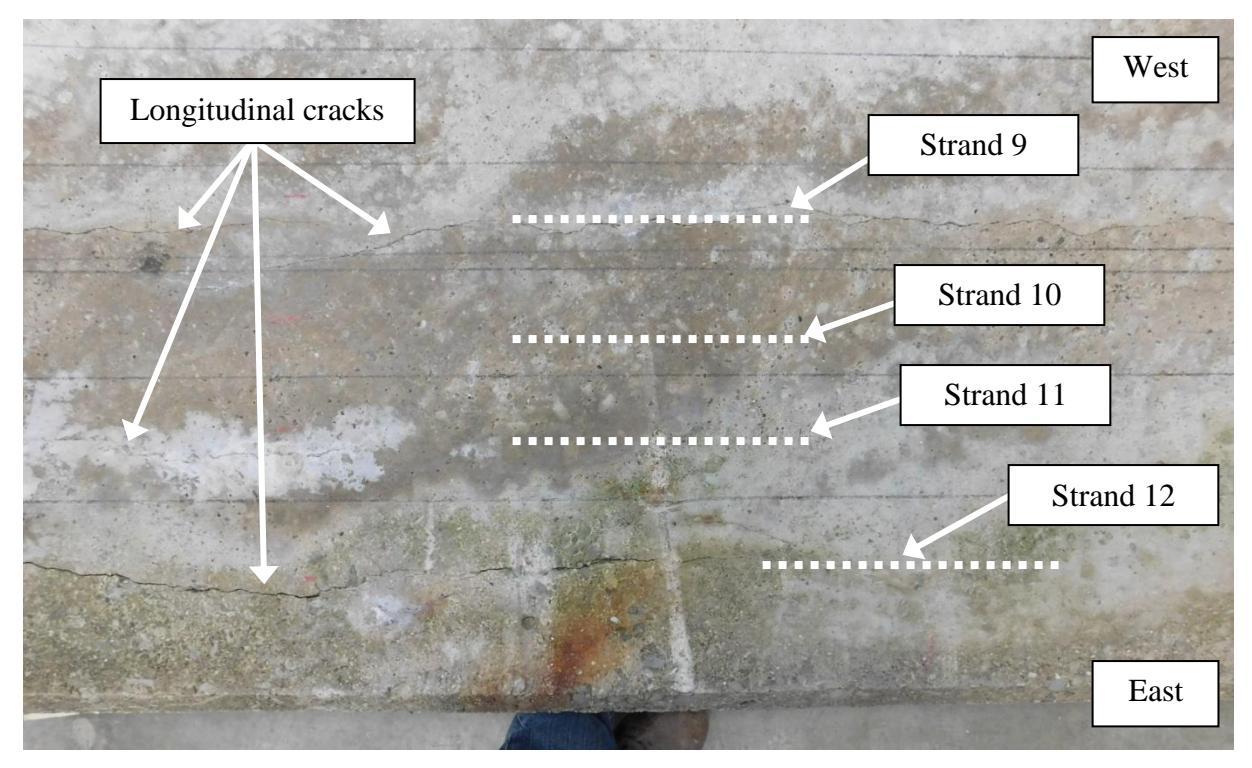
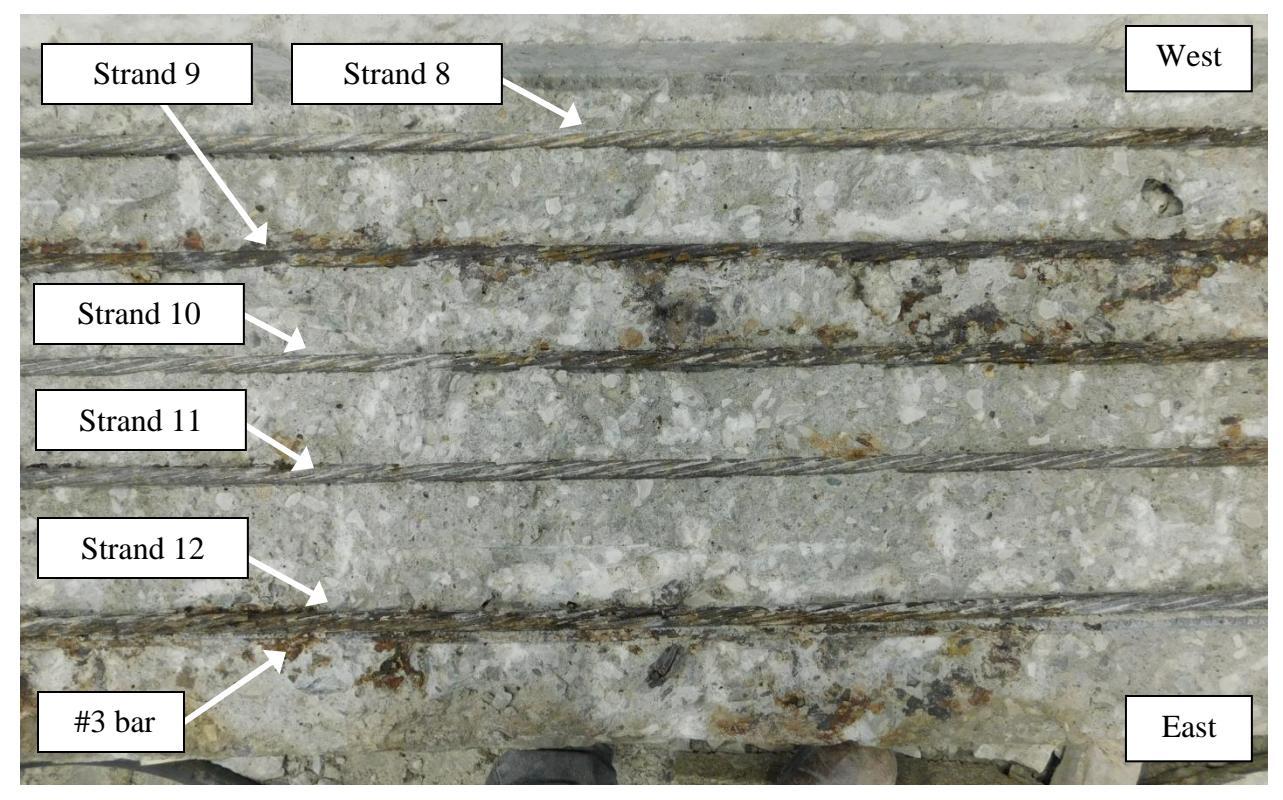
In Figure 3.37, longitudinal cracks are noted on the east side of Segment A. The approximate locations of Strands 9 to 12 have been indicated in Figure 3.37(a) with white dotted lines. Strands 9 to 12 were found corroded in the region shown in Figure 3.37(b), and Strand 8 was observed with surface corrosion. The strand spacing between Strands 11 and 12 was 4-1/4 in. The corroded strands correspond to the region of the beam that was cracked and heavily stained.

(b) After cover was removed Figure 3.37: Strand Condition at Longitudinal Cracks in Segment A of 102-3-LC

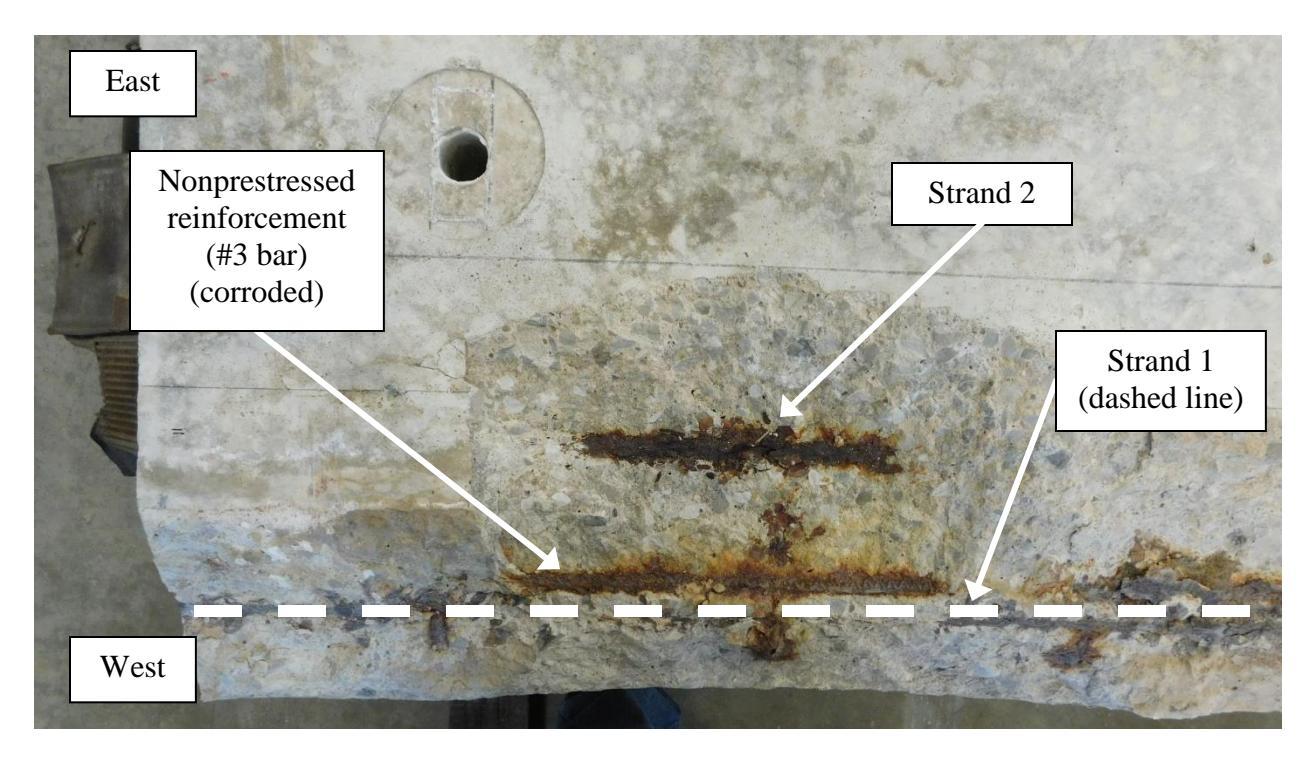
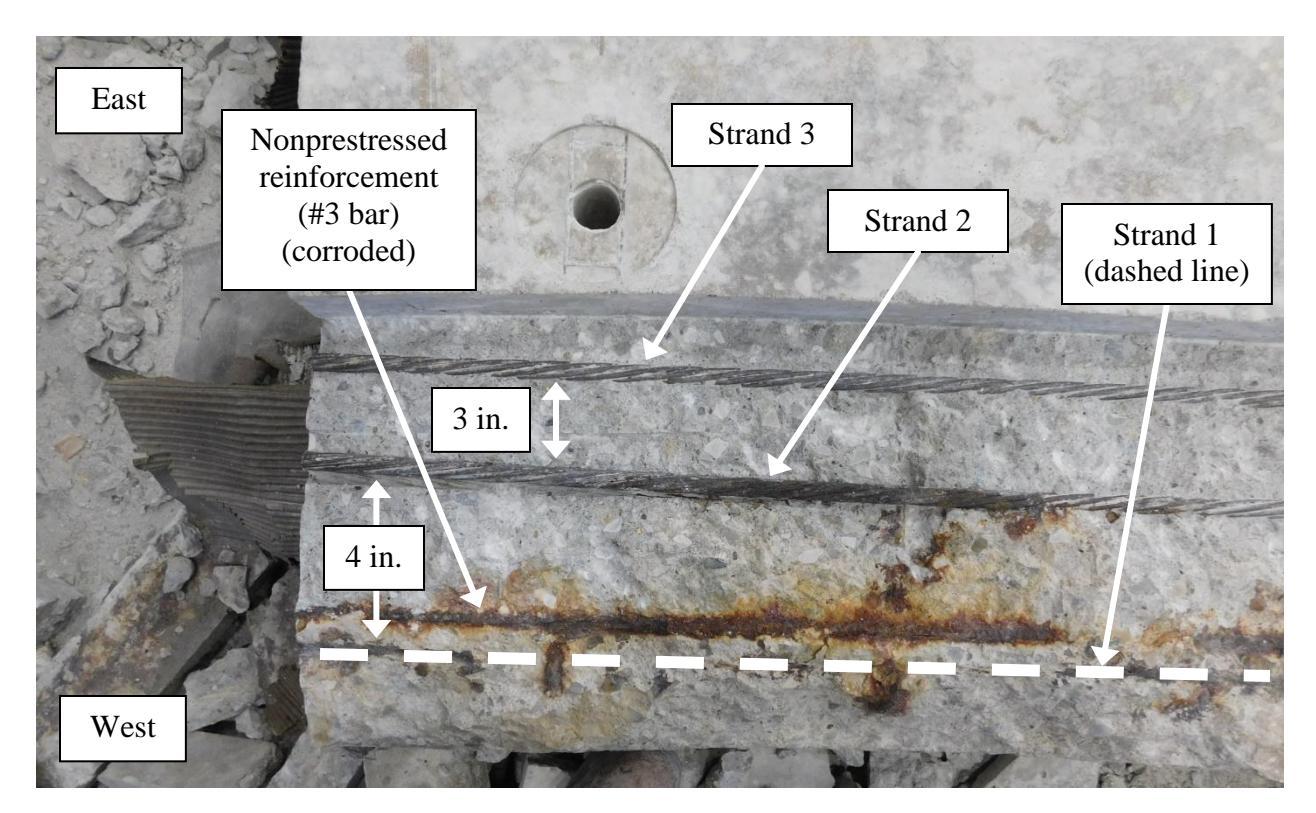
Figure 3.38: Strand Condition at Exposed and Broken Strands in Segment B of Specimen 102-3-BS

In Figure 3.38 and Figure 3.39, the same trend in deterioration was observed as in the previous specimens. No corrosion was observed on the strands adjacent to corroded strands at longitudinal cracks, and a large spacing was measured between strands. The strand spacing was 4 in. between Strands 1 and 2, and 3 in. between Strands 2 and 3.

The longitudinal extent of corrosion associated with longitudinal cracking corresponded to the extent of the longitudinal crack. For exposed strands (Strands 1 and 2), corrosion was observed to extend approximately 1 to 2 in. past the concrete spall on either end of the exposed region.

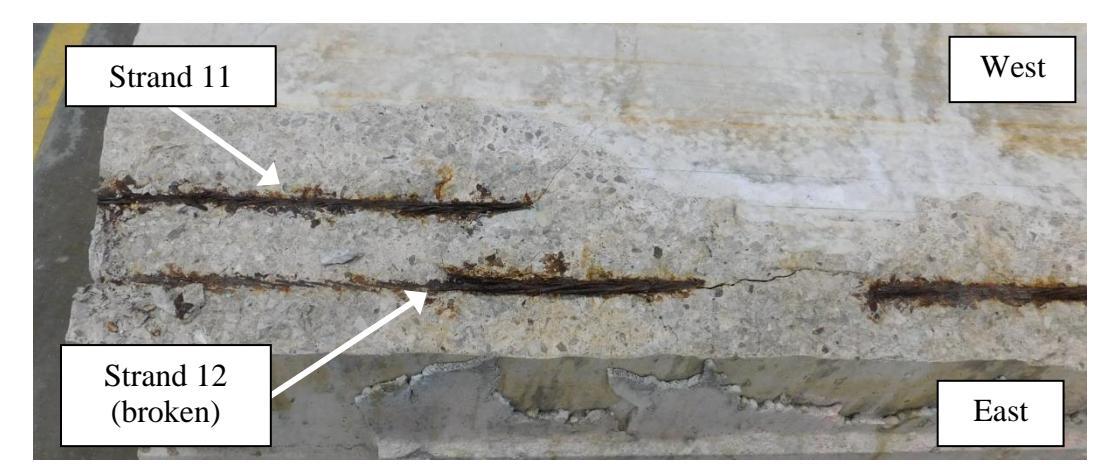
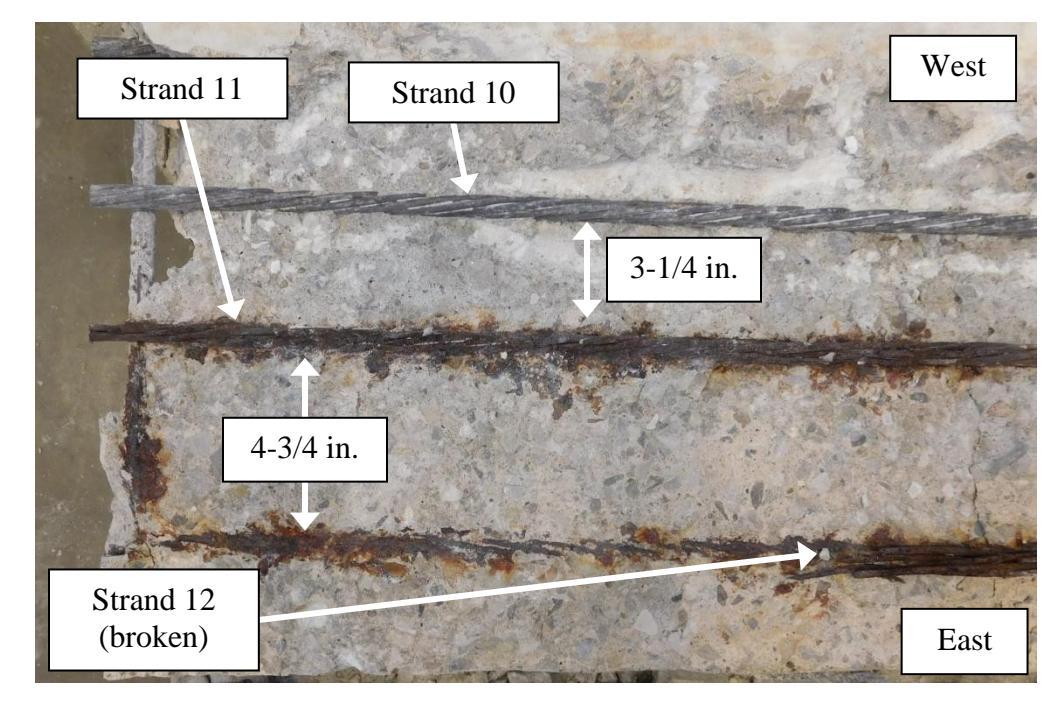
Figure 3.40: Strand Condition at North Exposed and Broken Strand in Northeast Portion Segment B of Specimen 102-4-BS

In the northeast end of Segment B, there was an exposed strand (Strand 11) adjacent to a broken strand (Strand 12) (Figure 3.40(a)). When cover was removed from Strand 10, no corrosion was observed (Figure 3.40(b)). The spacing of strands was 3-1/4 in. between Strands 10 and 11 and 4-3/4 in. between Strands 11 and 12.

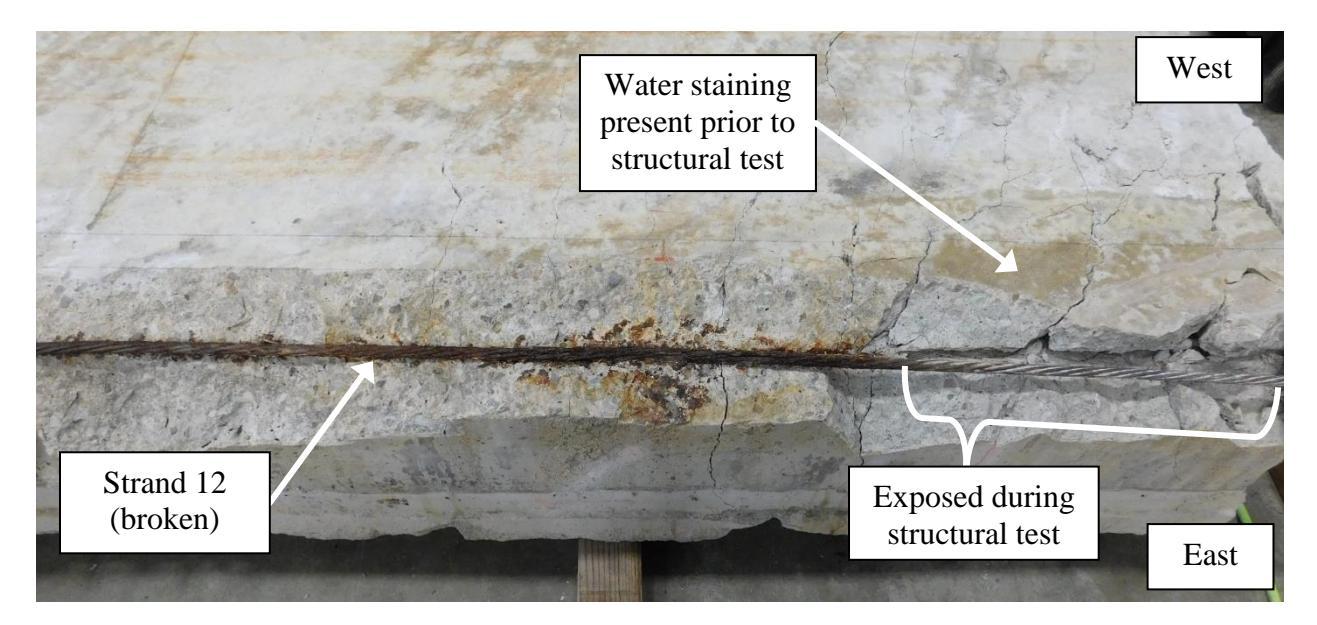
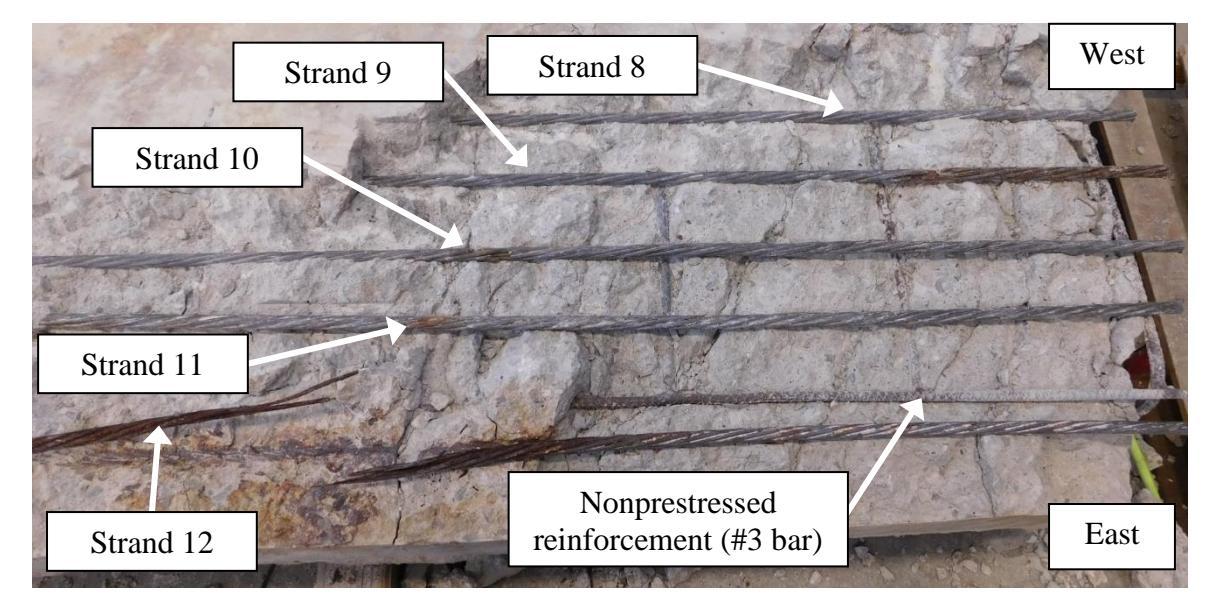
The exposed strand (Strand 12) in the southeast end of Segment B was further exposed during the structural test (Figure 3.41(a)). When cover was removed from Strand 11, a small section of corrosion was found, and delamination of the concrete was observed when the cover was chipped away. Cover was then removed from Strands 8 to 10 to determine the extent of the delamination (Figure 3.41(b)). Strands 9 and 10 were found with sections of corrosion and Strand 8 was found with no corrosion. The corrosion on Strand 9 corresponds to the existing longitudinal crack shown in Figure 3.42. The corrosion on Strands 10 and 11 correspond to a transverse crack observed prior to testing (Figure 3.43). It should be noted that the light corrosion at the crack was localized and consisted of mainly surface rust.

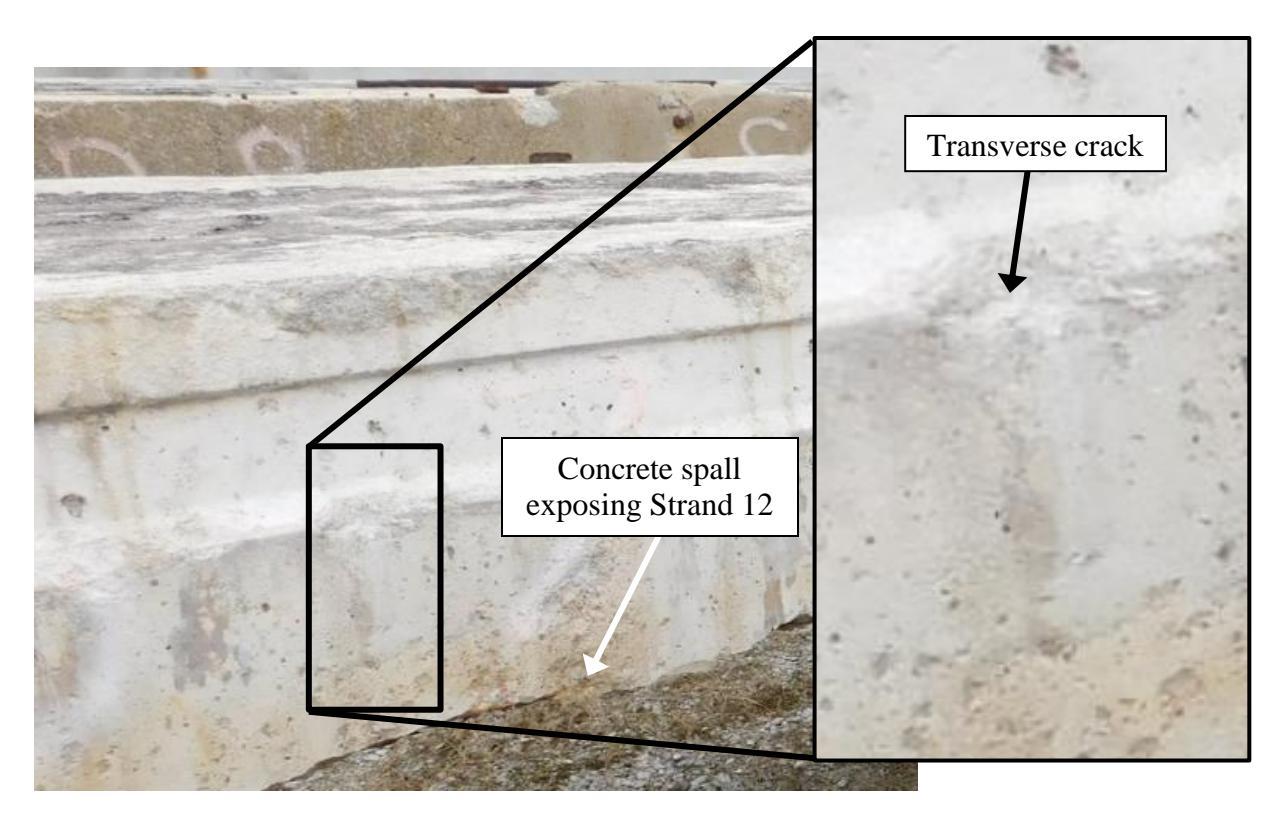
Figure 3.43: Existing Transverse Crack on East Side of Specimen 102-4-BS

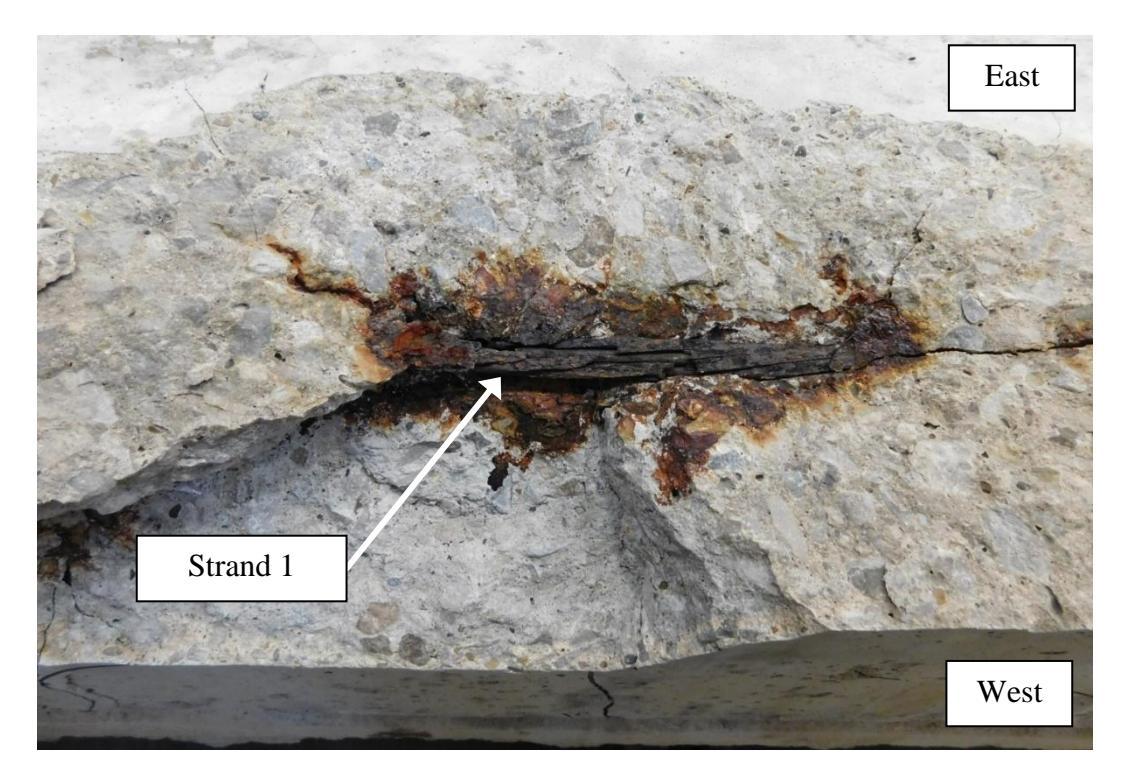
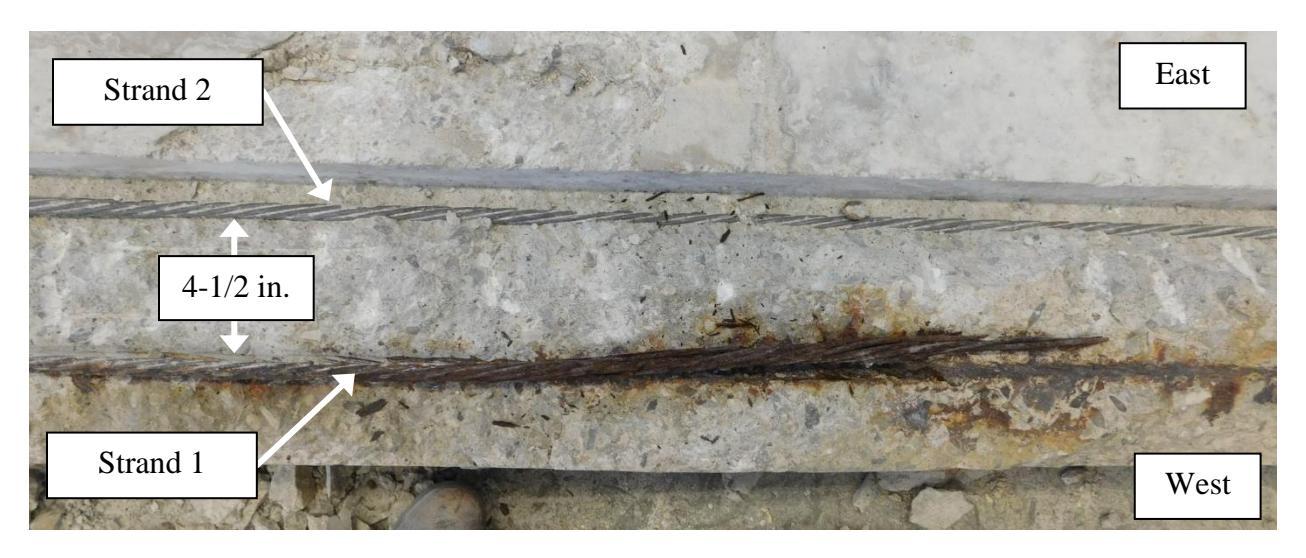
Figure 3.44: Strand Condition at Corner Crack in Segment B of 102-4-BS

The exposed strand (Strand 1) in Figure 3.44(a) was exposed during the structural test. Prior to the structural test, deterioration was indicated by longitudinal cracks in the bottom flange and side of the beam at the level of the strand (Figure 3.45). When cover was removed, only Strand 1 was found to be corroded. No corrosion was found on Strand 2.

(a) Before cover was removed (strand exposed during structural test)

(b) After cover was removed

In Specimen 102-4-BS (Figure 3.97), no corrosion was indicated at the longitudinal crack on the northwest side of the bottom flange where corrosion was observed during the strand extraction (Figure 3.44). This is the only instance where CEPRA gave no indication of corrosion where corrosion was observed after strands were extracted. It should be noted that this was observed prior to adjusting the corrosion rate scale and after adjustment.

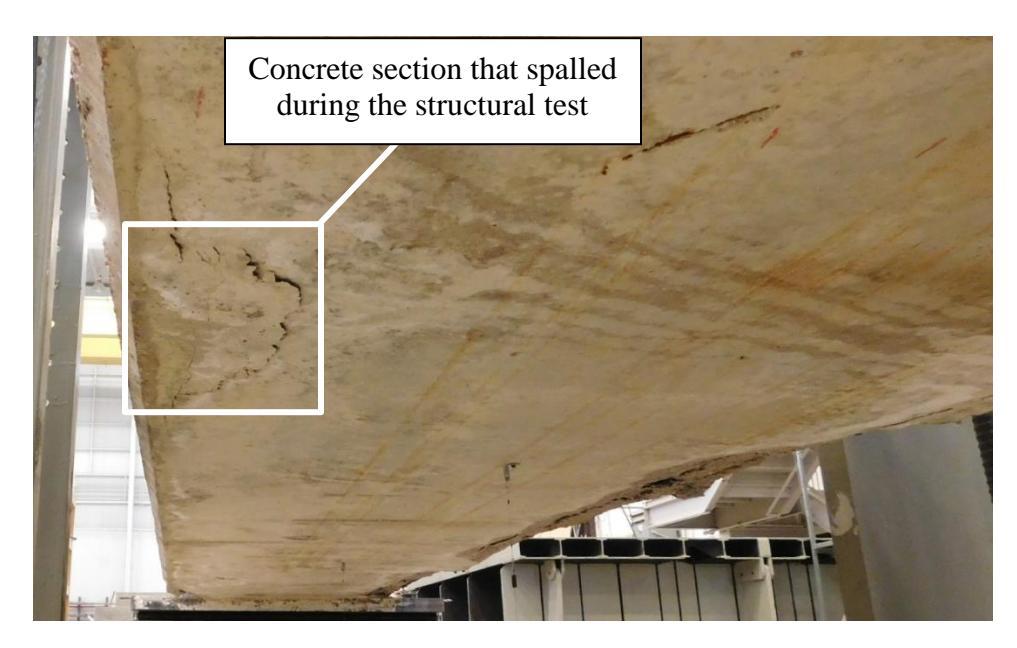
Figure 3.45: Longitudinal Cracking in Northwest Portion of Segment B in Specimen 102-4-BS

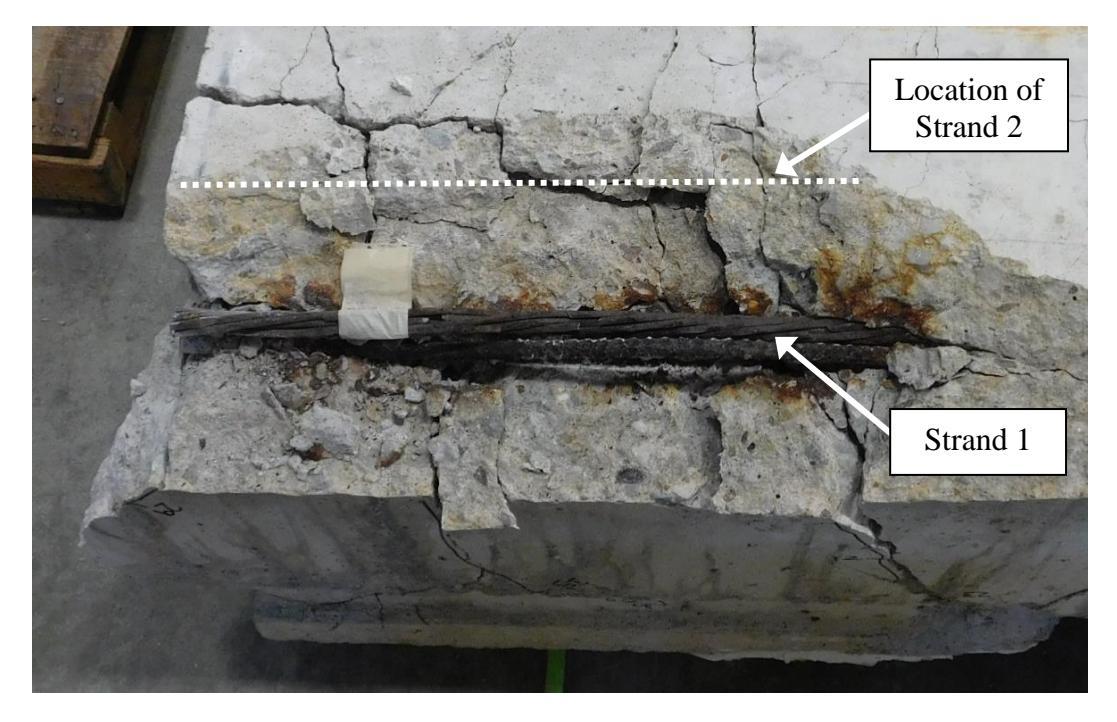
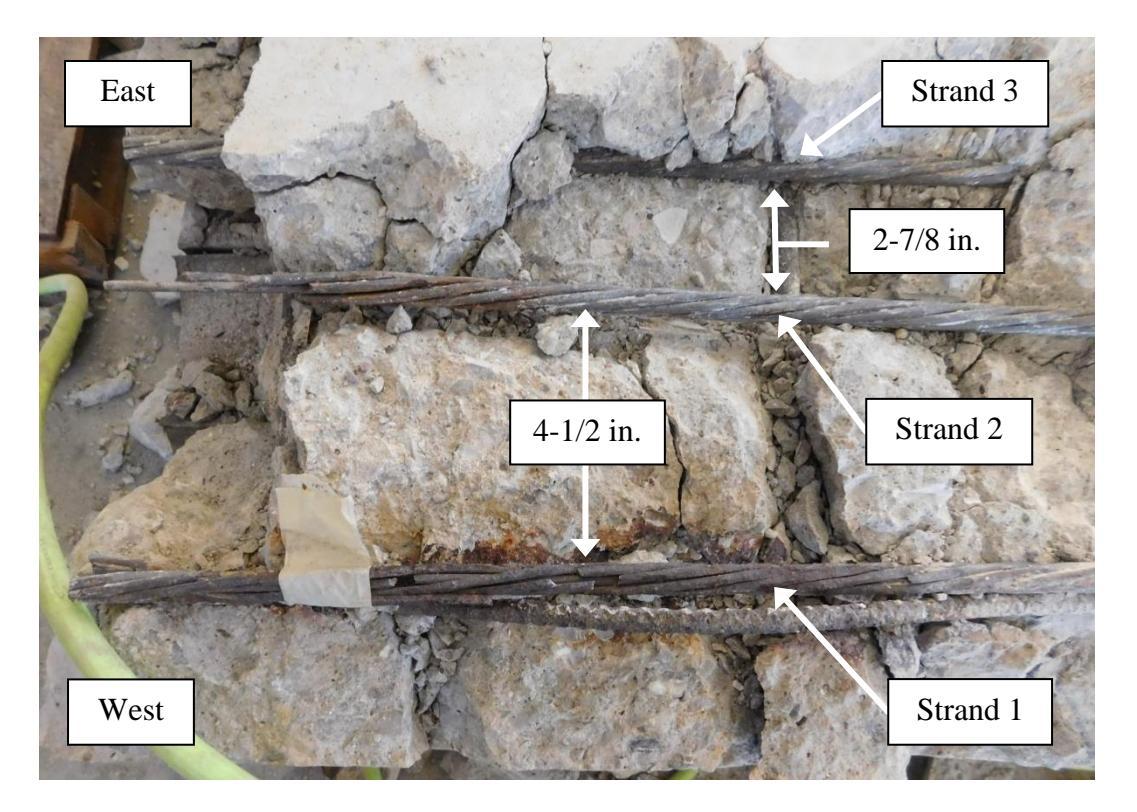
Figure 3.46: Strand Condition in Southwest Portion of Segment B of Specimen 102-4-BS

The exposed strand (Strand 1) in Figure 3.46 was located in the southwest portion of Segment B. After cover was removed from Strands 1 to 3, surface corrosion was observed on

Strand 2 (Figure 3.46(b)). Prior to the removal of cover, the concrete spall extended to Strand 2 but had not exposed the strand.

(a) Before cover was removed

(b) After cover was removed Figure 3.46: Continued

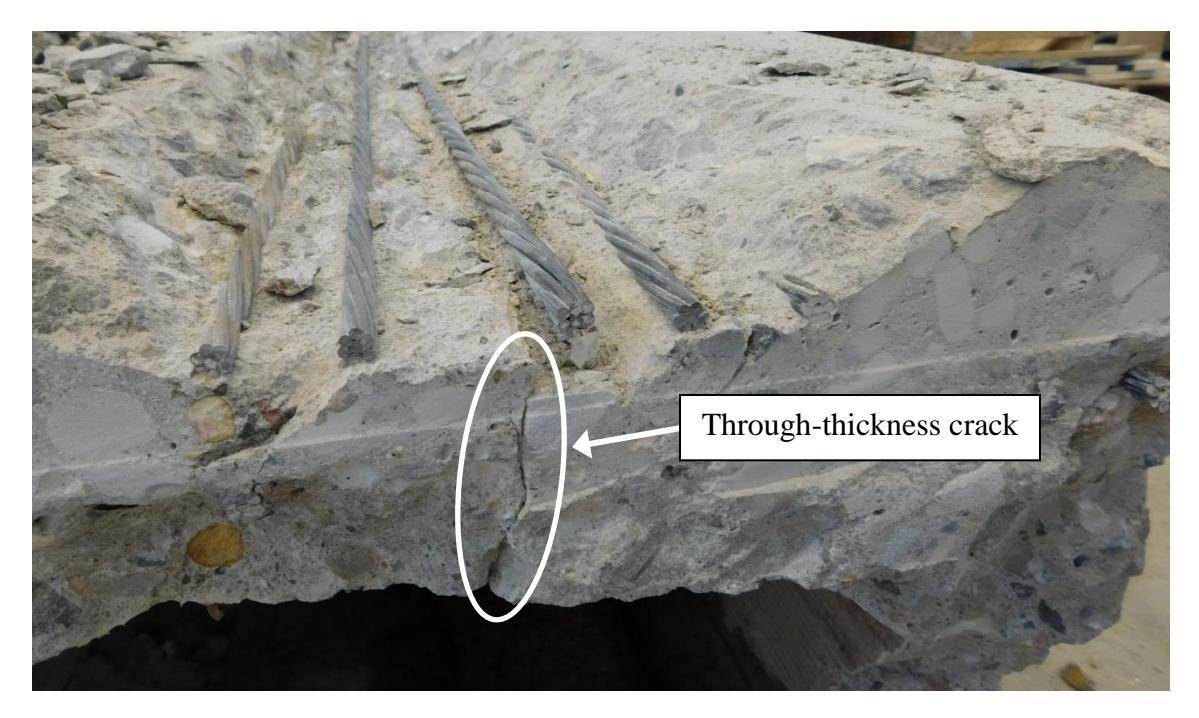
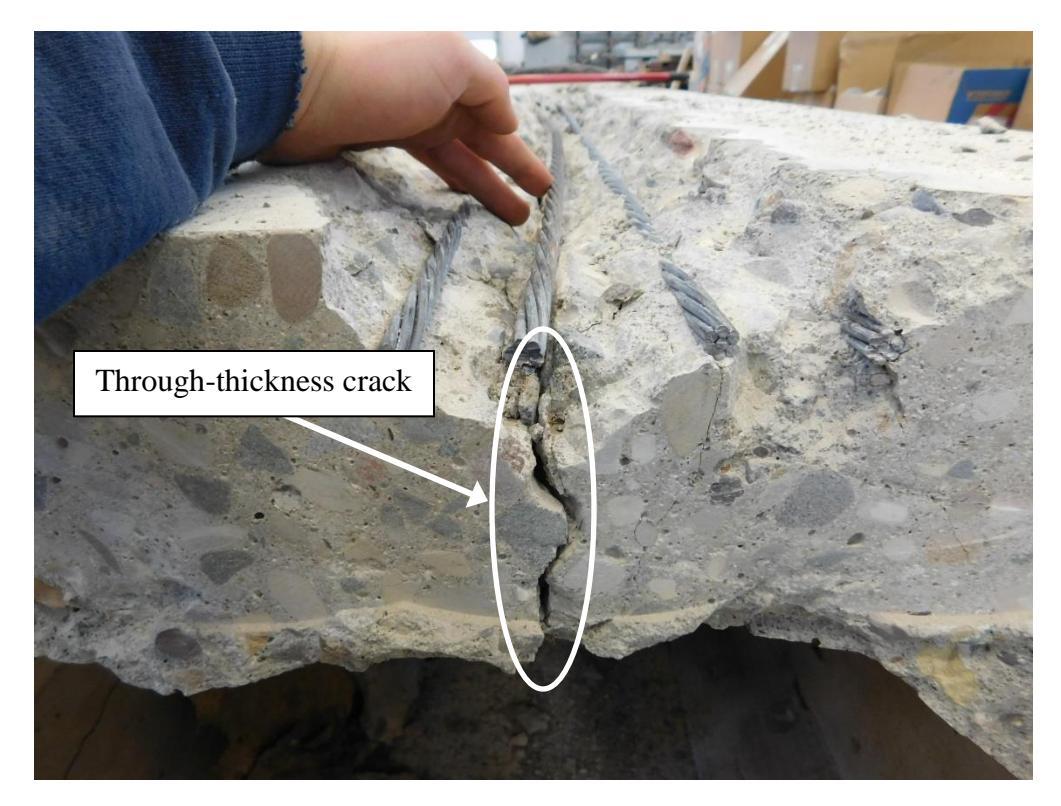
As shown in Figure 3.1, 244-1-LC had two large longitudinal cracks located away from the edges of the bottom flange. A section taken through each crack revealed that the cracks formed through the thickness of the bottom flange (Figure 3.47). In addition, the cardboard used to form the void was found to have disintegrated (Figure 3.48).

(a) Section at midspan through the rust-stained longitudinal crack

(b) Section at 12 ft from the south support through the south longitudinal crack Figure 3.47: Through-Thickness Cracks in 244-1-LC

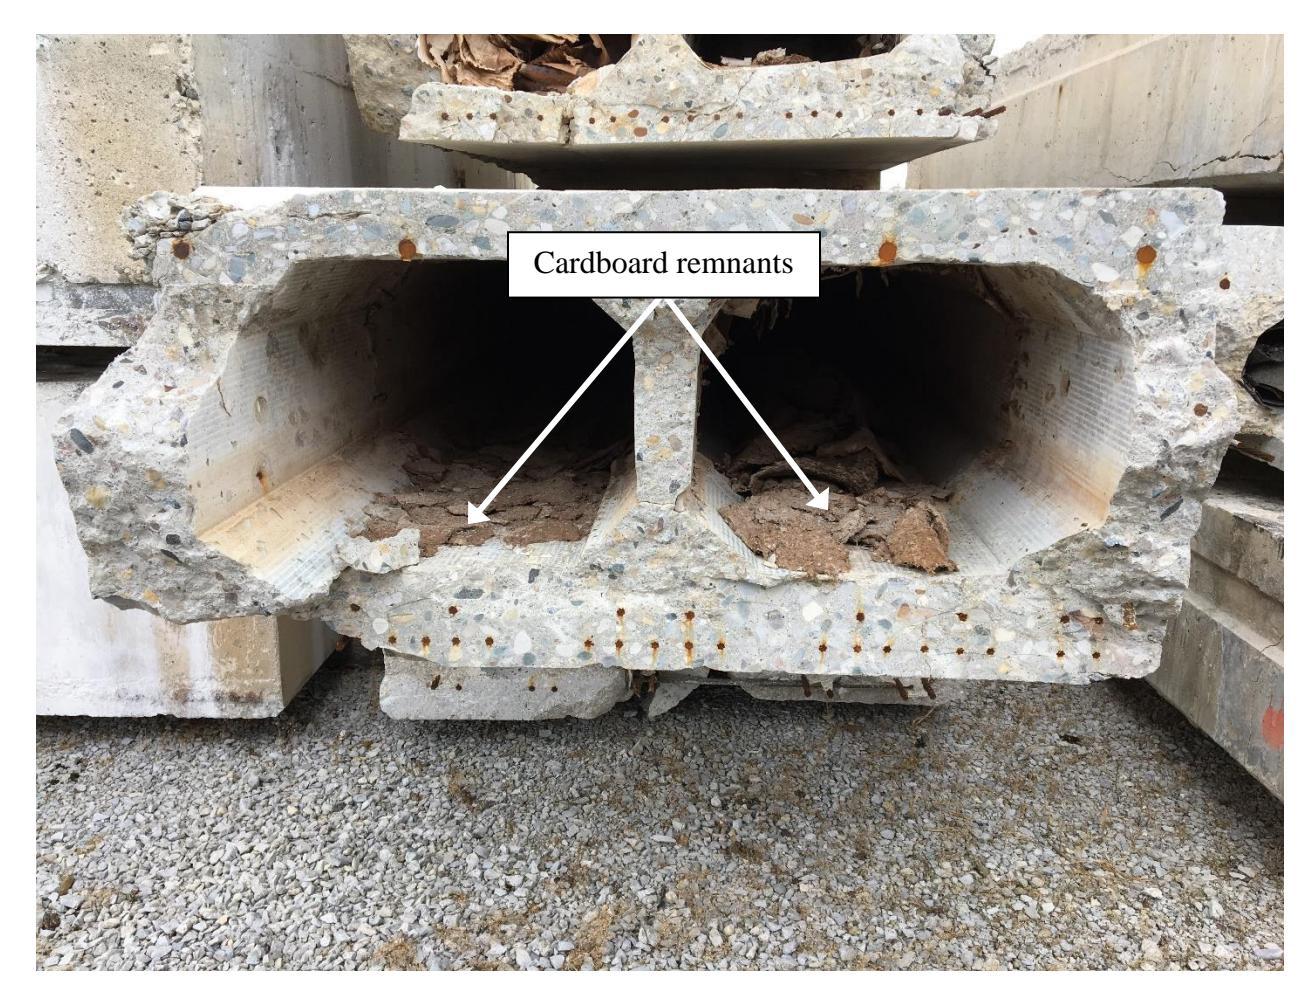
Figure 3.48: Disintegrated Cardboard Form

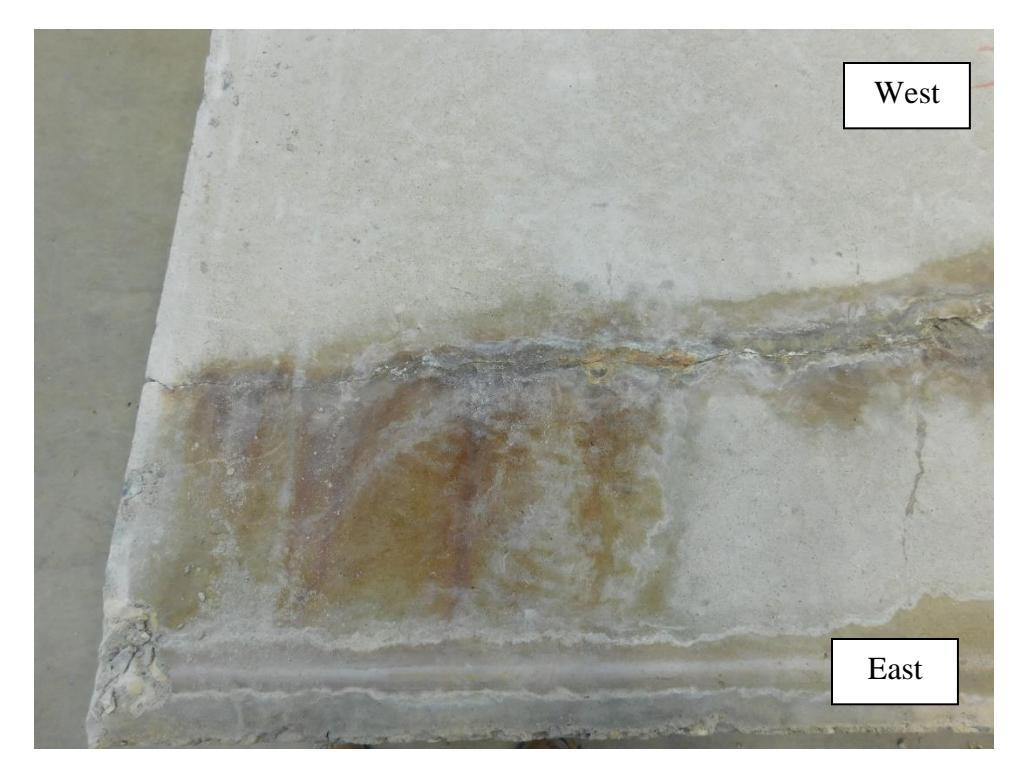
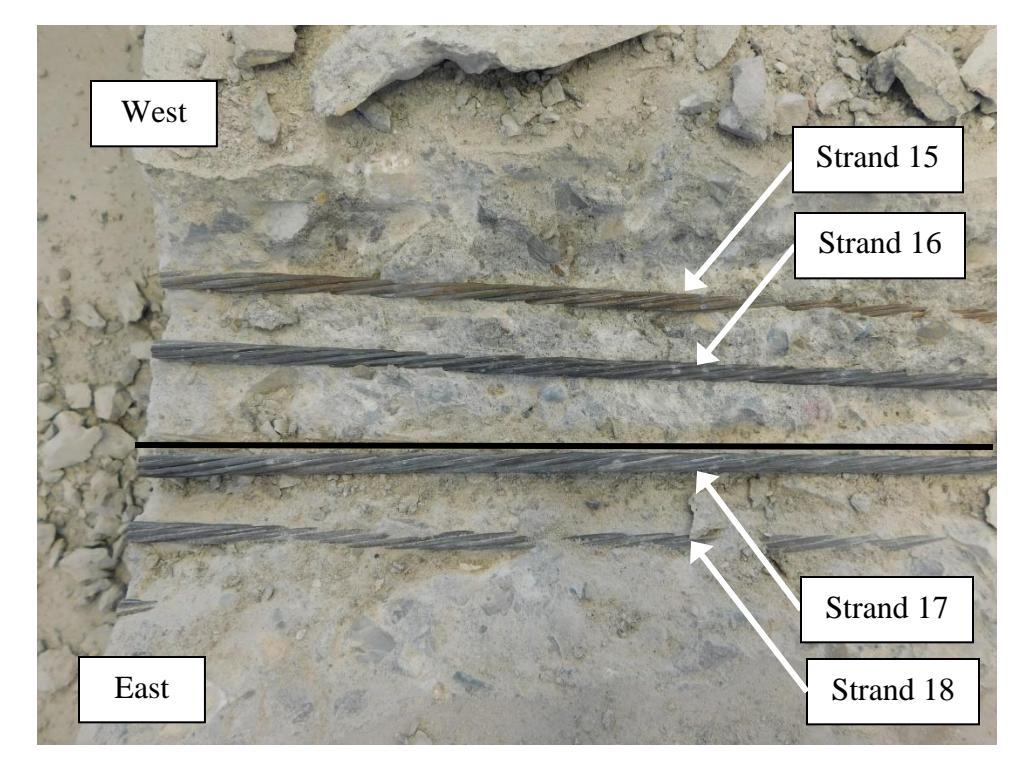
Figure 3.49: Strand Condition at Stained Longitudinal Crack in Northeast Portion of Segment B of Specimen 244-1-LC

The strands at the rust-stained crack in the northeast portion of Segment B (Figure 3.1) are shown in Figure 3.49 and Figure 3.50. A black line has been drawn in Figure 3.49(b) next to Strand 17 to locate the through-thickness crack. Notably, the strands were in good condition and extensive corrosion was not observed. Light surface corrosion was observed on the strands at the crack. Corrosion of Strand 17 was observed approximately 4 ft from the location in Figure 3.49 (Figure 3.50). Along the length of the crack, corrosion of the adjacent strands was not observed.

(a) Before cover was removed

(b) After cover was removed
