EVALUATION AND STRUCTURAL BEHAVIOR OF DETERIORATED PRECAST, PRESTRESSED CONCRETE BOX BEAMS

A Dissertation

Doctor of Philosophy

Lyles School of Civil Engineering West Lafayette, Indiana December 2019

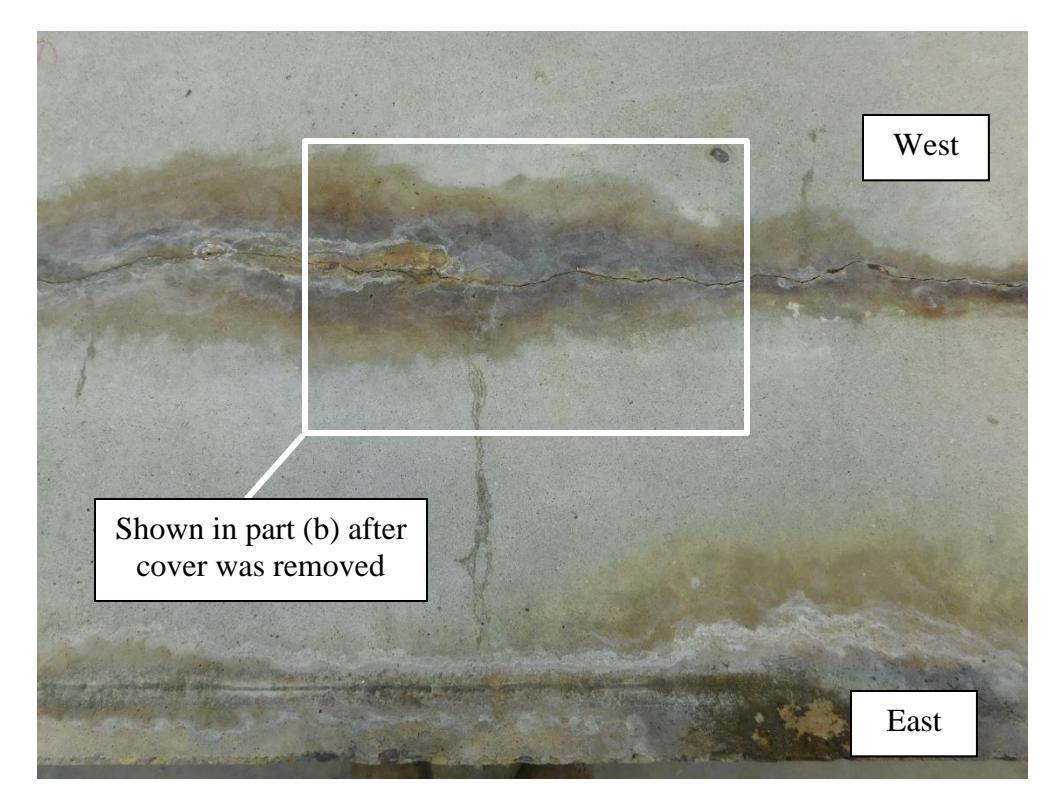
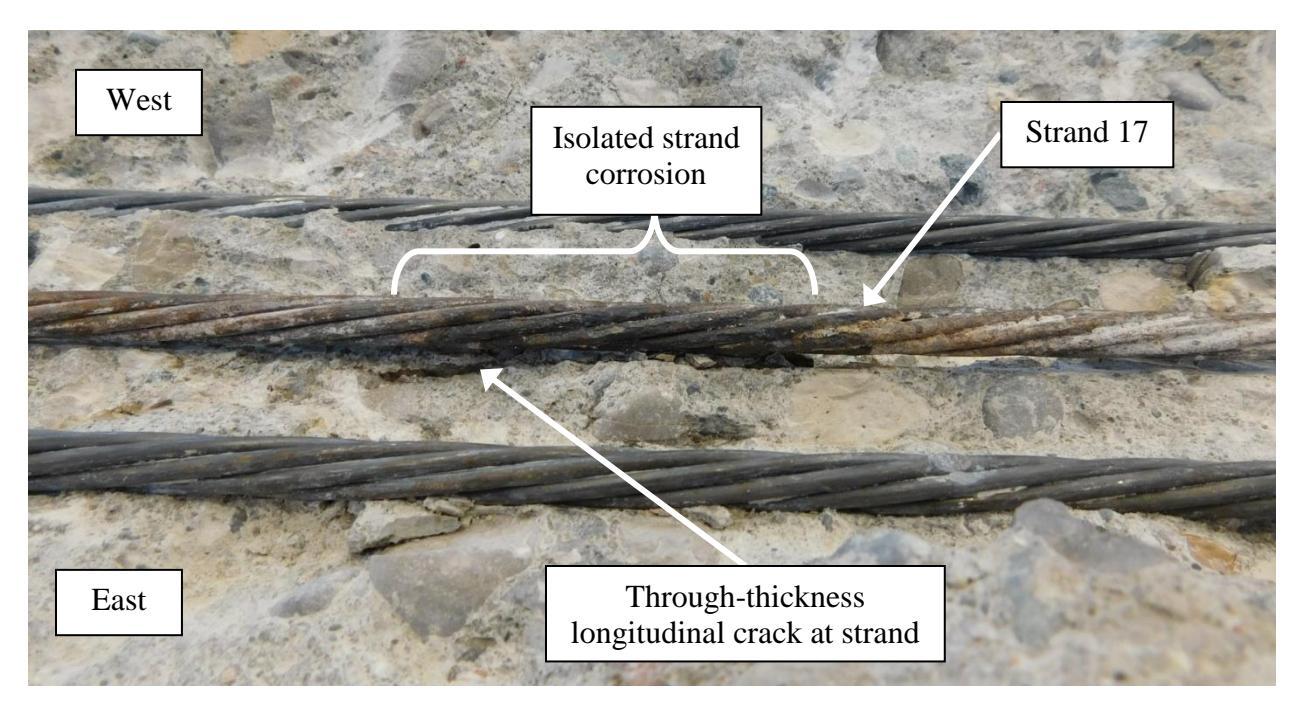
The strands at the rust-stained crack in the northeast portion of Segment B (Figure 3.1) are shown in Figure 3.49 and Figure 3.50. A black line has been drawn in Figure 3.49(b) next to Strand 17 to locate the through-thickness crack. Notably, the strands were in good condition and extensive corrosion was not observed. Light surface corrosion was observed on the strands at the crack. Corrosion of Strand 17 was observed approximately 4 ft from the location in Figure 3.49 (Figure 3.50). Along the length of the crack, corrosion of the adjacent strands was not observed.

Figure 3.50: Isolated Corrosion of Strand 17 in 5 ft from the North end of Segment B of Specimen 244-1-LC

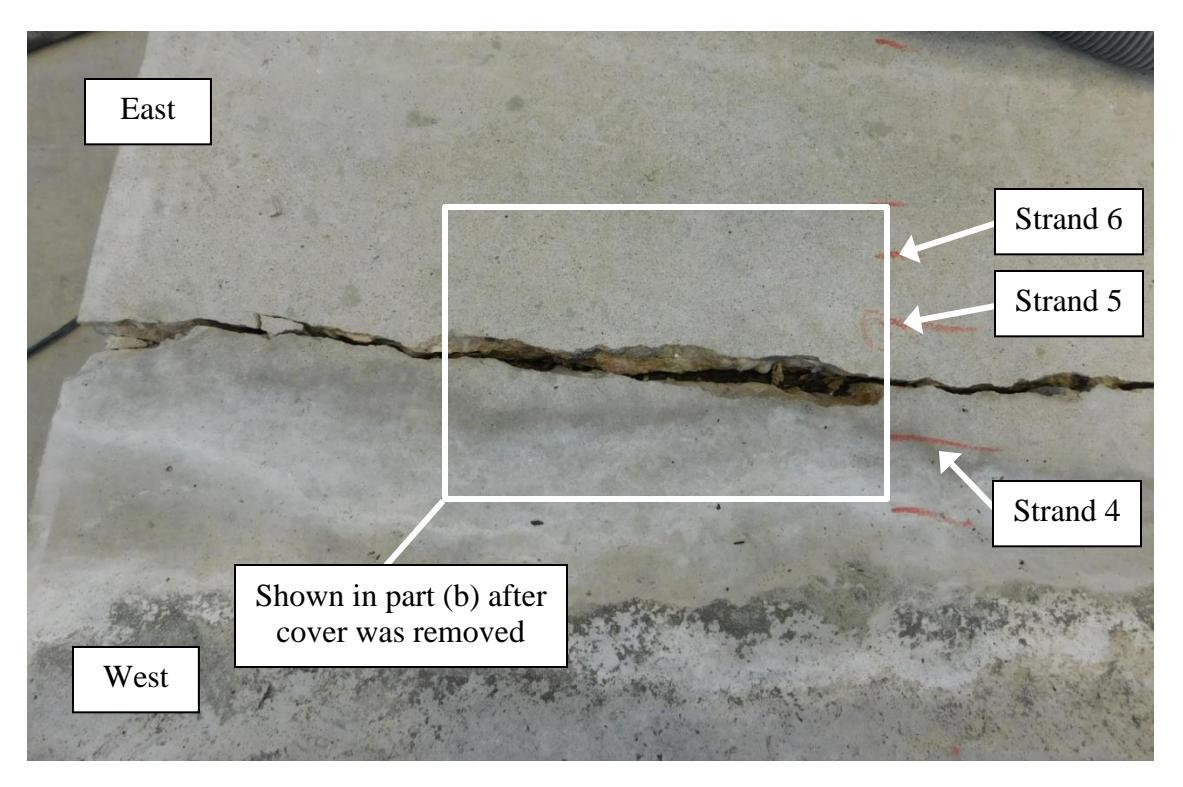
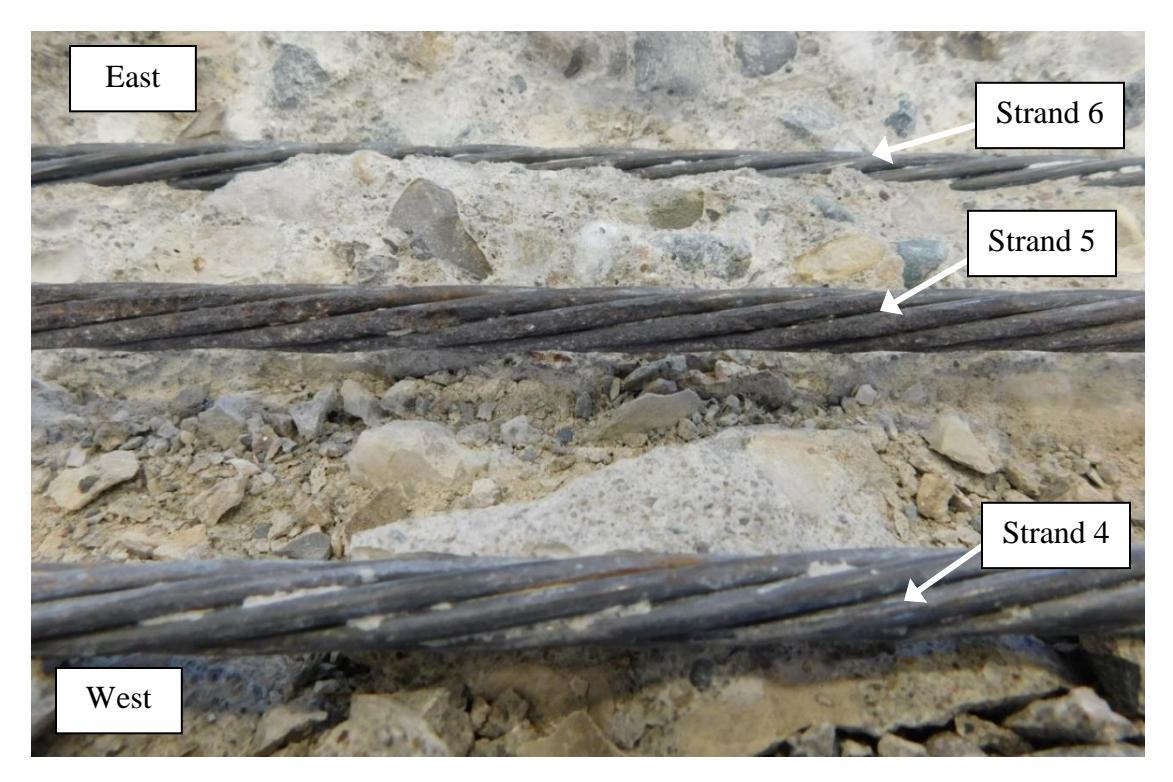
Figure 3.51 shows the strand condition at the longitudinal crack in the northwest portion of Segment A. Strand 5 was located at the longitudinal crack, and as shown in Figure 3.51(b), corrosion and minor section loss was observed. Corrosion of the adjacent strands was only observed at the locations where the strands were located at the longitudinal crack.

Figure 3.51: Strand Condition at Longitudinal Crack in Northwest Portion of Segment A of Specimen 244-1-LC

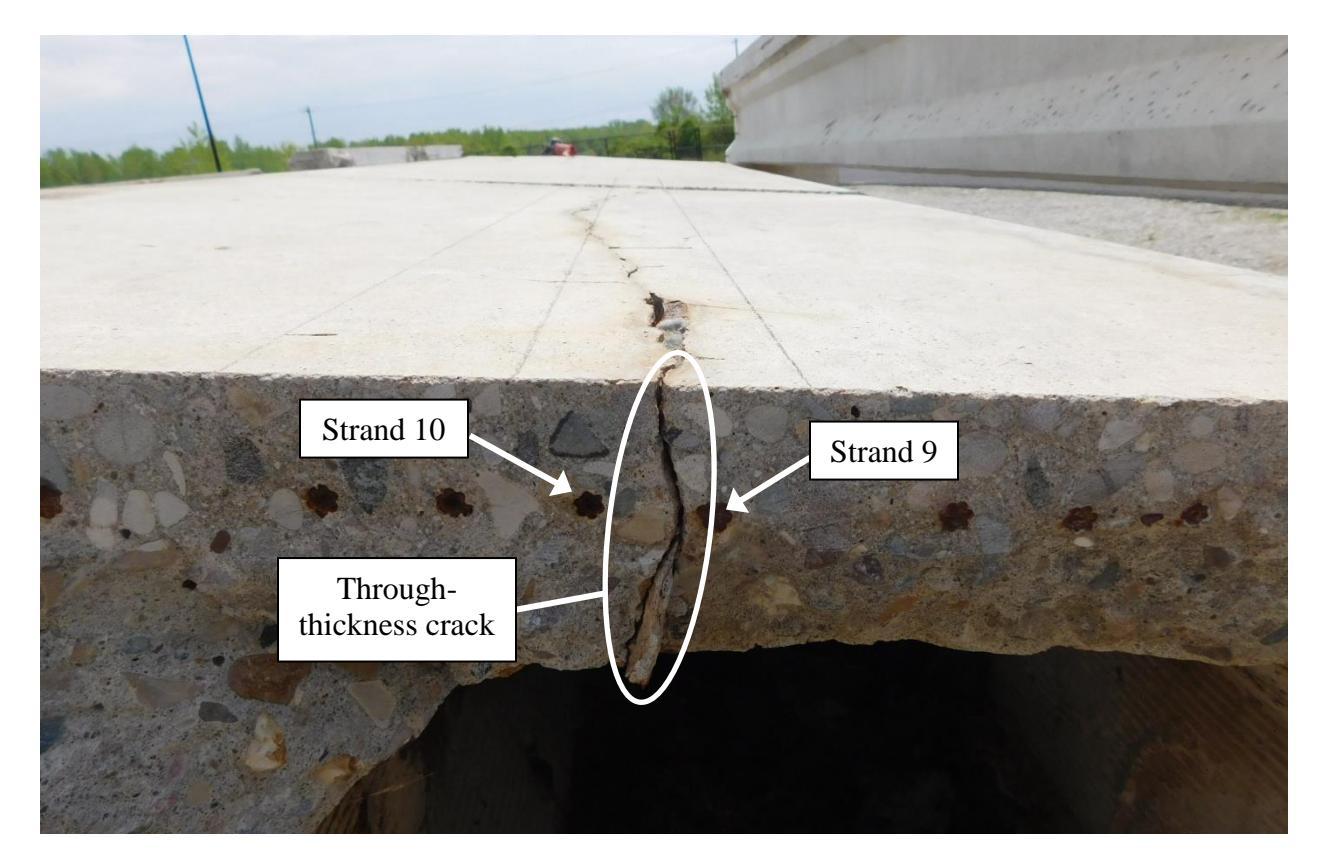
The deterioration of K5-1-LC consisted of two longitudinal cracks each extending from opposite ends of the beam and located away from the edge of the beam (Figure 3.4). A section was taken through the south longitudinal crack to investigate the extent of cracking (Figure 3.52). As shown, the crack extends through the thickness of the flange into the empty void. The strands at the north longitudinal crack (Figure 3.53) have surface corrosion due to 5 months of outdoor exposure after completion of the structural test. Strand 5 (located at the longitudinal crack), however, was observed with corrosion and minor section loss. At the south longitudinal crack (Figure 3.54), corrosion of Strands 10 and 11 was limited to the locations of the strands at the cracks, and no corrosion was observed on Strands 9 and 12. A black line has been drawn in Figure 3.54 to illustrate the location of the through-thickness crack.

Figure 3.52: Through-thickness Crack in South Portion of K5-1-LC

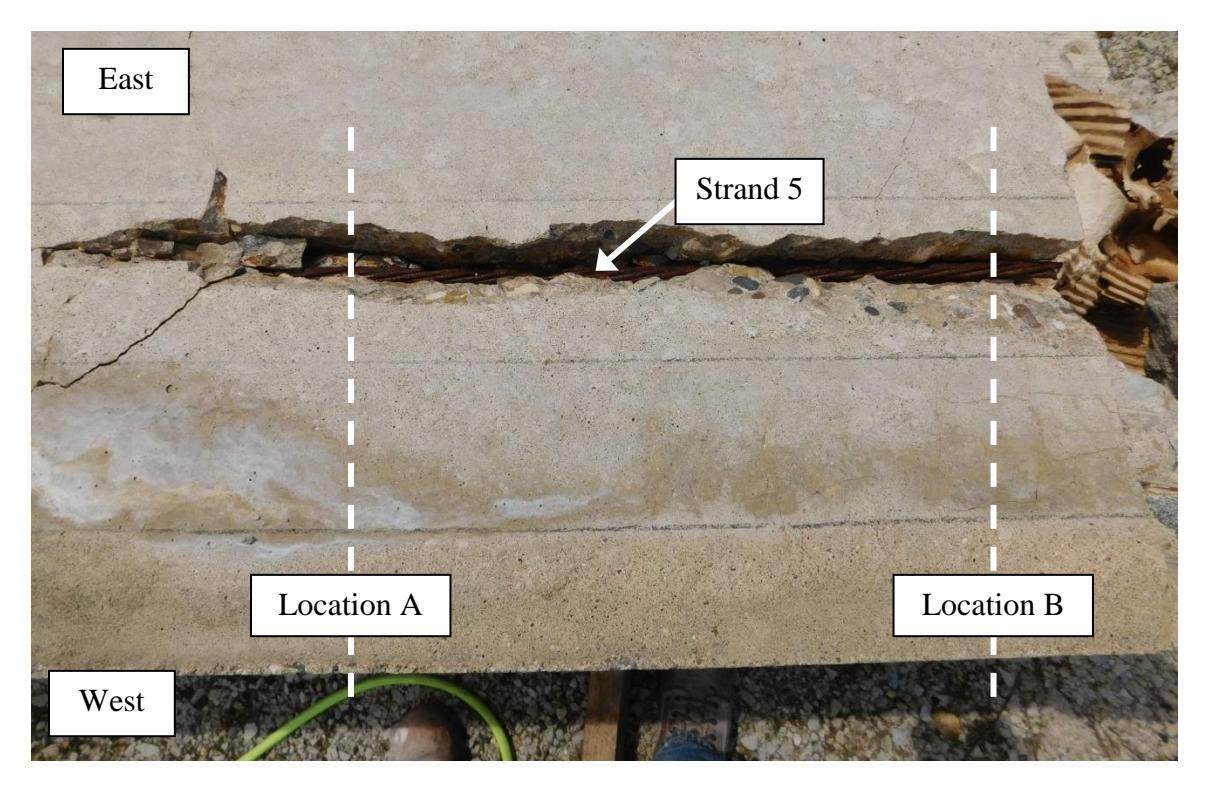
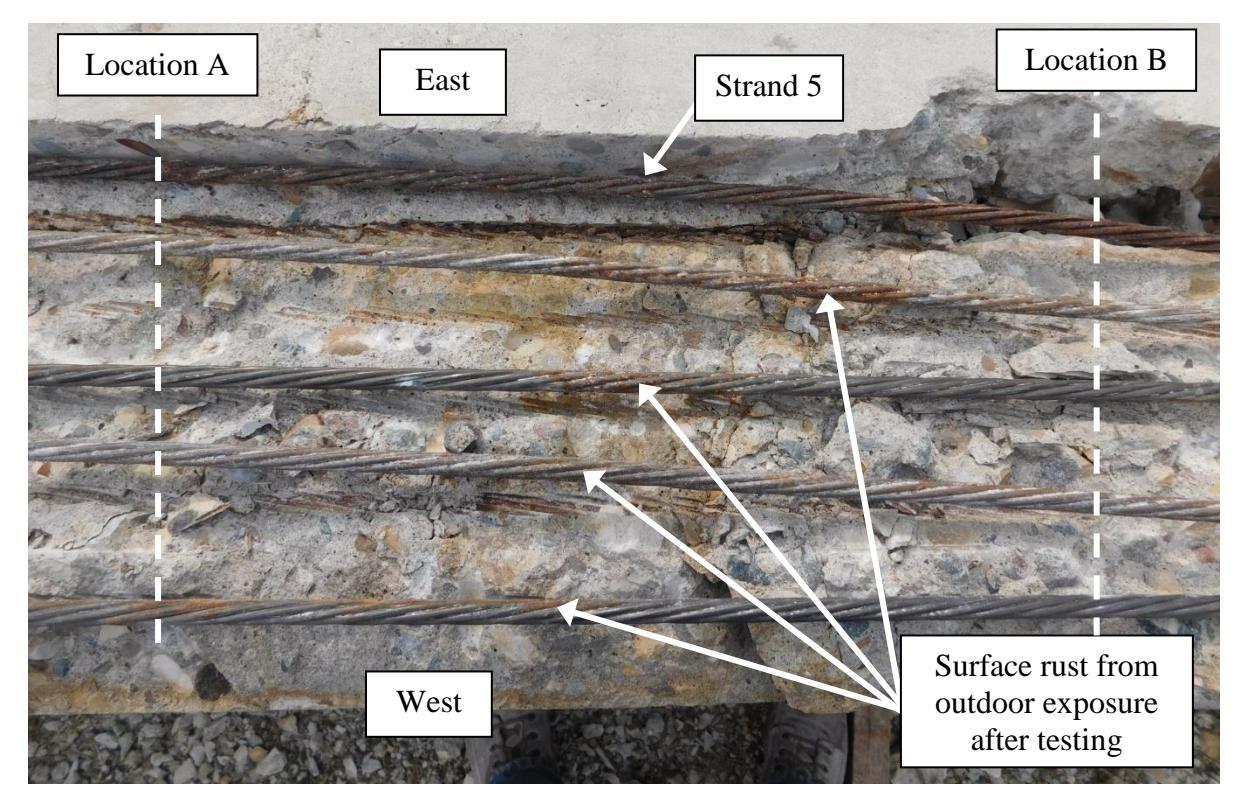
(b) After cover was removed Figure 3.53: Strand Condition at North Longitudinal Crack in K5-1-LC

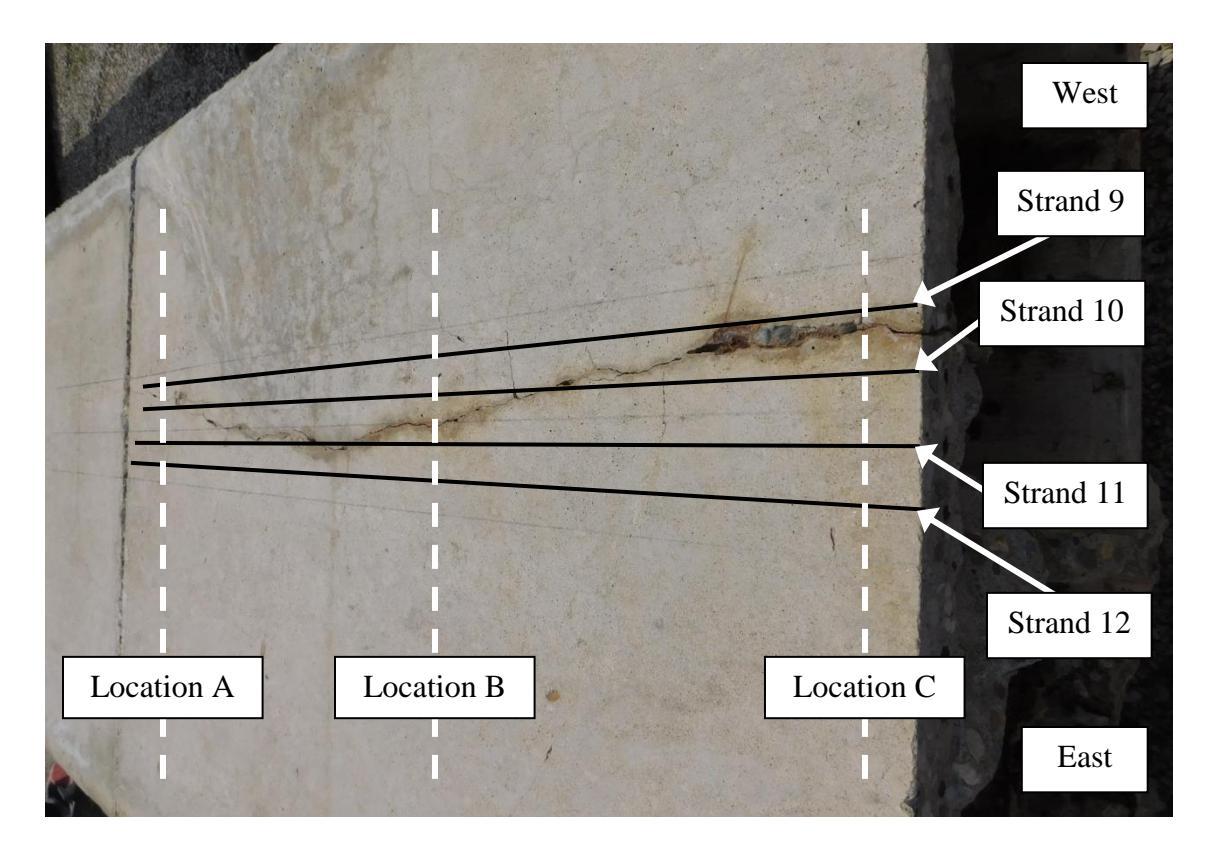
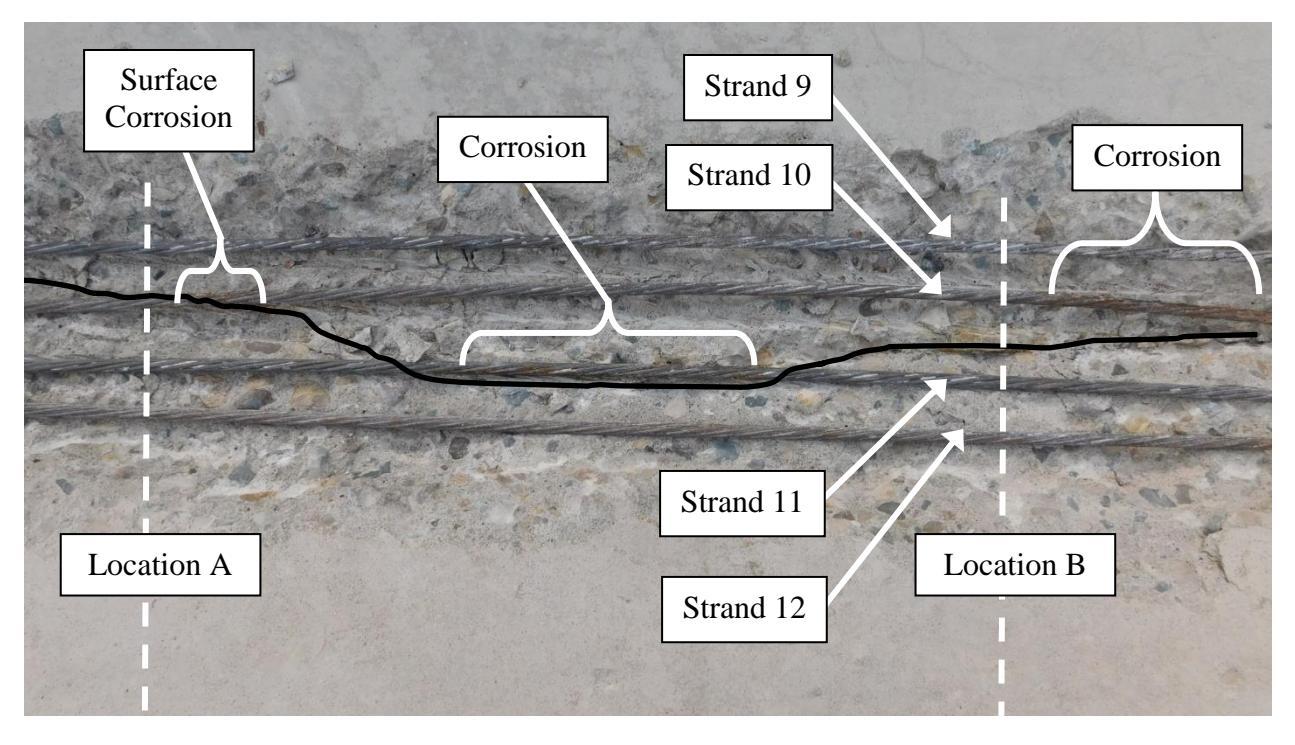
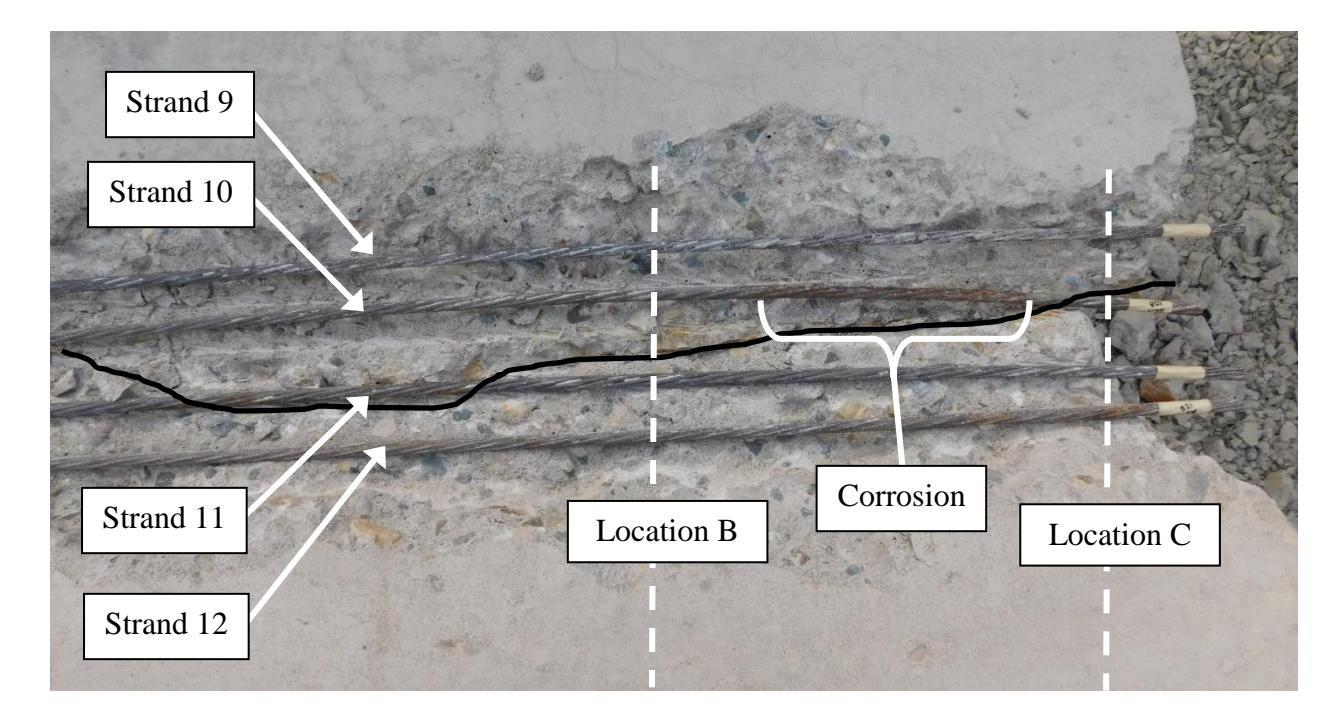
Figure 3.54: Strand Condition at South Longitudinal Crack in K5-1-LC

(a) Before cover was removed

(c) After cover was removed Figure 3.54: Continued

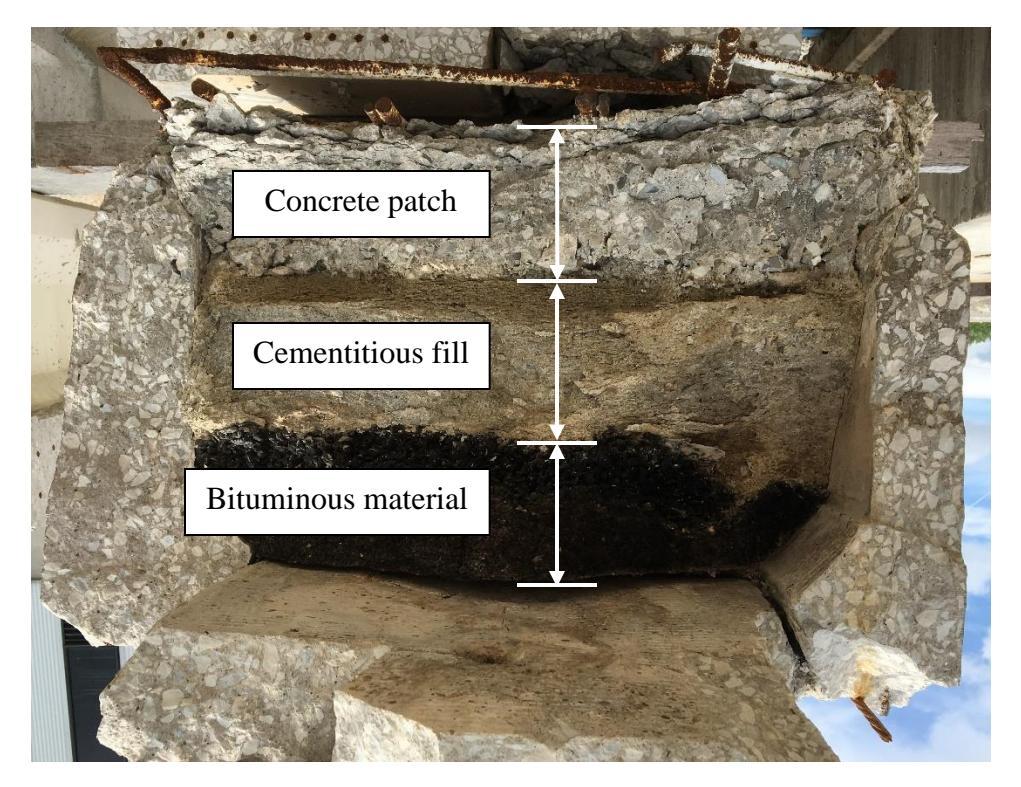
To investigate the extent of corrosion in K5-2-LC, the beam was cut into four segments (Figure 3.5). When the segments were separated, the void in the southern portion of the beam was found filled with a combination of bituminous material and cementitious fill (Figure 3.55). The top flange was also observed to have been patched. Records of this work while Newton K5 was in service were not available. It is assumed that the top flange failed during a routine resurfacing of the bridge. To repair the top flange, the void was filled with sand and cementitious fill as formwork for a structural concrete patch. To provide a comparison between the original and patched cross-section, the original cross-section is shown in Figure 3.56. The original cross-section was also observed with an empty void indicating that the cardboard used to form the void had disintegrated (Figure 3.56).

Figure 3.55: Patched Cross-Section of K5-2-LC

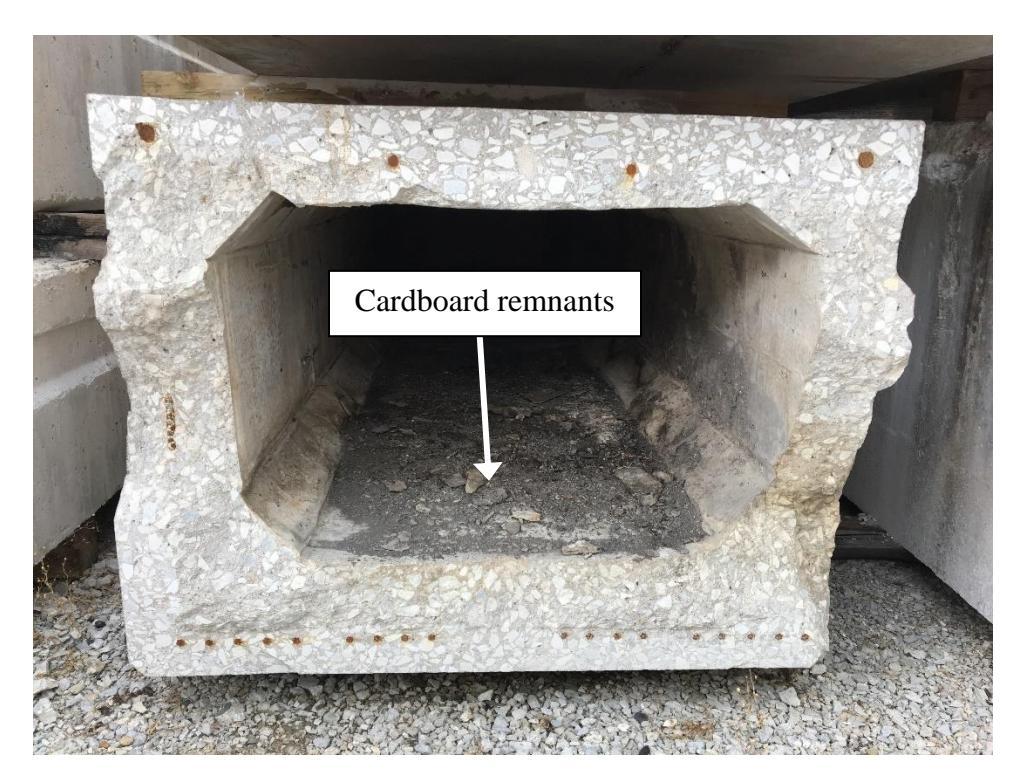
Figure 3.56: Original Cross-Section of K5-2-LC

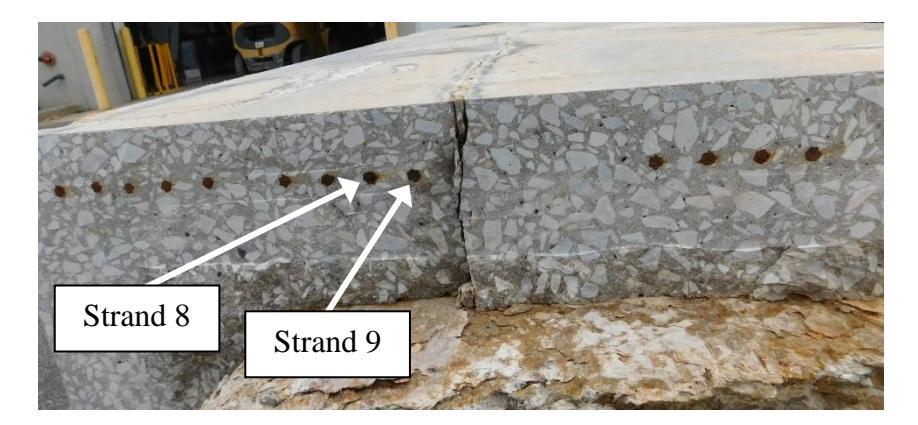
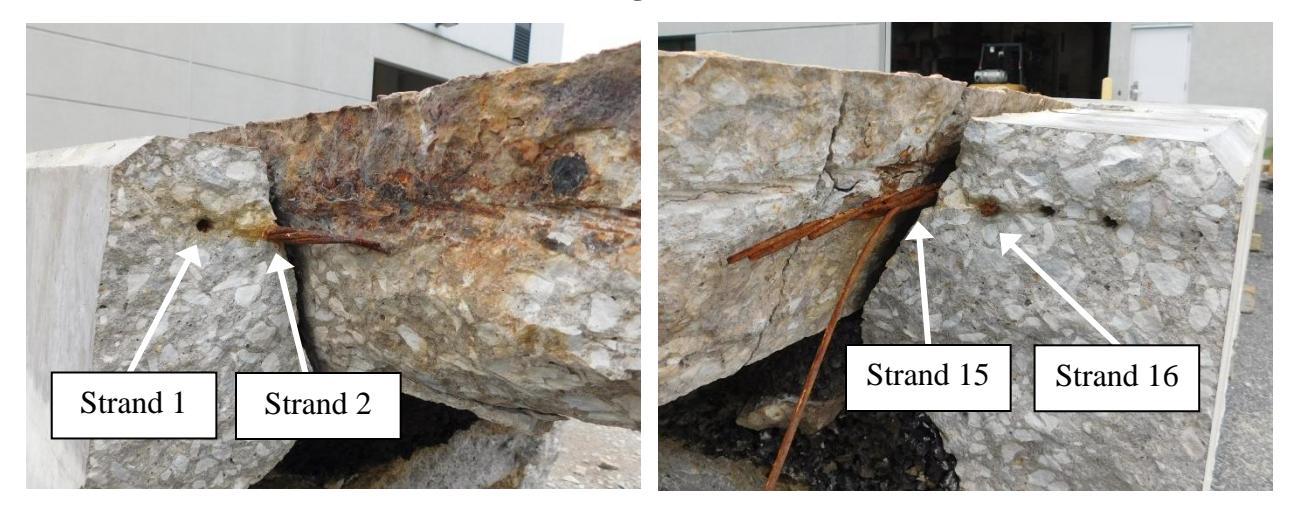
Figure 3.57: Through-Thickness Cracks in K5-2-LC

The deterioration of the bottom flange included three longitudinal cracks (Figure 3.5). Each of the longitudinal cracks were observed to extend through the thickness of the flange into the void (Figure 3.57).

(a) Segment A

- (b) West side of Segment C
- (c) East side of Segment C

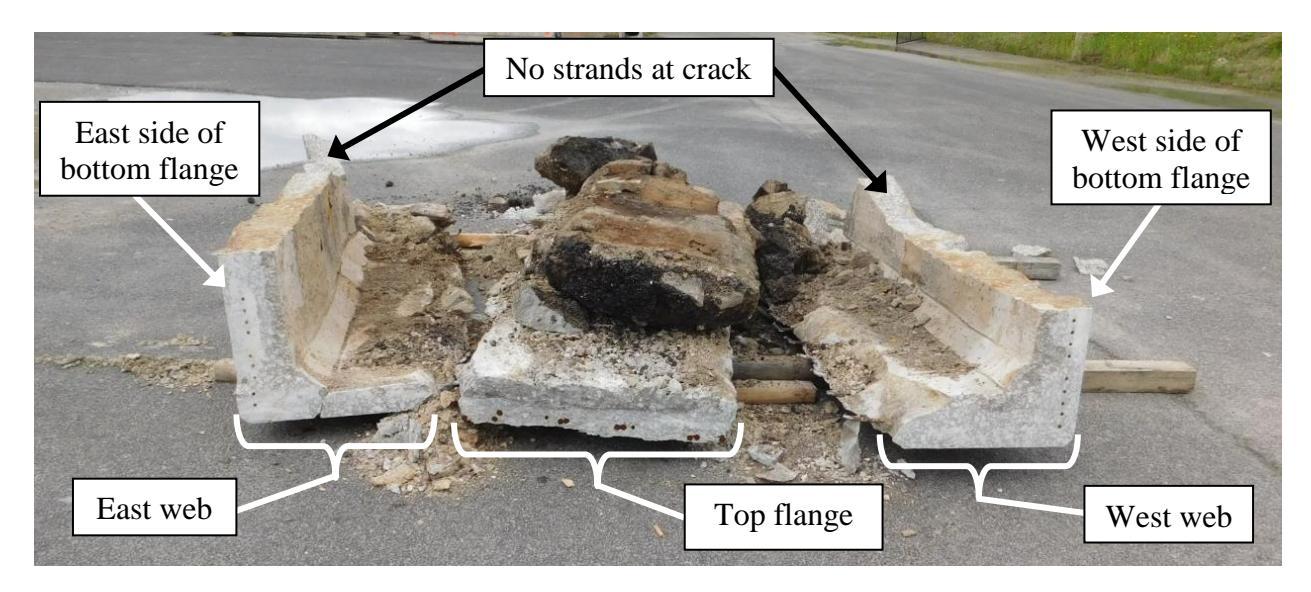
When Segment B was rolled onto its top flange to facilitate extraction of the strands, the beam split open longitudinally (Figure 3.58). As shown, no transverse steel was present in the bottom flange of the beam to hold the segment together, and the crack did not cross or align with any of the strand in the longitudinal direction. When the longitudinal crack was further investigated in Segment A, no corrosion of the strands was observed (Figure 3.59). This crack formation indicates that freezing of water in the void is the likely cause of bottom flange cracking.

Figure 3.58: Beam Segment B of K5-1-LC

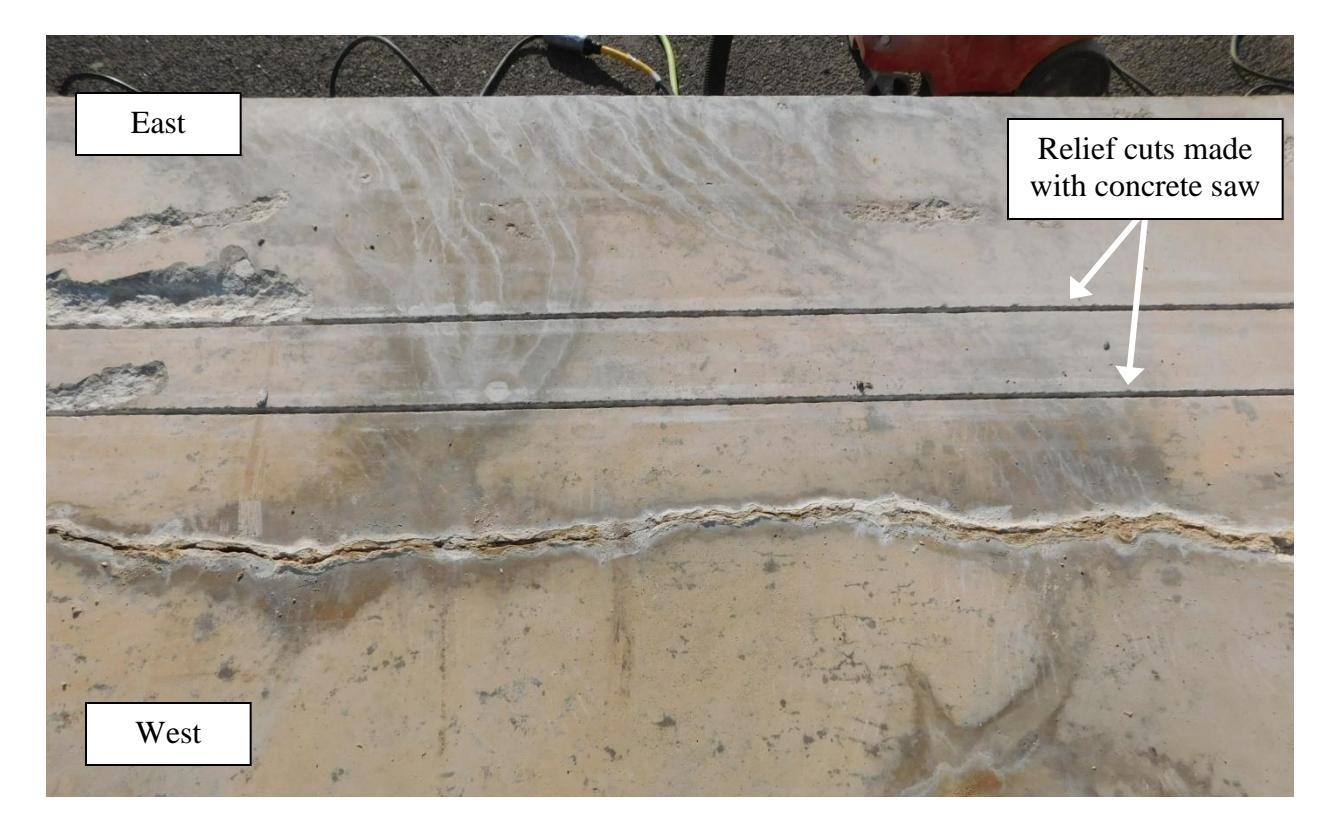
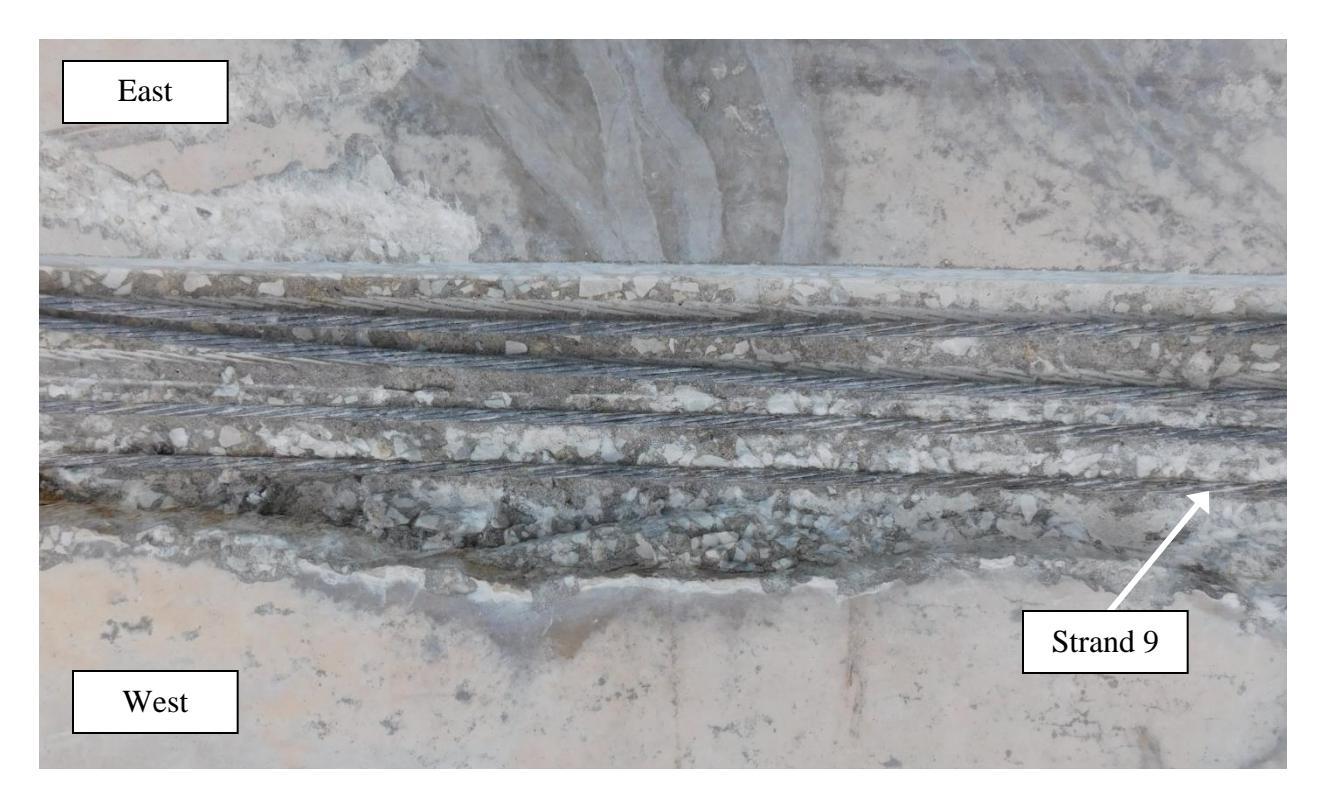
(a) Before cover was removed

(b) After cover was removed Figure 3.59: Strand Condition at Longitudinal Crack in Segment A of K5-2-LC The strands at the longitudinal cracks on either side of the drain hole spall in Segment C were observed to have isolated corrosion at the longitudinal cracks (Figure 3.60 to Figure 3.62). In addition to the corroded strand in Figure 3.57 (Strand 2), corrosion was observed on Strand 3 in Figure 3.61. The surface rust present on Strands 4 and 5 in Figure 3.61 was due to outdoor exposure of the flexural crack that formed during the structural test. Surface rust on Strands 14-18 at localized cracks shown in Figure 3.62 were also due to outdoor exposure following the structural test. Based on review of the specimen, all longitudinal cracks in K5-2-LC were observed with corrosion. Corrosion was limited to the locations where the cracks aligned with the strand.

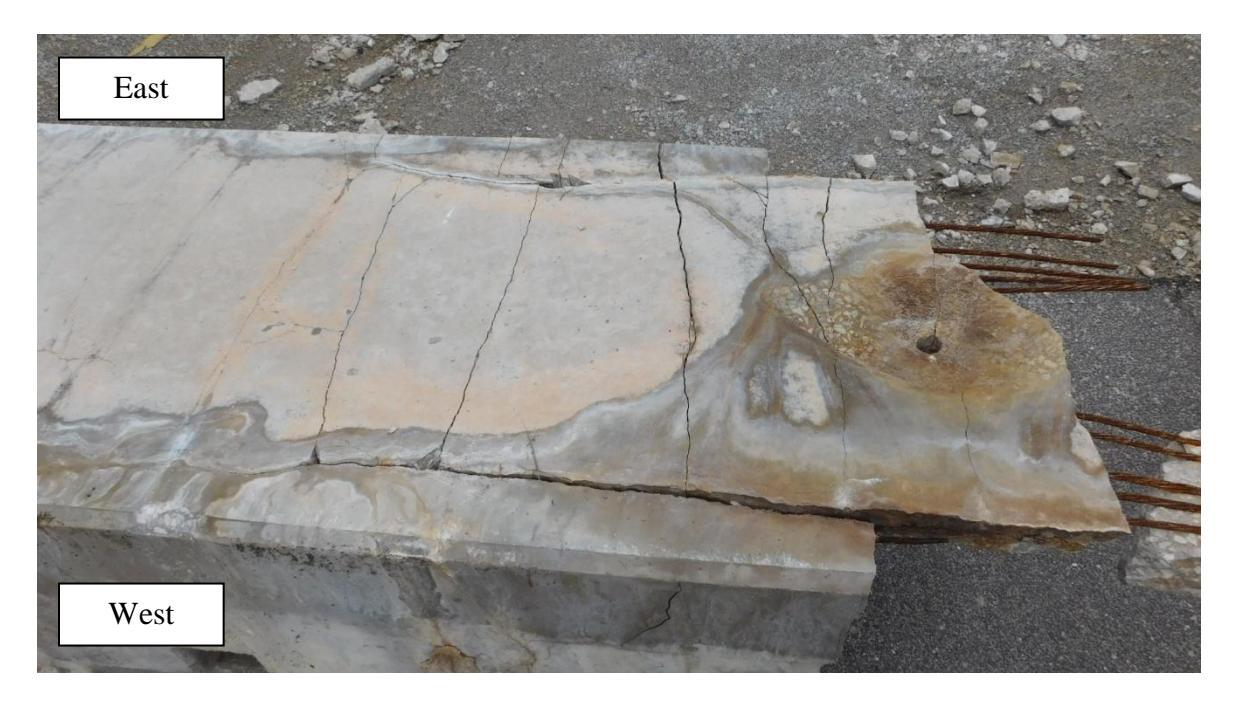
Figure 3.60: Longitudinal Cracks in Segment C of K5-2-LC Before Cover was Removed

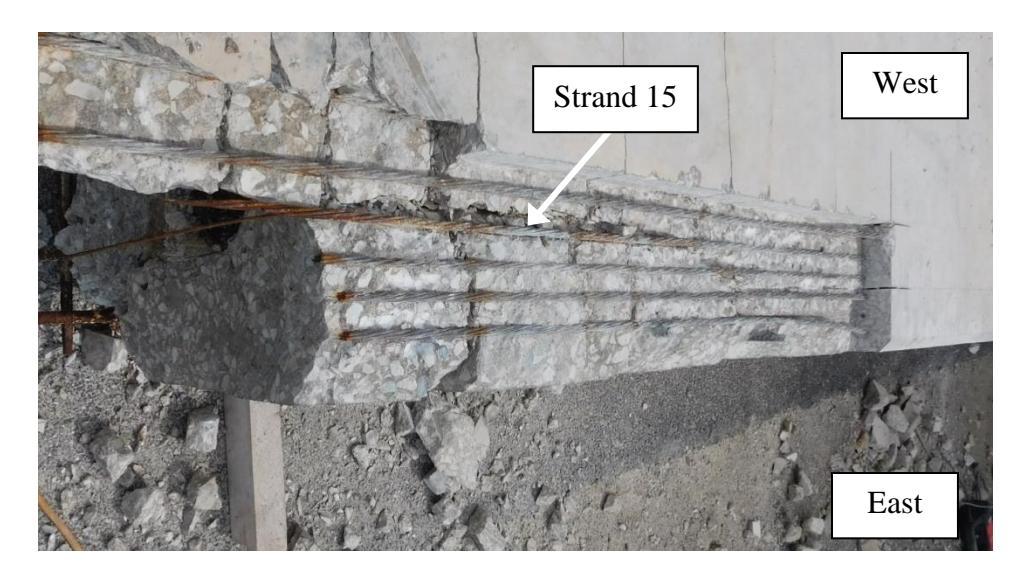
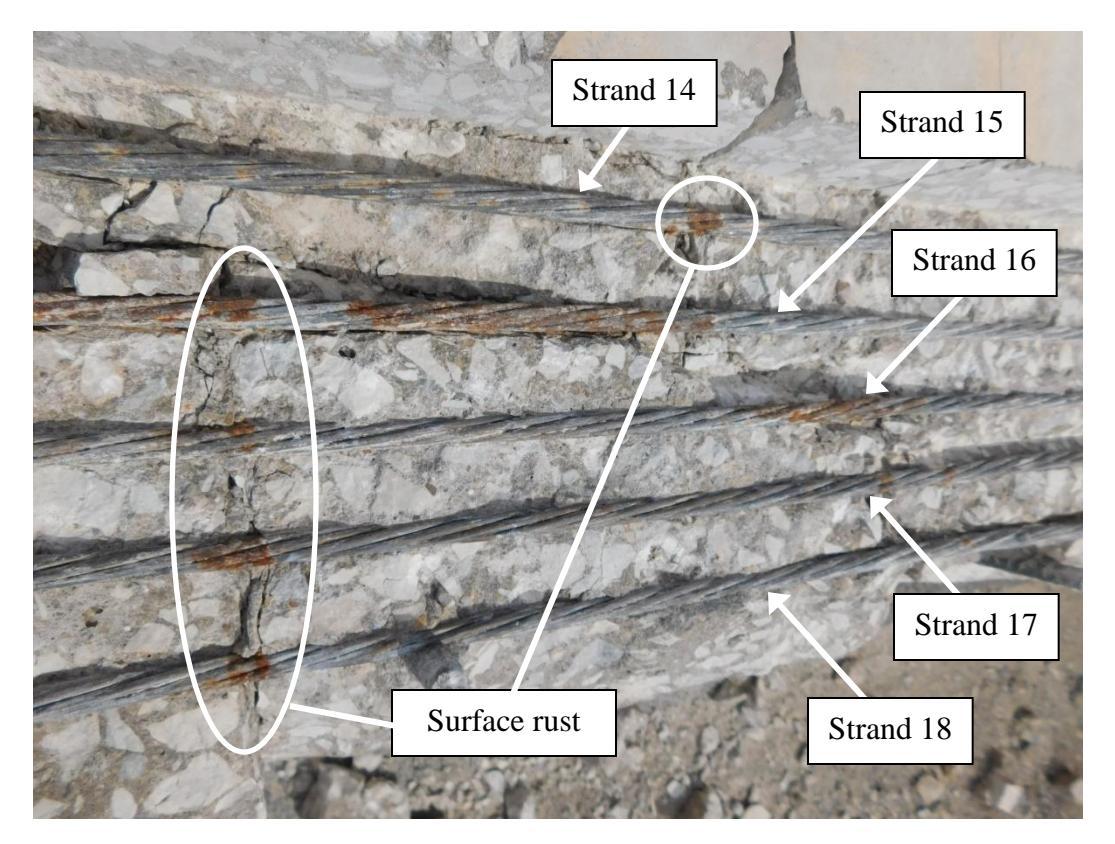
Figure 3.62: Strand Condition at East Longitudinal Crack in Segment C of K5-2-LC

(a) After cover was removed

(b) Close up view of strand corrosion

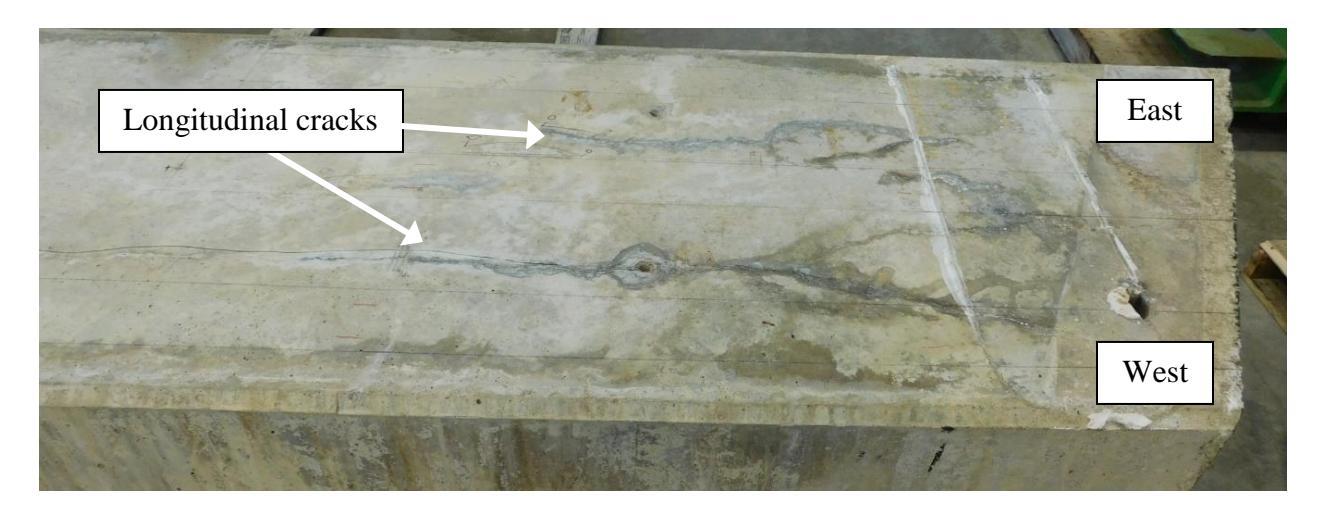
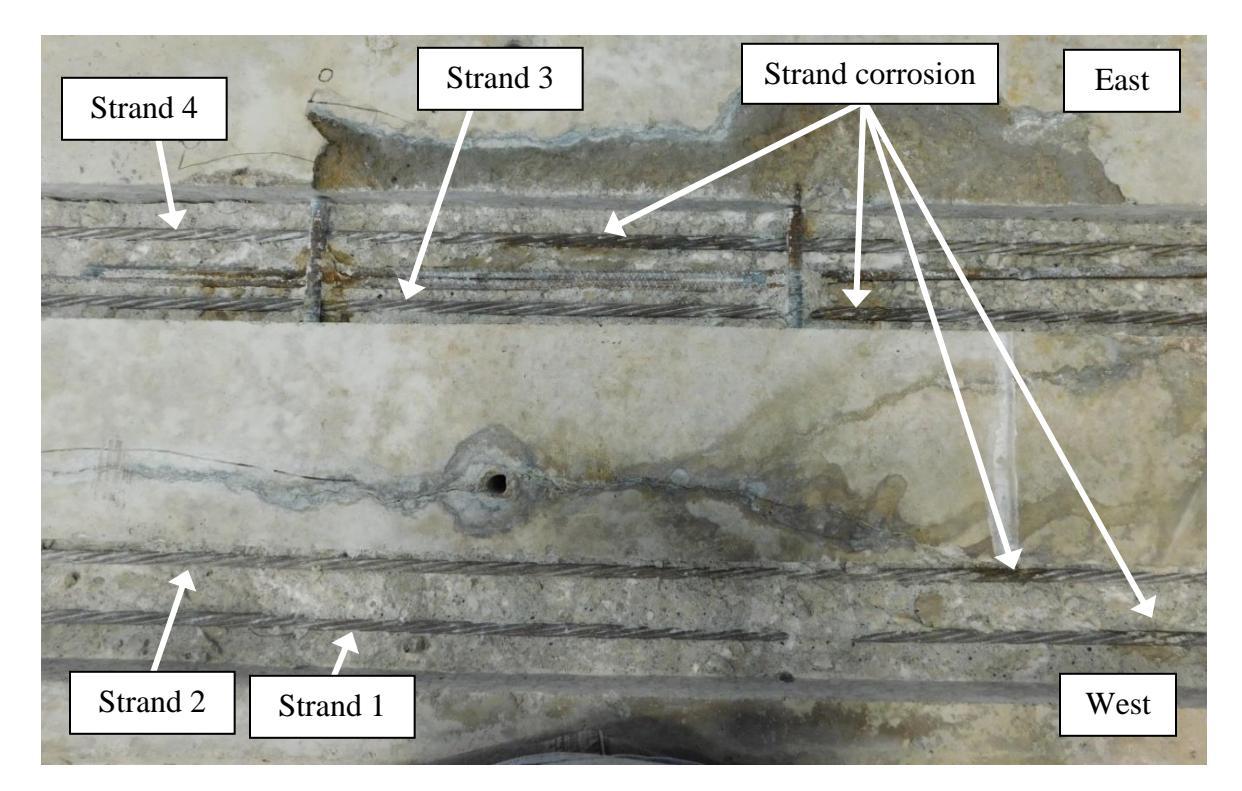
Two longitudinal cracks were observed on the north end of 79-4-LC (Figure 3.9). When the concrete cover was removed, corrosion was found on Strands 1 to 4 where the strands were located at the cracks (Figure 3.63(b)). No other strand corrosion was observed. The voids of the box beam were formed with cardboard sonotubes, and upon inspection of the voids, the cardboard was found to have disintegrated (Figure 3.64). This indicates that water was retained in the void and froze causing the longitudinal cracks.

(a) Before cover was removed Figure 3.63: Strand Condition at Longitudinal Cracks in 79-4-LC

(b) After cover was removed Figure 3.63: Continued

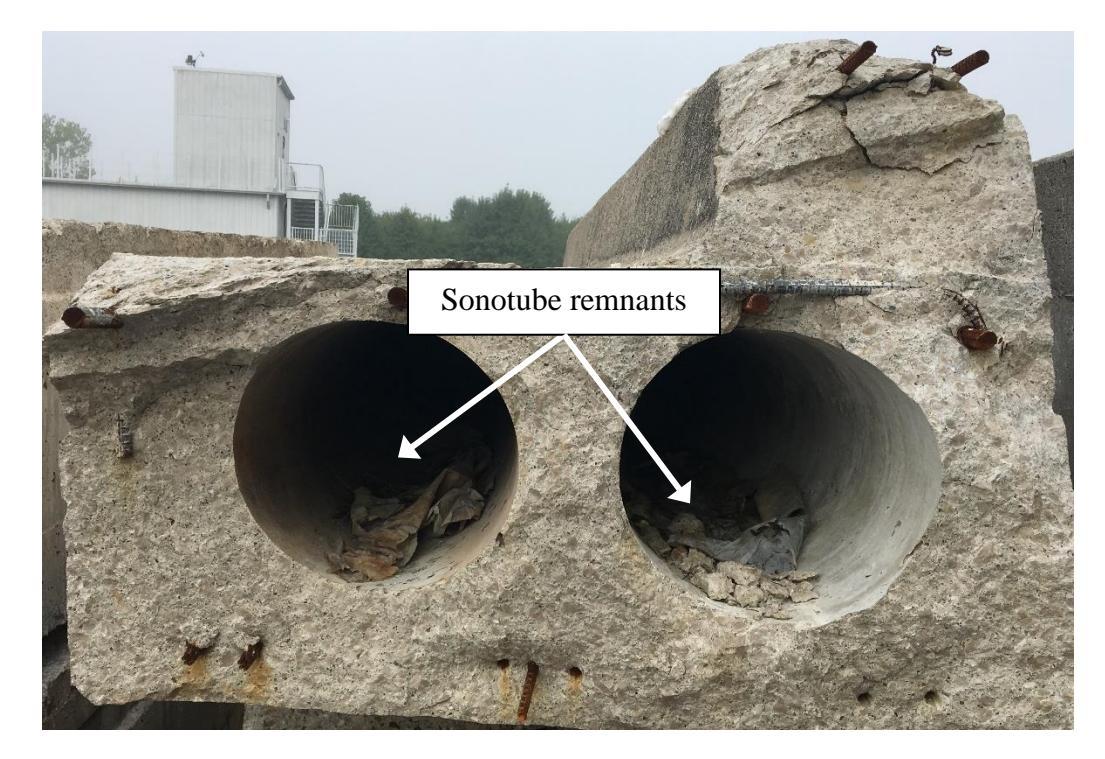
Figure 3.64: Disintegrated Cardboard Sonotubes

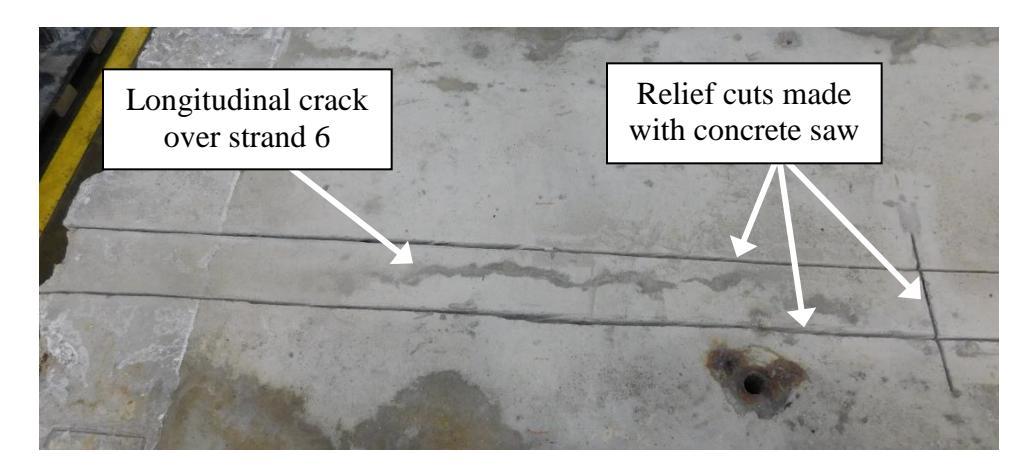
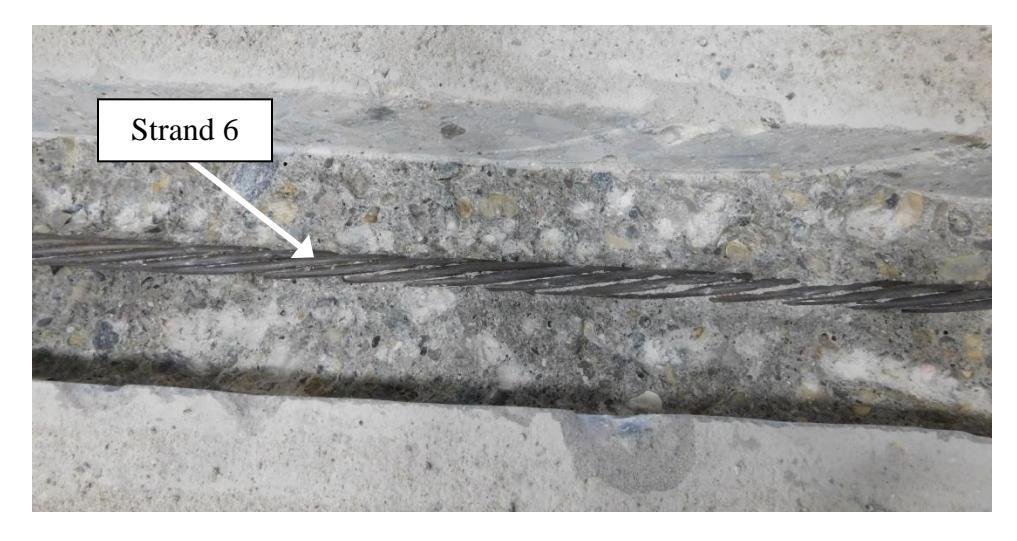
A single hairline longitudinal crack was observed in 56-1-LC at the end of the beam (Figure 3.10). The crack was located over Strand 6, and no corrosion was observed when the concrete cover was removed (Figure 3.65(b)). After removal of Strand 6, the extent of cracking was investigated, and the crack was not observed to continue through the thickness of the bottom flange. The formation of the longitudinal crack was assumed to be related to stresses induced at release of the strands after initial concrete curing.

(a) Before cover was removed

(b) After cover was removed Figure 3.65: Strand Condition at the Longitudinal Crack in 56-1-LC
