EVALUATION AND STRUCTURAL BEHAVIOR OF DETERIORATED PRECAST, PRESTRESSED CONCRETE BOX BEAMS

A Dissertation

Doctor of Philosophy

Lyles School of Civil Engineering West Lafayette, Indiana December 2019

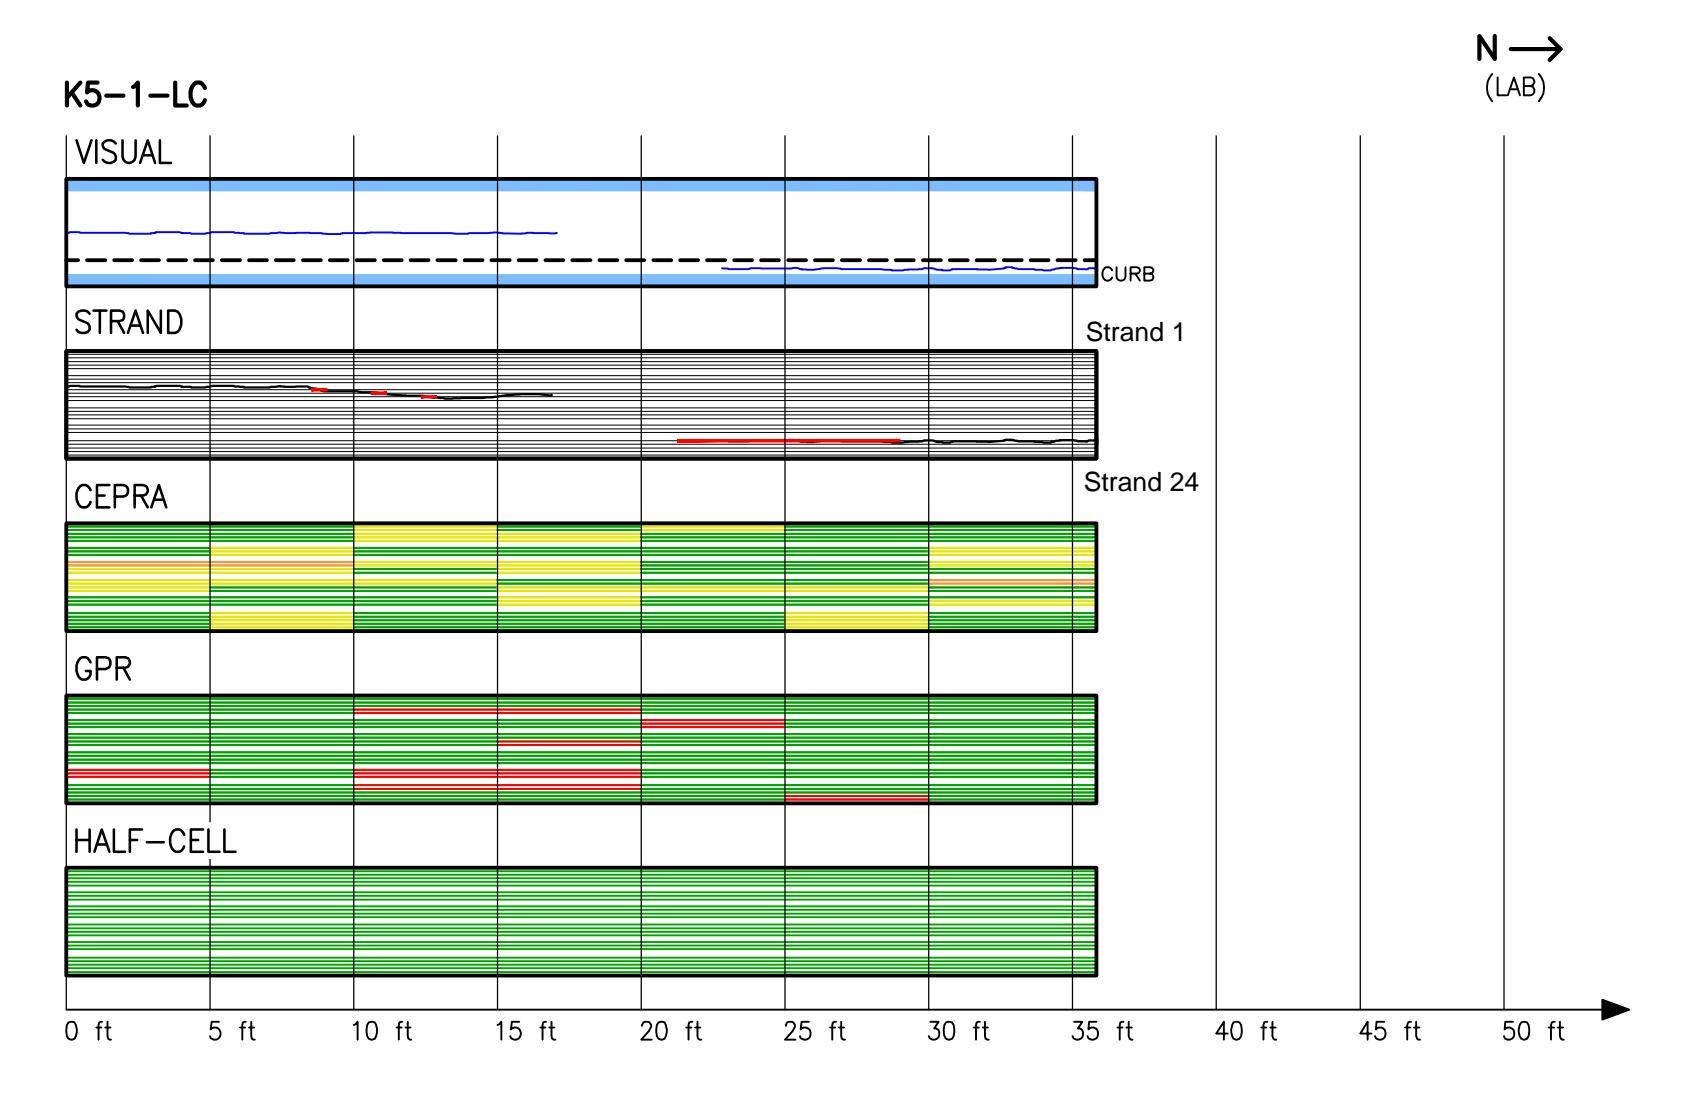
Figure 3.69: K5-1-LC Deterioration Map

For Specimens K5-1-LC and 79-1-UD, the GPR results in Figure 3.69 and Figure 3.71 indicate deterioration at scattered locations throughout the bottom flanges of either specimen. ASTM C6087 (2015) states that the threshold for deterioration may be between 6 to 8 dB. When 8 dB was used as the threshold for deterioration for Specimens K5-1-LC and 79-1-UD (Figure 3.101 and Figure 3.102), the GPR results showed little indication of deterioration, which is consistent with the visual inspection, adjusted CEPRA results, and half-cell potential results. However, if the 8 dB threshold is applied to the GPR results for Specimens 102-2-BS and 102-3-BS (Figure 3.103 and Figure 3.104) the indicated deterioration is lost. This indicates that the 8 dB threshold is not suitable for detecting strand corrosion, and that some noise in the data may be encountered when using the 6 dB threshold.

In Specimens K5-1-LC (Figure 3.69), 79-4-LC (Figure 3.74) and 56-1-LC (Figure 3.75), half-cell potential readings indicated no corrosion (green strand in figures) of the strands adjacent to longitudinal cracks as was observed during the strand extraction.

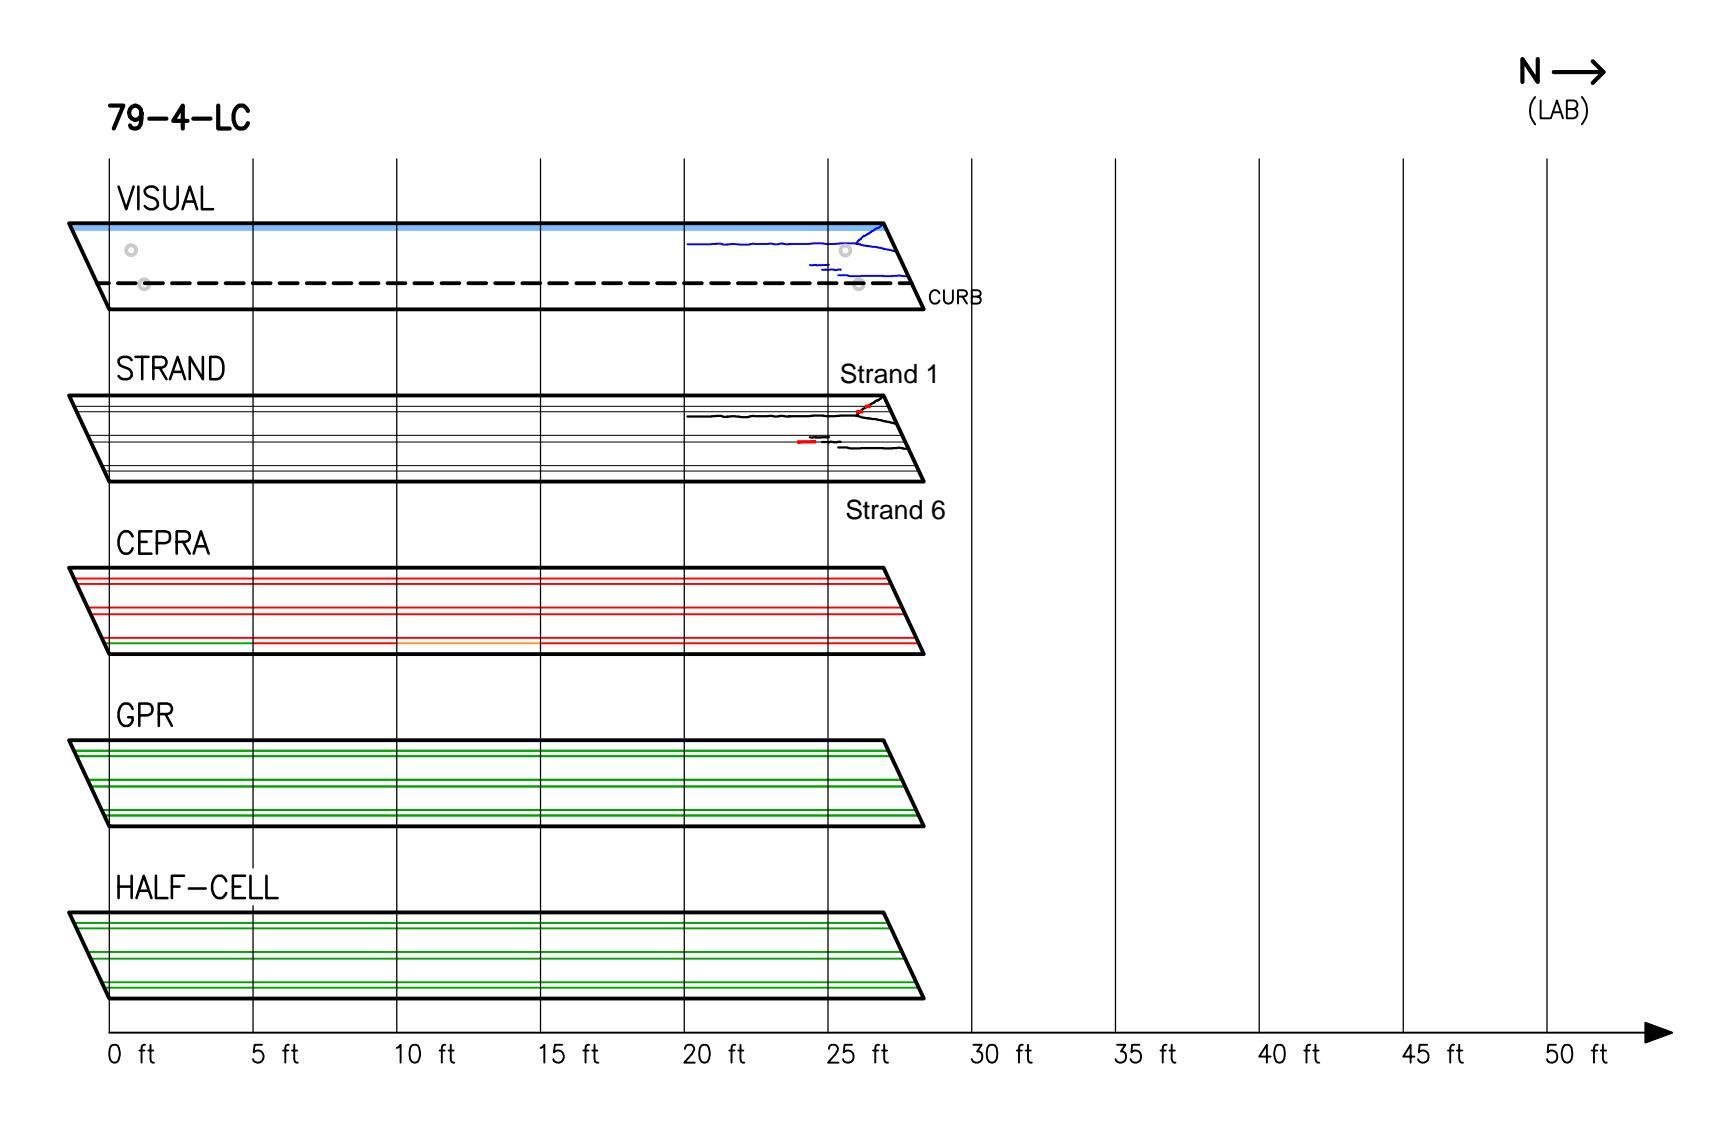
Figure 3.74: 79-4-LC Deterioration Map

A review of the CEPRA results and actual strand corrosion in Figure 3.66 to Figure 3.80 indicates that the corrosion rates provided by the CEPRA device, in general, overestimated the amount of corrosion. The CEPRA results in Figure 3.74 indicate "severe" corrosion (red) along the length of every strand with exception to the eastern most strand which had two lengths of strand indicated to have "passive" (green) and "visible" (orange) corrosion. Figure 3.81 provides the condition of the two west edge strands on the north end of the specimen. As shown, the strands exhibit no corrosion. The CEPRA results also indicated "visible" corrosion (orange) in Strands 3 to 5 between 25 ft and 30 ft in Figure 3.77. When cover was removed, no corrosion was observed (Figure 3.82).

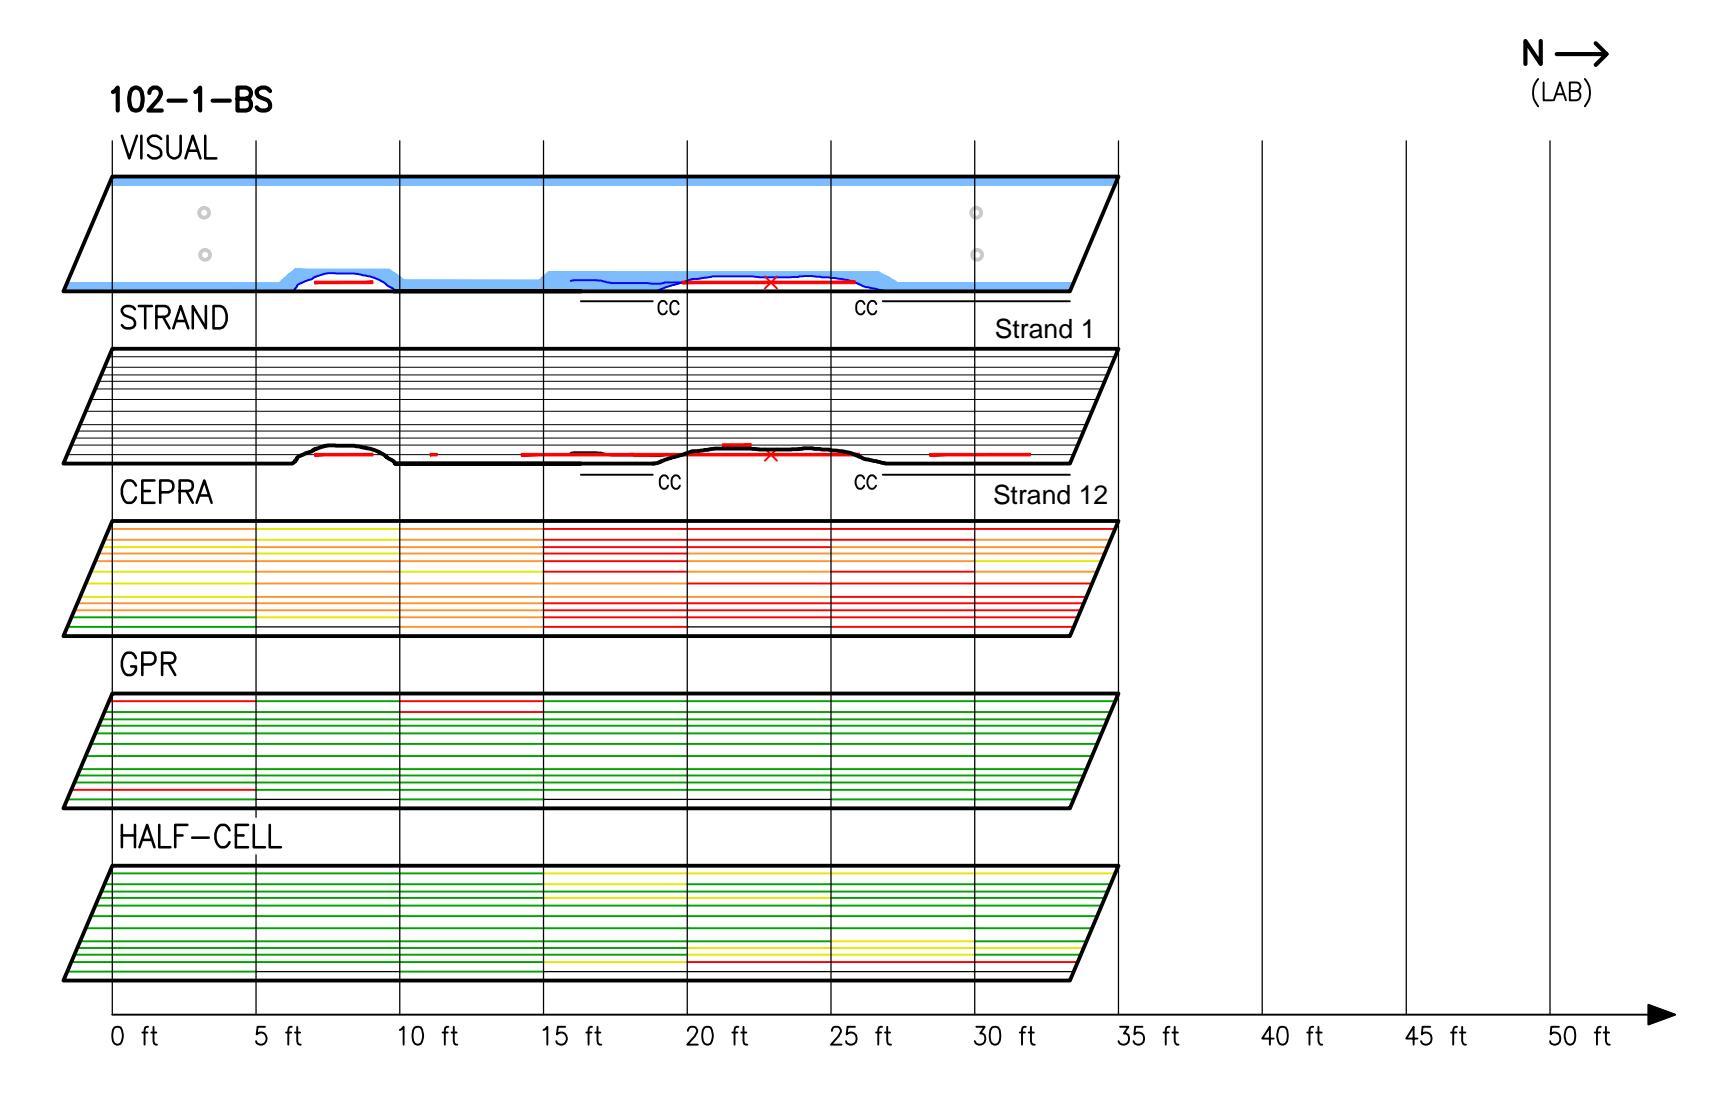
Figure 3.77: 102-1-BS Deterioration Map

Where corrosion was indicated by the half-cell potential readings, corrosion was often observed. In Specimen 102-1-BS, corrosion was indicated on the strand adjacent to the broken strand (Strand 11) on the east side of the specimen (Figure 3.77 between 20 ft and 35 ft). When cover was removed from Strand 11, corrosion was observed (Figure 3.32(b)). In Specimen 102-3-BS, corrosion was indicated on the Strands 9 to 12 located at the longitudinal cracks between 0 ft and 25 ft (Figure 3.79). When cover was removed from Strands 9 to 12, corrosion was observed (Figure 3.37(b)). It should be noted that corrosion was indicated on the strands at the longitudinal cracks in Specimen 102-3-BS even though the readings had to be taken adjacent to the cracks.

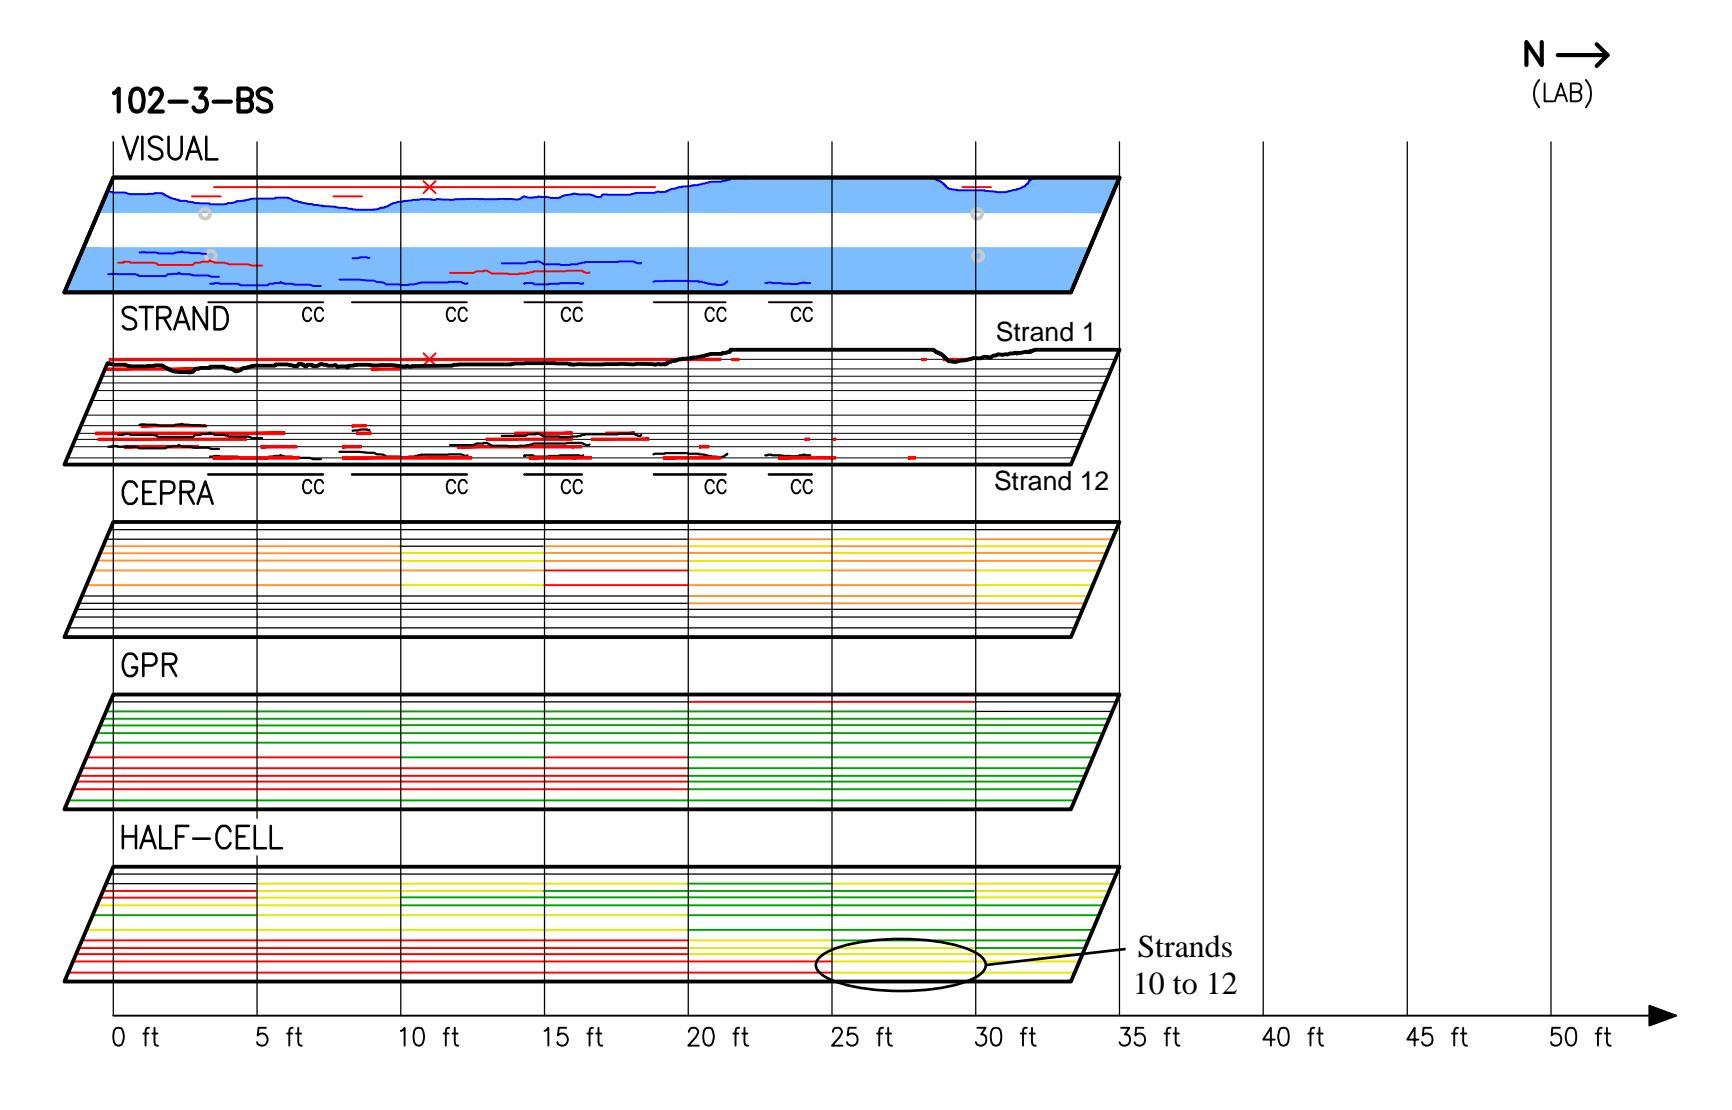
Figure 3.79: 102-3-BS Deterioration Map

Deterioration mapping with GPR was most successful in delaminated areas of the bottom flange (Specimens 102-2-BS (Figure 3.78) and 102-3-BS (Figure 3.79)). For Specimen 102-2-BS, the GPR results indicated strand deterioration between 15 ft and 25 ft in Figure 3.78 where the only visual indication of deterioration was a corner crack. As discussed previously, a corner crack would not be visible to a bridge inspector. Therefore, in this case, GPR provided indication of corrosion that would not have been otherwise visually detected.

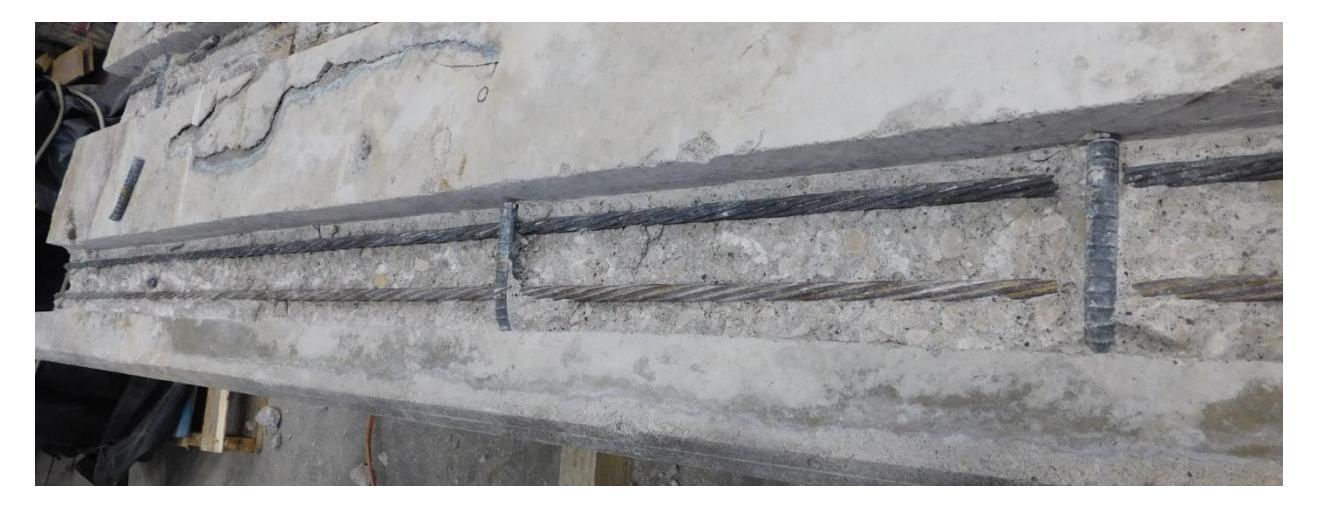
Figure 3.81: West Edge Strand Condition at North End of Specimen 79-4-LC

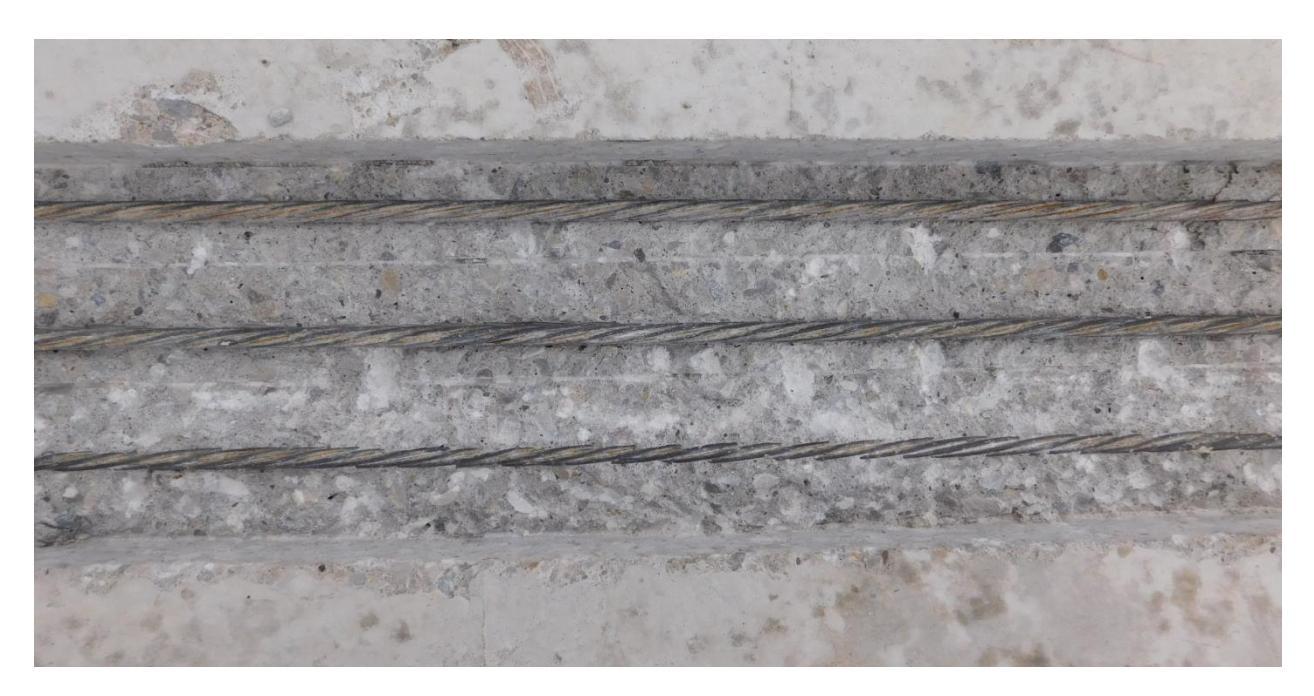
Figure 3.82: Strand Condition of North End Strands in Specimen 102-1-BS

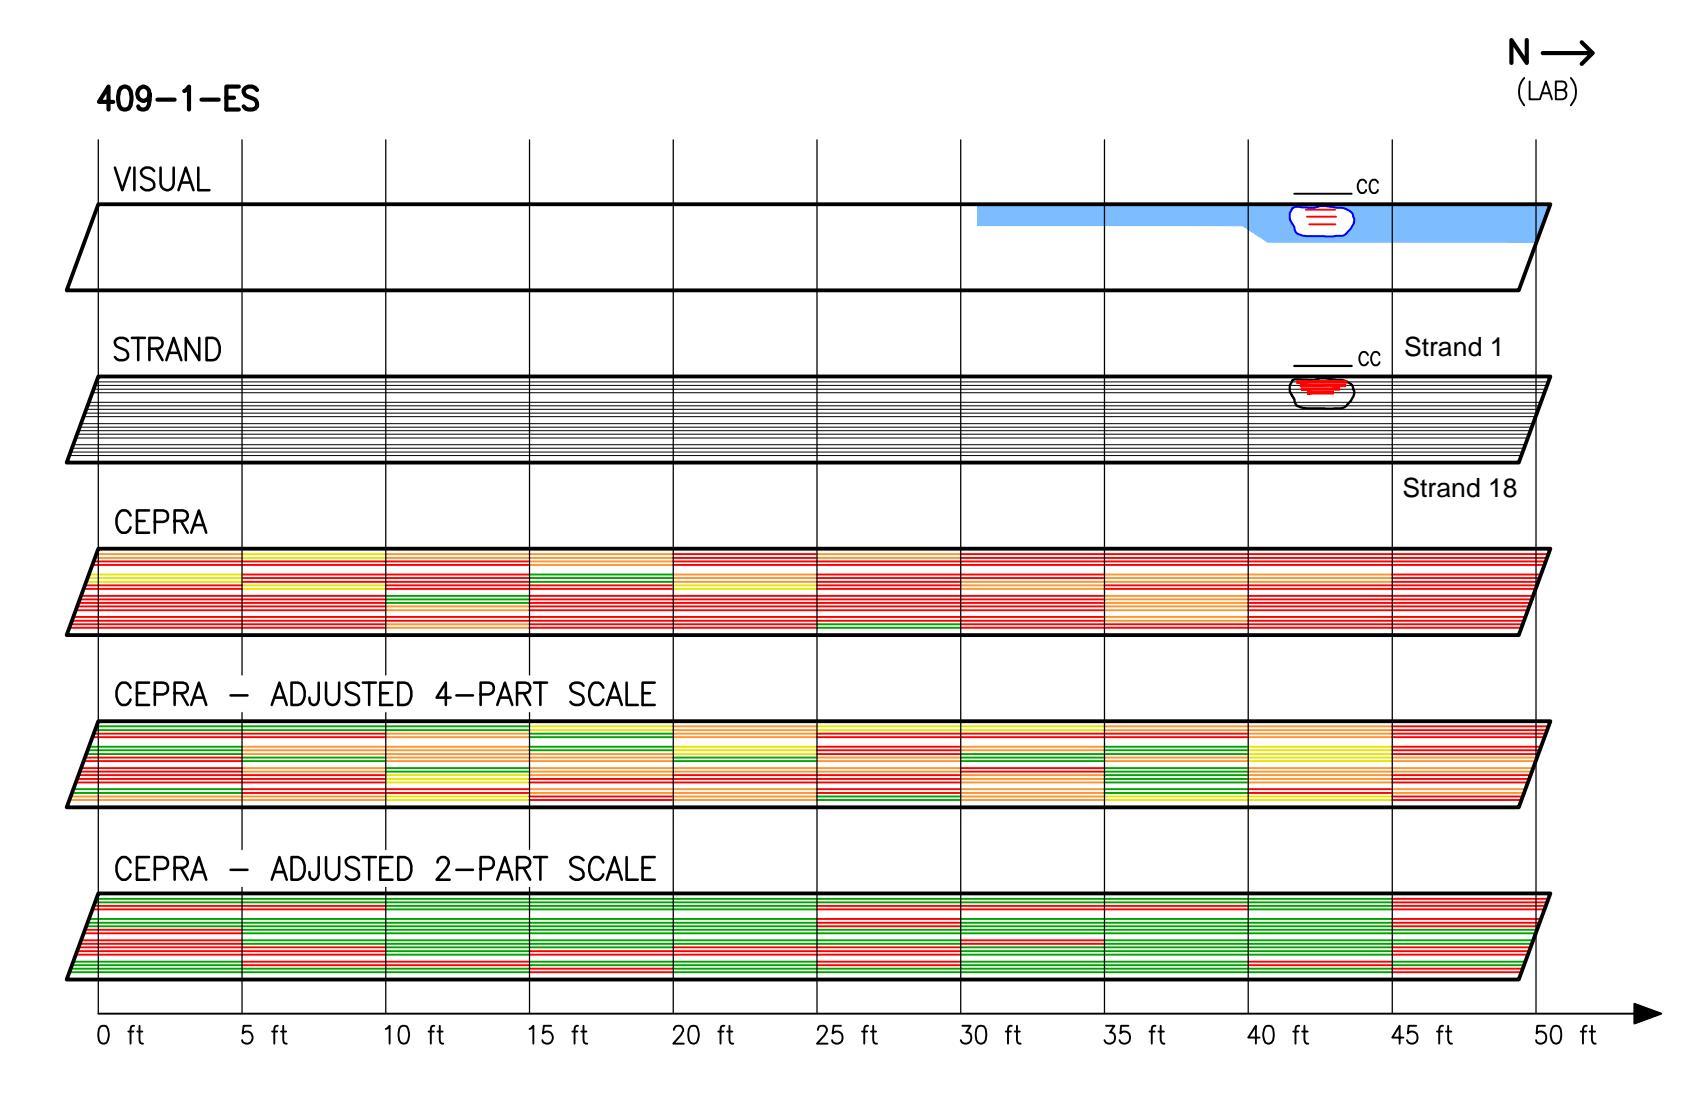
Figure 3.84: 409-1-ES Deterioration Map (CEPRA)

The corrosion rate measurements of Specimen 409-1-ES (Figure 3.84) were not consistent with the actual corrosion observed. Severe corrosion was indicated by CEPRA data where no strand corrosion was indicated in the visual inspection or by half-cell potential readings (Figure 3.67). In addition, strands extracted in a test area on the beam showed no signs of corrosion where severe corrosion was indicated by CEPRA (Figure 3.100). The measurements for 409-1-ES were repeated several times without significant change in the readings. The inconsistencies between the CEPRA results and the observed corrosion may have been caused by a combination of scatter in the measurements and irregularities in the concrete. The cause of discrepancies, however, could not be determined.

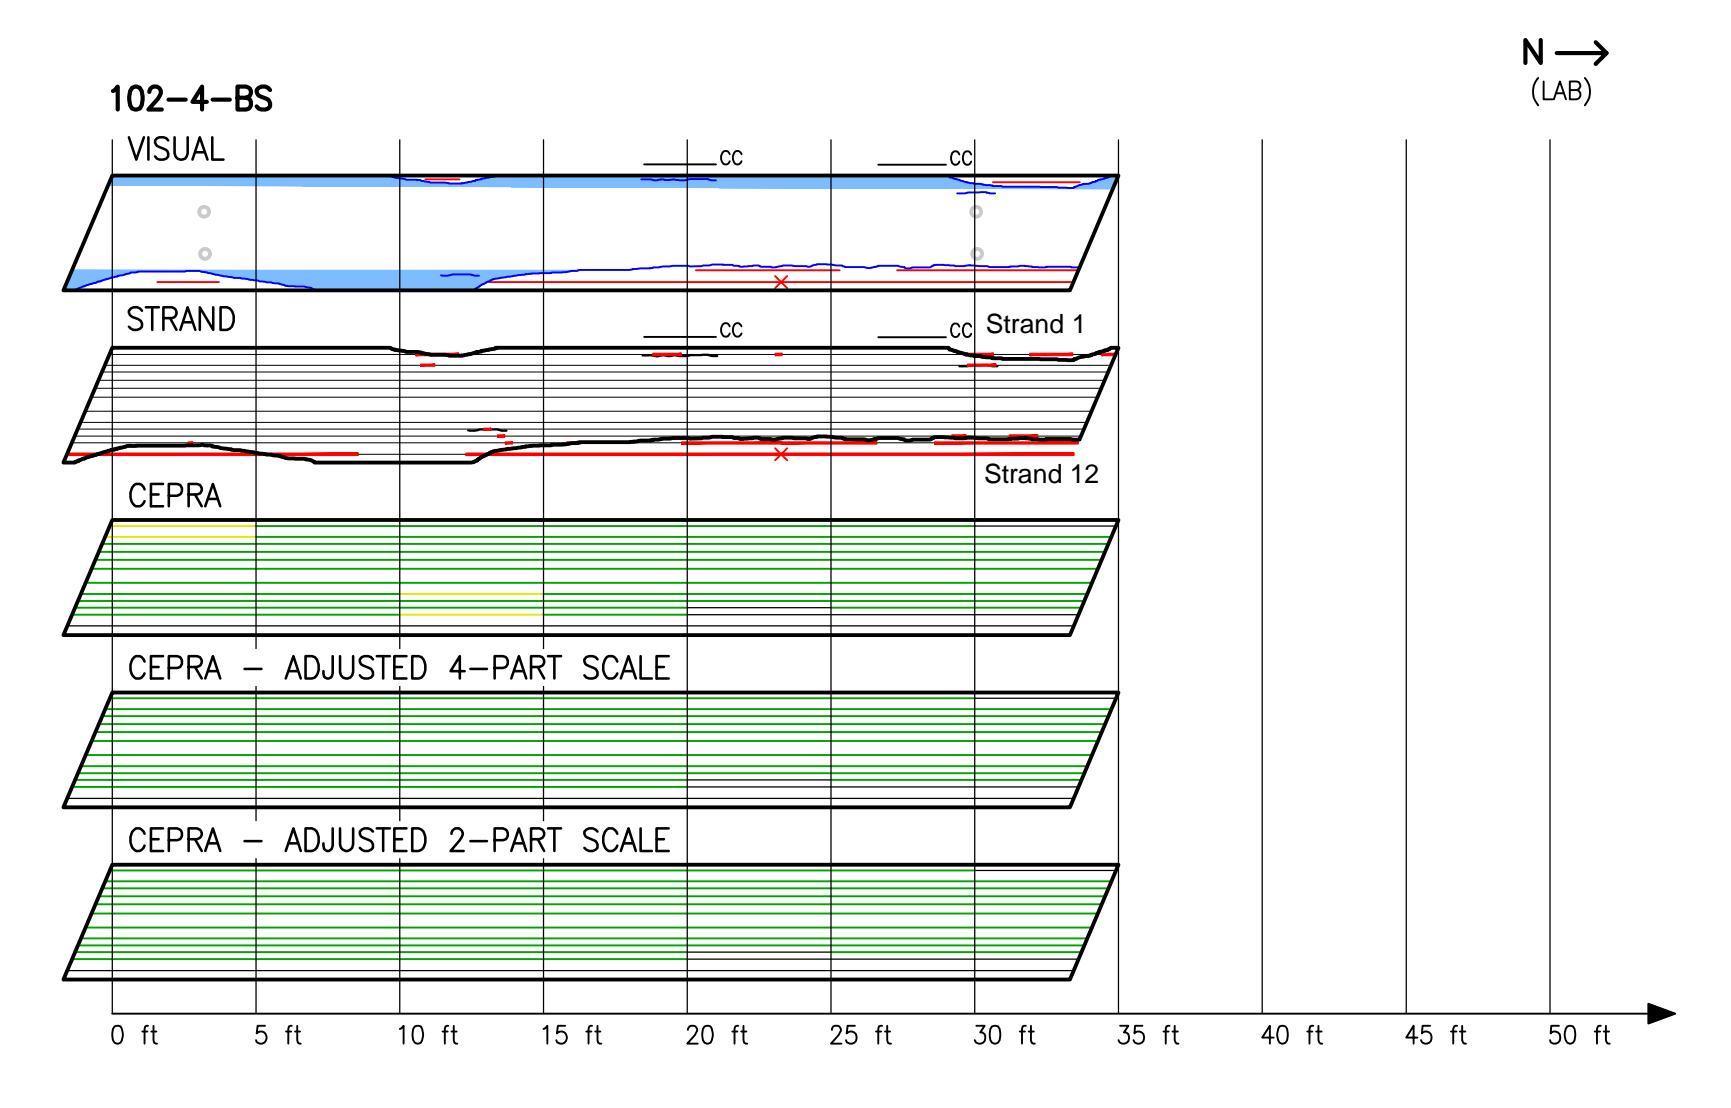
Figure 3.97: 102-4-BS Deterioration Map (CEPRA)

In Specimen 102-4-BS (Figure 3.97), no corrosion was indicated at the longitudinal crack on the northwest side of the bottom flange where corrosion was observed during the strand extraction (Figure 3.44). This is the only instance where CEPRA gave no indication of corrosion where corrosion was observed after strands were extracted. It should be noted that this was observed prior to adjusting the corrosion rate scale and after adjustment.

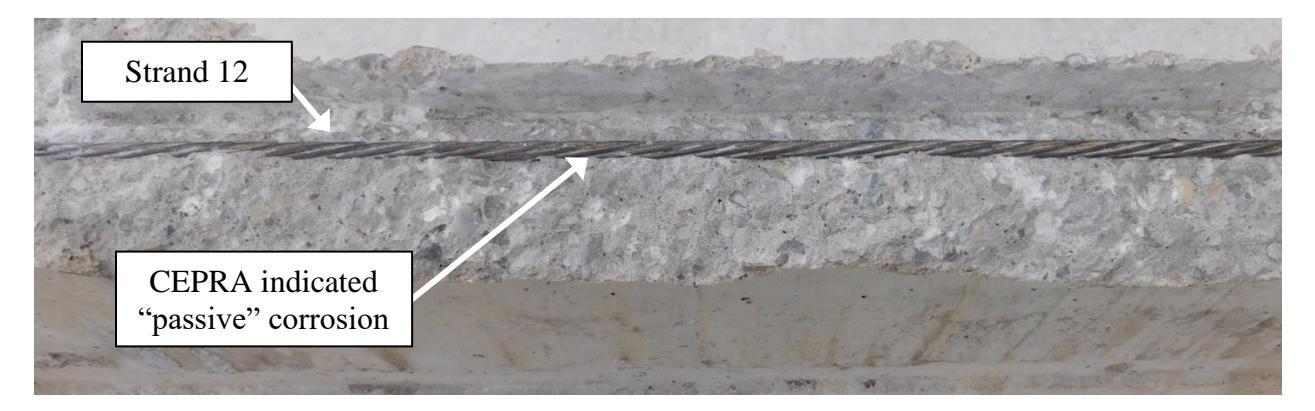
In locations where the adjusted corrosion rate indicated "passive" or "uncertain" corrosion (green or yellow strand in figures), strands were found with no corrosion. In Specimen 102-1-BS (Figure 3.94), "passive" corrosion was indicated on Strand 12 (adjusted four-part scale between 0 ft and 5 ft), and no corrosion was observed when cover was removed (Figure 3.98). In Specimen 56-2-ES (Figure 3.93), "uncertain" corrosion was indicated on Strand 12 (adjusted four-part scale between 15 ft and 20 ft), and no corrosion was observed when cover was removed (Figure 3.99).

Figure 3.98: Condition of Strand 12 in Specimen 102-1-BS

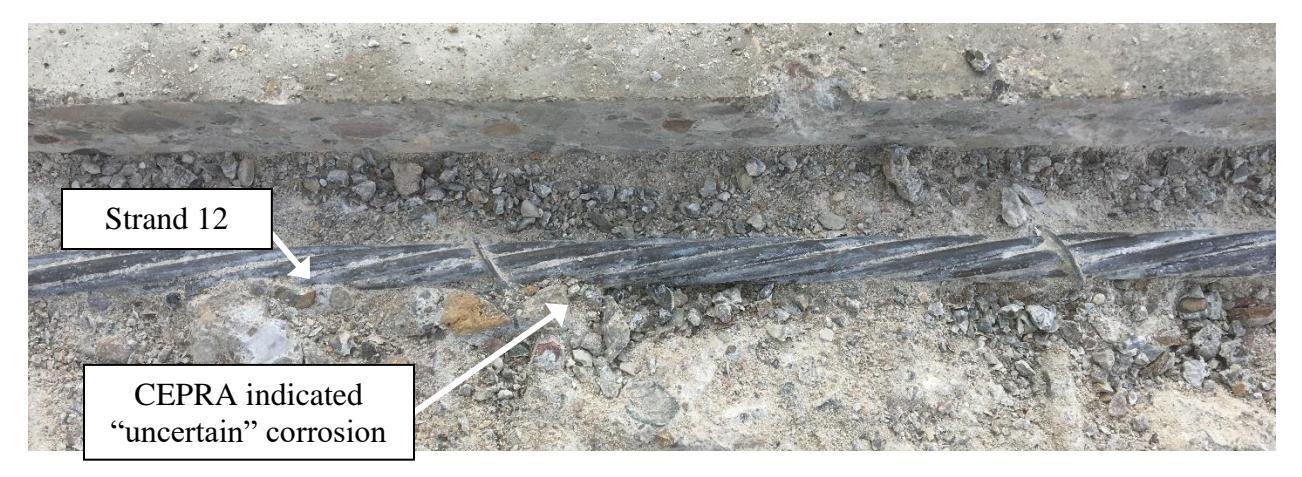
Figure 3.99: Condition of Strand 12 in Specimen 56-2-ES

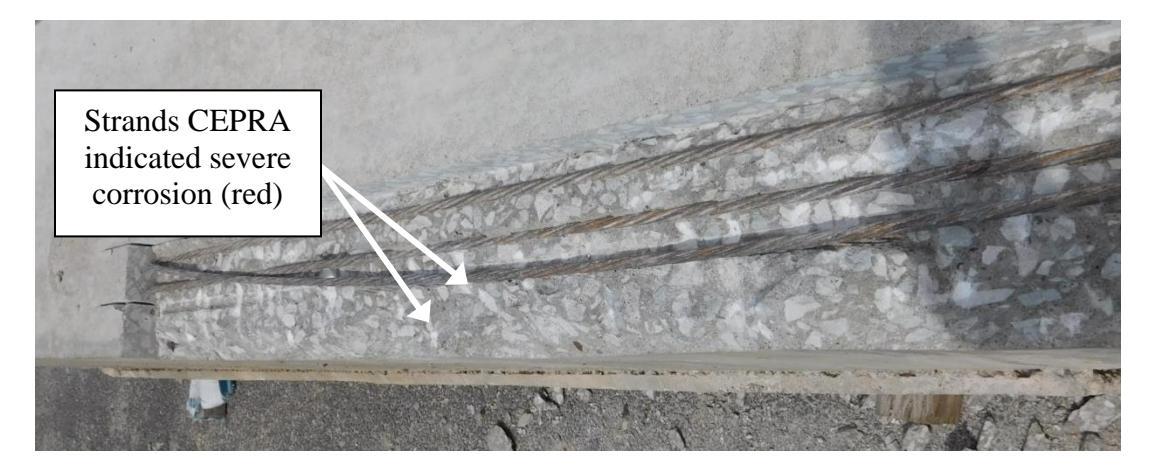
Figure 3.100: Condition of Strand at North Support of Specimen 409-1-ES 3.6.2 GPR

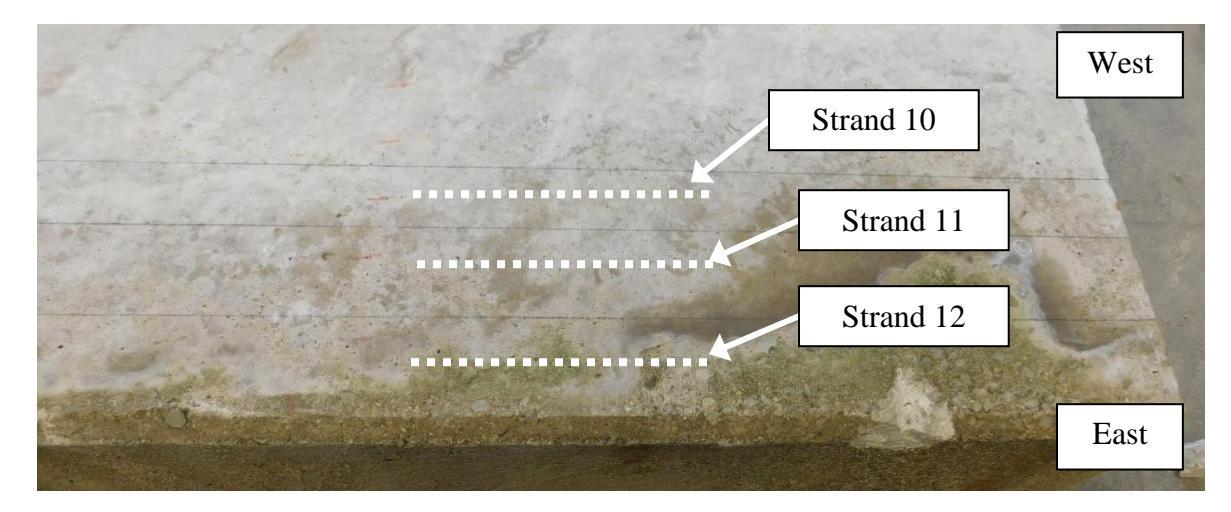
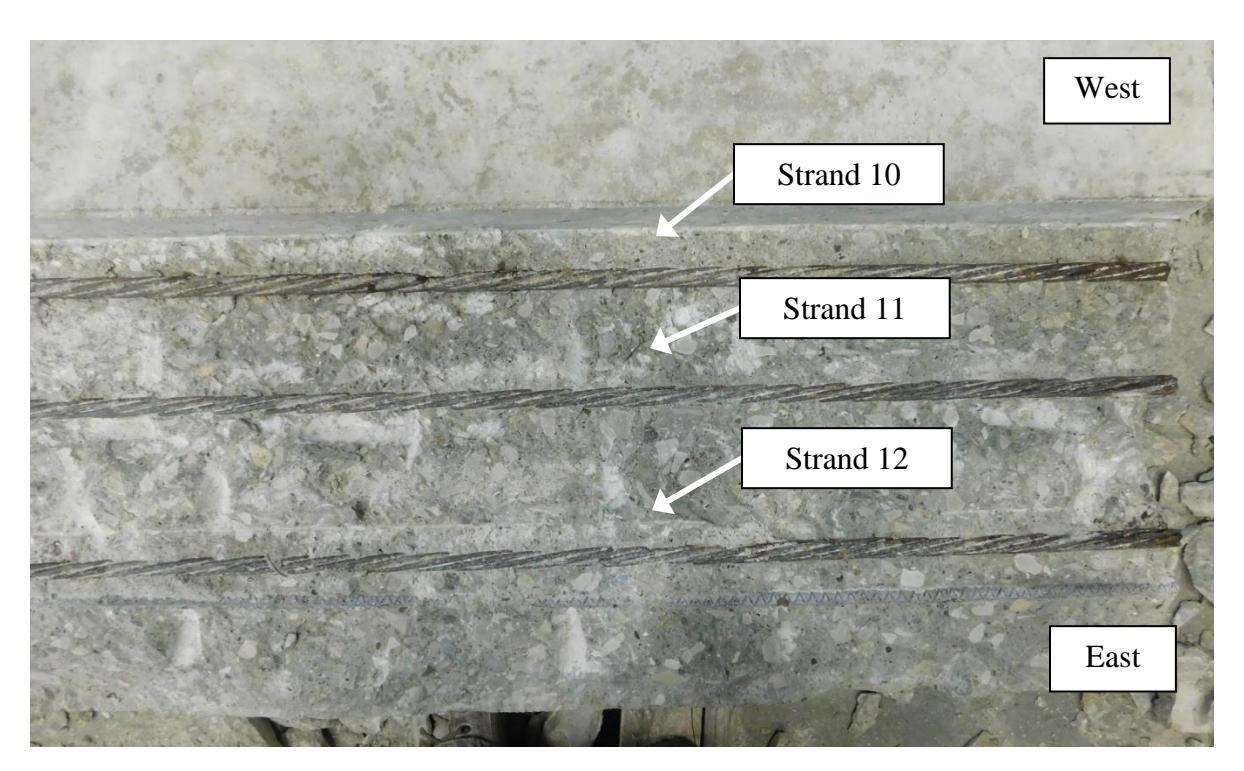
Where the half-cell potential readings indicated uncertain corrosion (yellow strand in figures), uncorroded strands were observed. In Figure 3.66 at the locations of the longitudinal cracks in Specimen 244-1-LC (half-cell readings between 5 ft and 15 ft on the west side of the specimen and between 20 ft and 25 ft on the east side of the specimen), uncertain corrosion was indicated for the strands adjacent to the longitudinal cracks. As shown in Section 3.4.2.1, no corrosion was observed on strands adjacent to longitudinal cracks. Uncertain corrosion was also detected in Strands 11 and 12 in Specimen 56-2-ES (Figure 3.76 between 10 ft and 15 ft on the east side of the specimen). As shown in Figure 3.28(b) and (c), Strand 11 was observed without any corrosion, and Strand 12 was found with only surface corrosion. In Specimen 102-3-BS (Figure 3.79 between 25 ft and 30 ft and the southeast portion of Segment D in Figure 3.14), Strands 10 to 12 were classified with uncertain corrosion. As shown in Figure 3.105, when cover was removed from Strands 10 to 12, in the southeast portion of Segment D, no corrosion was observed.

(a) Before cover was removed

(b) After cover was removed

Figure 3.105: Condition of Strands Classified with Uncertain Corrosion in Specimen 102-3-BS
