EVALUATION AND STRUCTURAL BEHAVIOR OF DETERIORATED PRECAST, PRESTRESSED CONCRETE BOX BEAMS

A Dissertation

Doctor of Philosophy

Lyles School of Civil Engineering West Lafayette, Indiana December 2019

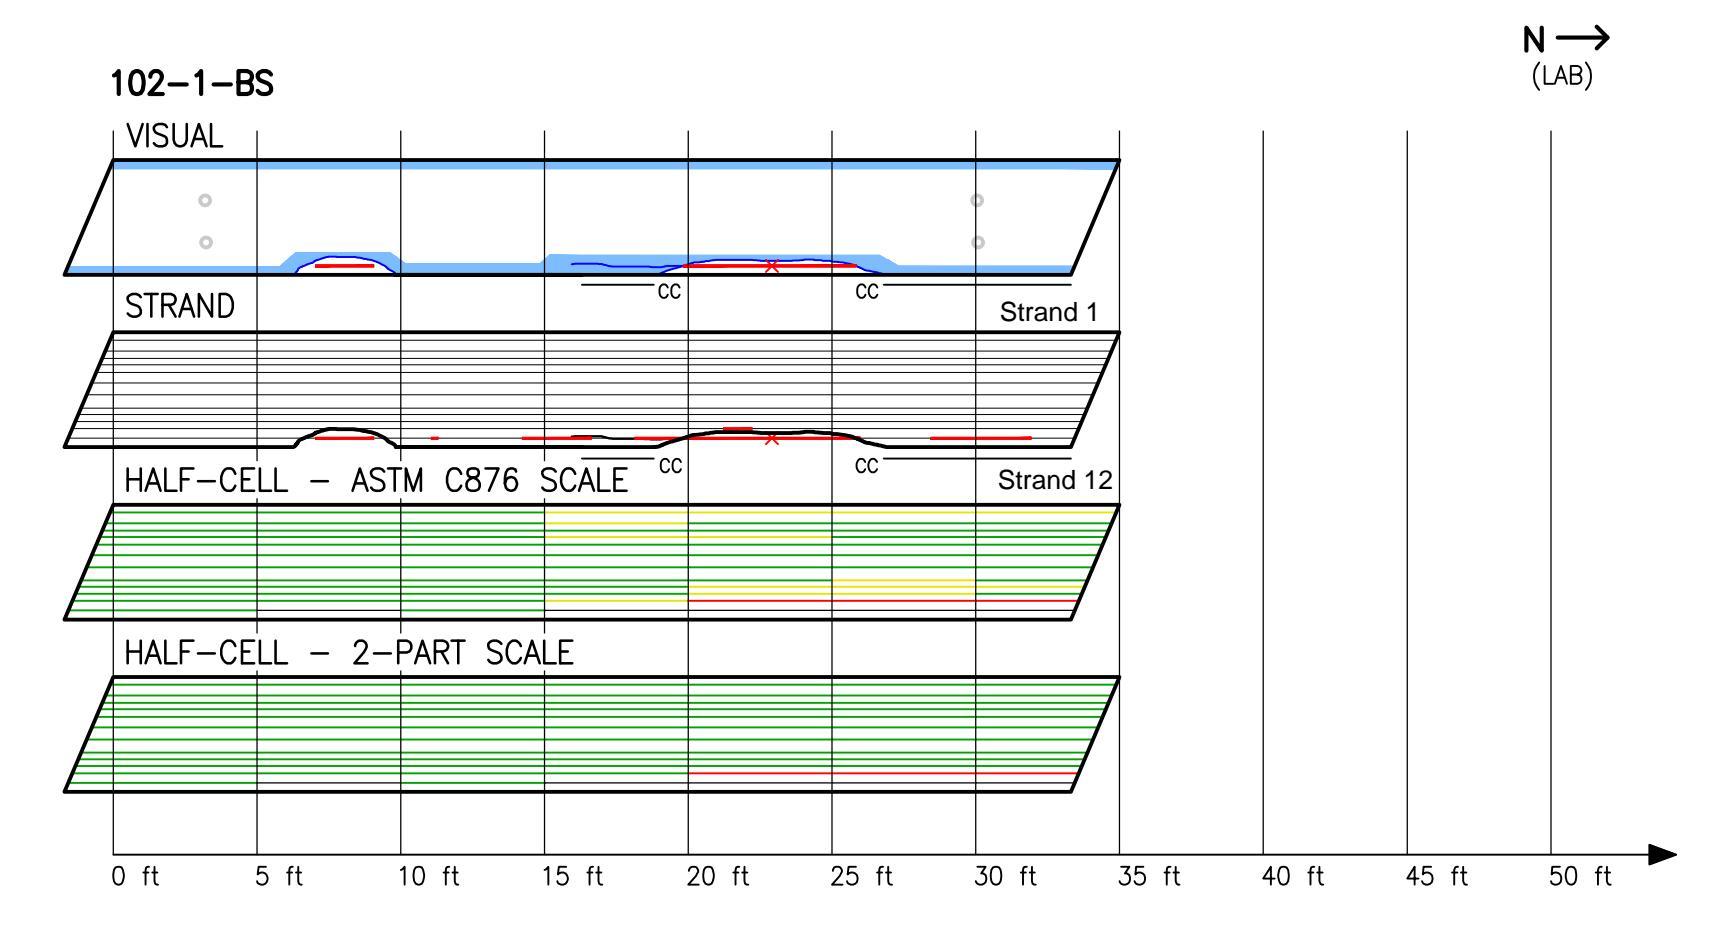
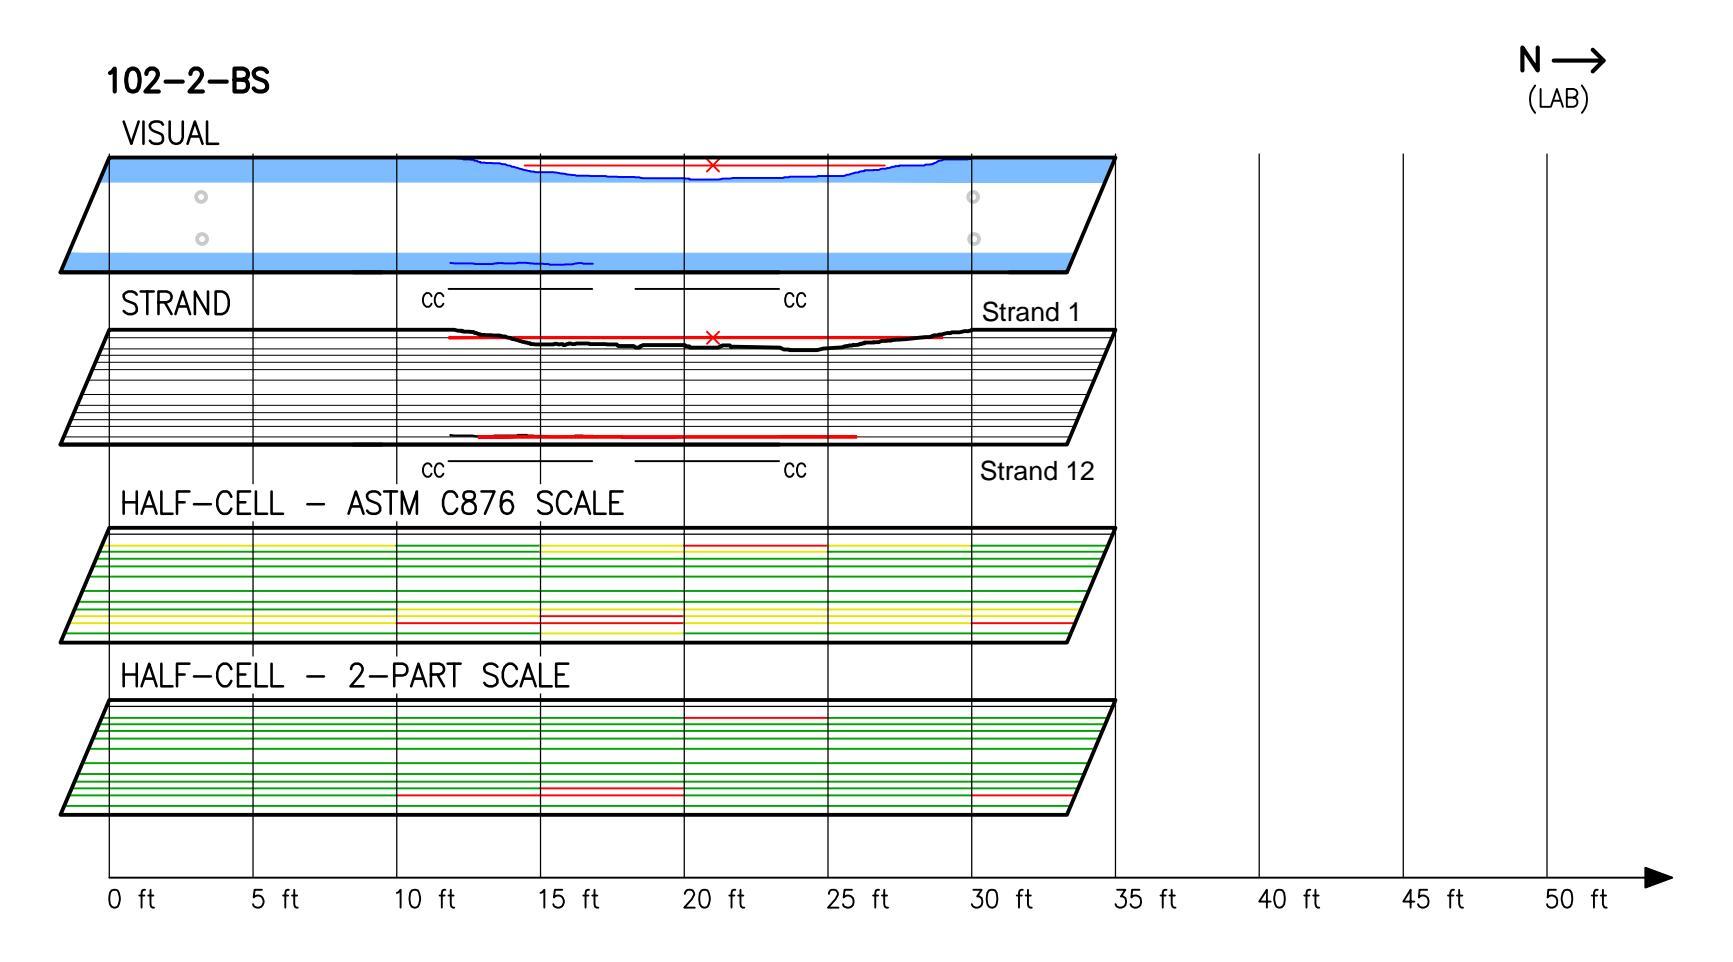
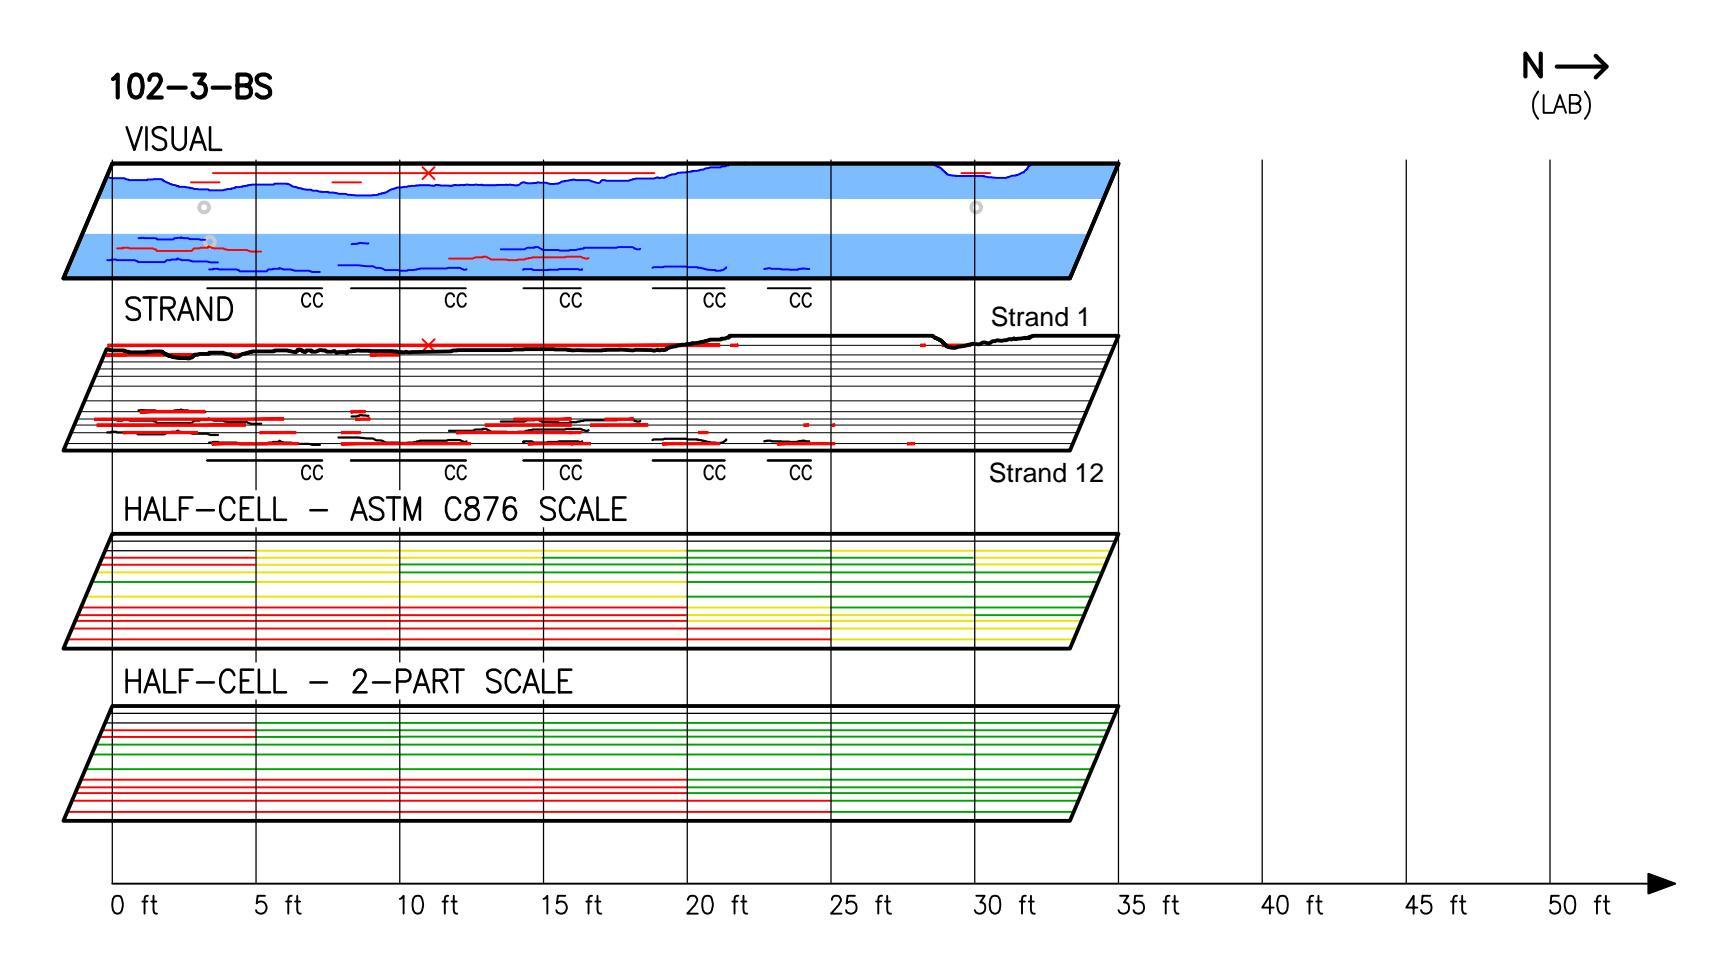
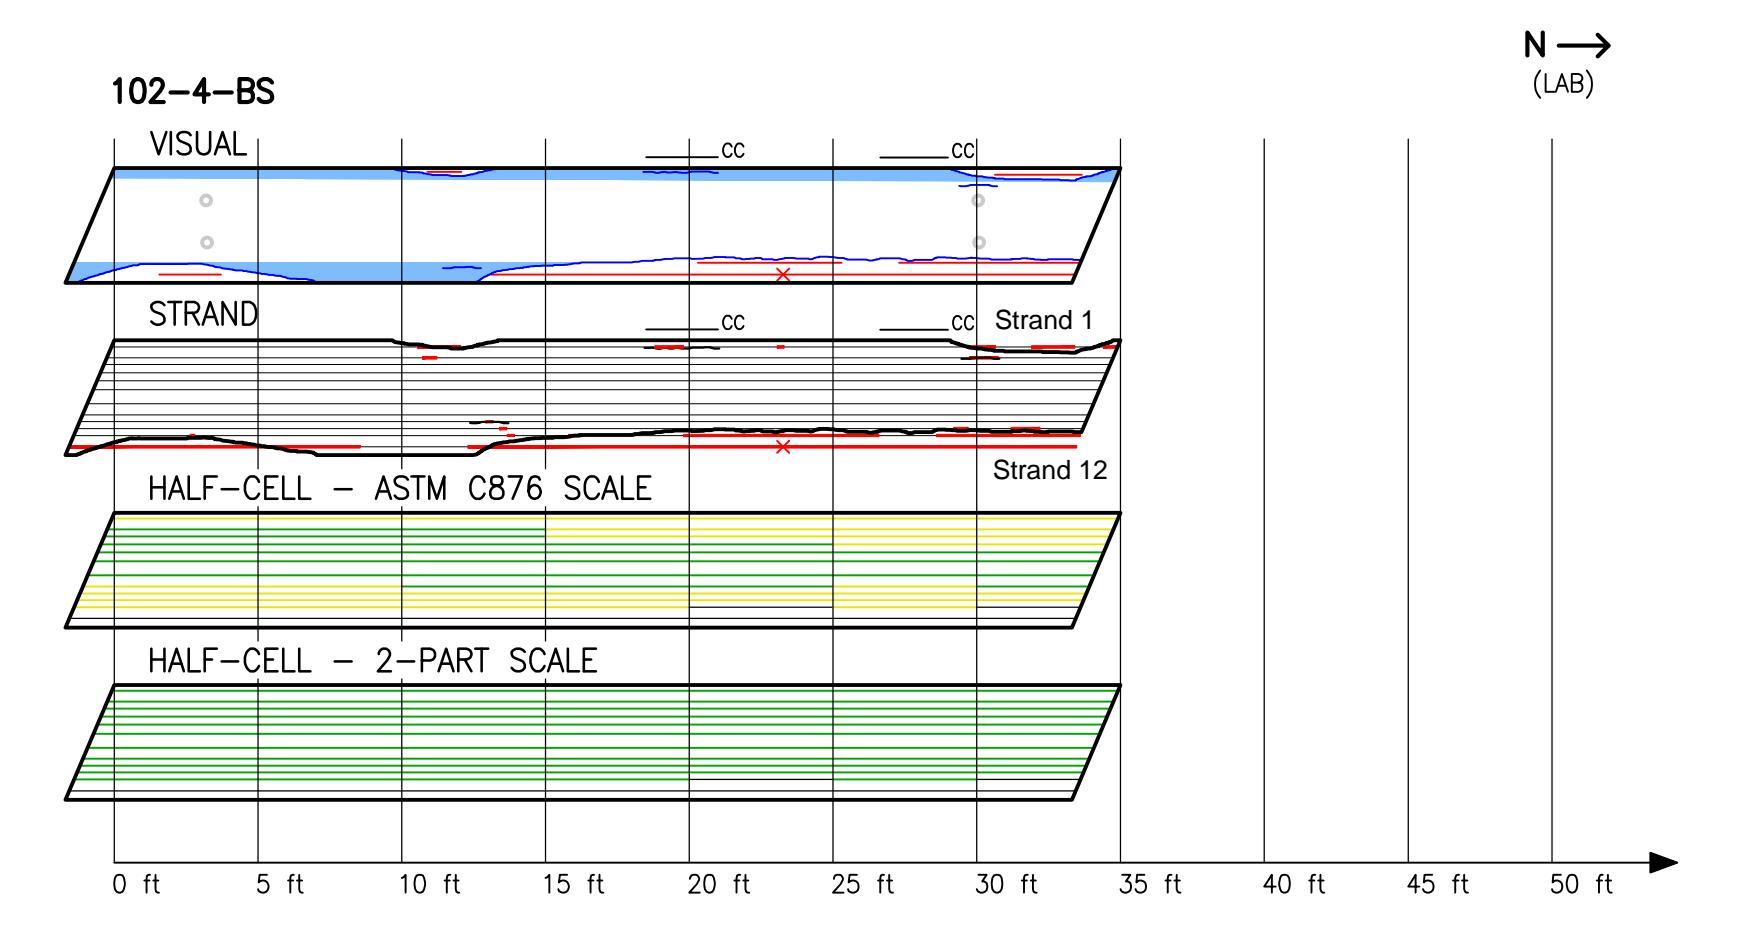
Considering the observed condition of the strands indicated with uncertain corrosion, the ASTM C879 three-part scale was condensed to a two-part scale with no corrosion (green strands) for voltage potential readings greater than or equal to -0.35 V and corrosion (red strands) for voltage potential readings less than -0.35 V. The condensed scale is provided in Table 3.10. The two-part scale was used with the results for Specimens 409-1-ES, 56-2-ES, 102-1-BS, 102-2-BS, 102-3-BS, and 102-4-BS and presented in Figure 3.106 to Figure 3.111. As shown, the two-part scale provides a "hotspot" view of the data.

Figure 3.108: Specimen 102-1-BS Adjusted Half-Cell Potential Results

Figure 3.109: Specimen 102-2-BS Adjusted Half-Cell Potential Results

Figure 3.110: Specimen 102-3-BS Adjusted Half-Cell Potential Results

Figure 3.111: Specimen 102-4-BS Adjusted Half-Cell Potential Results

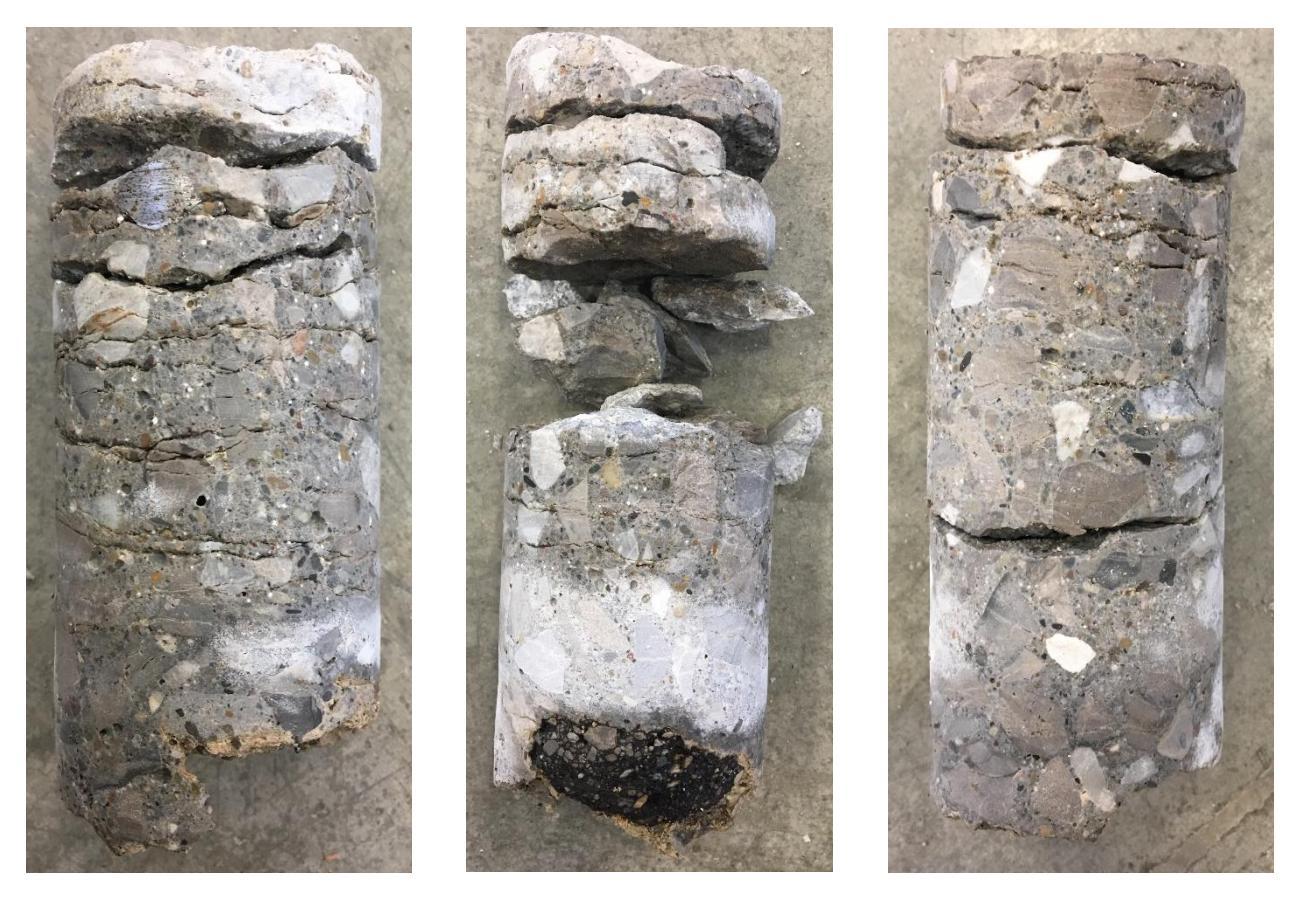
Three 4 in. diameter concrete cores were taken from the end diaphragm of each beam specimen. For the specimens with curbs (K5-1-LC, 79-3-UD, and 79-4-LC), three additional cores were extracted directly from the curb of each specimen. An additional series of 2-3/4 in. diameter cores were taken from the flanges of Specimens 244-1-LC and 56-2-ES and from the structural repair on Specimen K5-2-LC. The cores from Specimens 244-1-LC and 56-2-ES were taken to investigate the concrete strength near the failure region of the beam. The cores taken from the repair region in Specimen K5-2-LC could not be tested based on the condition of the concrete cores. The delaminated concrete from freeze-thaw damage penetrated through over half the flange repair thickness of Specimen K5-2-LC (Figure 4.1).

(a) Core 1(b) Core 2(c) Core 3Figure 4.1: Delamination in the Flange Repair Cores from K5-2-LC

The east and west longitudinal cracks caused corrosion of two strands at the plane of failure. The loss of these strands created a weak section where deformation was concentrated and drove fracture of additional strands. No further distress of the middle longitudinal crack was observed during the post-failure investigation of the beam. The structural repair of the top flange (Figure D.6) was not in good condition at the end of the test but did not suffer extensive damage until collapse of the beam. Concrete cores taken from the patch after testing revealed significant cracking parallel to the top surface of the beam (Figure 4.1). This indicates that delaminated concrete was present but did not control the failure mode.

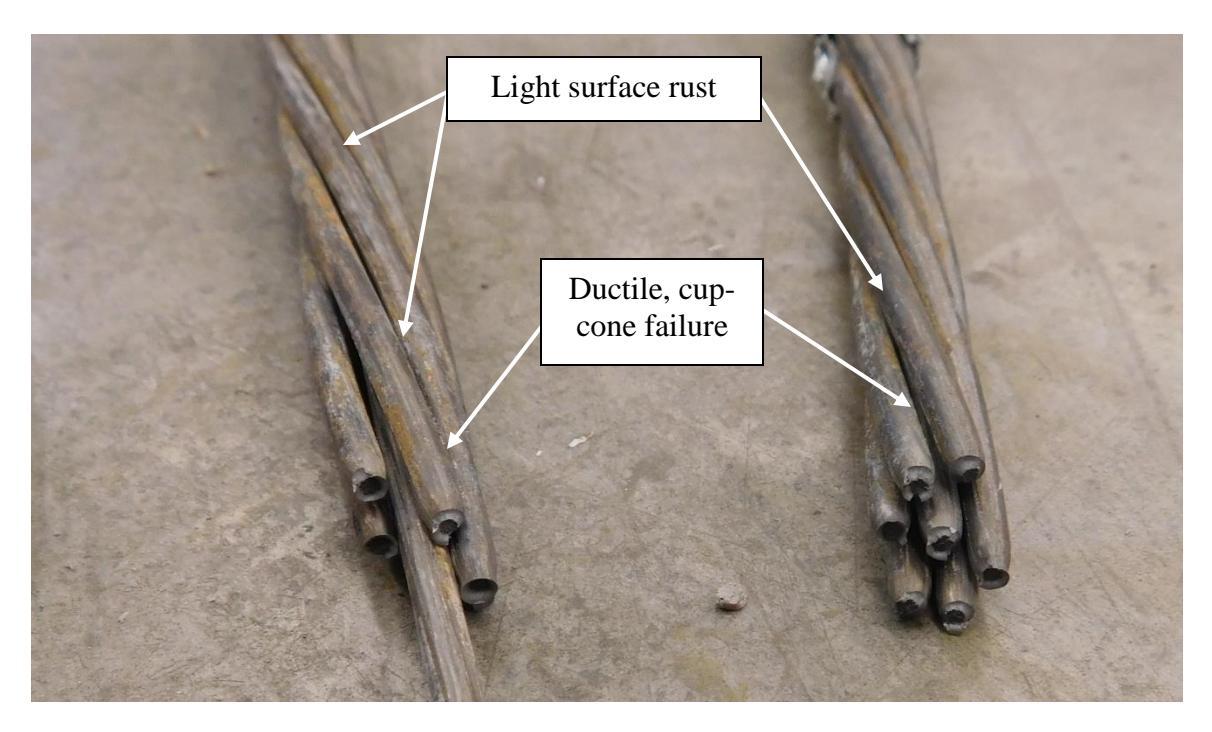
It should be noted that the measured strain at fracture for Strand 1 of Specimen 409-1-ES was significantly lower than that of Strands 2 and 3 of Specimen 409-1-ES. The failure mode of Strand Specimen 409-1-ES-1 was ductile although some surface rust was observed on the specimen (Figure 4.10). The difference in behavior of this strand is not clearly understood. Overall, all strands were capable of achieving strains greater than 0.04.

Figure 4.10: Strand Specimen 409-1-ES-1 After Tensile Testing

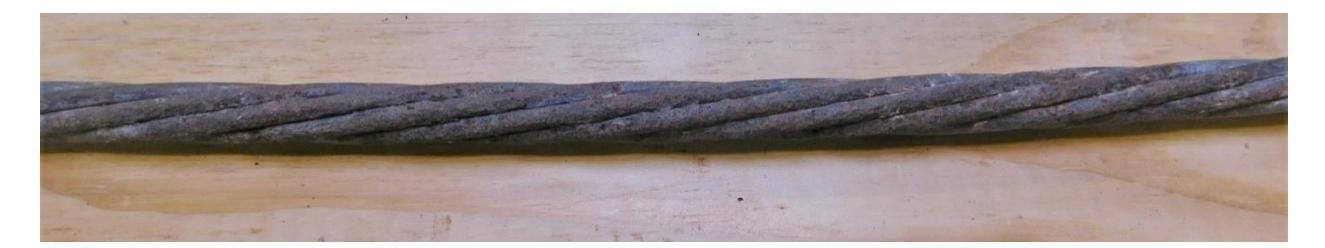
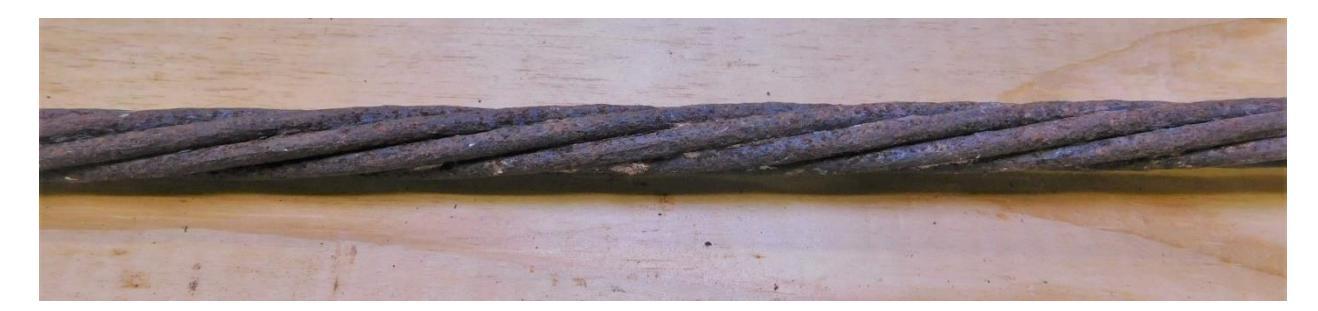
Two corroded strands were selected from Specimen 244-1-LC for tension testing. Both strands were located at a longitudinal crack that extended through-the-thickness of the bottom flange. Strand 5_{cor} (Strand 5 in Figure 3.51) is from Segment A, and Strand 6_{cor} is from Segment B (Figure G.1). Corrosion of each strand was relatively uniform along the length of the specimen and consisted of surface corrosion and minor pitting (Figure 4.11).

(b) Strand 6_{cor} Figure 4.11: Specimen 244-1-LC Corroded Strands

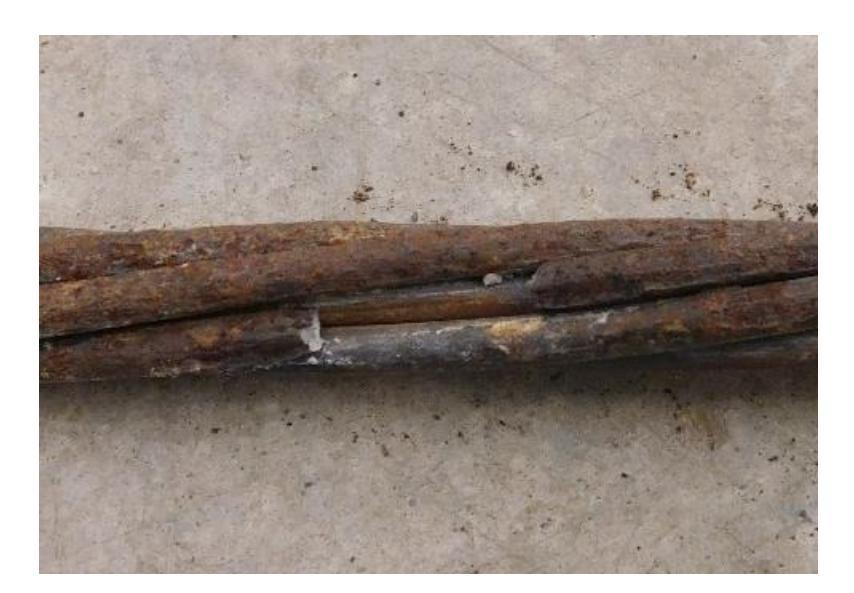
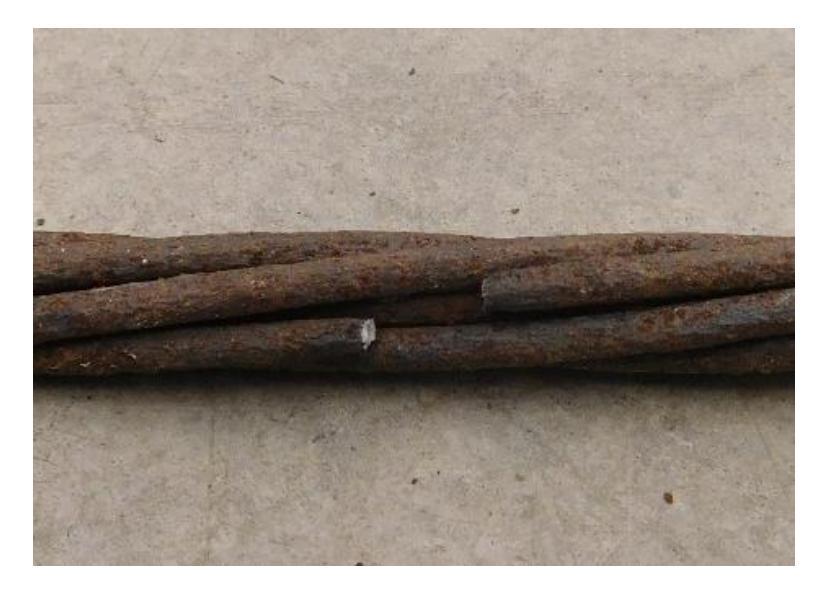
Failure of each strand was characterized by a single-wire fracture at peak load (Figure 4.12). The breaking load, f_{pu} , ε_{pu} , and E_{ps} are reported in Table 4.7. The percent of full capacity was calculated considering the average uncorroded breaking load as full strength. The stress-strain curve for each specimen is presented in Figure 4.13.

(b) Strand 6_{cor} Figure 4.12: Specimen 244-1-LC Corroded Strands After Failure

For comparison, the results from Strand Specimen 1 from Specimen 244-1-LC has been included in Table 4.7 and Figure 4.13. As shown, the corroded strand specimens had a capacity of at least 78% of the uncorroded strand capacity. In addition, the modulus of elasticity of the corroded strands was essentially the same as the uncorroded strands. The corroded strands, however, fractured before yielding occurred indicating that strand corrosion not only results in section loss but also in a loss of ductility. Brittle fracture of corroded strands is a known phenomenon attributed to a combination of corrosion, hydrogen embrittlement, and stress-corrosion cracking (ACI 222.2R-01).

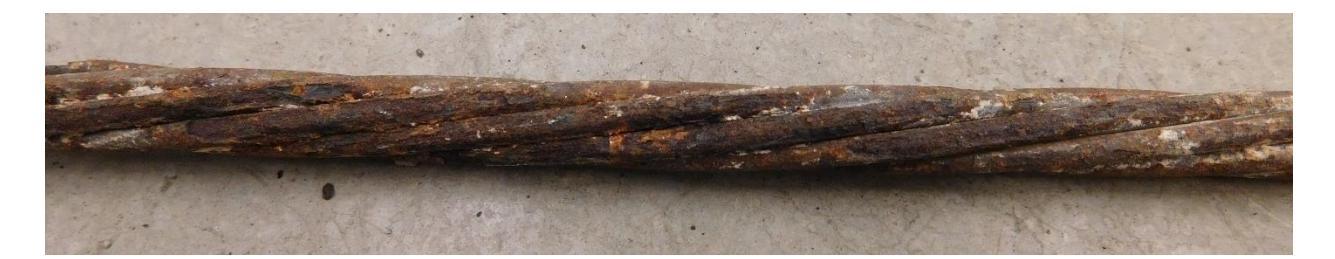
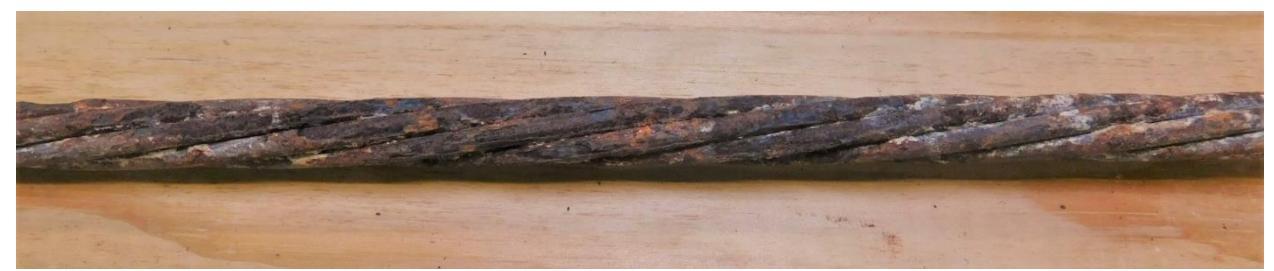
Two corroded strands were selected from Specimen K5-1-LC for tension testing. Both strands were located at a longitudinal through-thickness crack in Segment B of Specimen K5-1-LC (Figure G.2). Strand 10_{cor} and Strand 11_{cor} are Strands 10 and 11 in Figure 3.54. Corrosion of each strand was localized to a length of approximately 8-12 in. and consisted of surface corrosion and minor pitting (Figure 4.14).

(b) Strand 11_{cor} Figure 4.14: Specimen K5-1-LC Corroded Strands

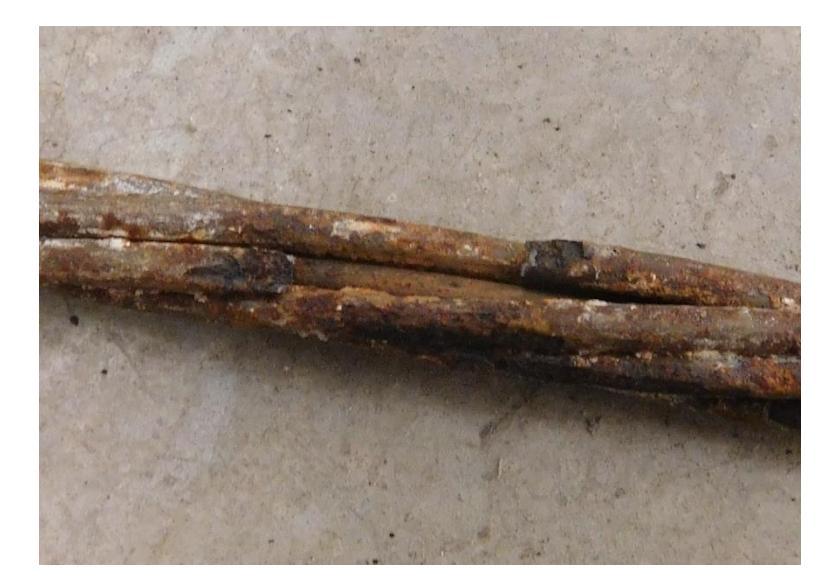
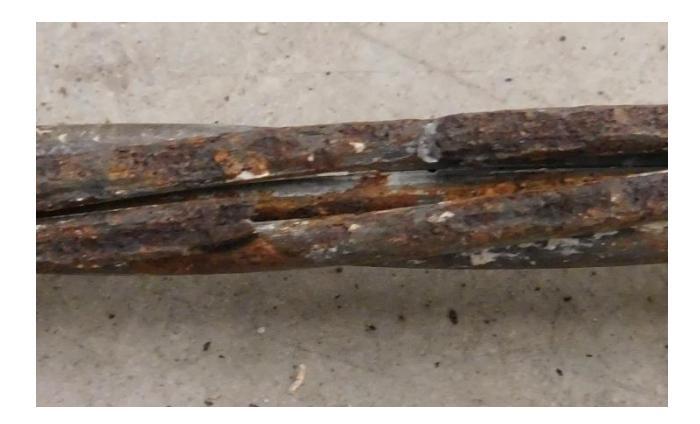
Similar to the corroded strands from Specimen 244-1-LC, failure of each strand was characterized by a single-wire fracture at peak load (Figure 4.15). The breaking load, f_{pu} , ε_{pu} , and E_{ps} are reported in Table 4.8, and the stress-strain curves are provided in Figure 4.16. As shown, the corroded strands were able to resist at least 78% of the average uncorroded breaking load with essentially the same modulus of elasticity. Strand 11_{cor} did begin to yield but fractured well before the uncorroded average of ε_{pu} . In general, both strands exhibited a lack of ductility characteristic of corroded prestressing strands.

(b) Strand 11_{cor} Figure 4.15: Specimen K5-1-LC Corroded Strands After Failure

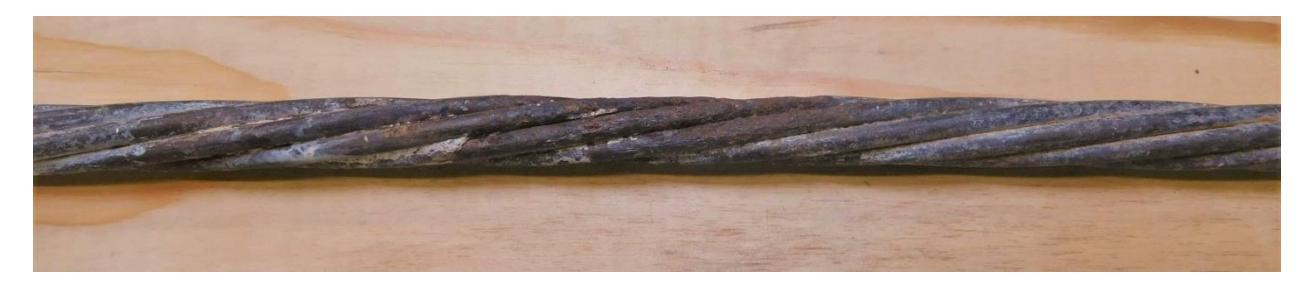
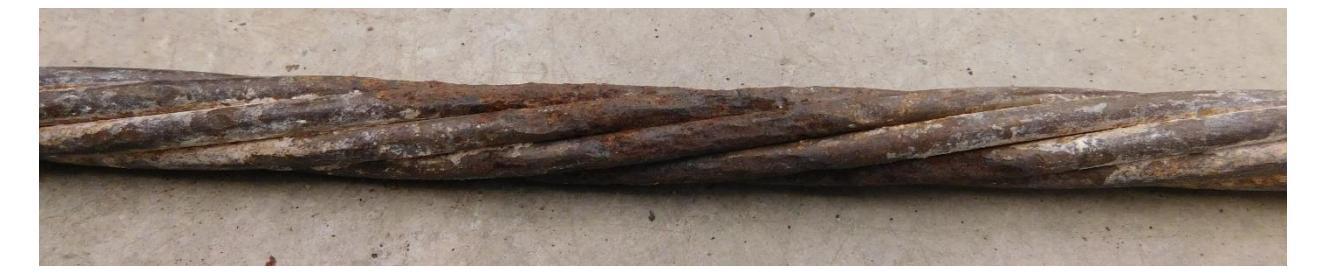
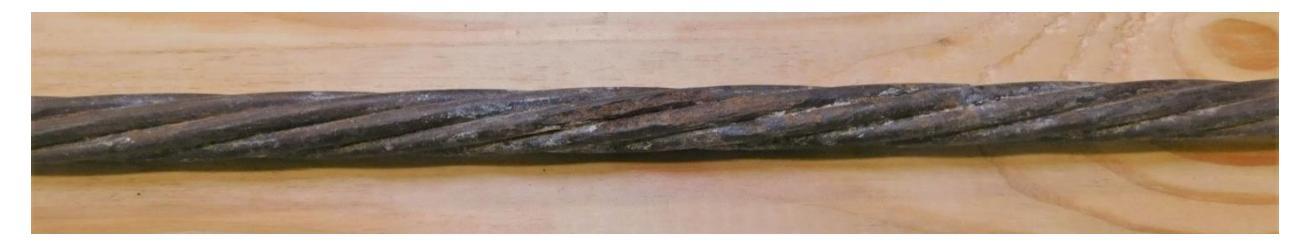
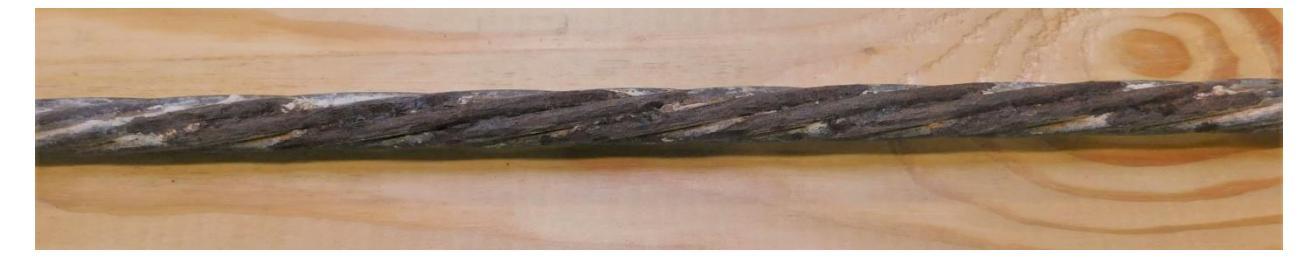
Four corroded strands were selected from Specimen 79-4-LC for testing. The strands were located in the end region with longitudinal cracks (Figure 3.63 and Figure G.3). Strands 1_{cor} through 4_{cor} are Strands 1 to 4 in Figure 3.63. Corrosion of each strand was limited to a localized area approximately 3 to 8 in. long and consisted of surface corrosion and minor pitting (Figure 4.17).

(d) Strand 4_{cor} Figure 4.17: Specimen 79-4-LC Corroded Strand Specimens

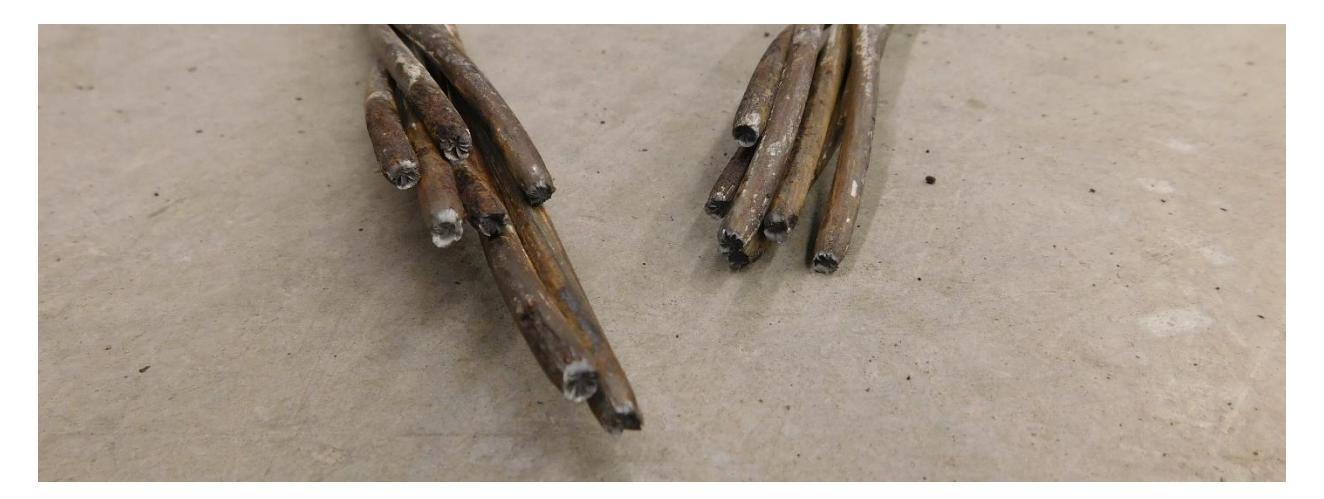
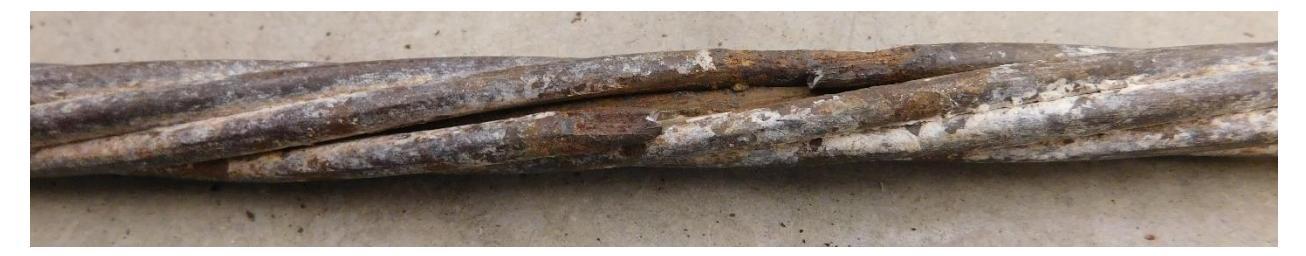
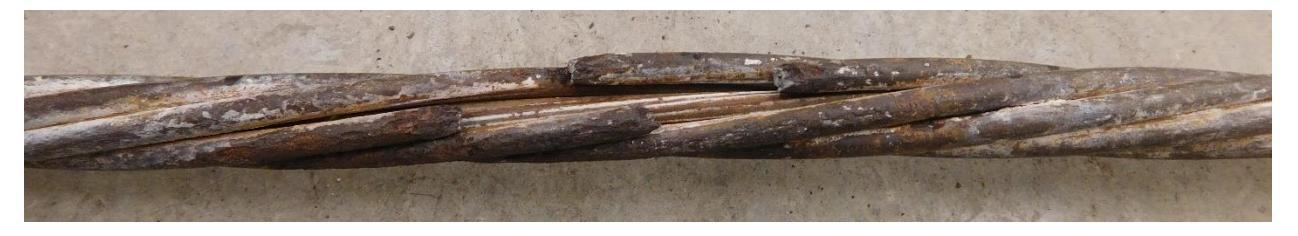
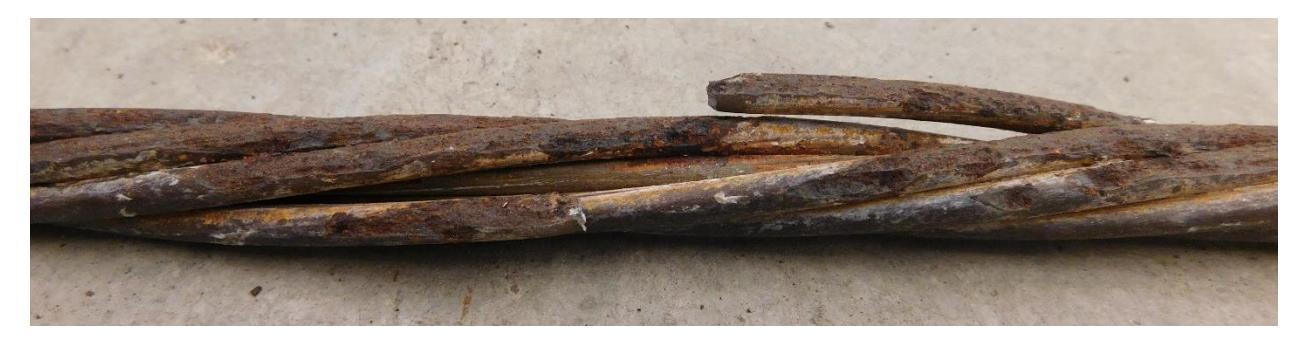
Figure 4.18: Specimen 79-4-LC Corroded Strand Specimens After Failure

All seven wires fractured at failure for Strand 1_{cor} (Figure 4.18(a)), and the breaking strength of Strand 1_{cor} was similar to the uncorroded strands. After yielding, the strand failed well short of the average value of ε_{pu} for uncorroded strand (Table 4.6 and Figure 4.19), providing further evidence of corrosion causing a decrease in ductility.

The failure of Strands 2_{cor} and 4_{cor} were characterized by single-wire fractures at failure (Figure 4.18(b) and (d)). Strand 2_{cor} and 4_{cor} resisted 89% and 94% of the average uncorroded breaking load but exhibited brittle behavior.

Two wires fractured at failure for Strand 3_{cor} (Figure 4.18(c)). As shown in Figure 4.19, yielding did occur and 95% of the breaking load was resisted, but fracture occurred very quickly after the onset of yielding with significantly reduced ductility.

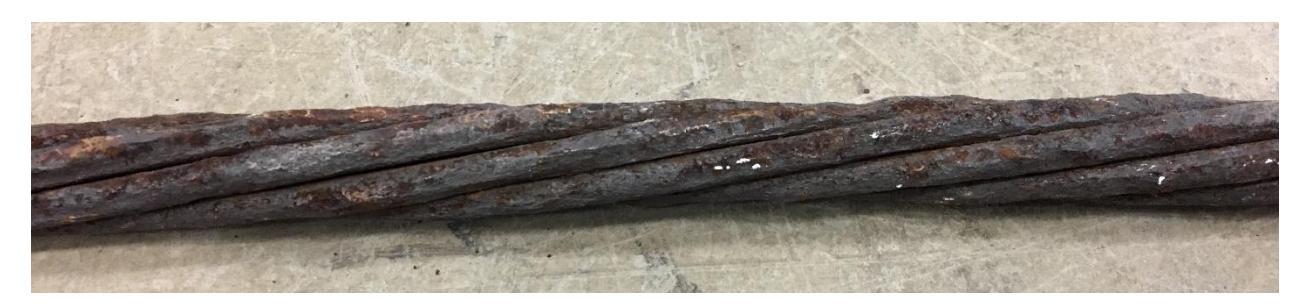
Strand 13_{cor} from Specimen 56-2-ES was cut from the exposed strand on the east side of the beam where extensive concrete spalling had occurred (Figure 3.11 and Figure G.4). Corrosion was relatively uniform along the exposed length of the strand and consisted of heavy pitting and minor section loss (Figure 4.20).

Figure 4.20: Strand 13_{cor} from Specimen 56-2-ES

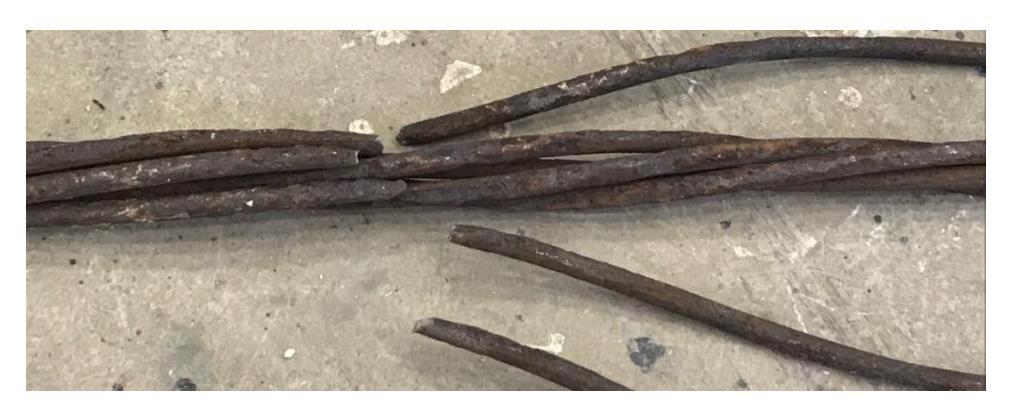
The failure section of Strand 13_{cor} is presented in Figure 4.21. As shown, failure was characterized by three wires fracturing at failure. The test results for Strand 13_{cor} are reported in Table 4.10, and the stress-strain curve is provided in Figure 4.22. As shown, the strand exhibited brittle behavior and a reduced modulus of elasticity, but the corroded section was able to resist 77% of the average breaking load of the uncorroded strands. A reduction in modulus had not been observed until this specimen test indicating an additional impact of more severe strand corrosion.

Figure 4.21: Specimen 56-2-ES Strand 13cor Failure

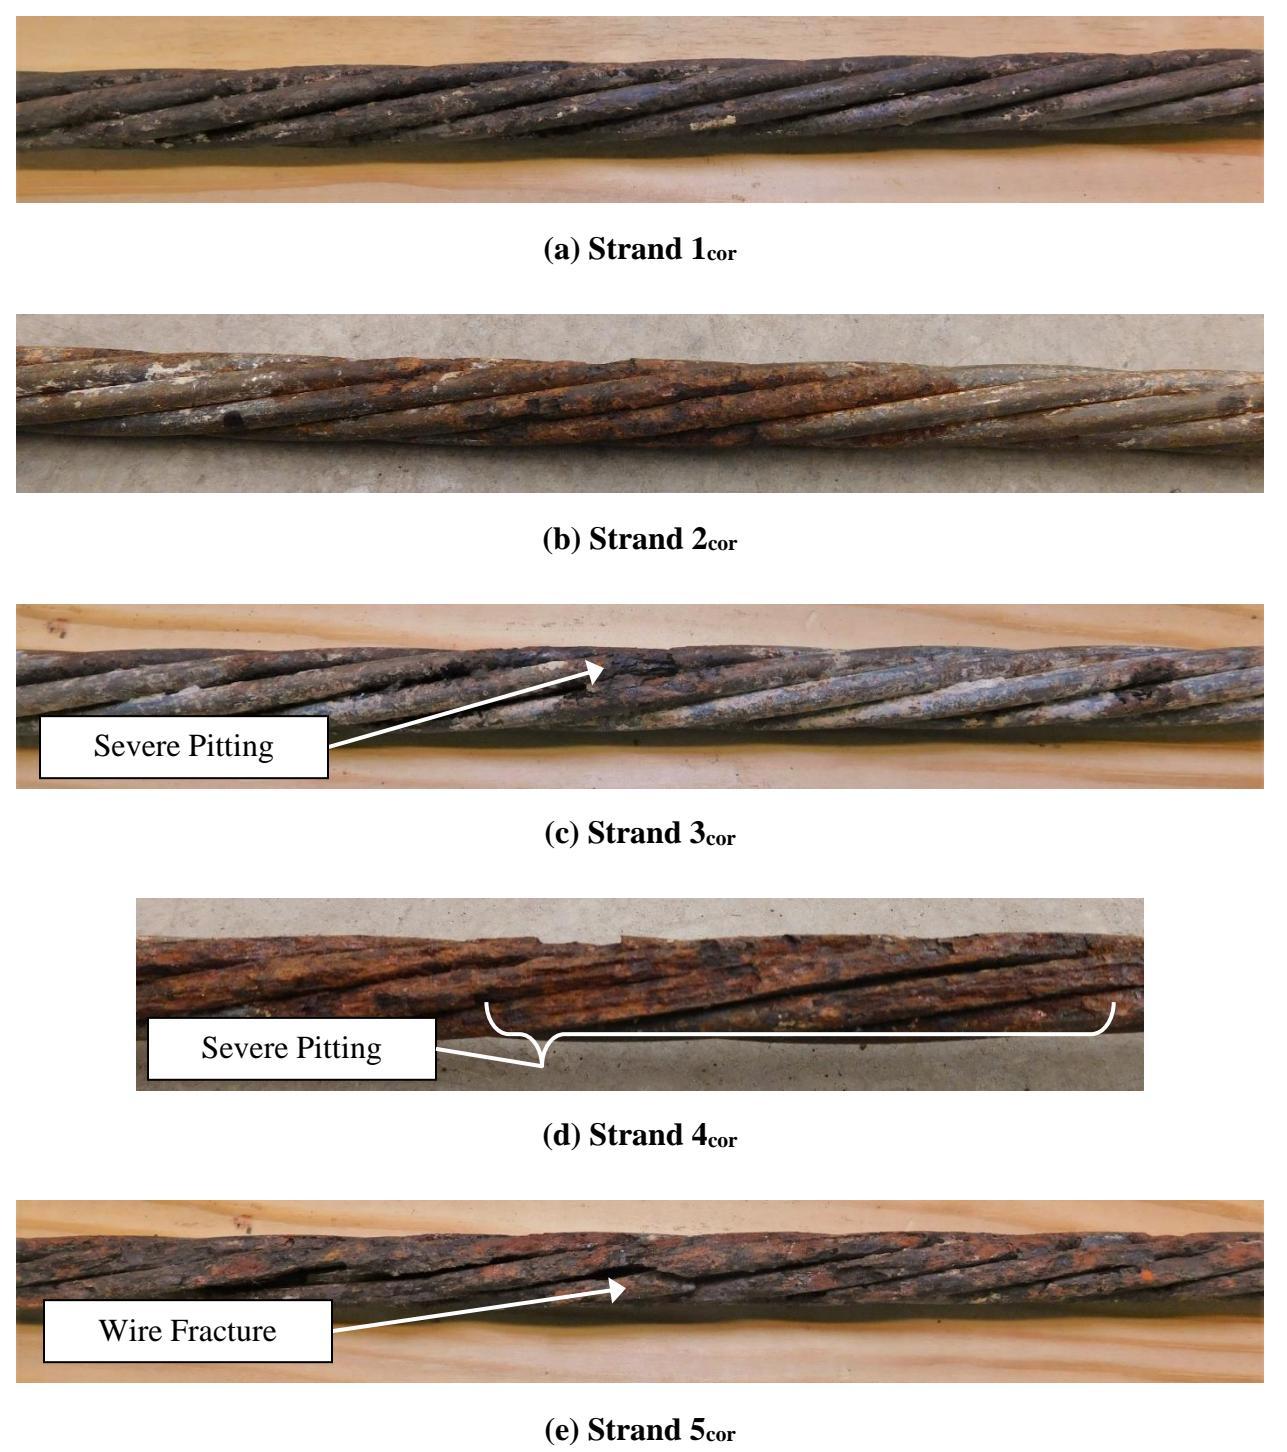
A series of five corroded strand sections were selected from Specimen 102-3-BS for testing. All strands were taken from Segment A and B (Figure 3.14 and Figure G.5). The strands exhibited various levels of corrosion ranging from surface corrosion with minor pitting (a) to severe section loss and fractured wires (e). The strands were labeled Strand 1_{cor} to 5_{cor} based on the level of corrosion with Strand 1_{cor} having the lightest corrosion and Strand 5_{cor} having the heaviest corrosion (Figure 4.23). Table 4.11 provides the actual strands numbers corresponding to Strands 1_{cor} to 5_{cor} .

Figure 4.23: Specimen 102-3-BS Corroded Strand Specimens

Strand 1_{cor} had surface corrosion with minor pitting along the length of the strand specimen (Figure 4.23(a)). Strand 2_{cor} had surface corrosion with localized pitting on three wires (Figure 4.23(b)). Strand 3_{cor} had minor surface corrosion with severe pitting of a single wire and no preexisting wire fractures (Figure 4.23(c)). Strand 4_{cor} was severely corroded with extensive pitting on four wires and no wire fractures prior to testing (Figure 4.23(d)). Strand 5_{cor} had severe section loss on six wires and three fractured wires before testing (Figure 4.23(e)). The wire fractures in Strand 5_{cor} occurred over a length of approximately 18 in. and could not be photographed all together.

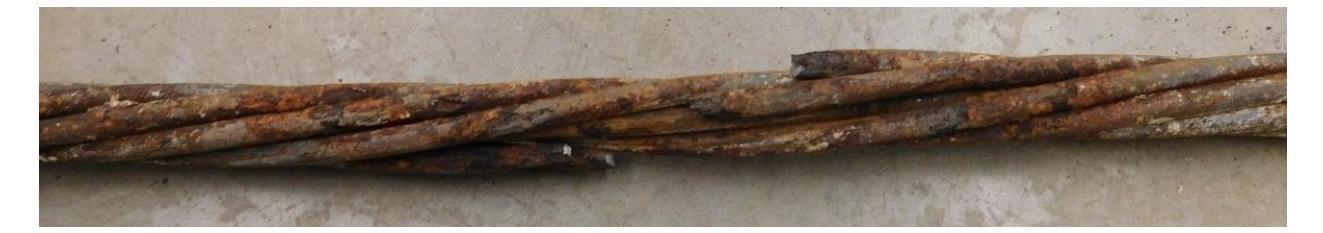
(a) Strand 1cor

The failure section of each strand is presented in Figure 4.24. The tests results are reported in Table 4.12, and the stress-strain curves are provided in Figure 4.25. Two wires fractured at failure of Strand 1_{cor} (Figure 4.24(a)). As shown in Figure 4.25, the strand failed as yielding was initiating. Strand 2_{cor} and Strand 3_{cor} exhibited three wire fractures at failure (Figure 4.24(b) and (c)). No yielding was observed in either strand before failure.

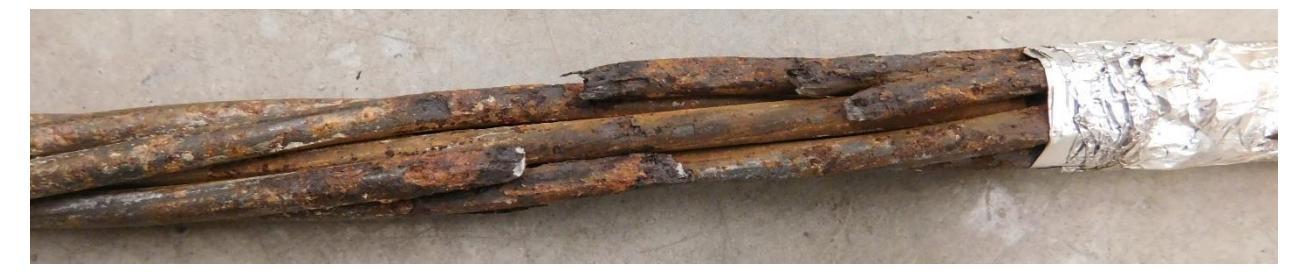
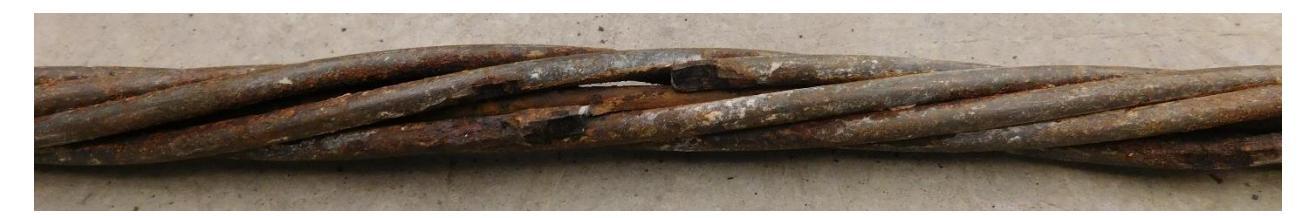
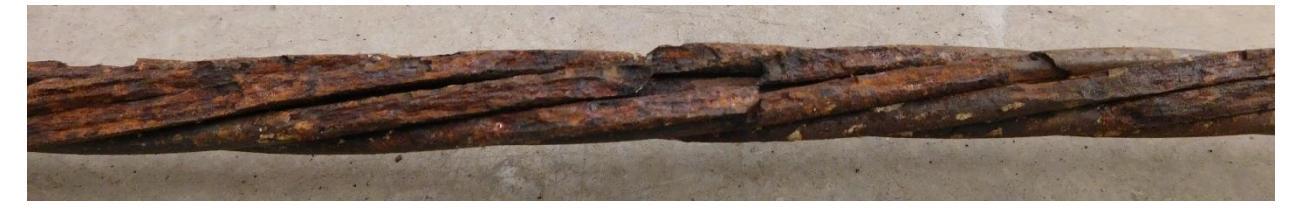
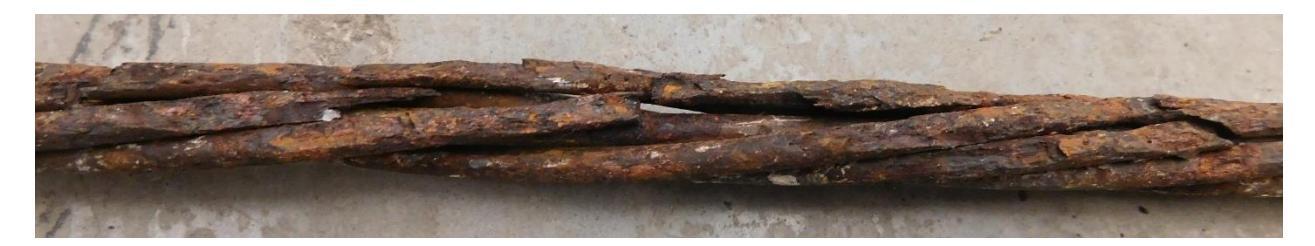
Failure of Strand 4_{cor} was characterized by four wires fracturing at peak load (Figure 4.24(d)). Initial loading of Strand 4_{cor} indicated the strand would exhibit a similar modulus of elasticity as the other corroded and uncorroded strands of Specimen 102-3-BS. At a stress (on the nominal cross-sectional area) of approximately 50 ksi, the stiffness of the strand softened slightly

and continued at a constant but reduced stiffness to failure. The reduction in stiffness may have been caused by one of the wires fracturing before failure.

Strand 5_{cor} , which initially had three fractured wires, fractured an additional two wires at failure (Figure 4.25(e)). While 4 wires were intact, the remaining strength was only 20% of the uncorroded breaking load. Considering that 4 wires may theoretically carry 57% of the uncorroded breaking load, the low value of breaking strength indicates the effect of corrosion on the remaining strands. The stiffness of Strand 5_{cor} from initial loading to failure was constant and similar to the reduced stiffness observed in Strand 4_{cor} from 50 ksi to failure. Based on this similarity, the reduced stiffness in Strand 4_{cor} is believed to have been caused by wire fracture during the test. Overall, as the level of corrosion increased, a significant reduction in the tensile capacity of the strand occurred.

(b) Strand 2_{cor} Figure 4.24: Specimen 102-3-BS Corroded Strand Specimens After Failure
