EVALUATION AND STRUCTURAL BEHAVIOR OF DETERIORATED PRECAST, PRESTRESSED CONCRETE BOX BEAMS

A Dissertation

Doctor of Philosophy

Lyles School of Civil Engineering West Lafayette, Indiana December 2019

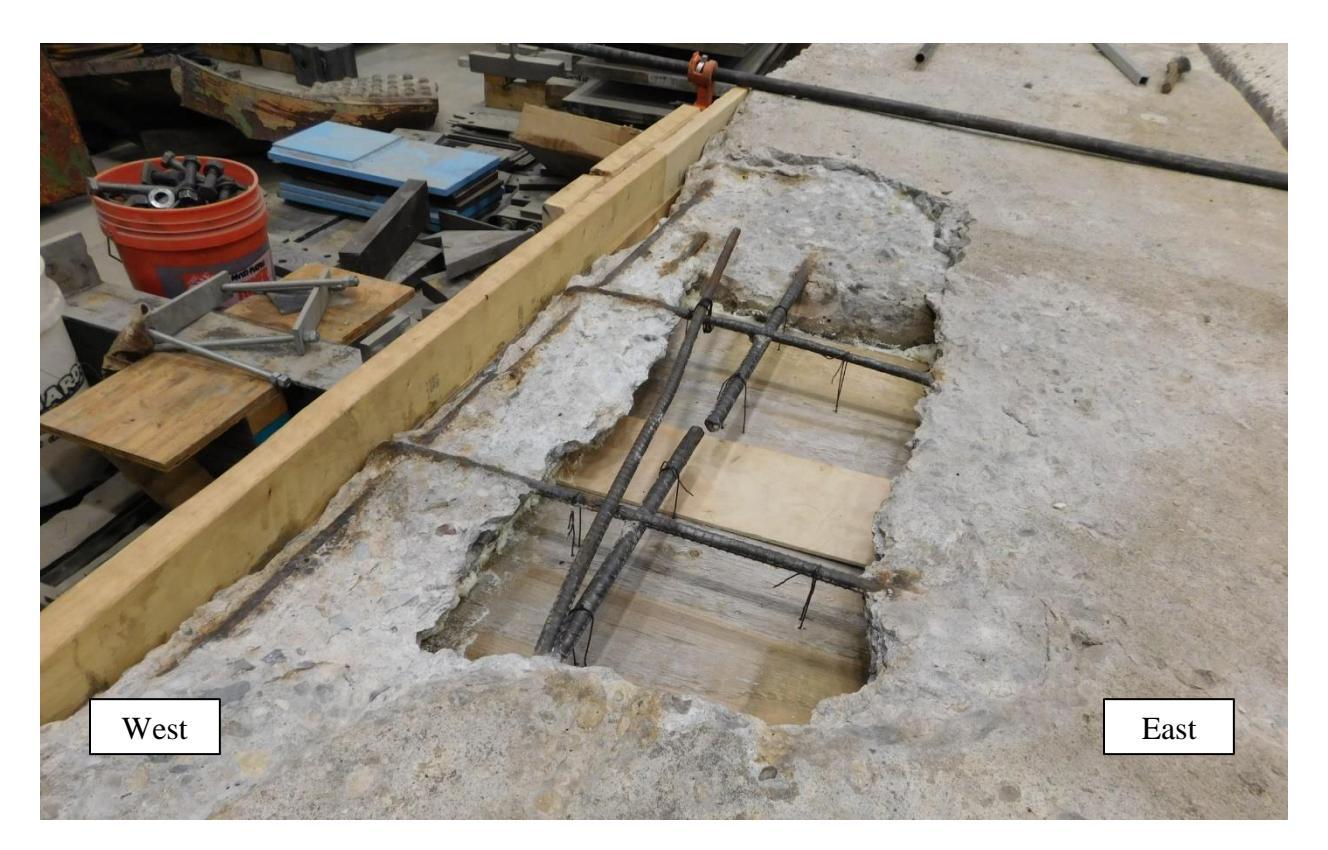
Figure 4.34: West Formwork for Specimen 244-1-LC Flange Repair

To replicate a repair procedure observed in the field, the concrete surrounding the hole was chipped away using a hammer and chisel until removal of concrete became difficult. Existing steel reinforcement exposed by the chipping operation was observed to be corroded. All corrosion product was removed with a wire brush, and after cleaning the reinforcement was observed to have very little section loss. Therefore, no additional steel was added to the repair. Formwork was then installed in the void to prevent concrete from filling the void (Figure 4.34 and Figure 4.35). The formwork and concrete were thoroughly cleaned with a wire brush and vacuum prior placing the

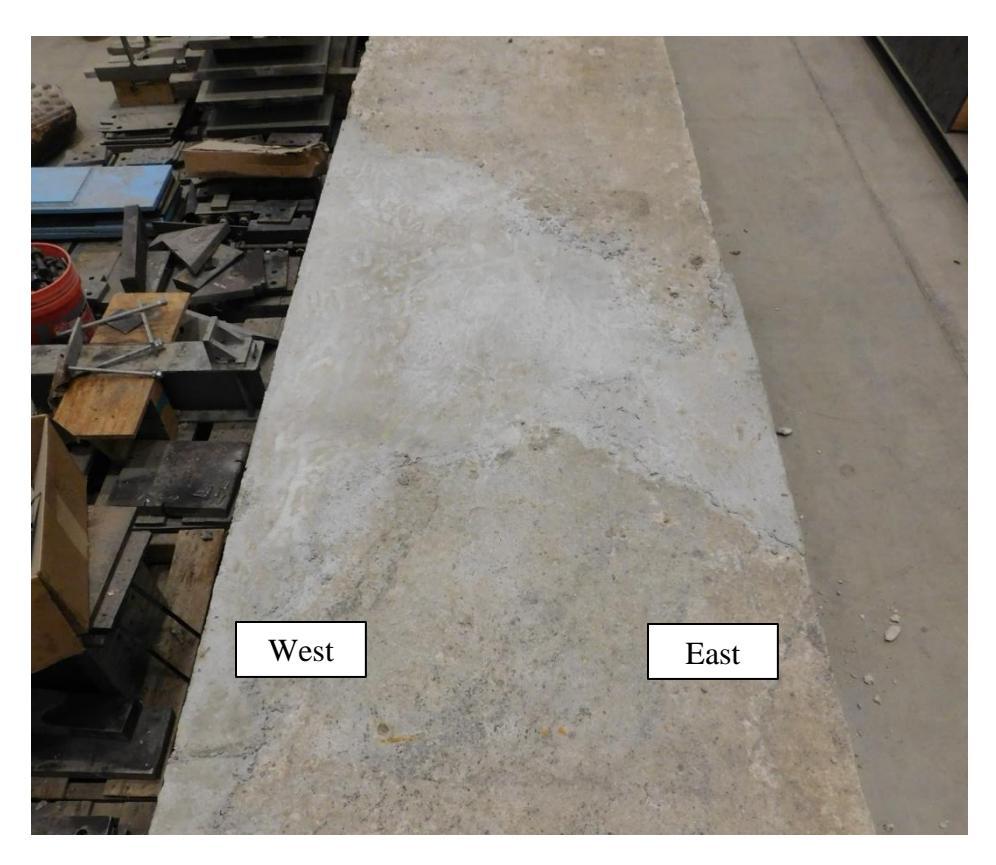
Figure 4.36: Specimen 244-1-LC Patch After Removal of Formwork

patch. The patch concrete consisted of Commercial Grade Quikrete 5000 with an estimated 28day strength of 5000 psi. The concrete was mixed and placed according the manufacturer's directions. Formwork was removed following 3-days of wet-curing with burlap covered by a plastic sheet. After formwork was removed, no additional curing time was used to simulate the in-service repair. Figure 4.36 shows the patch after formwork was removed.

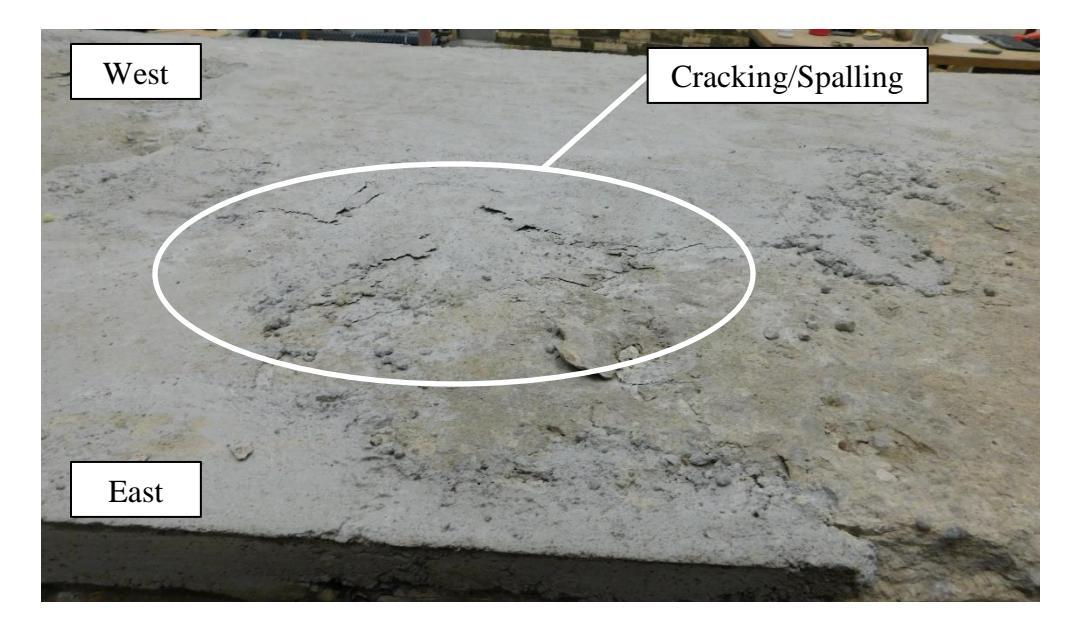
At an applied force of 35 kips, a change in stiffness was indicated by the load-deflection curve, and flexural cracking was observed (Figure 4.37). Loading continued after first cracking without any signs of distress in the longitudinal cracks. While crack mapping during the load pause at 3.5 in. of midspan deflection, the first signs of concrete crushing were noticed in the repaired top flange (Figure 4.38). Loading continued, and at an applied force of 49.4 kips (3.7 in

Figure 4.38: First Signs of Concrete Crushing

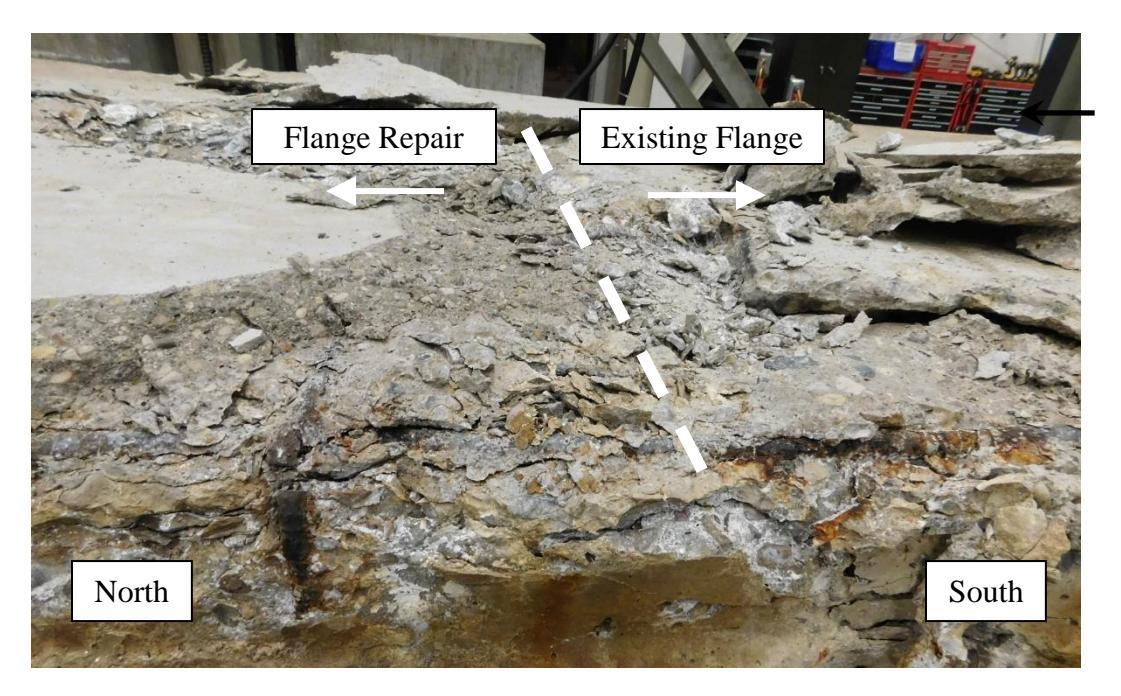
Investigation of the failure region revealed that concrete crushing extended throughout the width of the top flange. On the west side, where the repair was made, crushed concrete was observed both in the repair and in the existing concrete (Figure 4.39). On the east side, where a shallow spall had been repaired, crushing was observed to extend into the exterior web of the beam (Figure 4.40(a)) and through the entire thickness of the existing flange (Figure 4.40(b)). Cores taken from the top flange after failure indicated that the concrete in the top flange was delaminated (Figure 4.41).

Figure 4.39: Extent of Crushing on West Side of Top Flange

The condition of the concrete that crushed around the flange repair was very poor. The extent of deteriorated concrete was not fully removed by a hammer and chisel. A more destructive method would have been required to remove the deteriorated concrete to ensure that sound concrete had been reached before casting a new top flange. However, the process used in this test is consistent with that typically conducted in the field by contractors.

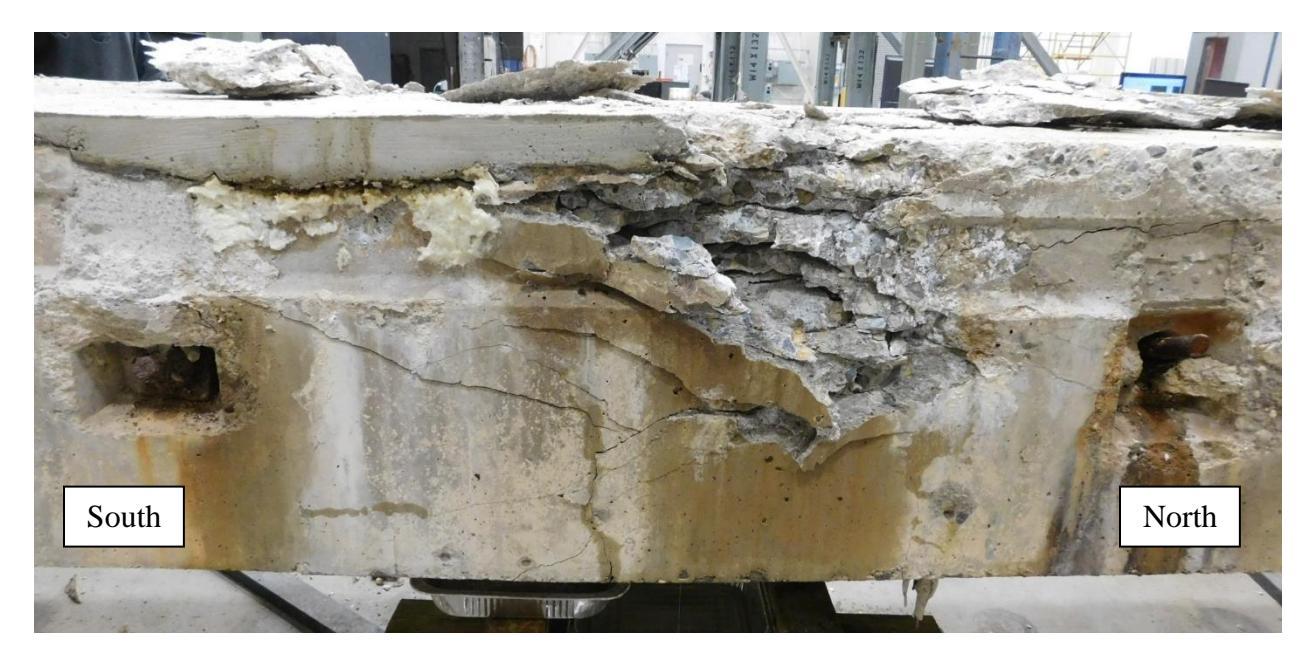
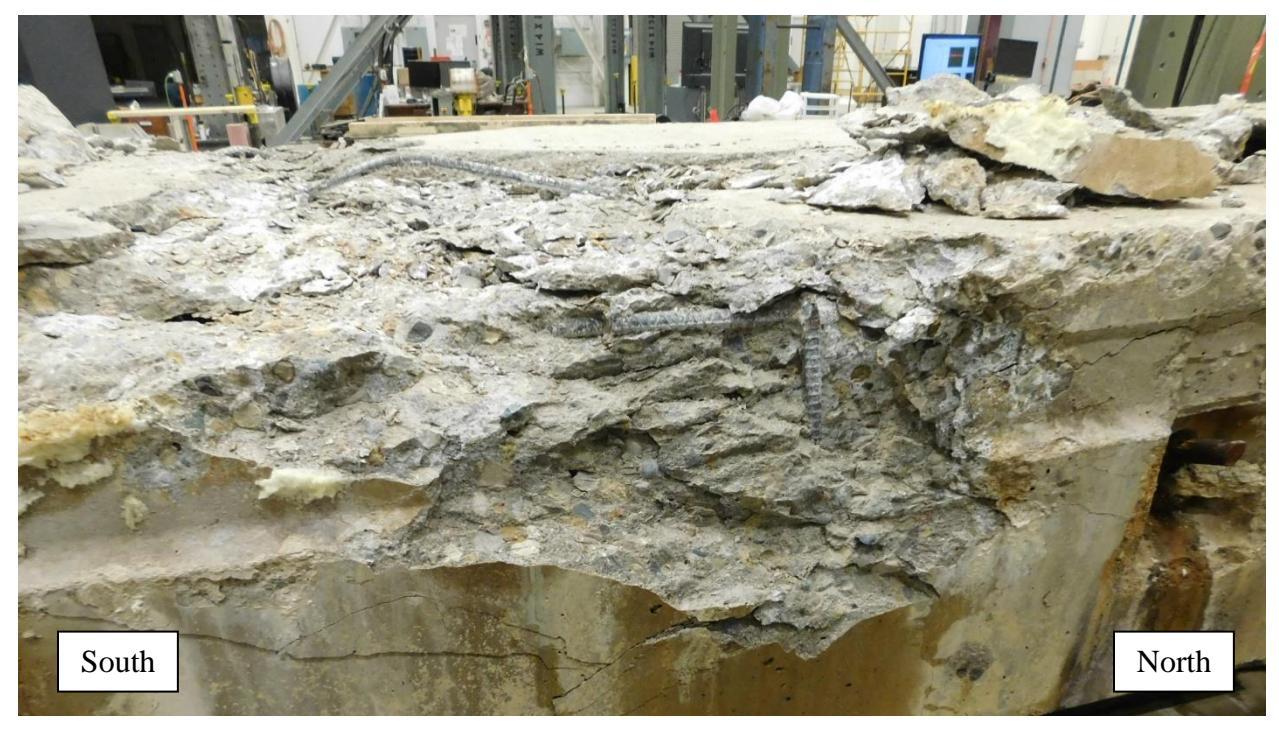
(b) After concrete spalls removed Figure 4.40: Extent of Crushing on East Side of Top Flange

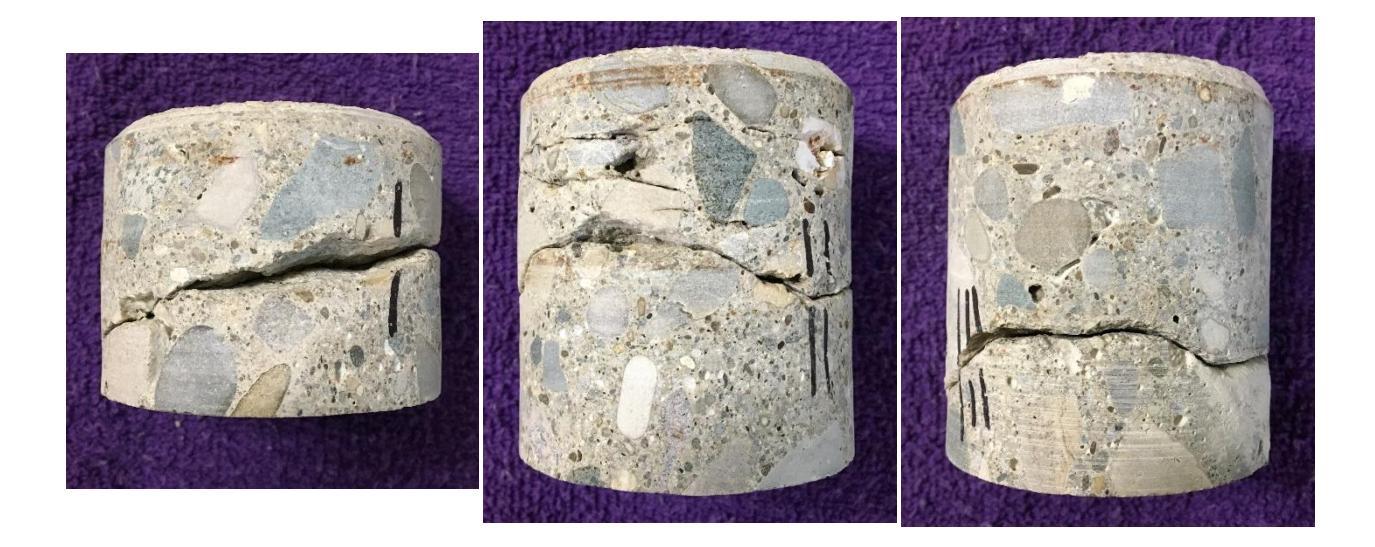
Figure 4.41: Concrete Cores from Specimen 244-1-LC Top Flange

The load-deflection curves for Specimen 244-1-LC are provided in Figure 4.126. As shown, the estimated undeteriorated behavior for the analytical and refined models follow the test data until the test ended at a midspan deflection of 3.7 in. The black dot on the refined curve indicates the load and deflection corresponding to a strain in the extreme fiber in compression of 0.0009 and strain in the prestressing strands of 0.008. Considering that the concrete in the top flange was observed to be delaminated after the test (Figure 4.41), the low strain of 0.0009 suggests that the concrete could not achieve typical strain levels of 0.003. In fact, only one third of that value was obtained for the delaminated concrete.

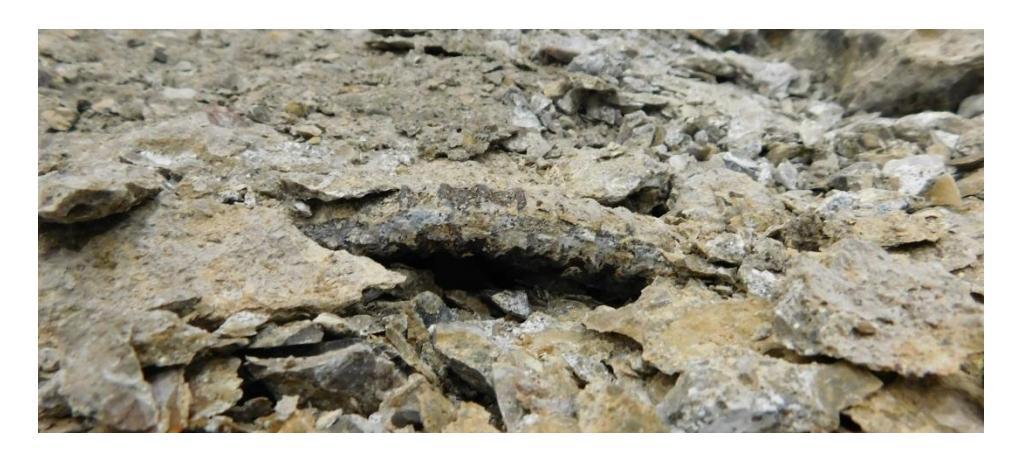
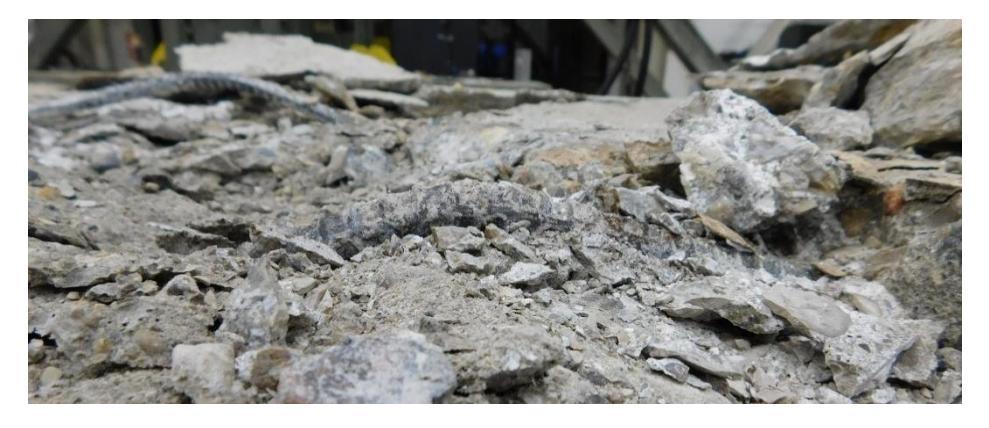
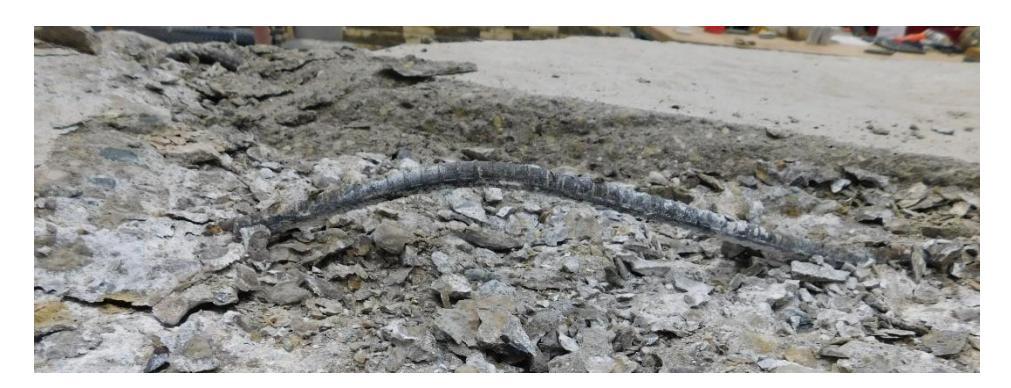
In addition to the extensive crushing, bar buckling was observed on the west side and middle of the failure region (Figure 4.42). The observation was also made that a corroded stirrup fractured on the west side of the beam (Figure 4.43). The stirrup was partially exposed during the repair process and observed with heavy pitting due to corrosion. Small flakes of corrosion product were removed from the stirrup while cleaning with a wire brush. No additional protection measures were taken prior to casting the patch.

(c) Middle of failure region Figure 4.42: Bar Buckling

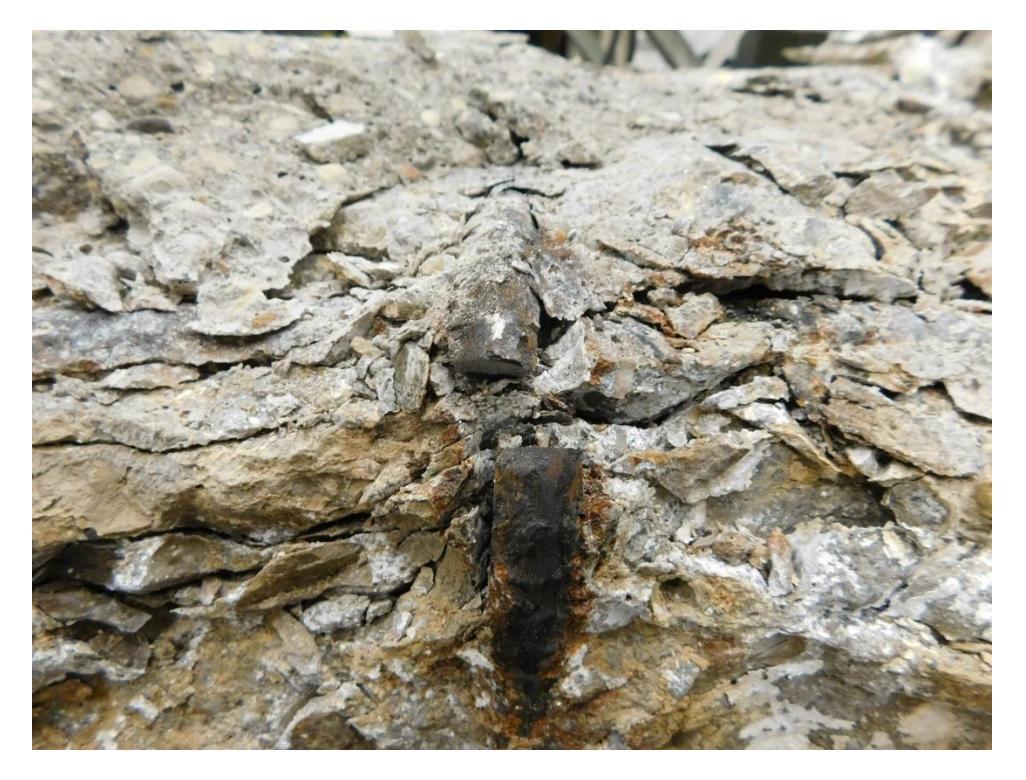
Figure 4.43: Fractured Stirrup

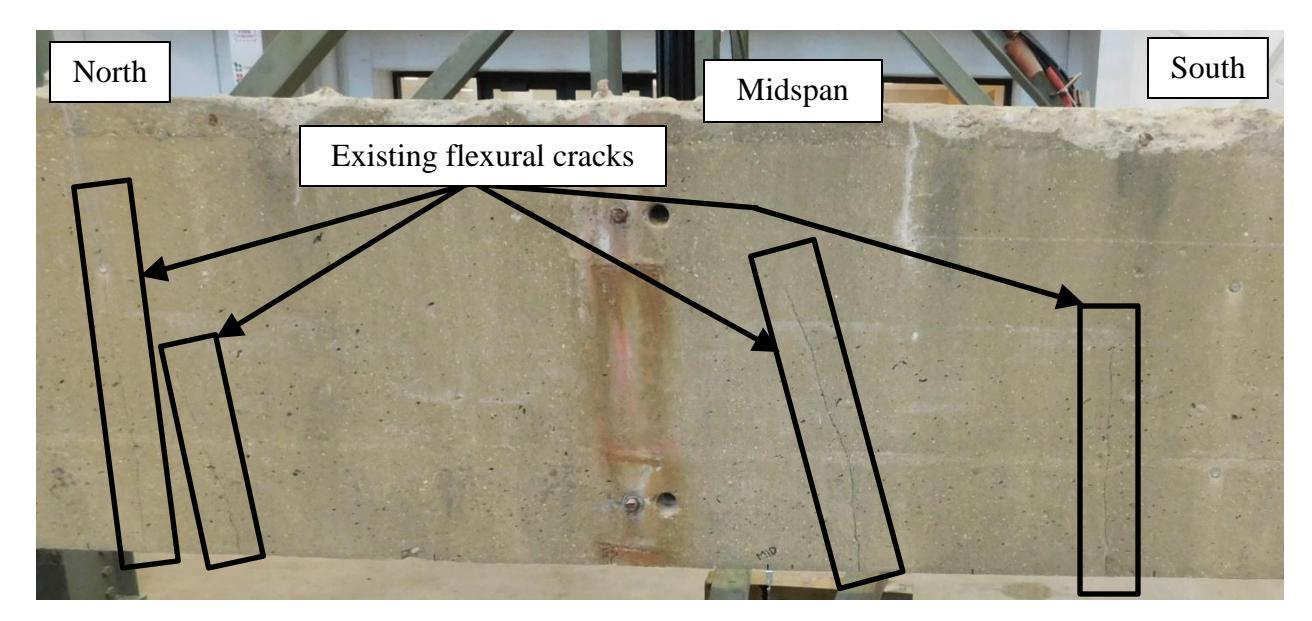
The deterioration of Specimen 409-1-ES consisted of a single concrete spall located 8 ft from the north end of the beam (Figure 3.2) and 7 ft 4 in. from the north test support. The specimen was constructed with a 2-1/2 in. thick concrete topping (Figure D.2). Prior to testing, flexural cracking was observed in the constant moment region (Figure 4.44).

Figure 4.44: Existing Flexural Cracking

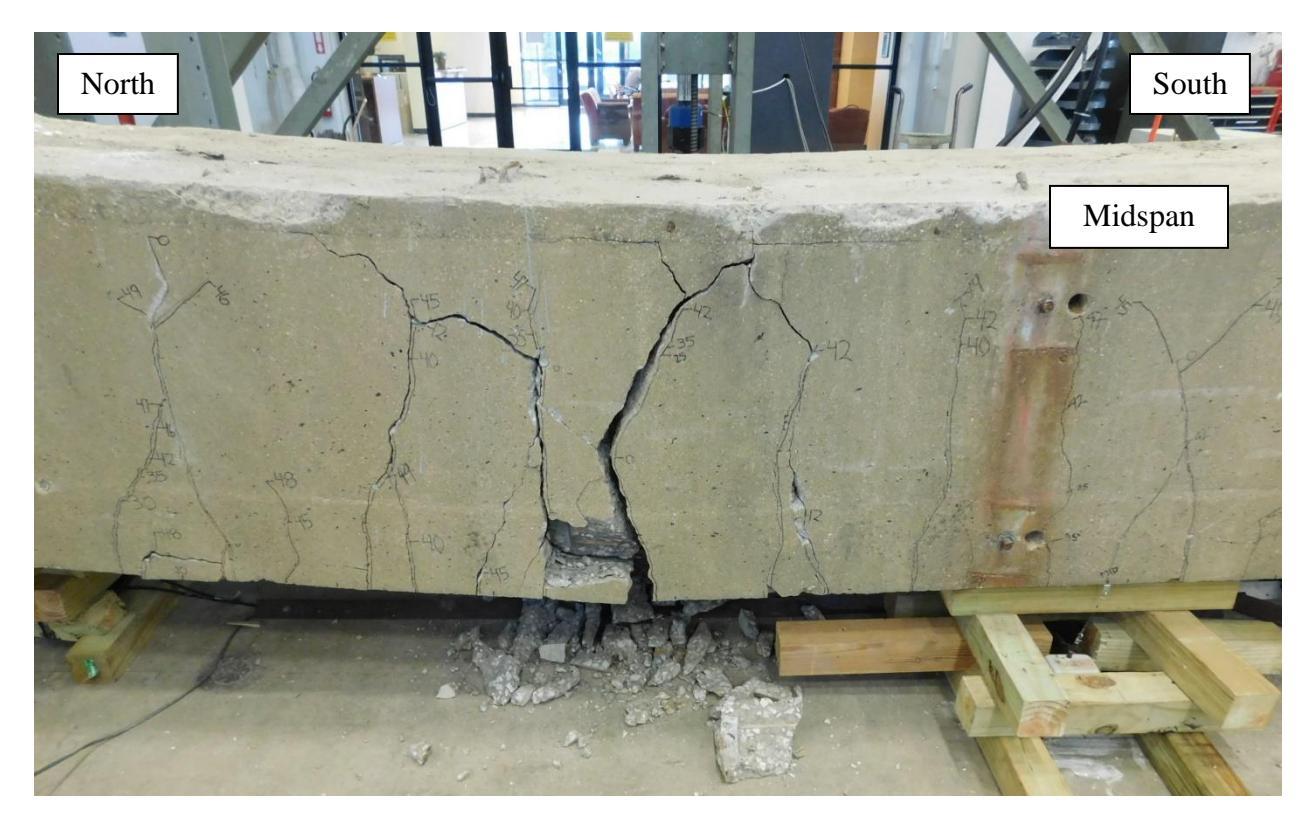
Figure 4.47: Collapse of Specimen 409-1-ES

As shown in Figure 4.47, no concrete crushing was observed in the top flange indicating that failure was controlled by strand fracture. In addition, no slip between the topping slab and top of beam was observed throughout the test. The lack of slip indicates that the topping slab acted compositely with the beam throughout the test.

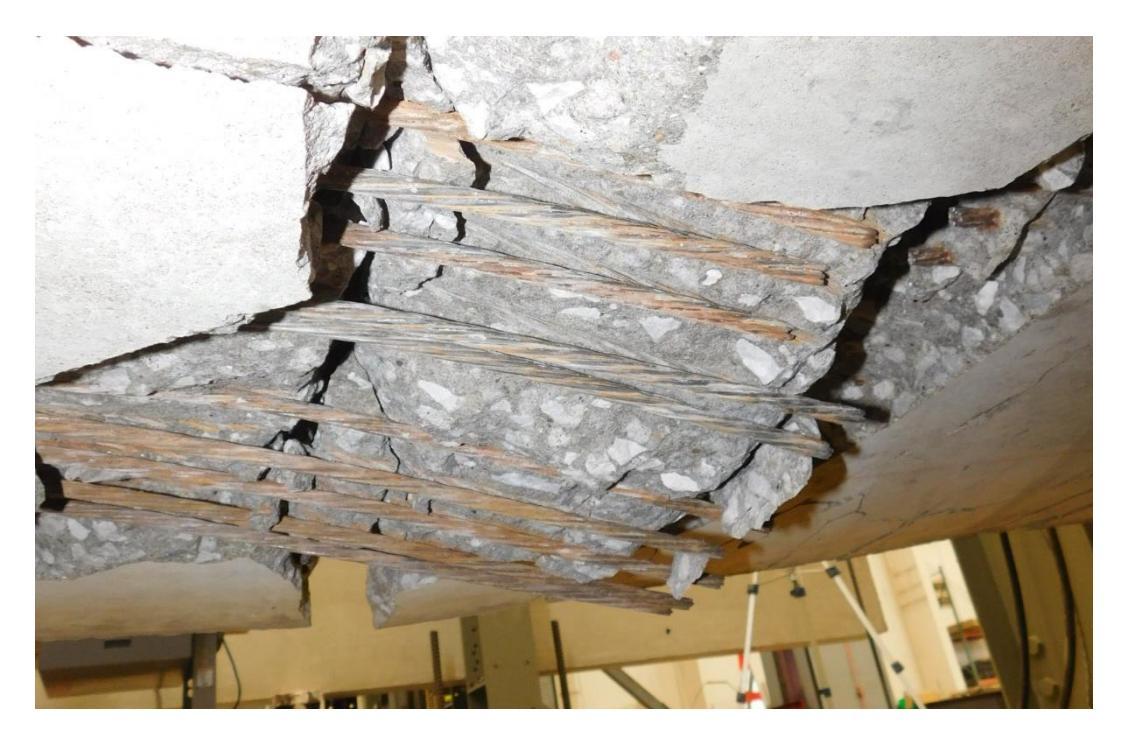
Visual inspection of the strands revealed that some very light surface rust was present on the strands at the fracture location (Figure 4.48). In addition, the failure section corresponded to one of the existing cracks shown in Figure 4.44. Considering the reduction in ductility observed in the corroded strand tension tests, the cause of failure for Specimen 409-1-ES is likely related to a reduction in the ultimate tensile strain capacity of the strand.

Figure 4.48: Light Surface Rust on Strands

The existing strand fractures in Specimens 102-1-BS, 102-2-BS, 102-3-BS, and 102-4-BS were located within the maximum moment region. Therefore, the overall prestress force at the section of maximum moment was reduced because there was zero force in the fractured strands. The loss of prestress at a section of maximum moment leads to a reduced cracking moment that may lead to flexural cracking under service loads which may result in strand corrosion. Corrosion was observed at existing flexural cracks in Specimens 409-1-ES (Figure 4.48) and 102-4-BS (Figure 3.41).

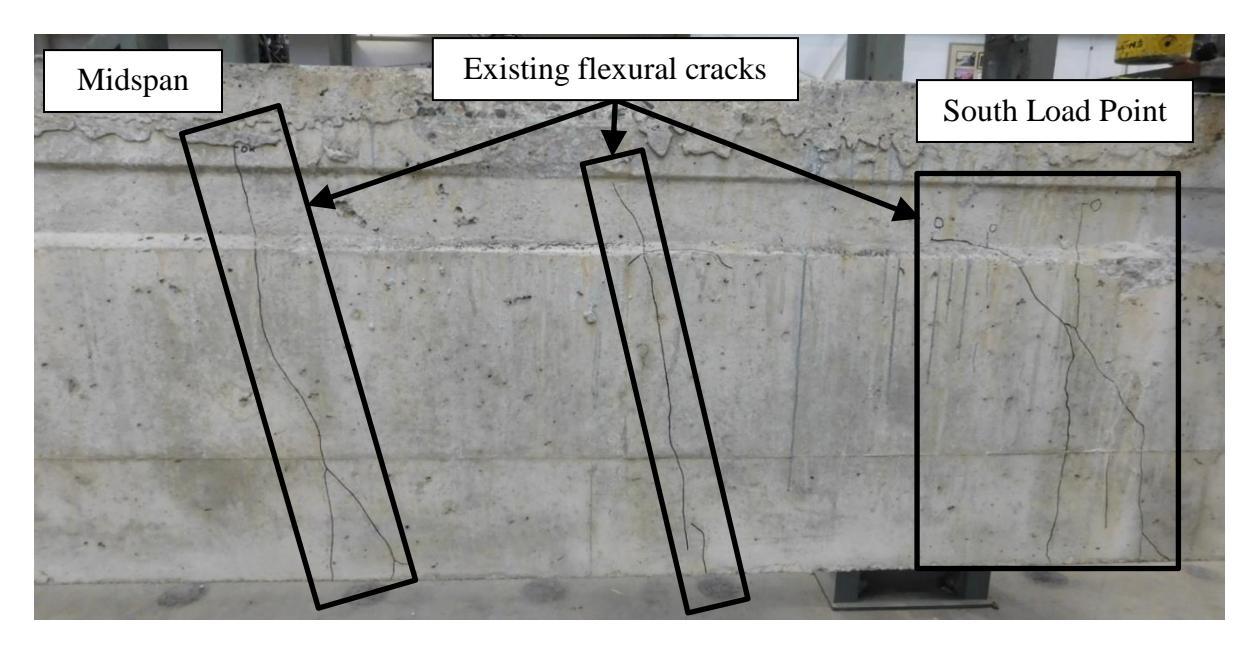
The only deterioration observed in Specimen 409-2-UD was water staining on the west edge from a leaking shear key (Figure 3.3). The specimen was constructed with a 2-1/2 in. thick concrete topping slab (Figure D.3). Existing flexural cracks were also observed and marked before testing began (Figure 4.49).

Figure 4.49: Existing Flexural Cracks in Constant Moment Region

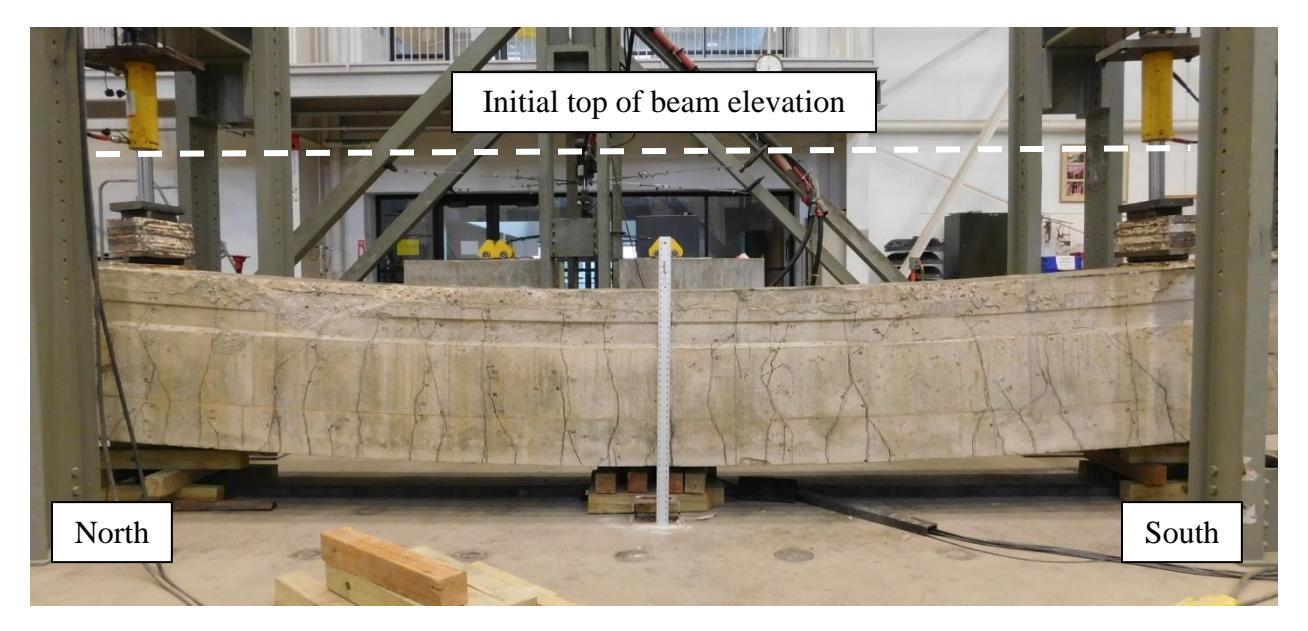
The stroke limit of the hydraulic jacks was reached at a midspan deflection of 12.4 in. and again at 17.7 in. Each time the stroke limit was reached, the beam was completely unloaded, and steel shim-plates were added to continue loading. At 21.1 in. of midspan deflection, the midspan string potentiometers were removed to prevent damage to the sensors. Loading continued using a ruler to record the midspan deflection. At approximately 23 in. of midspan deflection and an applied force of 50.3 kip, the test was discontinued as the limits of the test setup had been reached (Figure 4.51 and Figure 4.52). Although no concrete crushing or strand fracture was observed, the

Figure 4.51: Constant Moment Region at End of Test

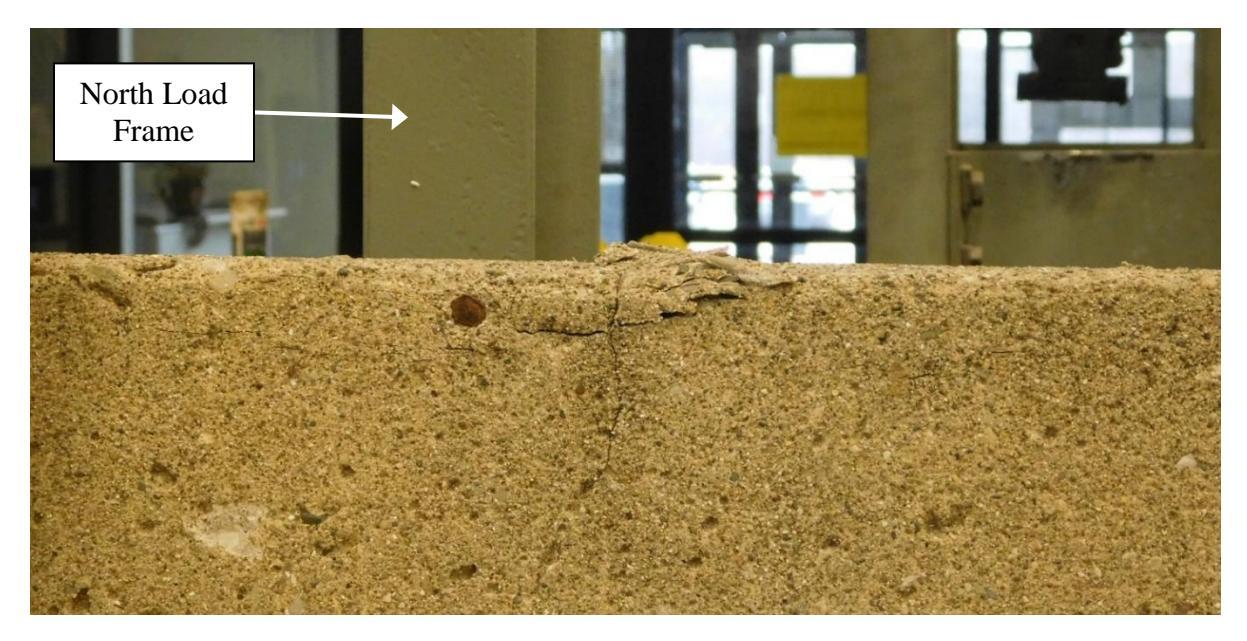
Figure 4.54: Initiation of Concrete Crushing at Top of Curb

After cracks became visible, the loading procedure was continued until cracking was heard from the north load point at an applied load of 67.5 kip and a midspan deflection of 4.6 in. Loading was paused, and crushing was observed in the top of the curb approximately 1 ft from the north load point within the constant moment region (Figure 4.54). The loading procedure was resumed until the rotation limit of the spherical bearing on the north hydraulic jack was reached (68.9 kips applied load, 5.22 in. midspan deflection). The specimen was completely unloaded, and the bearing plate was tilted using USG Hydro-Stone® to accommodate further rotation. When the specimen was reloaded, cracking in the top flange was observed indicating that the load plate was punching through the top flange (Figure 4.55). The test was discontinued, and the beam was cut apart at the north load point to determine the source of punching.

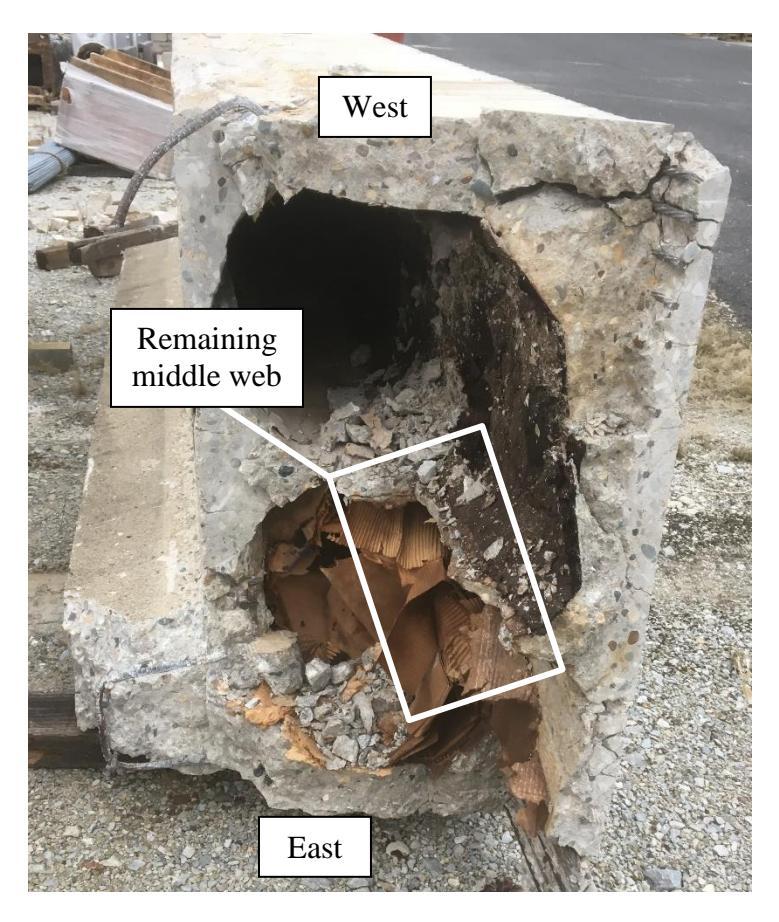
Figure 4.56: Middle Web Crushing

Once the beam was cut apart, the middle web was observed to be crushed for a length of approximately 18 in. (Figure 4.56). In addition, the middle web thickness was measured to be 1 in. For comparison, the standard drawings for Specimen K5-1-LC indicate that the middle web thickness should have been 3.5 in. (Figure D.4(b)). The steel bearing plates used between the hydraulic jacks and the beam were 18 in. wide, 6 in. long and 1 in. thick (plate width oriented across beam width as shown in Figure 4.55). The size of the plate clearly influenced the punching shear failure. If the plate had been wider, the applied force could have been spread to the outer webs. To avoid web crushing in future tests, the size of the bearing plate was increased to 48 in. wide, 12 in. long, and 2 in. thick.

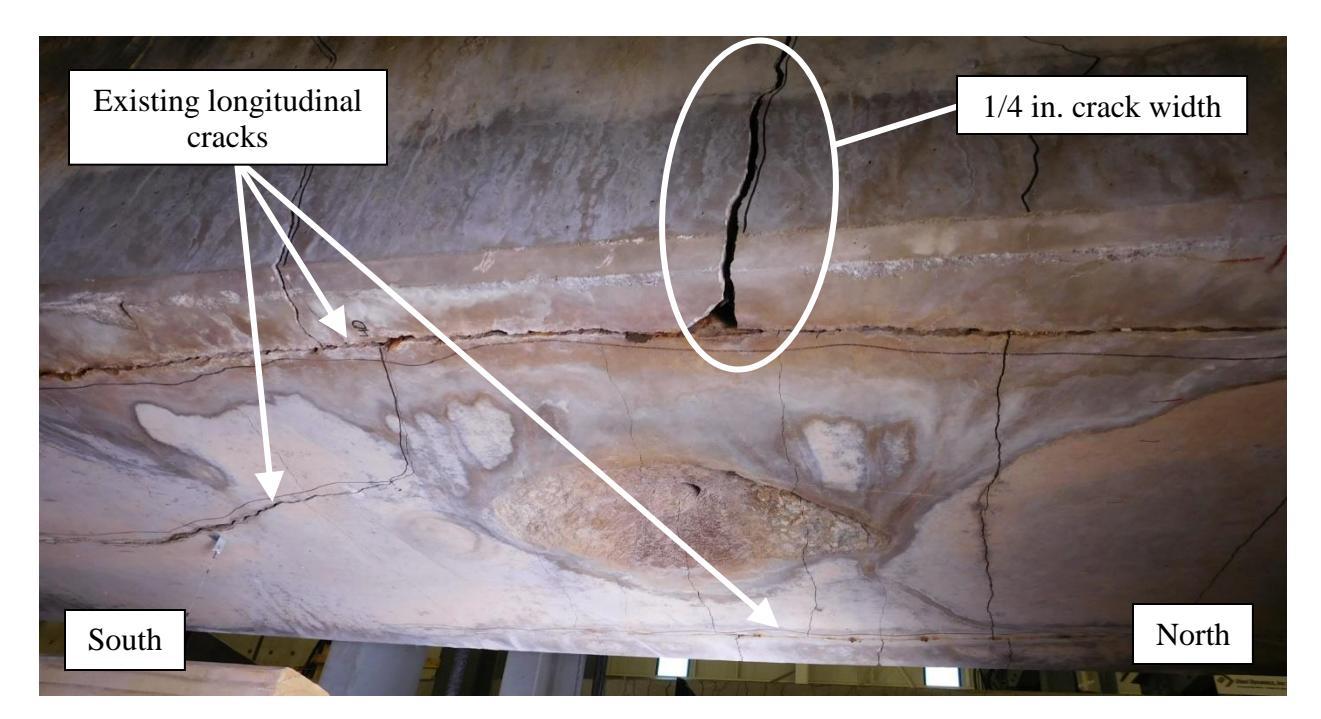
Figure 4.58: Flexural Crack at Existing Deterioration

After the cracking moment was exceeded, cracking and popping were heard throughout the loading periods and during the load pauses. Each noise was associated with a small decrease in measured force. The load procedure was continued up to an applied load of 49.3 kips and a midspan deflection of 3.5 in., when two loud pops were heard. The loud pops were accompanied by a drop in measured force of 4.2 kips, and therefore assumed to correspond to strands fracturing. At the loading pause after the decrease in load, a flexural crack on the east side of the specimen was observed to have increased in width to approximately 1/4 in. (Figure 4.58).

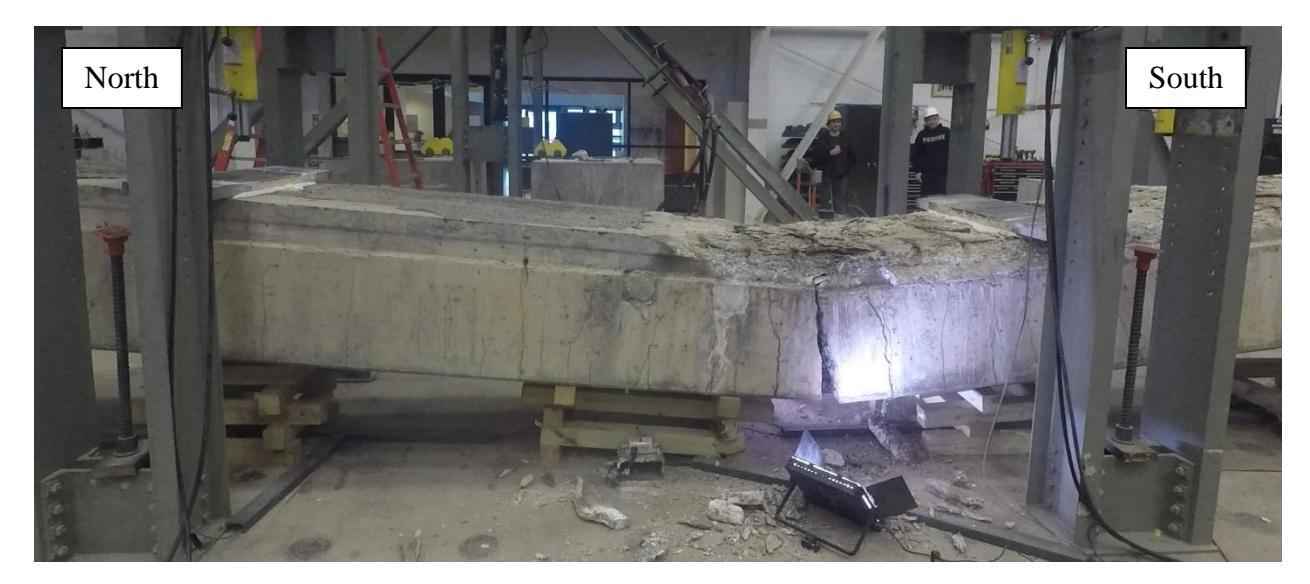
Figure 4.59: Failure of Specimen K5-2-LC

Loading continued and loud pops were heard again at midspan deflections of 4.0 in. (45.0 kip) and 5.0 in. (43.9 kip). Each pop was accompanied by a drop in measured force of 1 to 2 kips. As loading continued, flexural cracks in the deteriorated region continued to increase in width. At 5.6 in. of midspan deflection (42.5 kip), concrete spalling was observed in the top flange approximately 3 ft from the south load point into the constant moment region. After a load pause at 6.0 in. of midspan deflection, loading continued to a midspan deflection of 6.6 in. when a very loud pop was heard that was immediately followed by total collapse of the beam (Figure 4.59).

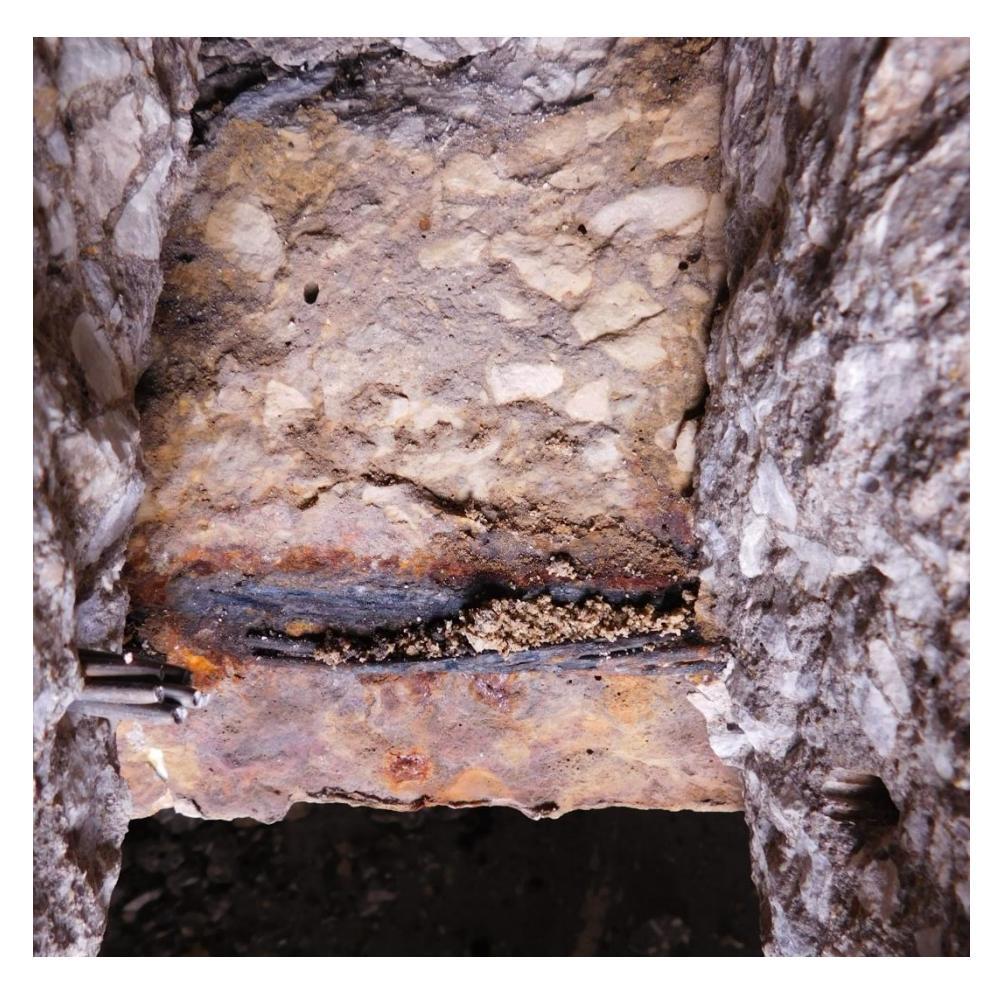
Figure 4.60: Large Flexural Crack on West Side After Failure

The failure section corresponded to the location of the large flexural crack on the west side of the specimen observed after the first two loud pops (Figure 4.60). As shown, the crack exposed the corroded strand at the west longitudinal crack in the bottom flange. On the east side of the beam, the failure region exposed the strand crossed by the east longitudinal crack (Figure 4.61). In addition, minor concrete crushing was observed in the top flange (Figure 4.62) which was evident after failure of the strands.

The east and west longitudinal cracks caused corrosion of two strands at the plane of failure. The loss of these strands created a weak section where deformation was concentrated and drove fracture of additional strands. No further distress of the middle longitudinal crack was observed during the post-failure investigation of the beam. The structural repair of the top flange (Figure D.6) was not in good condition at the end of the test but did not suffer extensive damage until collapse of the beam. Concrete cores taken from the patch after testing revealed significant cracking parallel to the top surface of the beam (Figure 4.1). This indicates that delaminated concrete was present but did not control the failure mode.

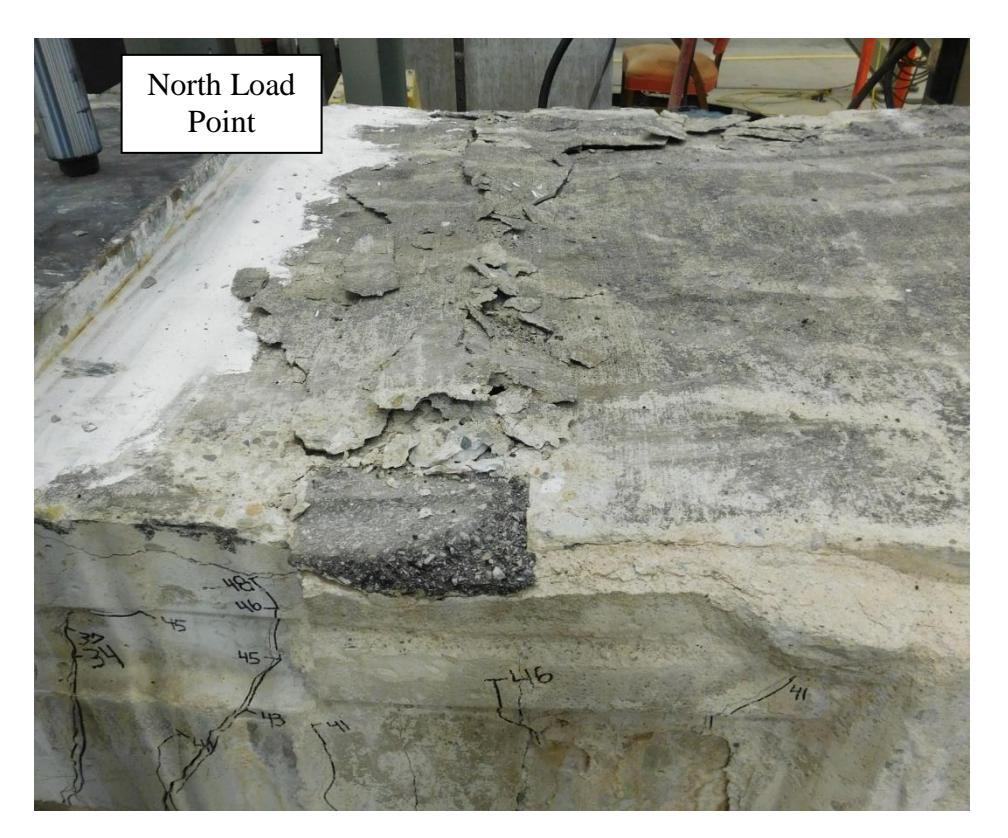
Figure 4.68: Concrete Crushing at 11.0 in. of Midspan Deflection

After first cracking, the load procedure continued until the measured force started to drop at a midspan deflection of 10.9 in. (50.5 kips). As loading continued, the force steadily dropped until loading was paused at 11.0 in (47.7 kips). As the beam was inspected, the concrete suddenly crushed 2 ft from the north load point into the constant moment region, and the measured force reduced to 43.0 kips (Figure 4.68 and Figure 4.69). The stroke limit of the hydraulic jacks had nearly been reached at 11.0 in of midspan deflection. Therefore, considering the 15% reduction in measured force and the evidence of concrete crushing, the test was concluded, and the specimen was unloaded. No strand fracture was observed.

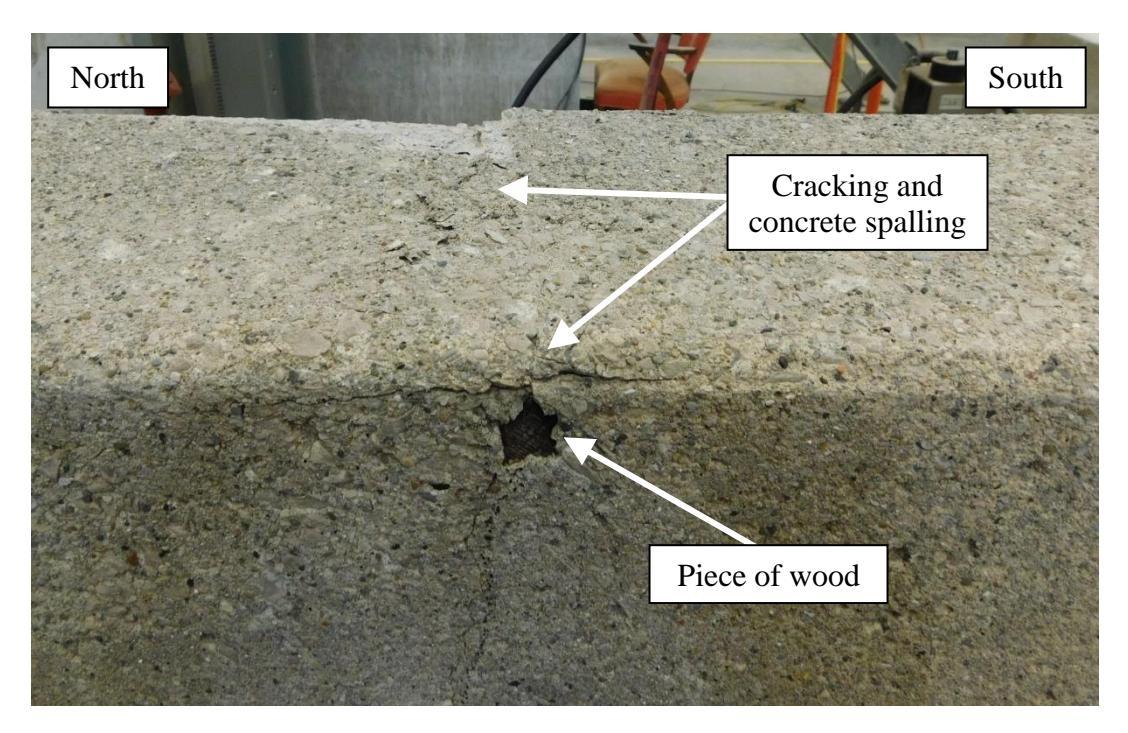
Figure 4.72: Initiation of Concrete Crushing

After the cracking moment was exceeded, the loading procedure was continued up to 2.0 in. of midspan deflection (43.3 kips) where the first signs of crushing were observed at the top of the curb at the location of a small piece of wood embedded in the curb (Figure 4.72). As loading continued, concrete crushing around the piece of wood increased. Figure 4.73 shows the region at a midspan deflection of 3.0 in. (46.5 kips).

The compression test results for the concretes cores from the curb of Specimen 79-3-UD showed that, on average, the strain at peak stress was 0.0027 (Table 4.4) which is higher than the estimated strain of 0.0019. This indicates that the piece of wood embedded in the curb (Figure 4.72) prevented the surrounding concrete from reaching its full strain capacity and caused premature concrete crushing in the curb of the specimen, resulting in reduced ductility of the specimen.
