EVALUATION AND STRUCTURAL BEHAVIOR OF DETERIORATED PRECAST, PRESTRESSED CONCRETE BOX BEAMS

A Dissertation

Doctor of Philosophy

Lyles School of Civil Engineering West Lafayette, Indiana December 2019

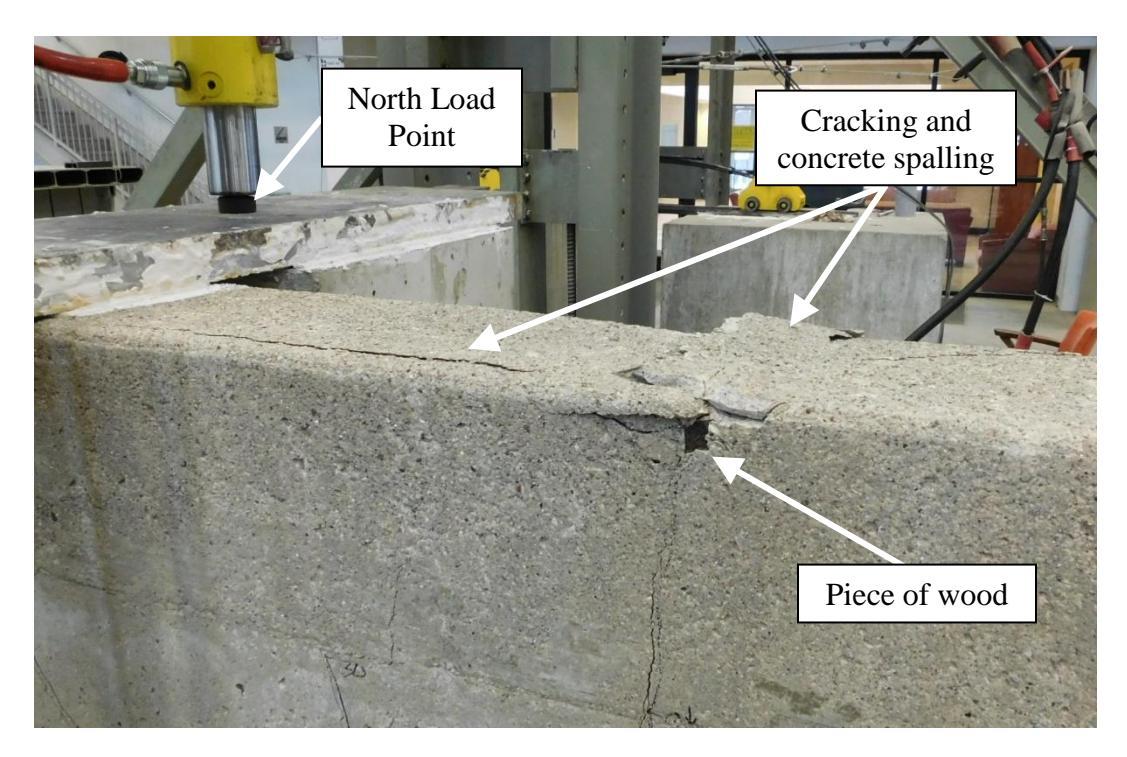
Figure 4.73: Concrete Crushing at 3.0 in. of Midspan Deflection

After the cracking moment was exceeded, the loading procedure was continued up to 2.0 in. of midspan deflection (43.3 kips) where the first signs of crushing were observed at the top of the curb at the location of a small piece of wood embedded in the curb (Figure 4.72). As loading continued, concrete crushing around the piece of wood increased. Figure 4.73 shows the region at a midspan deflection of 3.0 in. (46.5 kips).

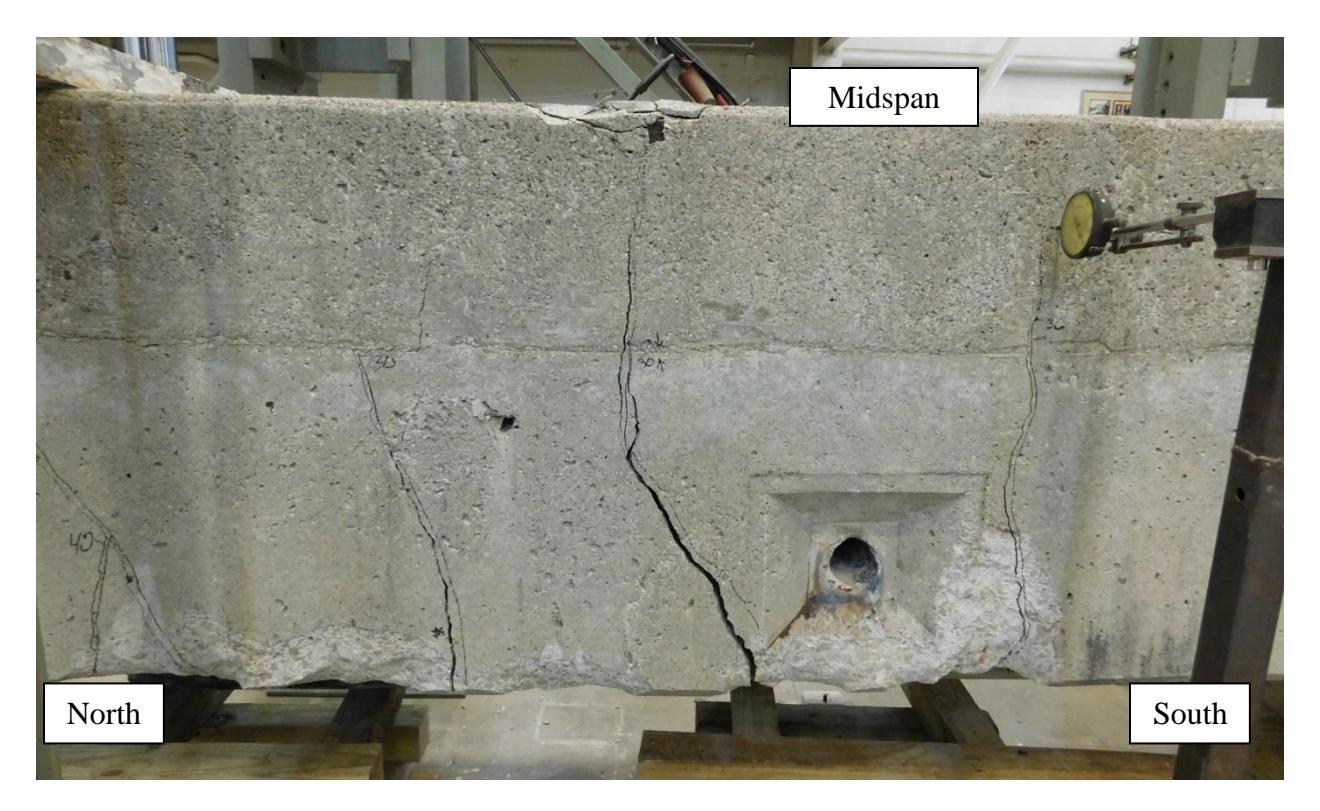
Figure 4.74: Flexural Crack on West Side After Decrease in Measured Force

The loading procedure resumed, and at a midspan deflection of 3.2 in. (46.7 kips), the measured force started to decrease. Three loud pops were heard in succession, and the measured force decreased to 35.1 kips. One of the flexural cracks on the west side (curb side) of the specimen was observed to increase in width to approximately 3/8 in. (Figure 4.74). A similar increase in crack width was not observed on the east side of the specimen. Concrete crushing around the piece of wood increased on the east side of the curb but not on the west side (Figure 4.75).

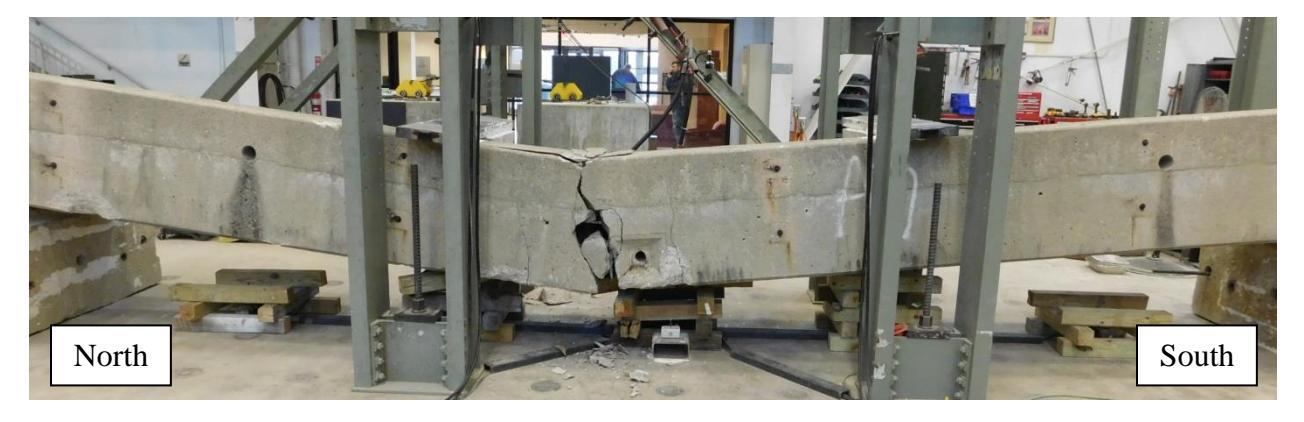
Figure 4.76: Collapse of Specimen 79-3-UD

The loading procedure was resumed, and at a midspan deflection of 3.8 in., a loud pop was heard that was immediately followed by total collapse of the beam (Figure 4.76). Figure 4.77 and Figure 4.78 show the extent of crushing observed after collapse. The first strand fracture was heard on the curbside of the beam. The beam was also observed to have swayed toward the curbside after failure.

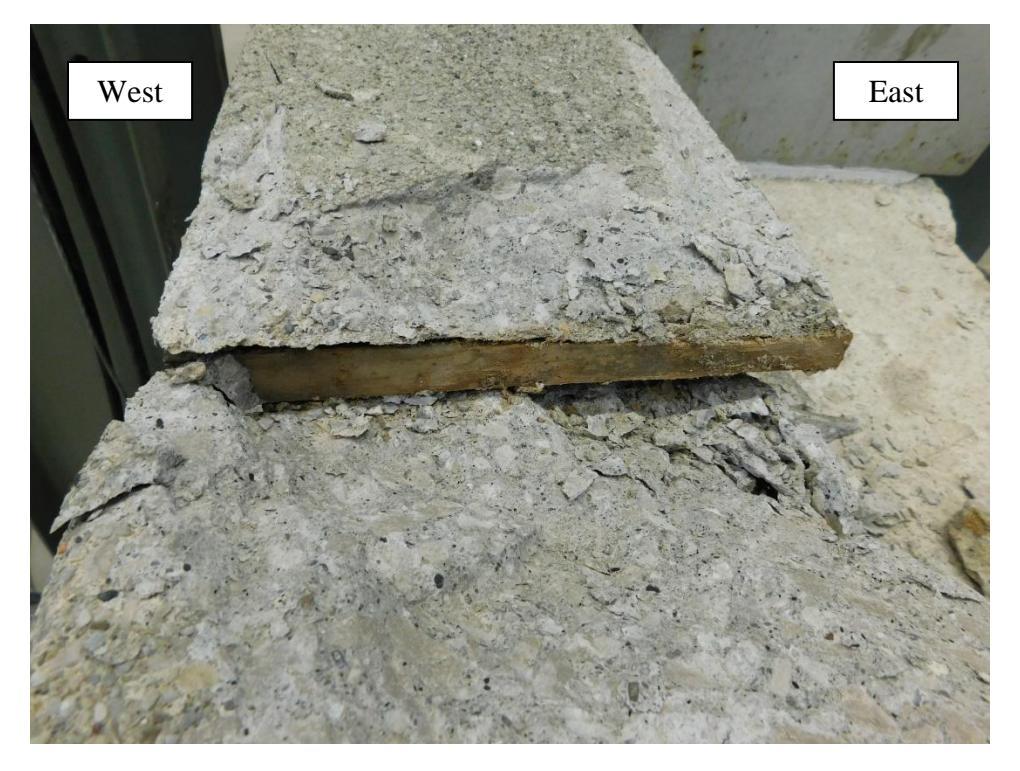
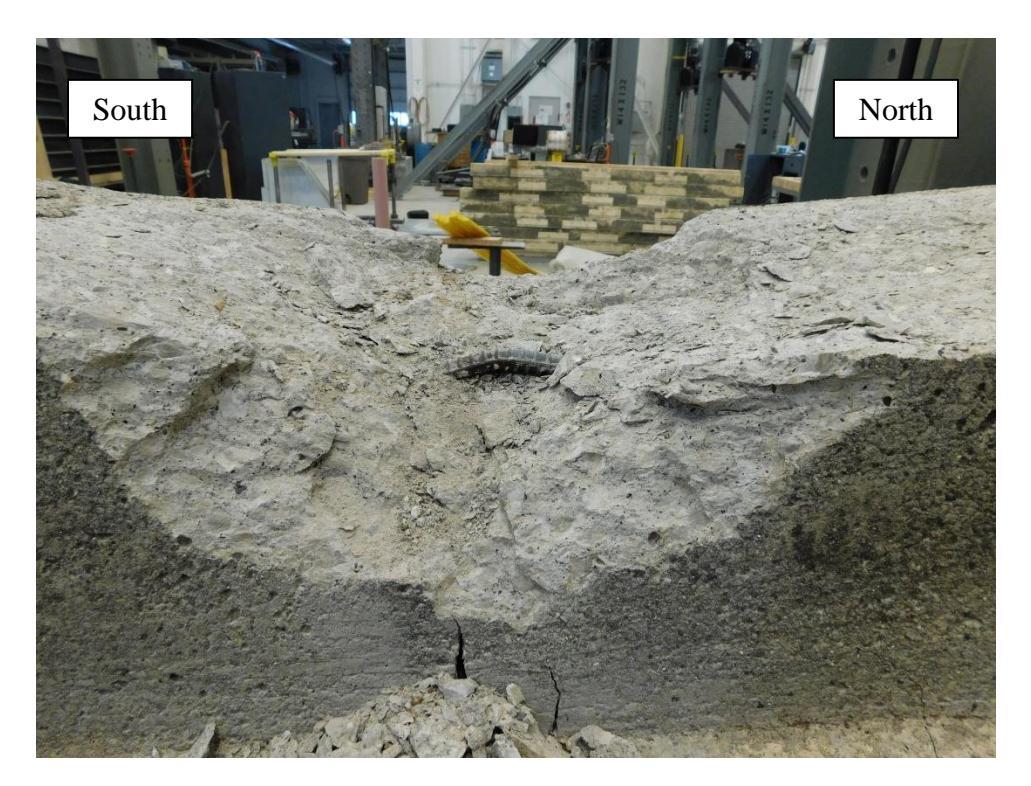
Figure 4.77: Extent of Crushing Around the Piece of Wood

Figure 4.78: Extent of Crushing with Wood Removed

The piece of wood embedded in the top portion of the curb was approximately 1 in. tall by 1/2 in. wide and 11 in. long (length of wood equal to width of curb). This piece of wood caused the cracking and spalling that was observed at 2.0 in. of midspan deflection. After the first signs of crushing were observed, the measured force did not decrease until strand fractures were heard. Therefore, the failure mode of the specimen was assumed to be controlled by strand fracture. No corrosion was observed on the strands during the post-failure review.

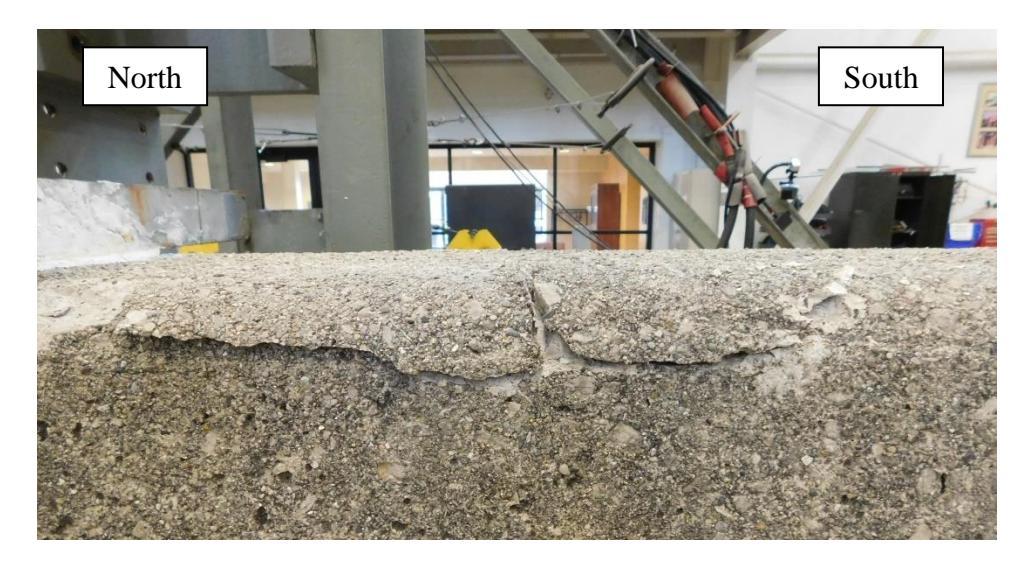
Figure 4.80: Concrete Spall on West Side of Curb at 3.3 in. of Midspan Deflection

After the cracking moment was exceeded, loading was resumed up to a midspan deflection of 3.3 in. (48.3 kips) where a concrete spall was observed on the west side of the curb (Figure 4.80). As loading continued, the extent of concrete spalling increased along the corner of the west side of the curb until a midspan deflection of 5.1 in. (49.3 kips) was reached. Figure 4.81 shows concrete spalling along the west corner of the curb within the constant moment region. It also appeared that delamination of the concrete in the curb was occurring as evident by the longitudinal cracks over the region.

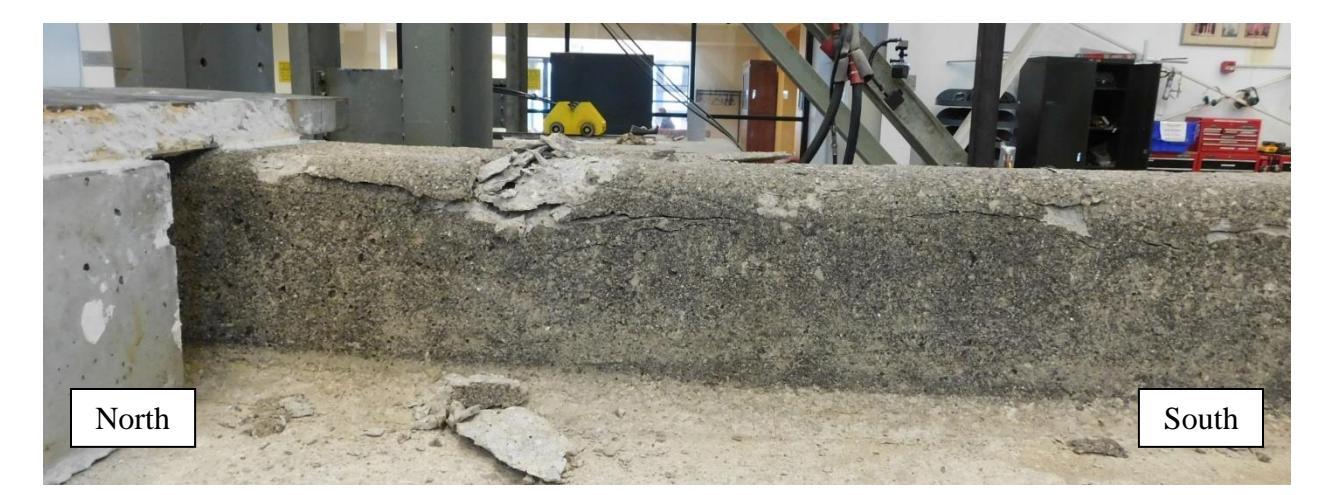
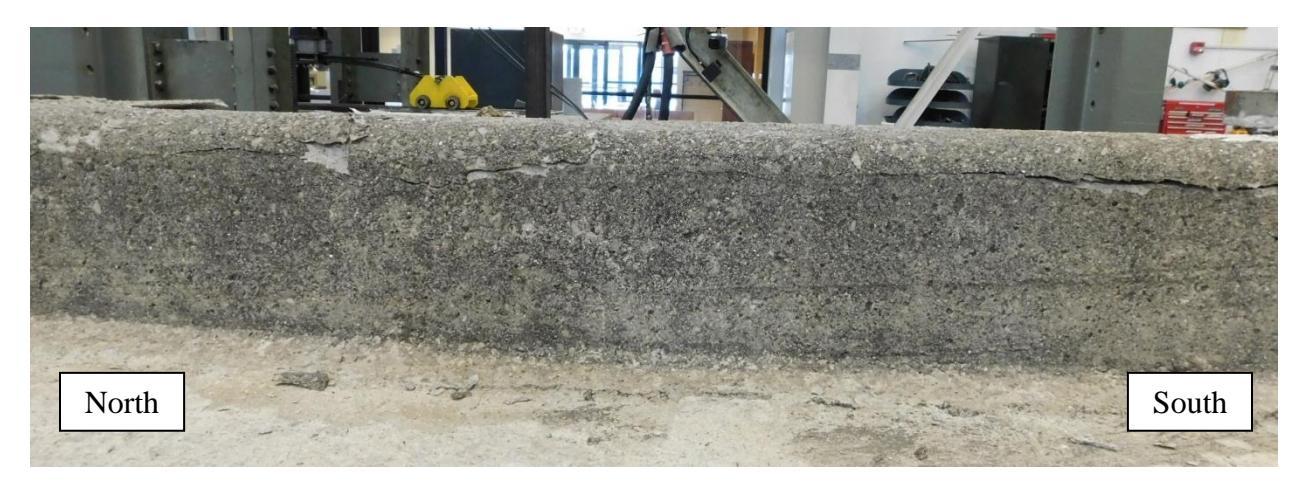
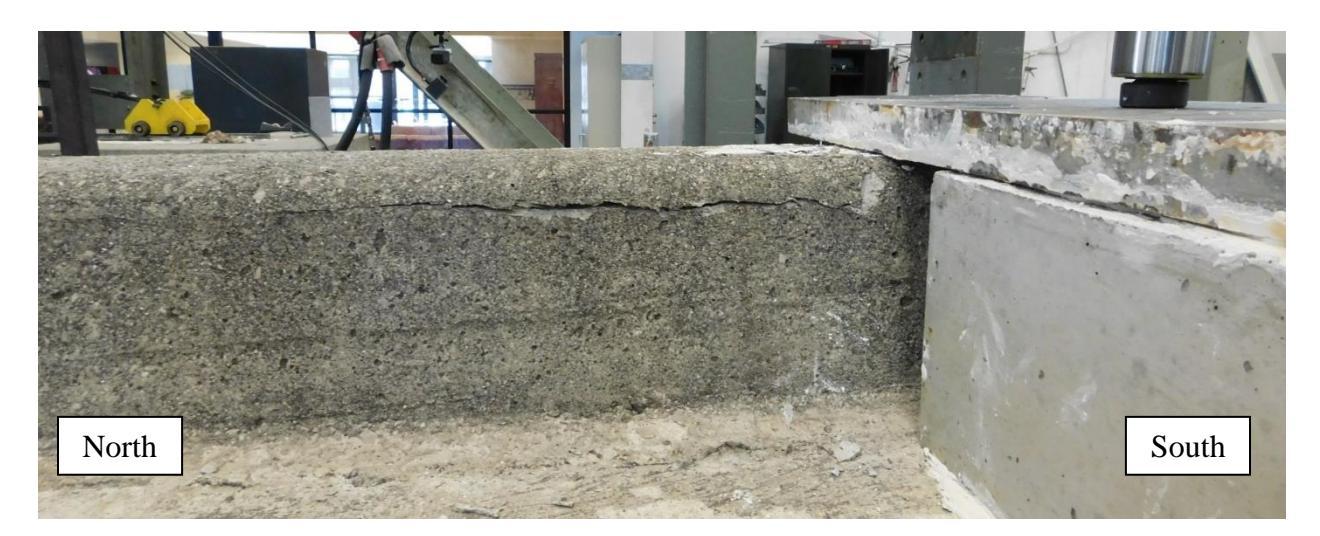
(a) Concrete spalling next to north load point

(b) Concrete spalling at midspan

(c) Concrete spalling next to south load point Figure 4.81: Concrete Spalls at 5.1 in. of Midspan Deflection

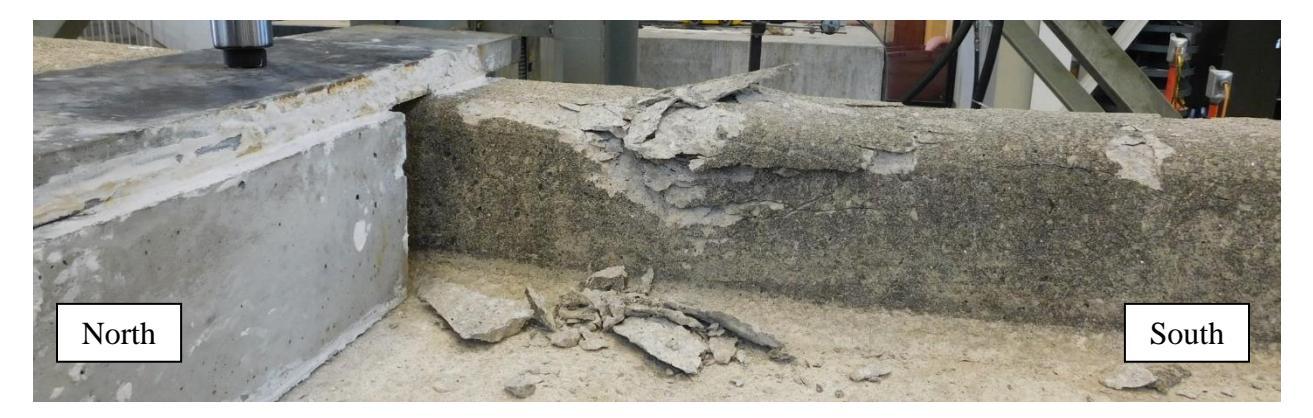
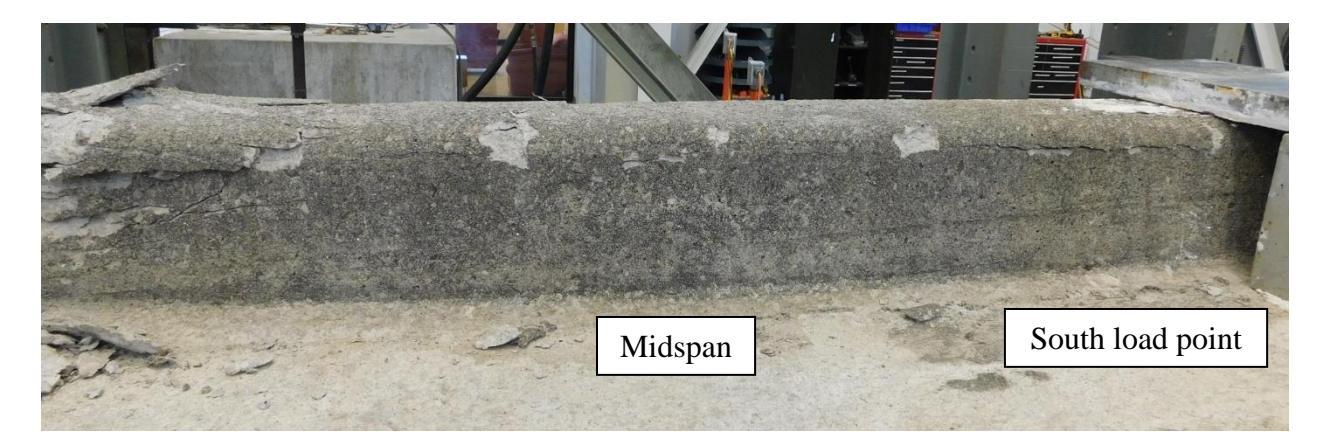
When loading resumed, concrete crushing intensified (Figure 4.82), and the measured force did not exceed 48.2 kips. At a midspan deflection of 5.4 in. (48.2 kips), a loud pop was heard indicating a strand fracture. As loading continued, the measured force steadily decreased as the midspan deflection increased to 5.8 in. (45.5 kip). A loud series of strand fractures followed until total collapse of the beam was observed (Figure 4.83 and Figure 4.84). No corrosion was observed in the strands in the failure region during the post-failure review.

(a) Concrete crushing next to north load point

(b) Concrete spalling at midspan and next to south load point Figure 4.82: Concrete Crushing at 5.4 in. of Midspan Deflection

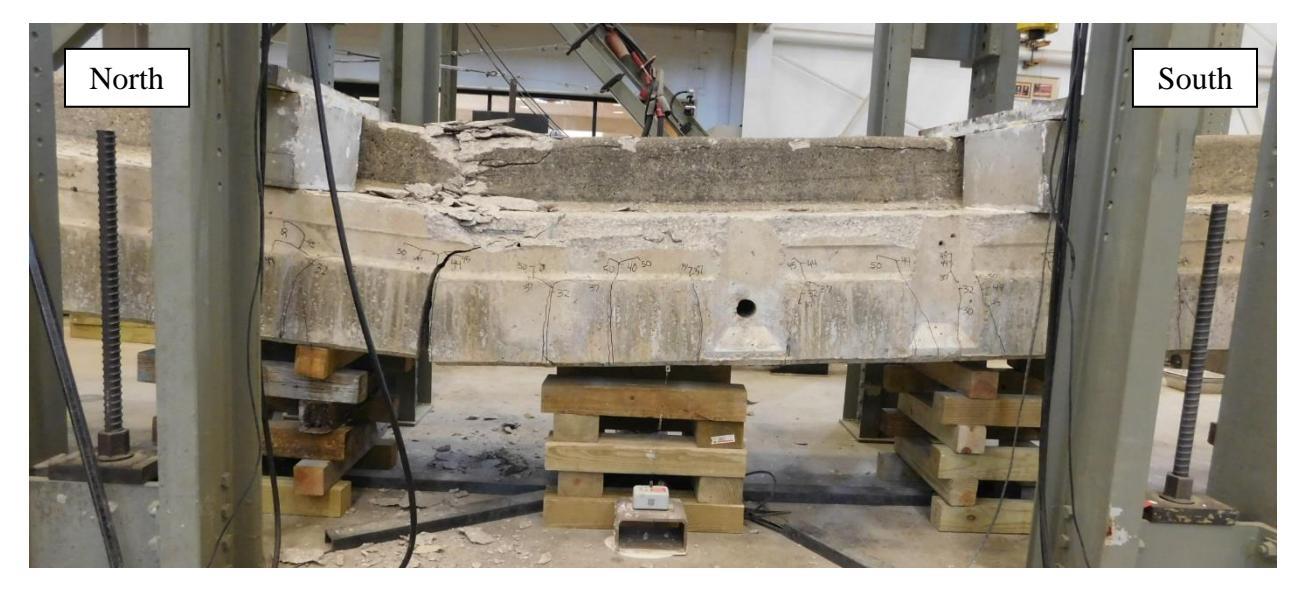
Figure 4.83: Collapse of Specimen 79-4-LC

The maximum force applied was 49.3 kips and was measured at a midspan deflection of 5.1 in. The loss of moment resistance observed after 5.1 in. of midspan deflection was attributed to concrete crushing. Therefore, the failure mode was controlled by concrete crushing.

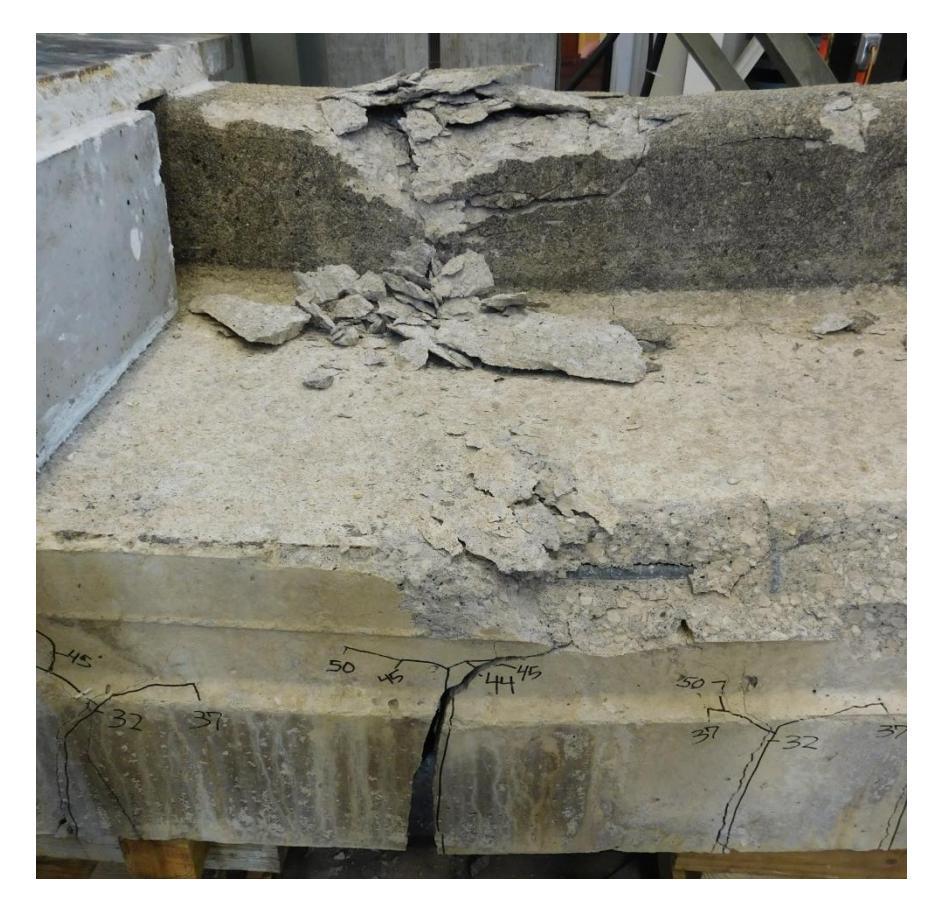
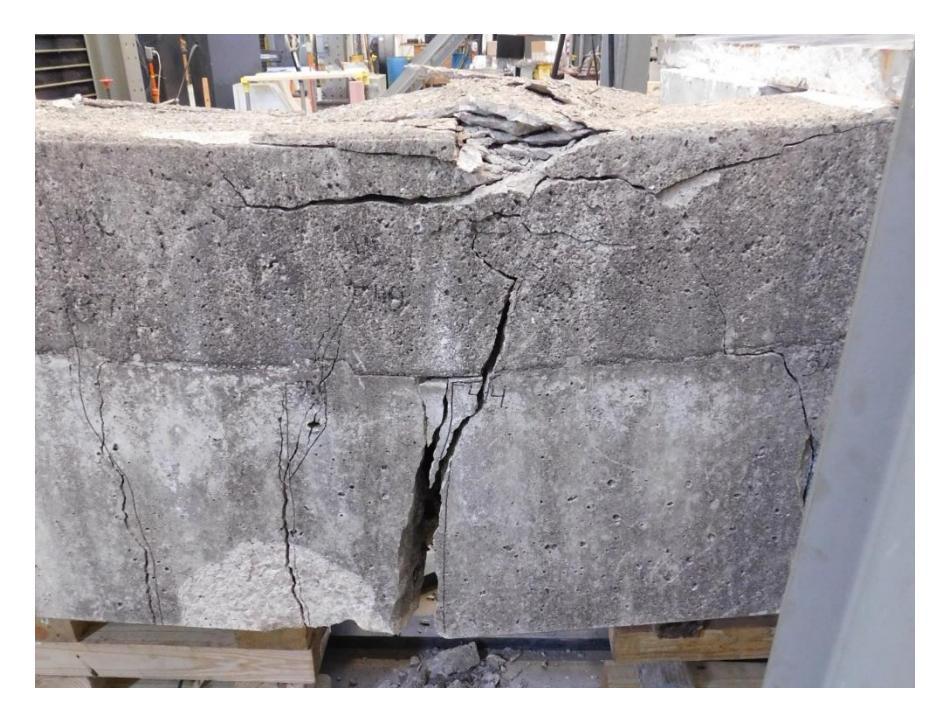
(a) West side of failure region

(b) East side of failure region Figure 4.84: Specimen 79-4-LC Failure Region

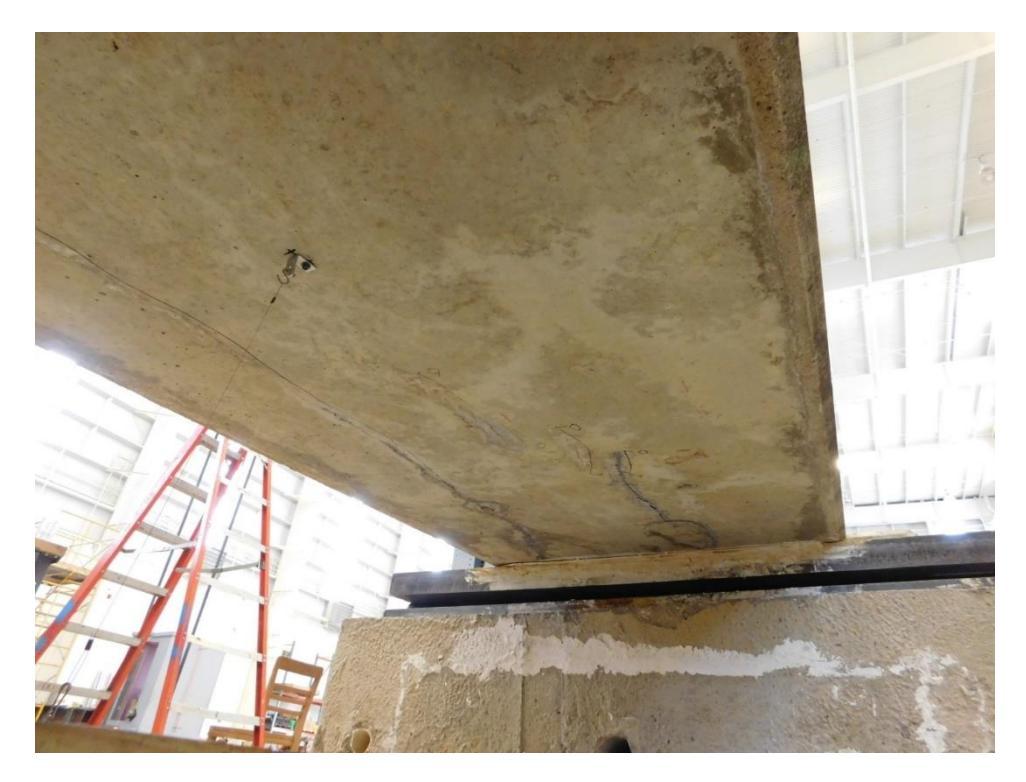
Figure 4.85: Longitudinal Cracks After Collapse of Specimen 79-4-LC

Throughout the test, the longitudinal cracks in the north end of the beam were observed to have no change or any sign of distress (Figure 4.85).

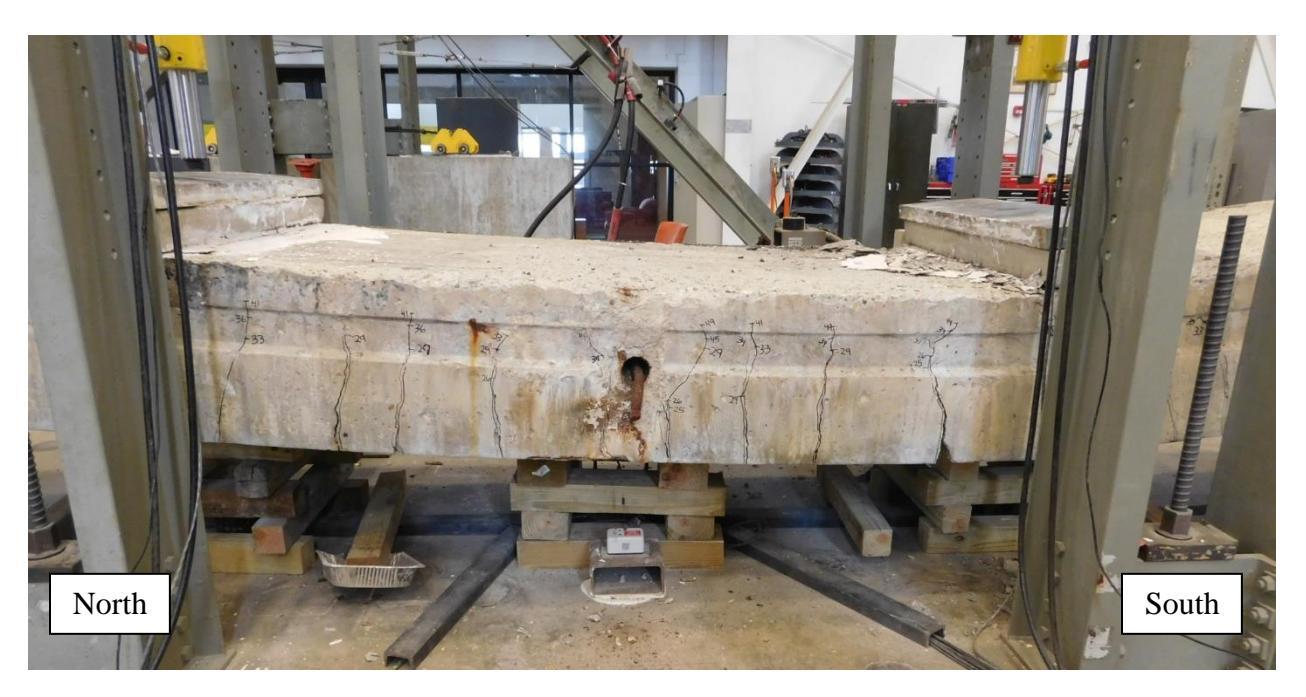
At a midspan deflection of 12.4 in. (55.4 kips), a strand fracture was heard, and the measured force decreased by 3.8 kips. As loading continued, concrete crushing was observed at the south load point that was immediately followed by fracture of the remaining strands and complete collapse of the beam (Figure 4.87). Figure 4.88 shows the extent of concrete crushing

Figure 4.87: Collapse of Specimen 56-1-LC

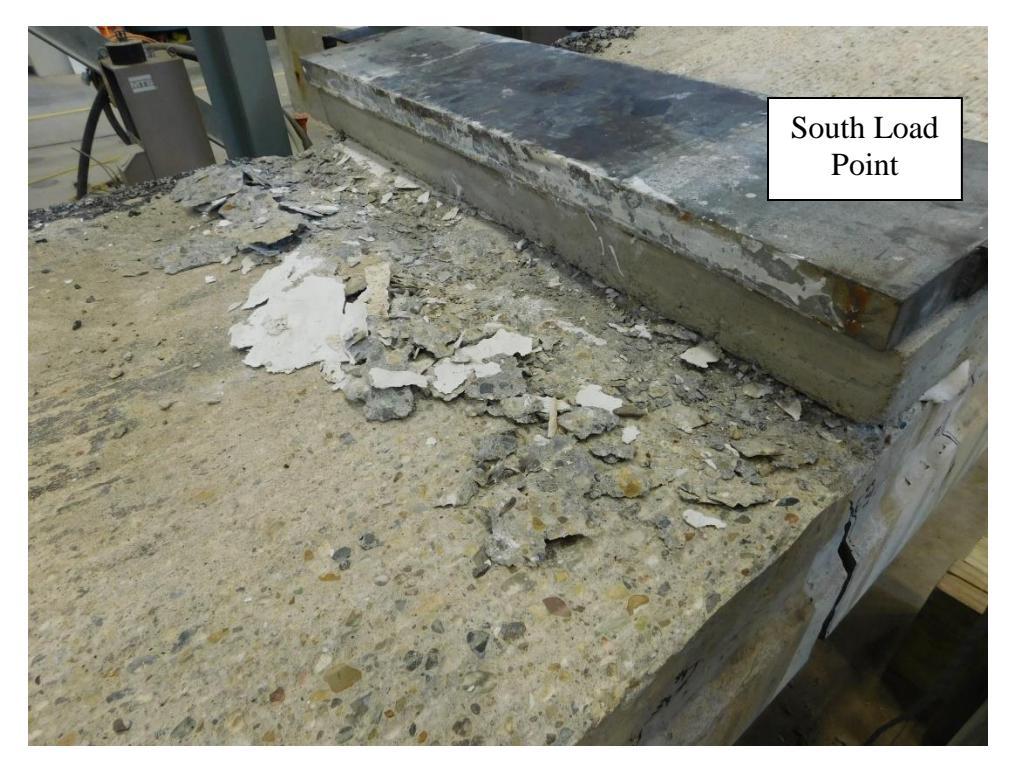
Figure 4.88: Concrete Crushing at Failure

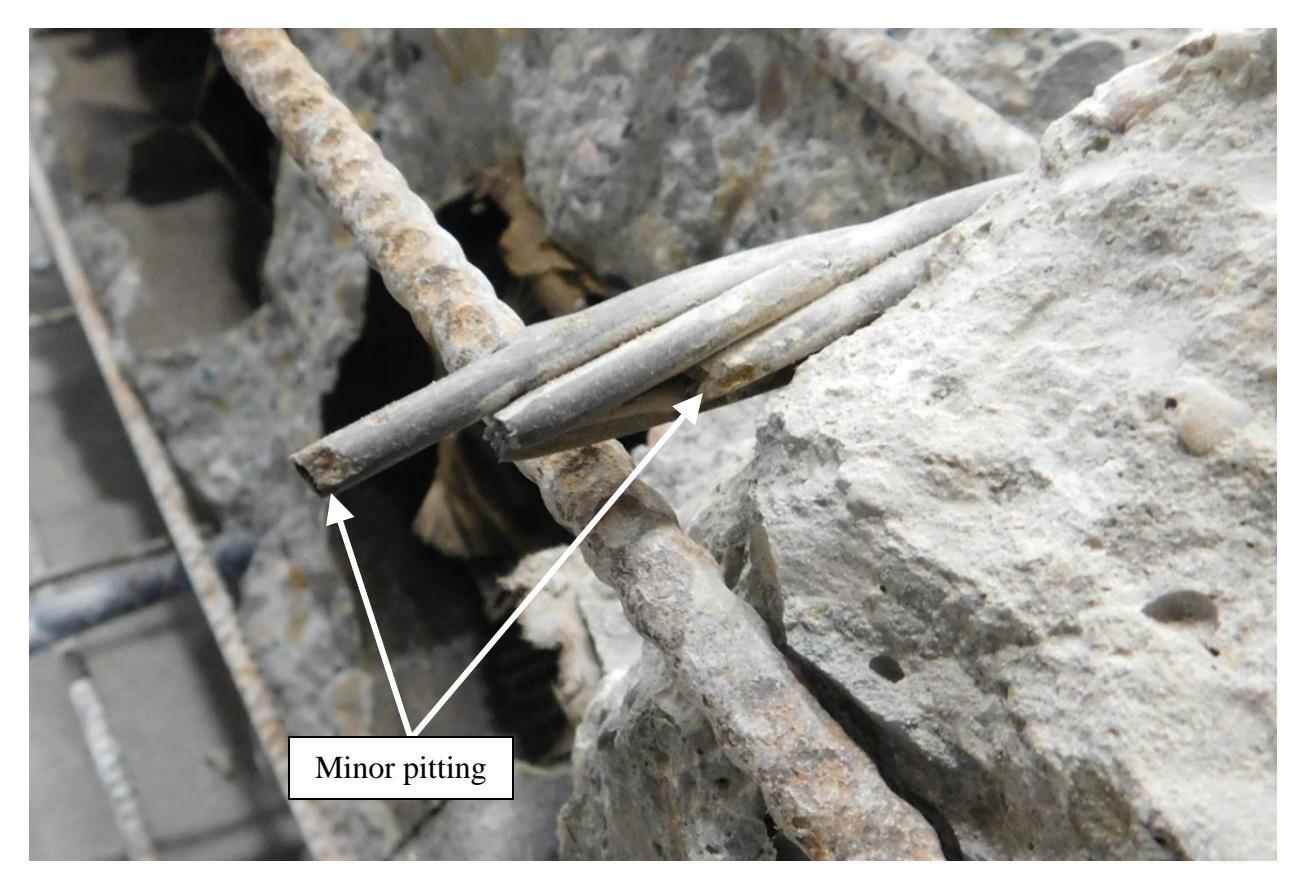
at failure. After the specimen was removed from the test setup, the beam was examined. Minor pitting was observed on Strand 4 at the failure region (Figure 4.89). Strand 4 was assumed to have fractured at 12.4 in. of midspan deflection.

Figure 4.89: Strand 4 of Specimen 56-1-LC After Failure

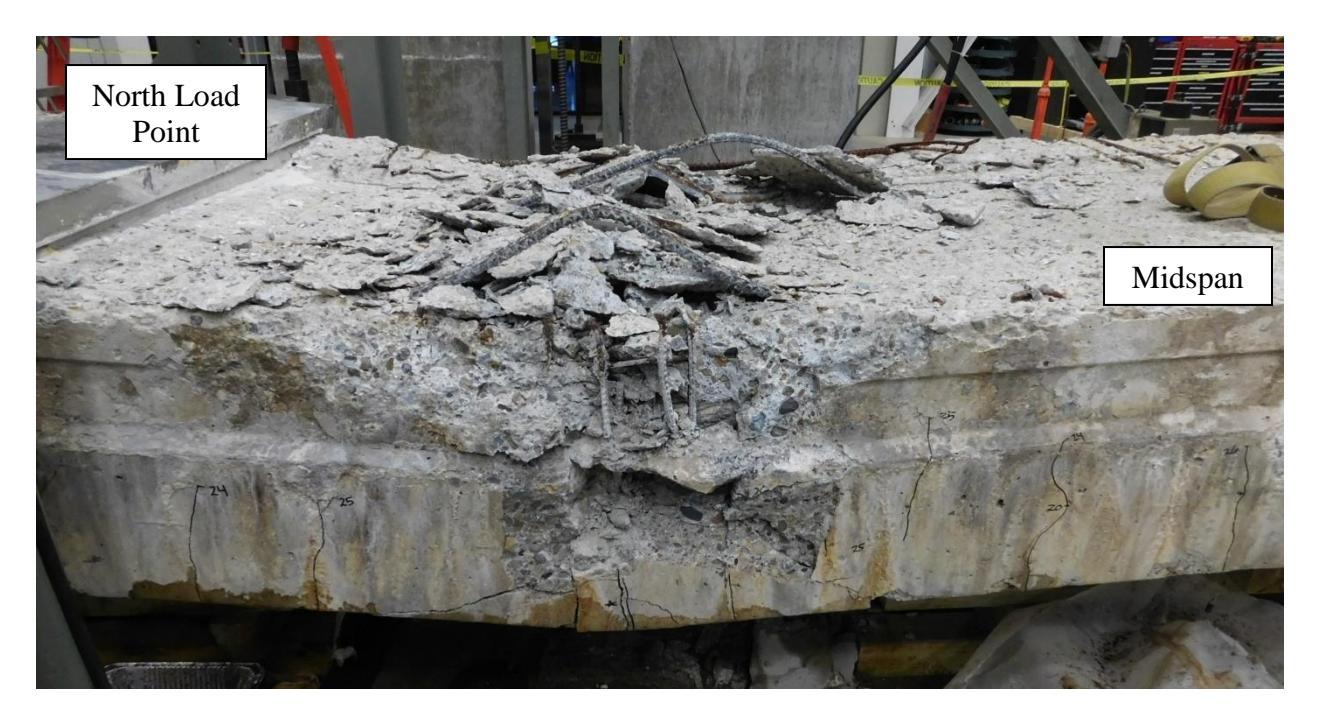
concrete in the top flange 4 ft from the north load point suddenly crushed at a midspan deflection of 8.0 in. and an applied force of 37.0 kips (Figure 4.92). Total collapse of the beam was observed with crushing of the concrete top flange (Figure 4.93).

Concrete cores extracted from the top flange of the beam for compression testing were noted to contain minor cracks in the top 1/2 in. of each core. In addition, the top flange on either side of the failure was observed to have delaminated concrete by sounding with a hammer.

Figure 4.92: Crushed Concrete at Failure

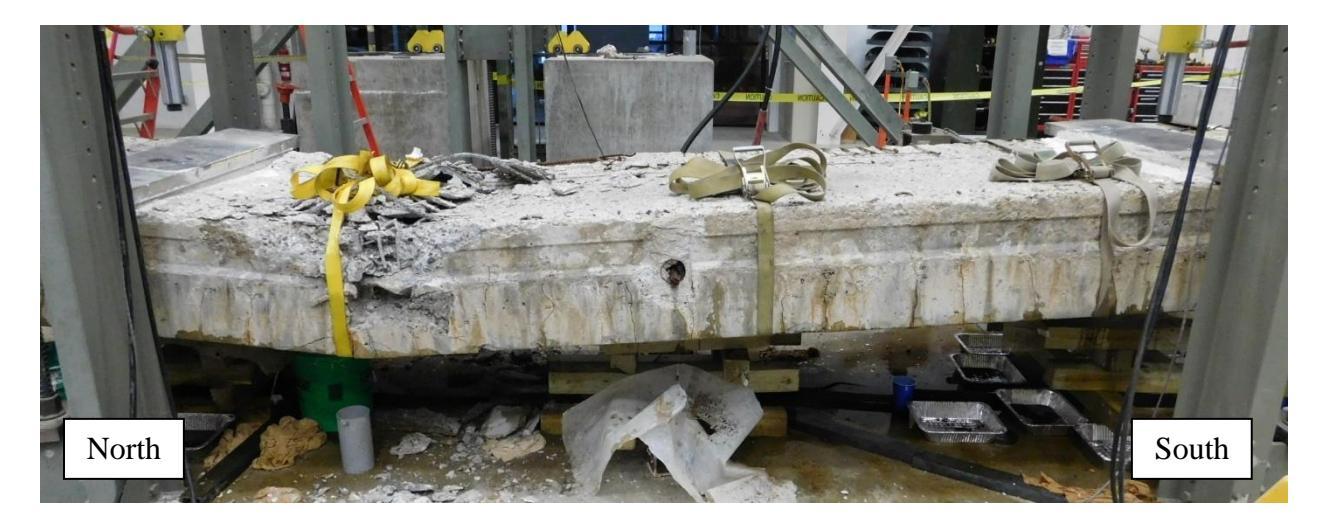
Figure 4.93: Collapse of Specimen 56-2-ES

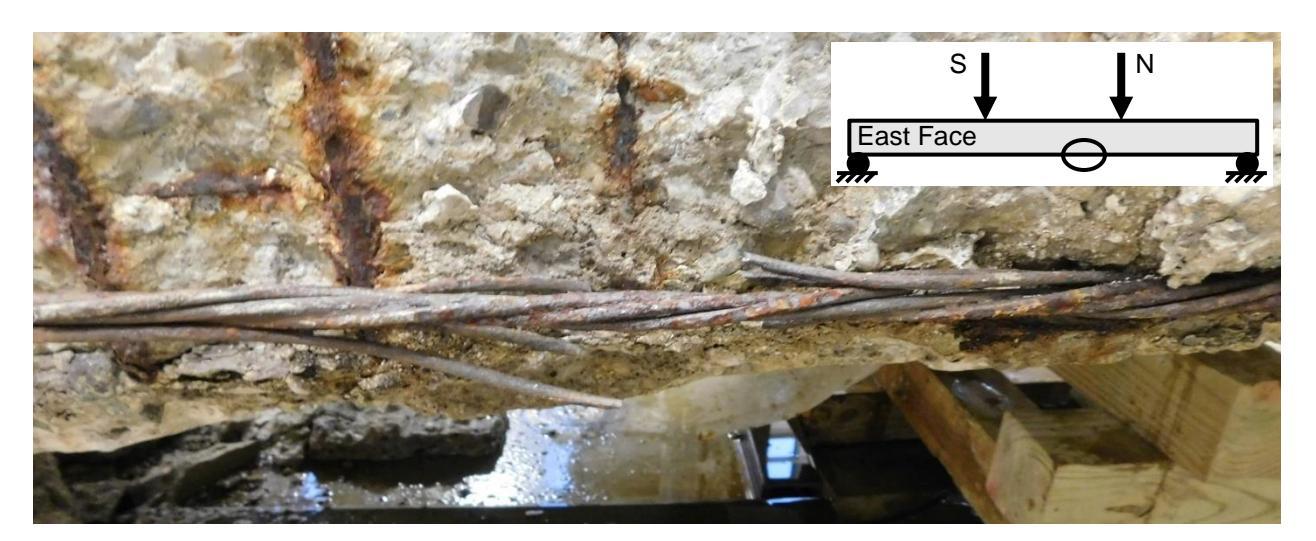
Investigation of the failure region revealed three broken wires on the exposed strand (Figure 4.94). These broken wires may have caused the drop in measured force at 7.6 in. of midspan deflection. The wire fractures in the exposed strand provide evidence that the corroded strand not only contributed to the flexural capacity but had adequate bond within the deteriorated regions on either end of the beam. All other strand at the failure region were intact without any broken wires or corrosion.

Figure 4.94: Exposed Strand Broken Wires

The agreement between the test results and the analysis model curves indicate that the exposed strand was effective in resisting the applied demand on the specimen. It should be noted that a pop was heard at 7.6 in. of midspan deflection, and after failure, the exposed strand was observed with multiple wire fractures (Figure 4.94). After crushing, redistribution of forces decreased the moment arm resulting in higher steel strains. The fracture of these wires in a brittle mode, however, indicates that the strand would not have remained effective if larger concrete strains could have been achieved.

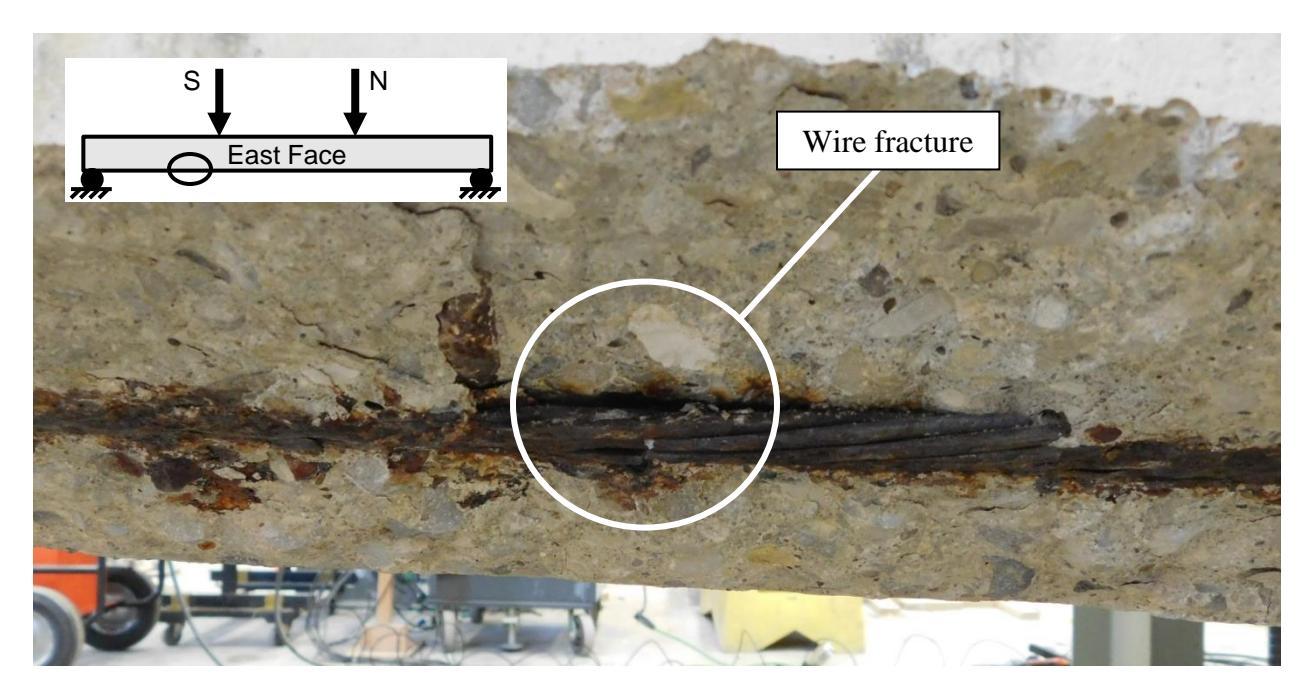
After the cracking moment was exceeded, many quiet cracking and popping noises were heard in between load steps. In between the load pauses at 3.5 in. and 4.0 in. of midspan deflection, a section of concrete spalled from the east edge of the bottom flange approximately 3 ft south of the south load point (Figure 4.97). The exposed strand at that location was further exposed, and a wire fracture was observed.

Figure 4.97: Concrete Spall and Wire Fracture

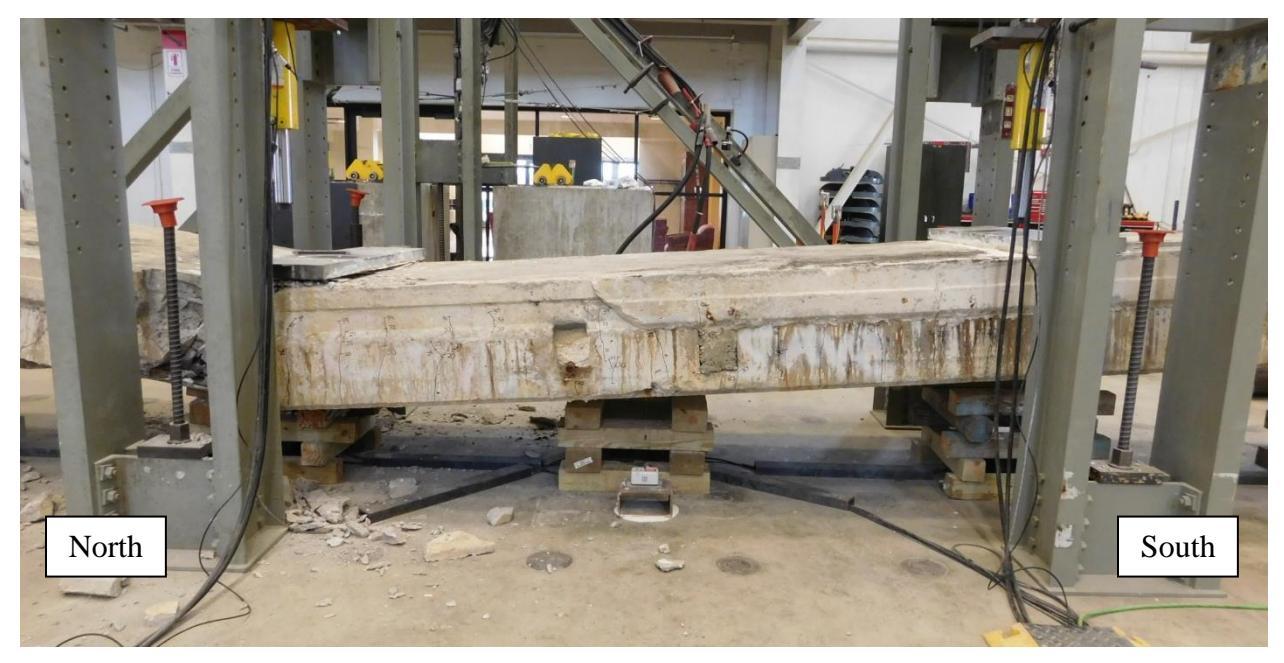
As loading continued, the measured force did not exceed the previous maximum of 42.3 kips. At a midspan deflection of 9.5 in. (41.8 kips), the measured force began to steadily decrease. At a midspan deflection of 9.8 in. and an applied load of 41.0 kips, the beam collapsed (Figure 4.98). Inspection of the failure region revealed that a large shear crack had formed on the north side of the north load point (Figure 4.99). This crack was not noticed prior to failure. As shown, the shear crack propagated in between two halves of the transverse reinforcement. Figure 4.100(a) illustrates how the transverse reinforcement detail was built, while Figure 4.100(b) illustrates the as-designed detail. This poor detailing led to failure of the specimen.

Figure 4.98: Collapse of Specimen 102-1-BS

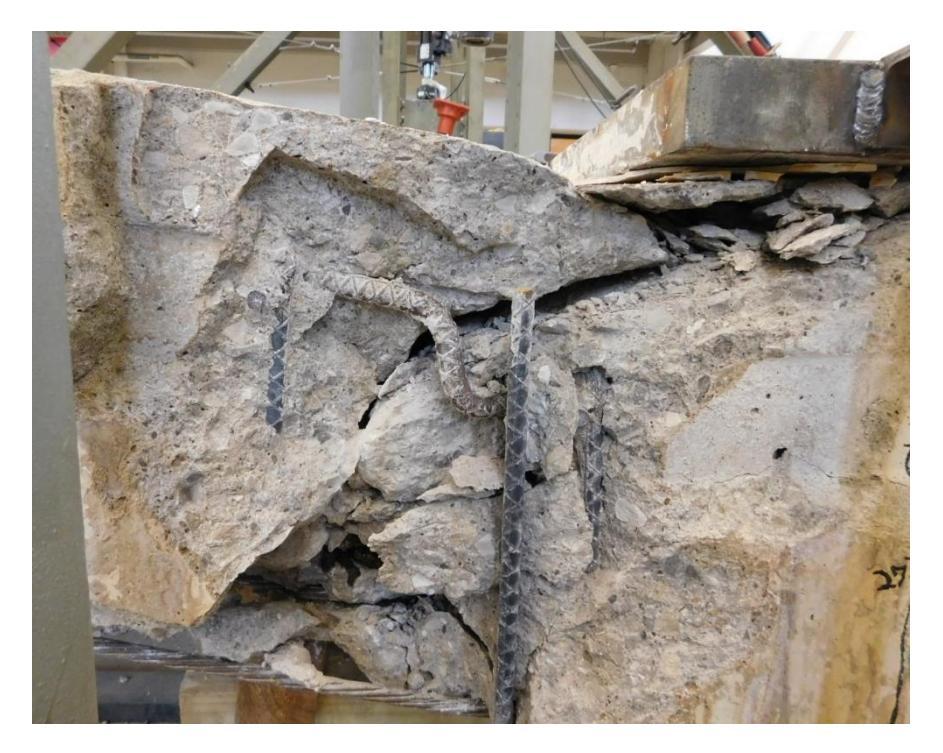
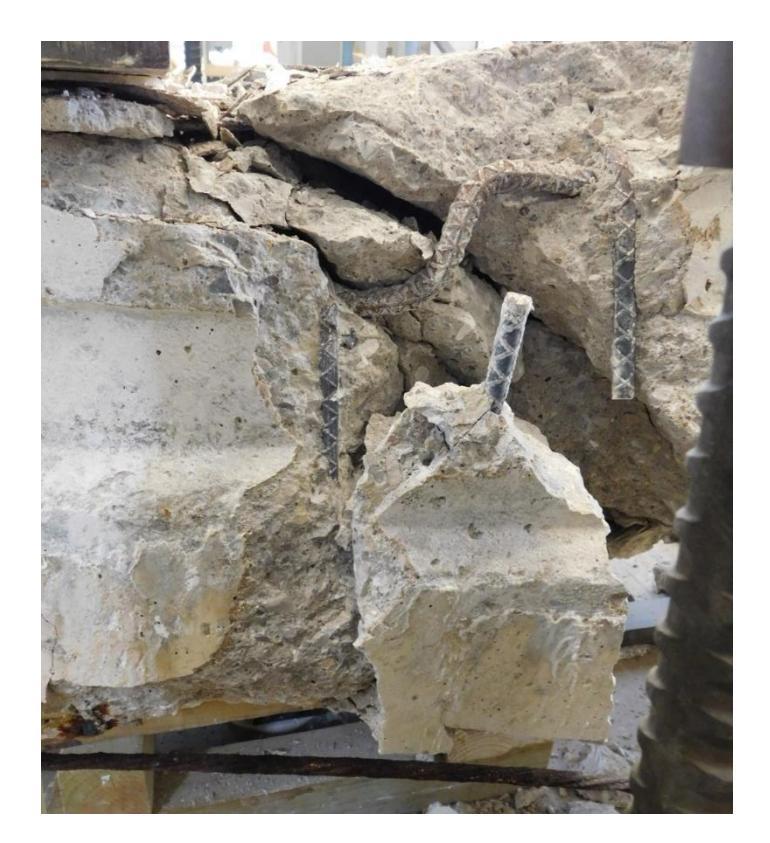
Although collapse of the specimen was caused by shear failure at the north load point. The decrease in the applied load was caused by strand fracture at the maximum applied load of 42.3 kip and 7.6 in. of midspan deflection. The fractured strand was located slightly to the north of the bottom of the shear crack shown in Figure 4.99(b). This strand was by the east face of the specimen adjacent to the strand broken prior to testing. Corrosion of the strand consisted of pitting on one side of the strand (Figure 4.101). All other strands were found intact without any corrosion. Fracture of this strand (along with the previously broken strand) likely led to a decrease in shear capacity which explains the shear failure following strand rupture.

(b) East side Figure 4.99: Shear Failure
