EVALUATION AND STRUCTURAL BEHAVIOR OF DETERIORATED PRECAST, PRESTRESSED CONCRETE BOX BEAMS

A Dissertation

Doctor of Philosophy

Lyles School of Civil Engineering West Lafayette, Indiana December 2019

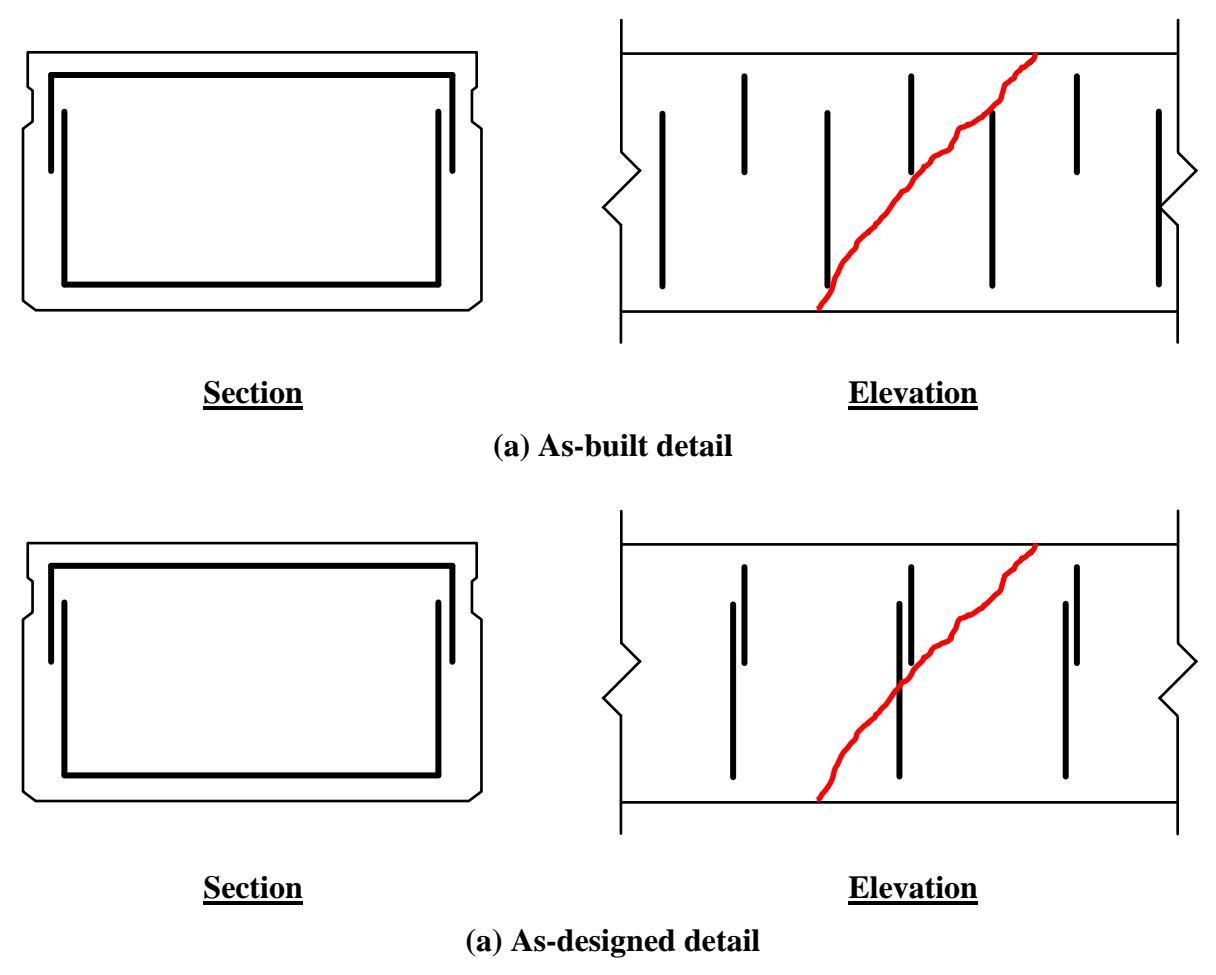
As loading continued, the measured force did not exceed the previous maximum of 42.3 kips. At a midspan deflection of 9.5 in. (41.8 kips), the measured force began to steadily decrease. At a midspan deflection of 9.8 in. and an applied load of 41.0 kips, the beam collapsed (Figure 4.98). Inspection of the failure region revealed that a large shear crack had formed on the north side of the north load point (Figure 4.99). This crack was not noticed prior to failure. As shown, the shear crack propagated in between two halves of the transverse reinforcement. Figure 4.100(a) illustrates how the transverse reinforcement detail was built, while Figure 4.100(b) illustrates the as-designed detail. This poor detailing led to failure of the specimen.

Figure 4.100: Transverse Reinforcement Detailing

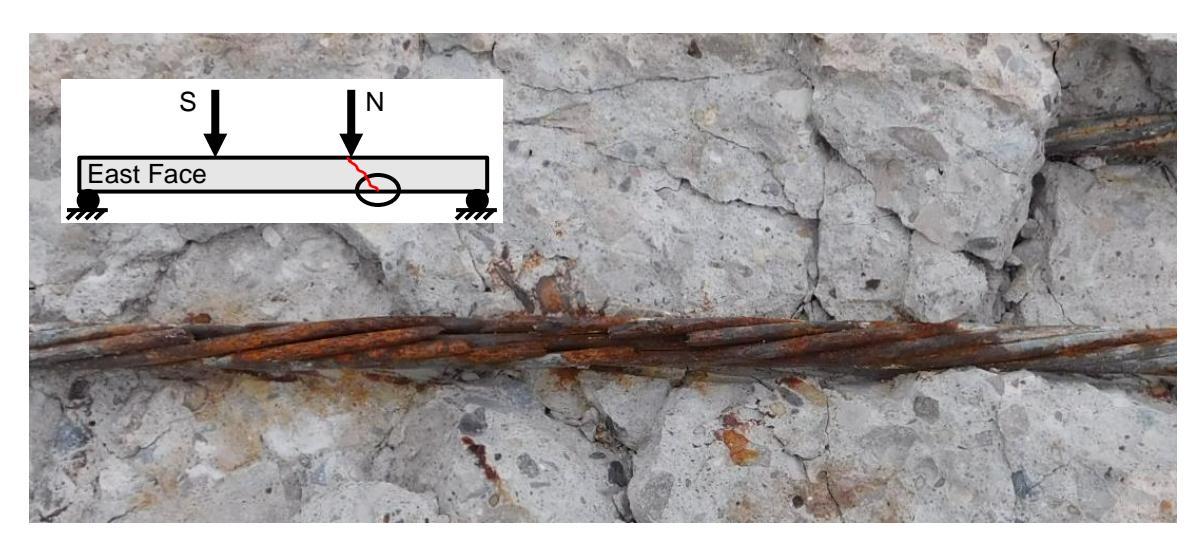
Figure 4.101: Condition of Fractured Strand Adjacent to Existing Broken Strand

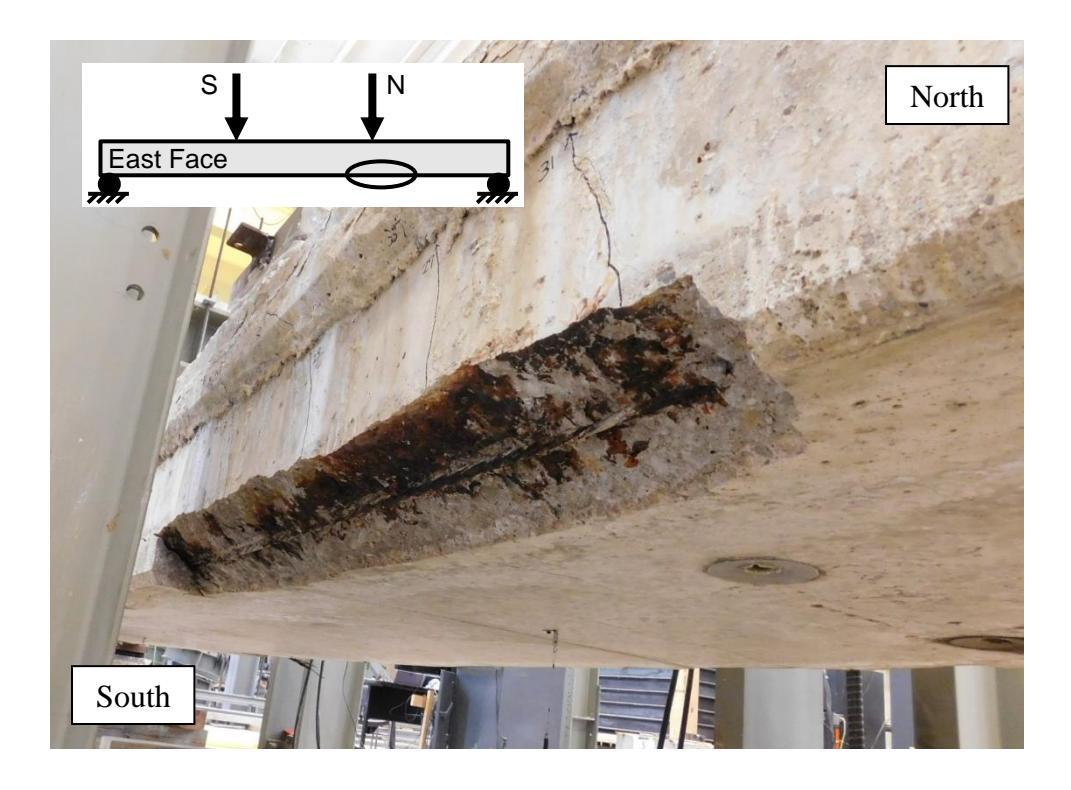
At 3.0 in. of midspan deflection and an applied load of 31.6 kips, a strand fracture was heard, and the measured force decreased by 3 kips. As loading continued, the concrete cover spalled away from the east edge strand between 4 in. and 5 in. of midspan deflection (Figure 4.103). The concrete spall increased in size between 7 in. and 8 in. of midspan deflection (Figure 4.104). The location of the concrete spall corresponded to the location of the north corner crack in the east edge of the bottom flange (Figure 3.13).

Figure 4.103: Concrete Spall from East Edge Strand

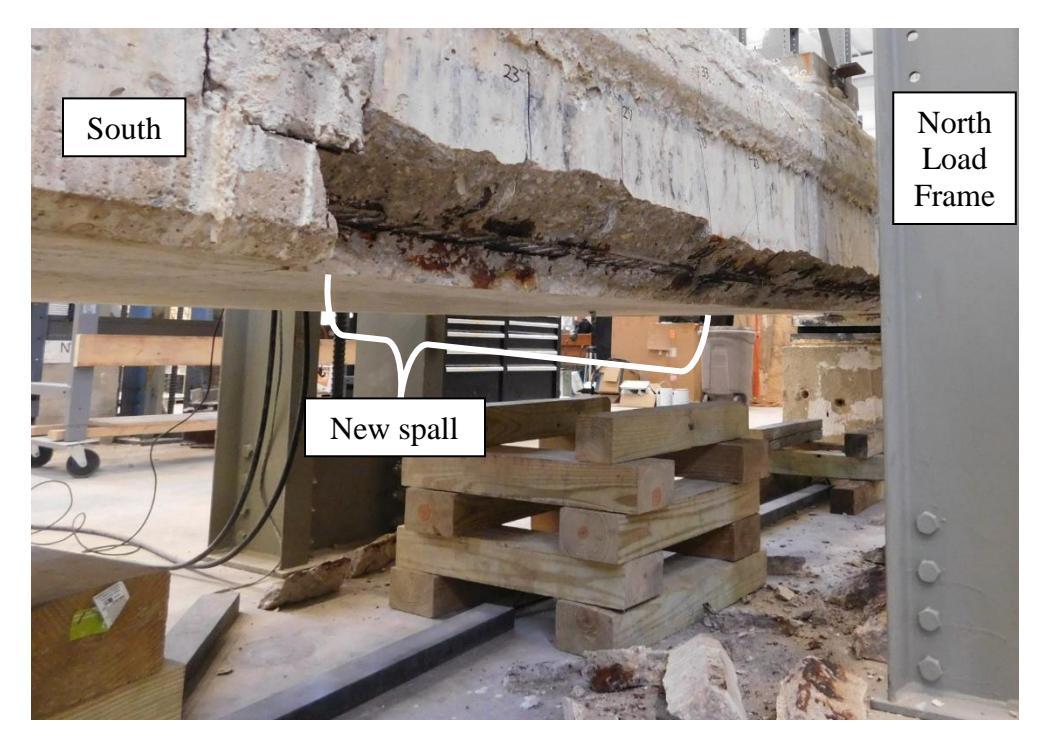
Figure 4.104: Further Concrete Spalling Along East Edge Strand

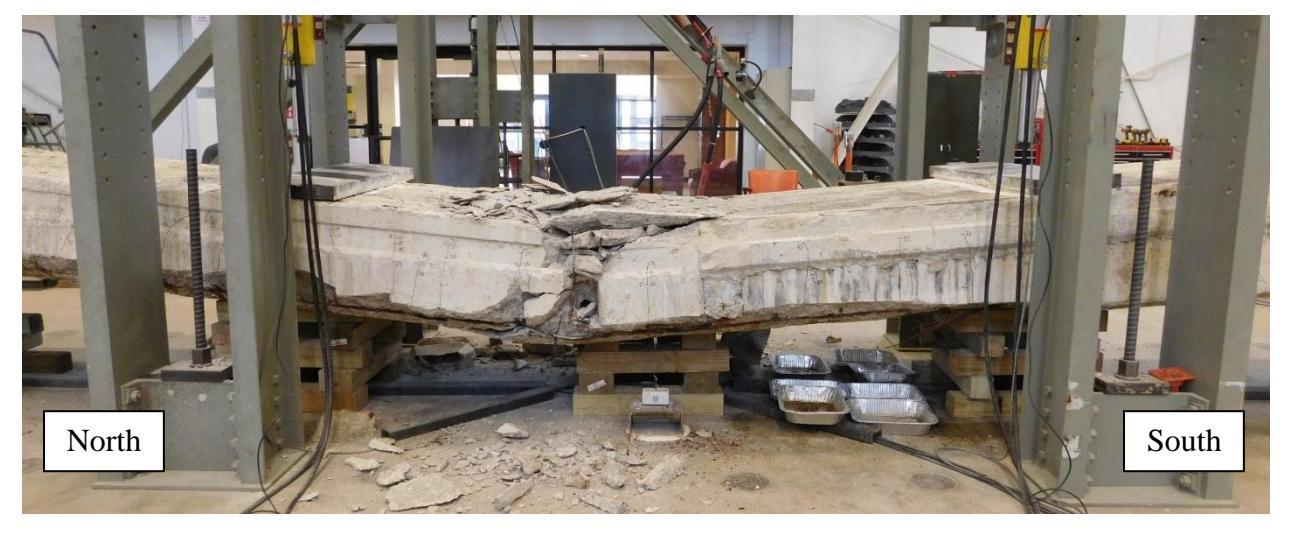
A maximum applied force of 40.2 kips was measured at 11.0 in. of midspan deflection. As part of the loading procedure, loading was paused, and the specimen was examined. When loading resumed, small chips of concrete were observed popping off of the top flange at midspan indicating the initiation of concrete crushing. At a midspan deflection of 11.2 in. the stroke limit of the hydraulic jacks was reached. Considering that concrete crushing had already initiated, the specimen was allowed to creep to failure. The decrease in measured force observed at the end of the load-deflection curve in Figure 4.102 is a result of the specimen creeping to failure over the course of approximately 2 minutes. At an applied load of 35.3 kips and a midspan deflection of 11.37 in., the specimen collapsed due to concrete crushing of the top flange (Figure 4.105).

Figure 4.105: Collapse of Specimen 102-2-BS

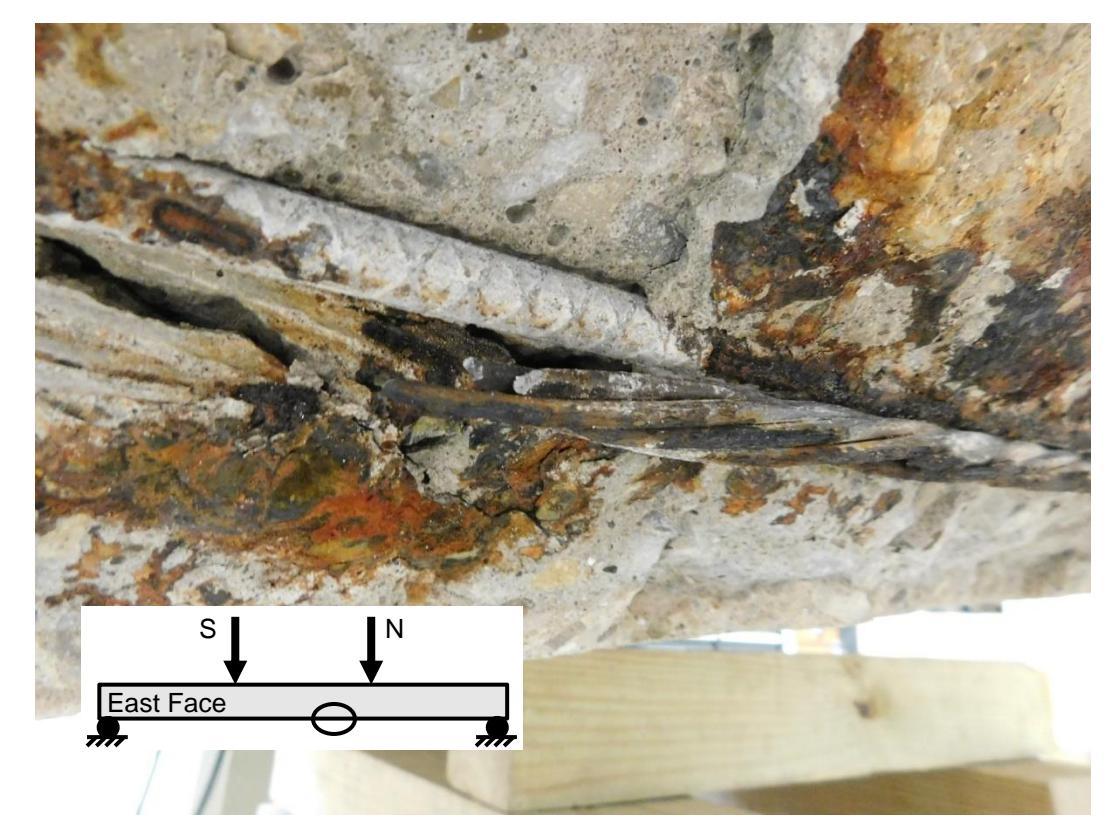
Post-failure investigation of the specimen revealed that only the east edge strand fractured during the test. Corrosion on the fractured strand consisted of heavy pitting on one side of the strand (Figure 4.106). All other strands were observed to be intact without any corrosion with the exception of the strand broken prior to testing.

Figure 4.106: Fractured East Edge Stand

11.0 in. of midspan deflection. The two ineffective strands correspond to the broken strand on the west edge of the bottom flange (Strand 1 in Figure 3.34) and the corroded strand at the longitudinal crack on the east edge of the bottom flange (Figure 4.106). In addition, the simplified deflection calculation accounting for deterioration estimated the midspan deflection within 2% (11.2 in.). This shows that the deteriorated model assuming two ineffective strands was in agreement with the experimental test data.

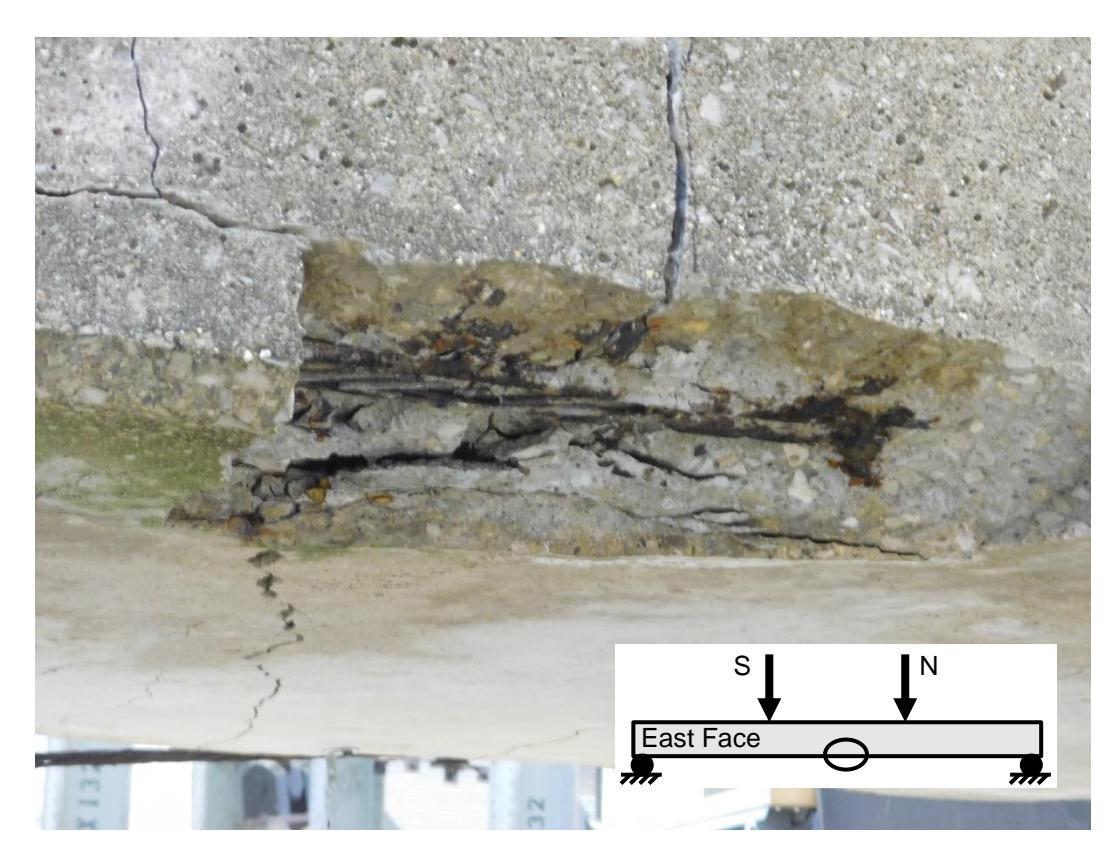
After the cracking moment was exceeded, many quiet cracking and popping noises were heard up to a midspan deflection of 2.25 in. (28.2 kips). At 2.25 in. of midspan deflection, a pop
was heard which was assumed to be a wire fracturing, and the measured force decreased by 0.3 kips. Loading continued up to an applied force of 28.9 kips at a midspan deflection of 2.87 in. This was followed by a series of popping sounds accompanied by decreases in measured force between 0.3 kips and 0.5 kips up to a midspan deflection of 4 in. Between 3.5 in. and 4 in. of midspan deflection, the east edge strand was exposed by concrete spalling (Figure 4.108). The strand was observed to have at least two fractured wires.

Figure 4.108: Exposed East Edge Strand at 4 in. of Midspan Deflection

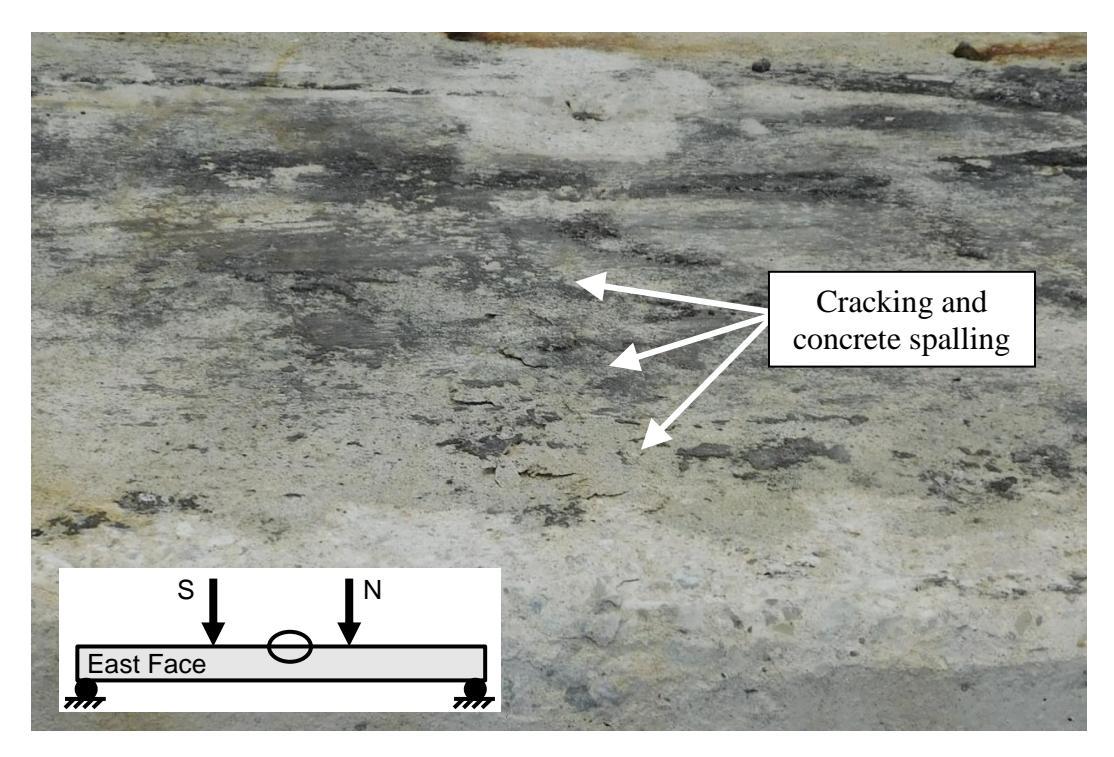
From 4 in. to 8 in. of midspan deflection, loading continued without any notable distress in the specimen. At the load pause of 8 in., a maximum applied force of 29.4 kips was measured, and small cracks and concrete spalls were observed in the top flange at midspan (Figure 4.109). When loading resumed, concrete crushing was observed in the top flange, and at 28.9 kips and 8.3 in. of midspan deflection, a strand fracture was heard followed by a decrease in measured load of 9 kips. The specimen was then loaded continuously until collapse was observed due to fracture of the remaining strands (Figure 4.110). Based on the discontinuities in the load-deflection curve between 8.3 in. of midspan deflection and collapse, two strands were assumed to have broken at 8.3 in. of midspan deflection with each of the following jumps assumed to correspond to one strand fracturing.

Figure 4.109: Top Flange Cracks and Small Concrete Spalls at 8 in. of Midspan Deflection

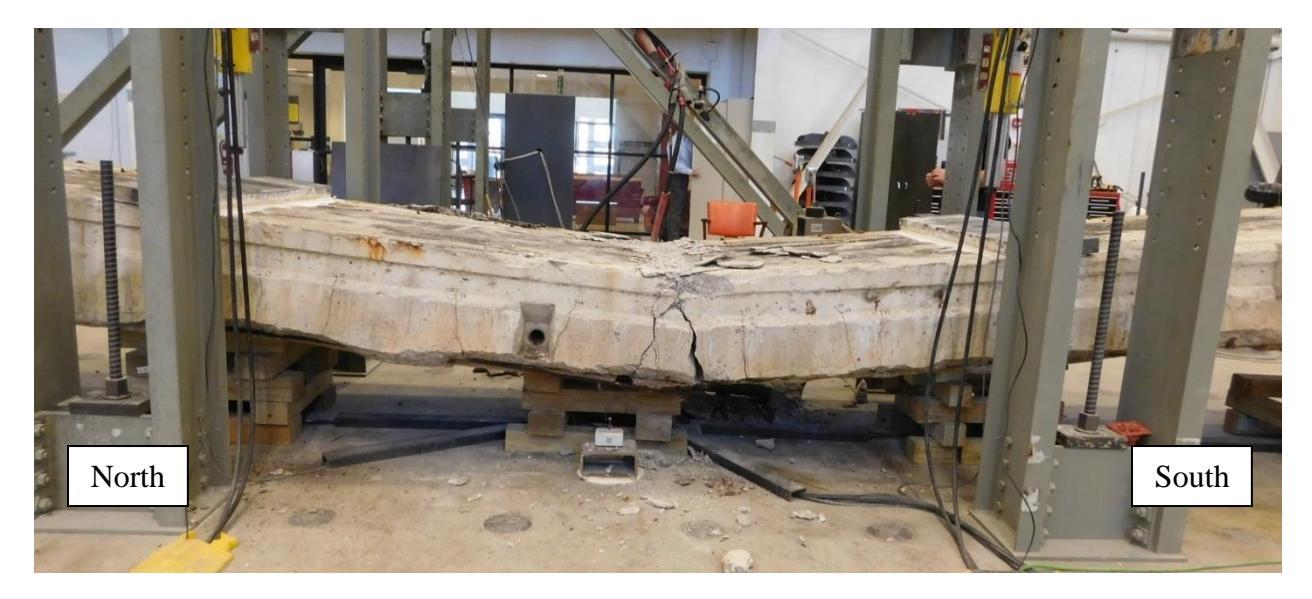
Figure 4.110: Collapse of Specimen 102-3-BS

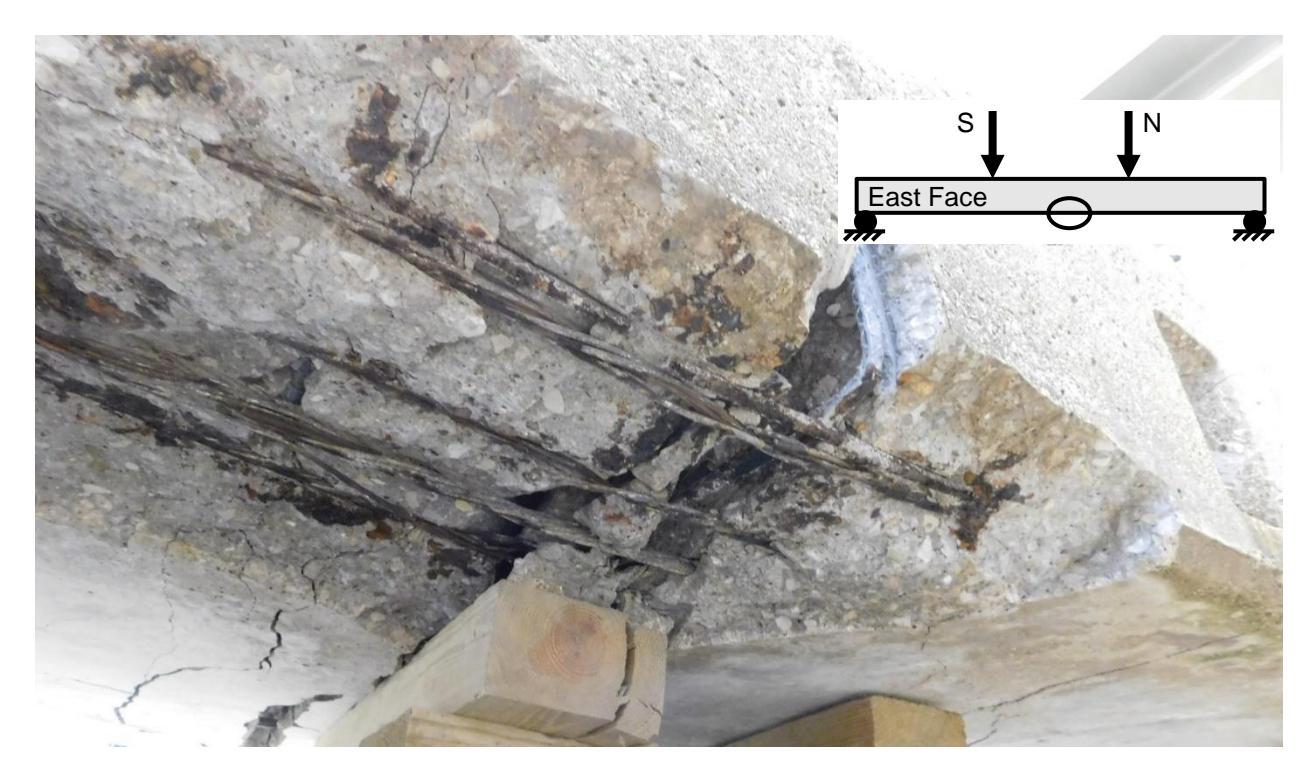
During the period of continuous loading to collapse, an additional portion of concrete spalled from the east edge of the bottom flange, exposing a total of four strands (Figure 4.111). All four strands were observed to be corroded. The corrosion consisted of heavy pitting with section loss. The location of the corroded strands corresponded with corner cracking, longitudinal cracking, and concrete staining. It should also be noted that the corroded strands were on the exterior side of the beam (an edge beam) when the beam was in-service. A total of 5 strands were observed to be corroded at the failure section, 4 strands on the east side of the specimen and 1 strand that was broken prior to testing.

Figure 4.111: Exposed Strands on East Side of Bottom Flange after Collapse

The load-deflection curves for Specimen 102-3-BS are presented in Figure 4.142. The load-deflection curves calculated using the analytical and refined models assumed that the broken strand observed prior to testing was ineffective. The refined model with the simplified deteriorated deflection model was used to compute the deteriorated curve ("Det"), which was calculated assuming a total of five strands at midspan were ineffective. The five strands include the existing broken strand on the west side of the bottom flange and the four corroded strands at the longitudinal cracks on the east side of the bottom flange (Figure 4.111).

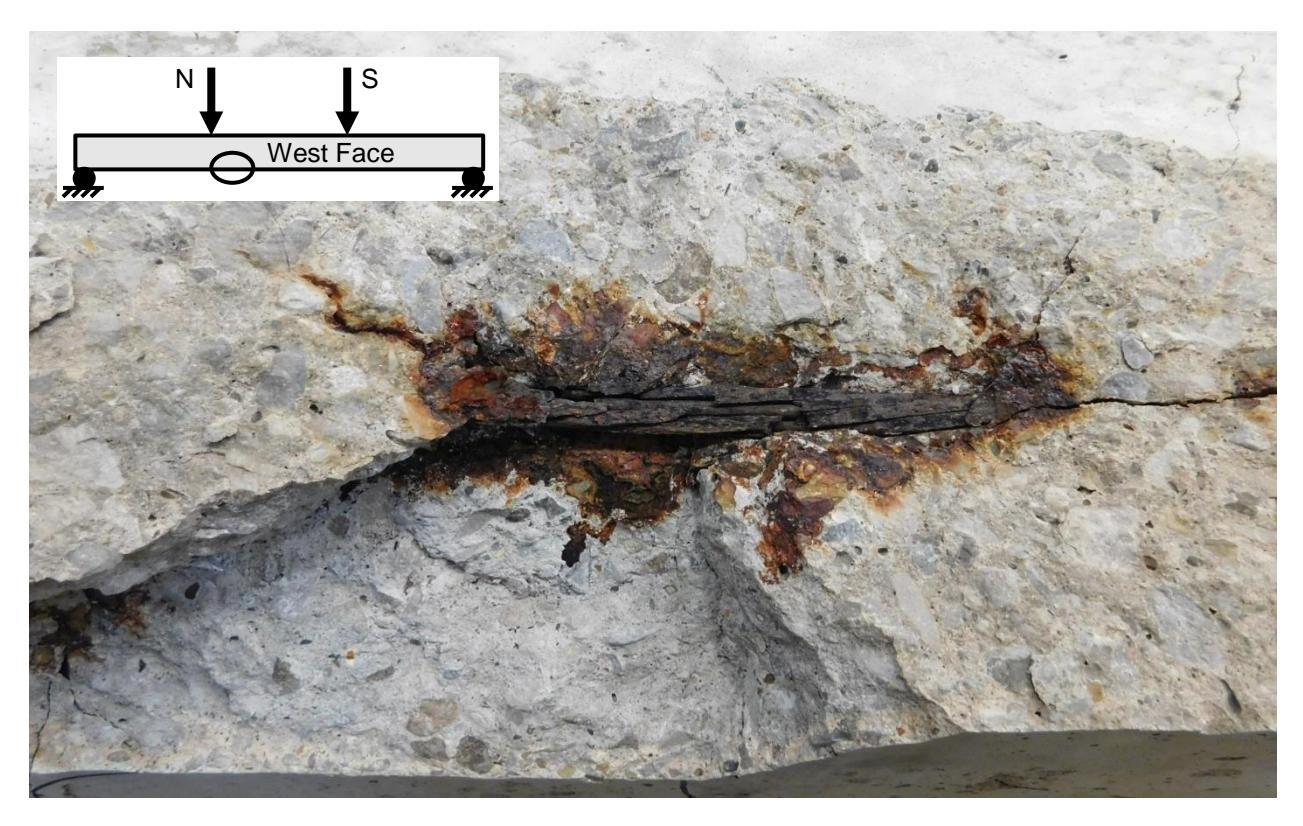
After the cracking moment was exceeded, quiet popping and cracking were heard from around the north load point. At 3 in. of midspan deflection, a portion of concrete spalled from the west side of the bottom flange near the north load point, exposing the edge strand (Figure 4.113). This spall coincided with the location of the corner crack (Segment B, Figure 3.15). Quiet popping and cracking continued up to 5 in. of midspan deflection. From 5 in. to 6 in. of midspan deflection, no further distress was observed in the specimen near the north load point. At 6.7 in. of midspan deflection, the maximum applied load of 36.2 kips was measured and, a loud pop was heard near the south load point. Strand fracture occurred and was accompanied by a decrease in measured force of 0.6 kips. The fracture location coincided with the location of concrete spalling from the east edge strand at the south load point. The spalling further exposed the east edge strand (Figure

Figure 4.113: Concrete Spall at North Load Point at 3 in. of Midspan Deflection

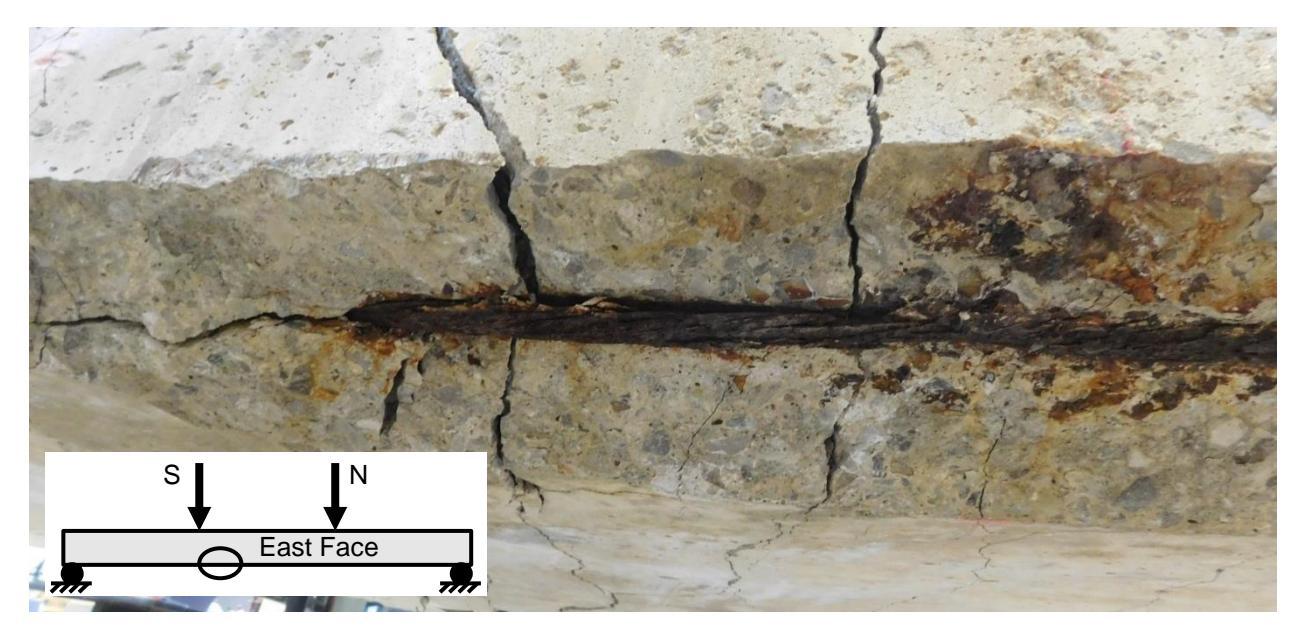
4.114). As loading continued, a quiet cracking sound was heard, and the measured force decreased slightly until a pause in loading at 7 in. of midspan deflection.

Figure 4.114: Concrete Spall at South Load Point at 6.7 in. of Midspan Deflection

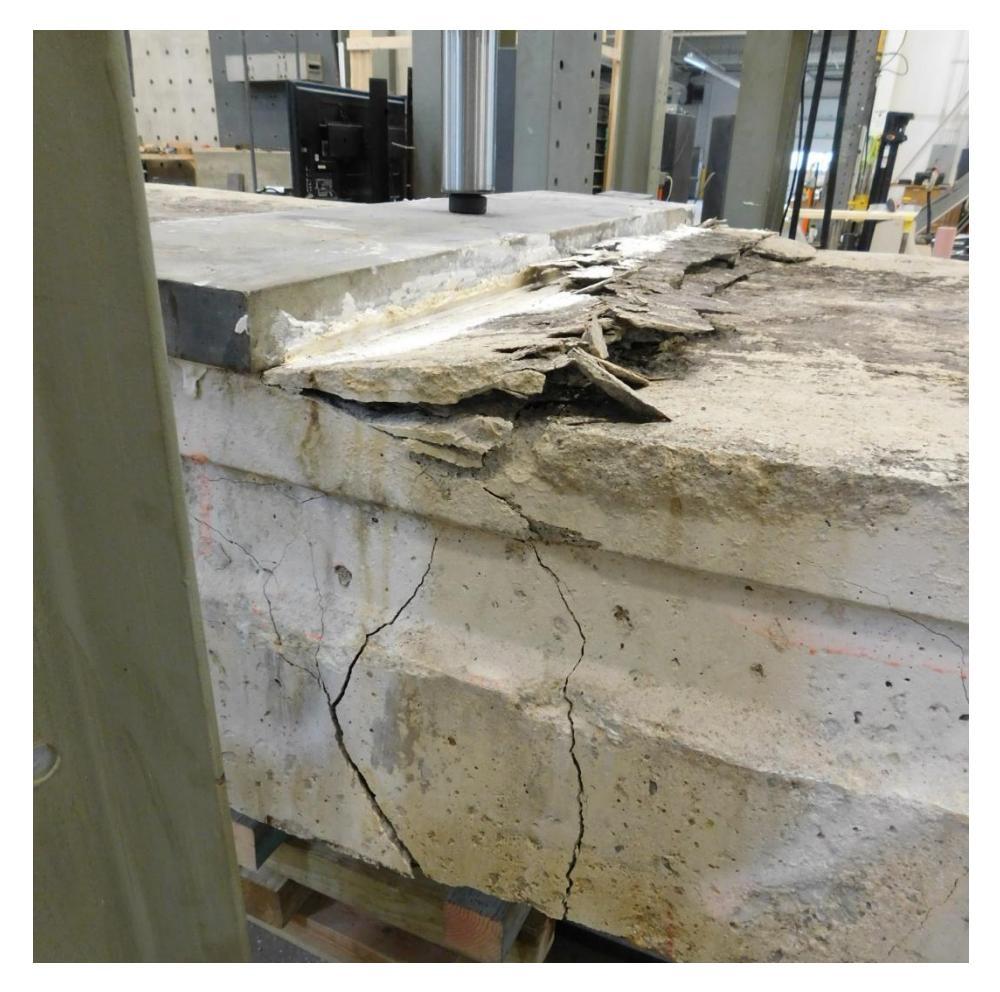
When loading resumed, the measured force increased until, at 7.3 in. of midspan deflection, a loud pop was heard near the south load point, and the measured force decreased by 2.7 kips. As loading continued, the concrete in the top flange at the south load point began to crush (Figure 4.115). At 8.0 in. of midspan deflection, another loud pop was heard near the south load point, and the measured force decreased by 3.8 kips. As loading continued, concrete crushing intensified. At 8.5 in. of midspan deflection, a loud pop was heard, and the measured force decreased by 3 kips. At a midspan deflection of 9.0 in., the stroke limit of the hydraulic jacks was reached, and the test was concluded (Figure 4.116).

Figure 4.115: Concrete Crushing at South Load Point

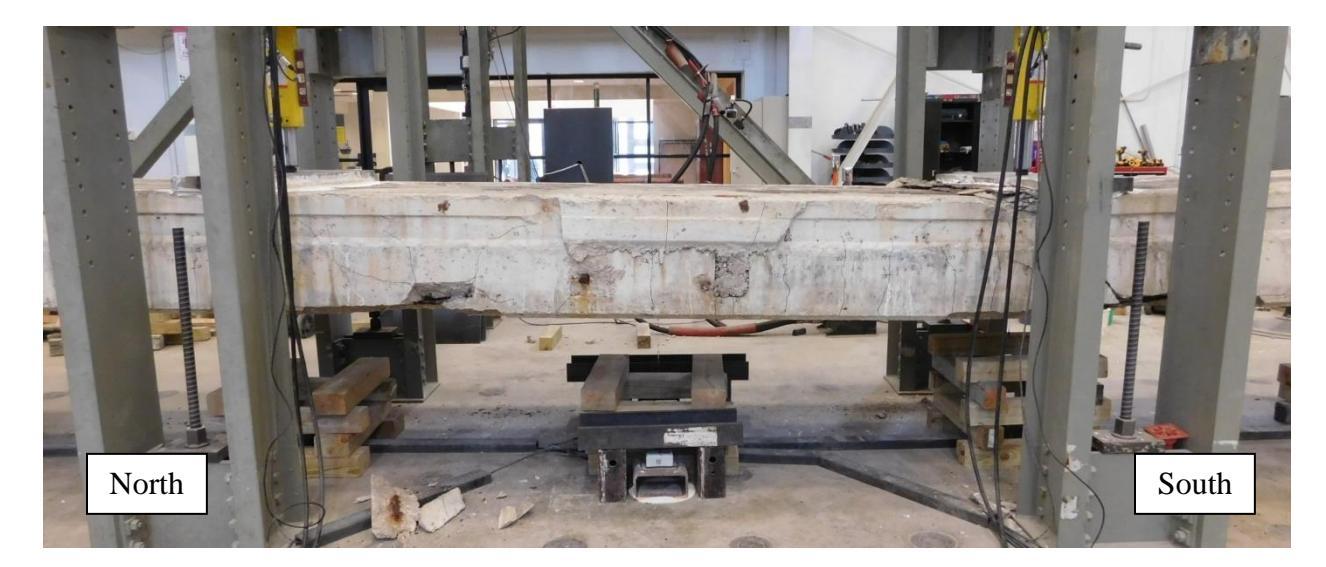
Figure 4.116: Specimen 102-4-BS at Maximum Deflection of 9.0 in.

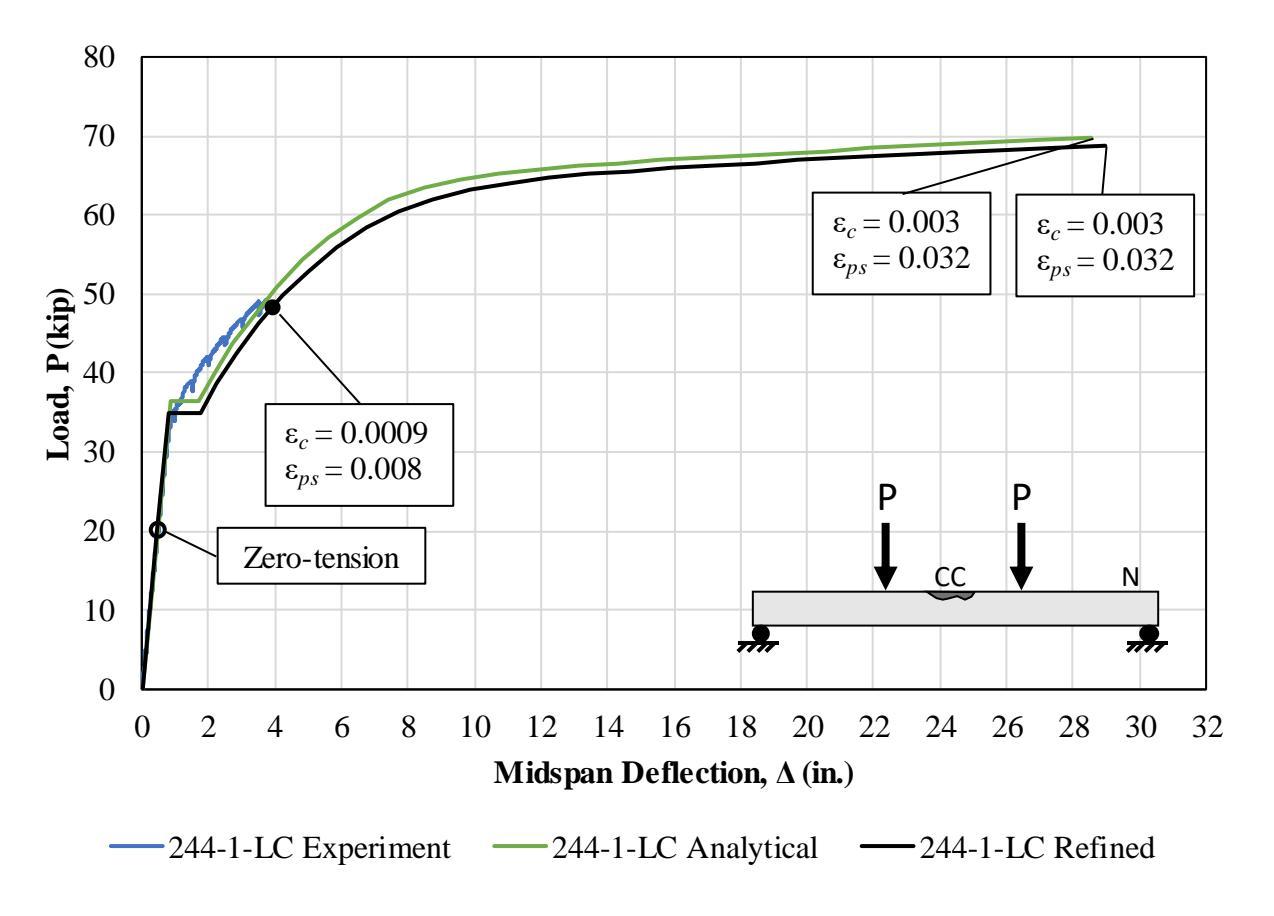
Figure 4.126: Specimen 244-1-LC Load vs. Deflection

The load-deflection curves for Specimen 244-1-LC are provided in Figure 4.126. As shown, the estimated undeteriorated behavior for the analytical and refined models follow the test data until the test ended at a midspan deflection of 3.7 in. The black dot on the refined curve indicates the load and deflection corresponding to a strain in the extreme fiber in compression of 0.0009 and strain in the prestressing strands of 0.008. Considering that the concrete in the top flange was observed to be delaminated after the test (Figure 4.41), the low strain of 0.0009 suggests that the concrete could not achieve typical strain levels of 0.003. In fact, only one third of that value was obtained for the delaminated concrete.

Corroded strands were observed at the longitudinal cracks in the post-failure investigation, but as shown in the corroded strand tension tests, the strand extracted from midspan (Strand 5_{corr}) fractured at a strain of 0.012 which is greater than 0.008. As observed in the post-failure review, no strands fractured at specimen failure. This indicates that when the concrete crushed, the strain in the strands was not large enough to cause fracture of the corroded strands. If the concrete, however, would have been of better quality with improved strain capacity, fracture of the corroded strands was likely. To achieve the full stress-strain curve, the strand would need to achieve a strain of 0.032 (2.7 times the corroded strand capacity).

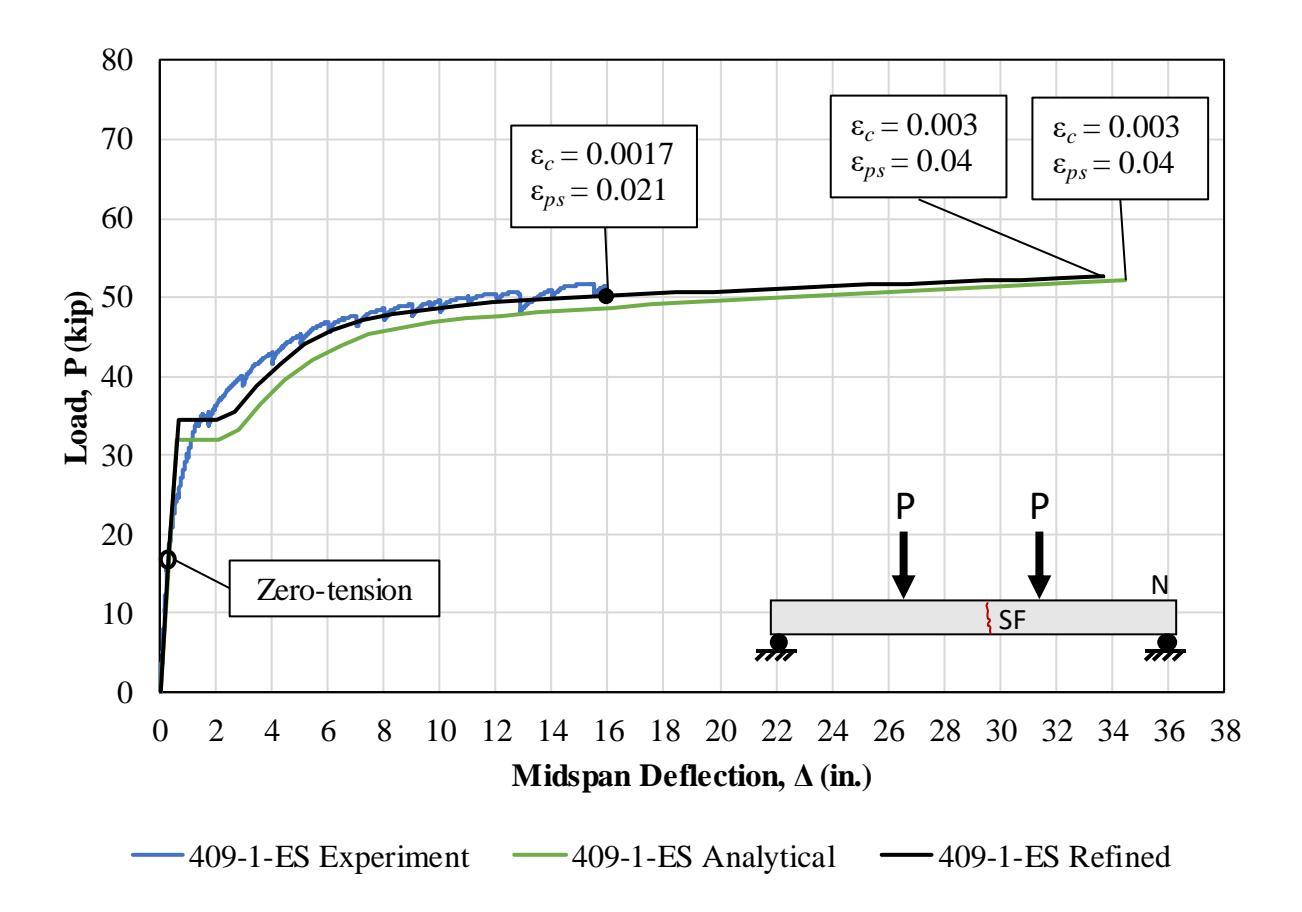
Figure 4.127: Specimen 409-1-ES Load vs. Deflection

The load-deflection curves for Specimen 409-1-ES are provided in Figure 4.127. The analysis was conducted assuming full composite action between the topping slab and beam. As shown in Figure 4.127, the estimated undeteriorated behavior of the analytical and refined models follow the test data until the test ended at a midspan deflection of 15.7 in. The hollow black circle on the refined curve indicates point of zero tension in the extreme fiber in tension at a load of 17.5 kips. The experimental curve does not deviate from initial stiffness until approximately 20 kips. This indicates that the remaining prestress in the section of 162 ksi was slightly underestimated using the cracking load and modulus of rupture of $7.5\sqrt{f_c'}$ (Table 4.18). The remaining stress estimated assuming the zero-tension point corresponds to 20 kips is 168 ksi.

The black dot on the refined curve indicates the load and deflection corresponding to a strain in the prestressing strands of 0.021 and an extreme fiber compressive strain of 0.0017. The low strain in the steel of 0.021 at fracture indicates that the surface corrosion observed during the post-failure review reduced the ductility of the strands. In addition, Strand Specimen 409-1-ES-1 (uncorroded) fractured at a strain of 0.024 ($f_{pu} = 276.2$ ksi, Table 4.6) and was observed with light surface rust (Figure 4.10). This indicates that very low levels of corrosion, due to the existing flexural cracks, influenced the ductility of the strand and compromised the overall ductility of the strand and compromised the overall ductility of the strand.

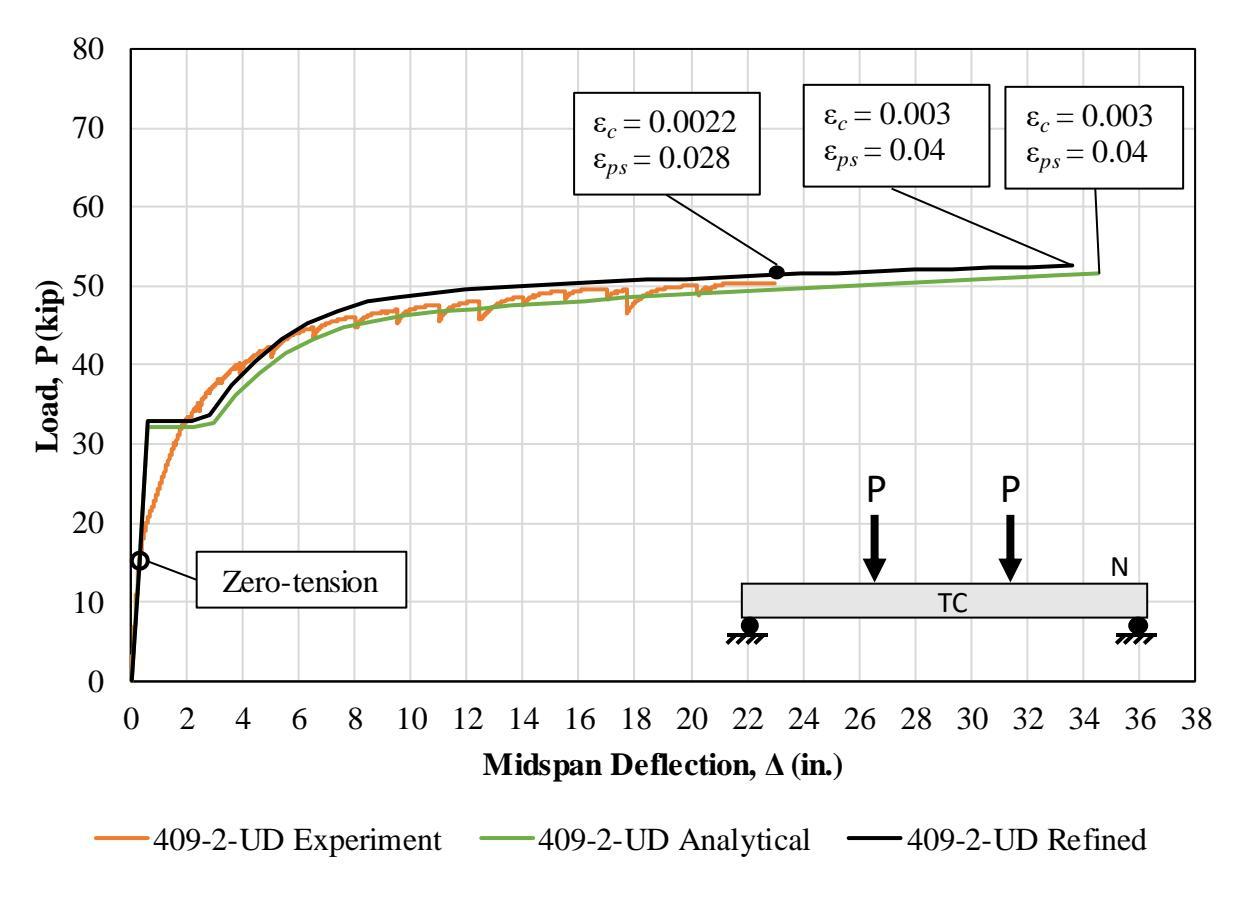
Figure 4.128: Specimen 409-2-UD Load vs. Deflection

The load-deflection curves for Specimen 409-2-UD are provided in Figure 4.128. The analysis was conducted assuming full composite action between the topping slab and beam. As shown in Figure 4.128, the estimated behavior of Specimen 409-2-UD follows the test data well until the test was concluded at a midspan deflection of 23 in. The hollow black circle indicates point of zero tension in the extreme fiber in tension at a load of 15.2 kips. The experimental curve does not deviate from initial stiffness until approximately 17 kips. This indicates that the remaining prestress in the section of 154 ksi was slightly underestimated using the cracking load and modulus of rupture of $7.5\sqrt{f_c'}$ (Table 4.18). The remaining stress estimated assuming the zero-tension point corresponds to 17 kips is 155 ksi.

The end of the calculated curves corresponds to a strain in the extreme compressive fiber of 0.003 and a strain in the strands of 0.04. The strain at peak stress for the cores from Specimen 409-2-UD was measured as high as 0.0032 (Table 4.4), and the average strain at fracture for the strands was 0.058 (Table 4.6). Considering the data, the lack of observed distress in the concrete and strands at 23 in. of midspan deflection is understood. This specimen fully achieved its capacity and was capable of achieving the full assumed concrete and steel strain levels.

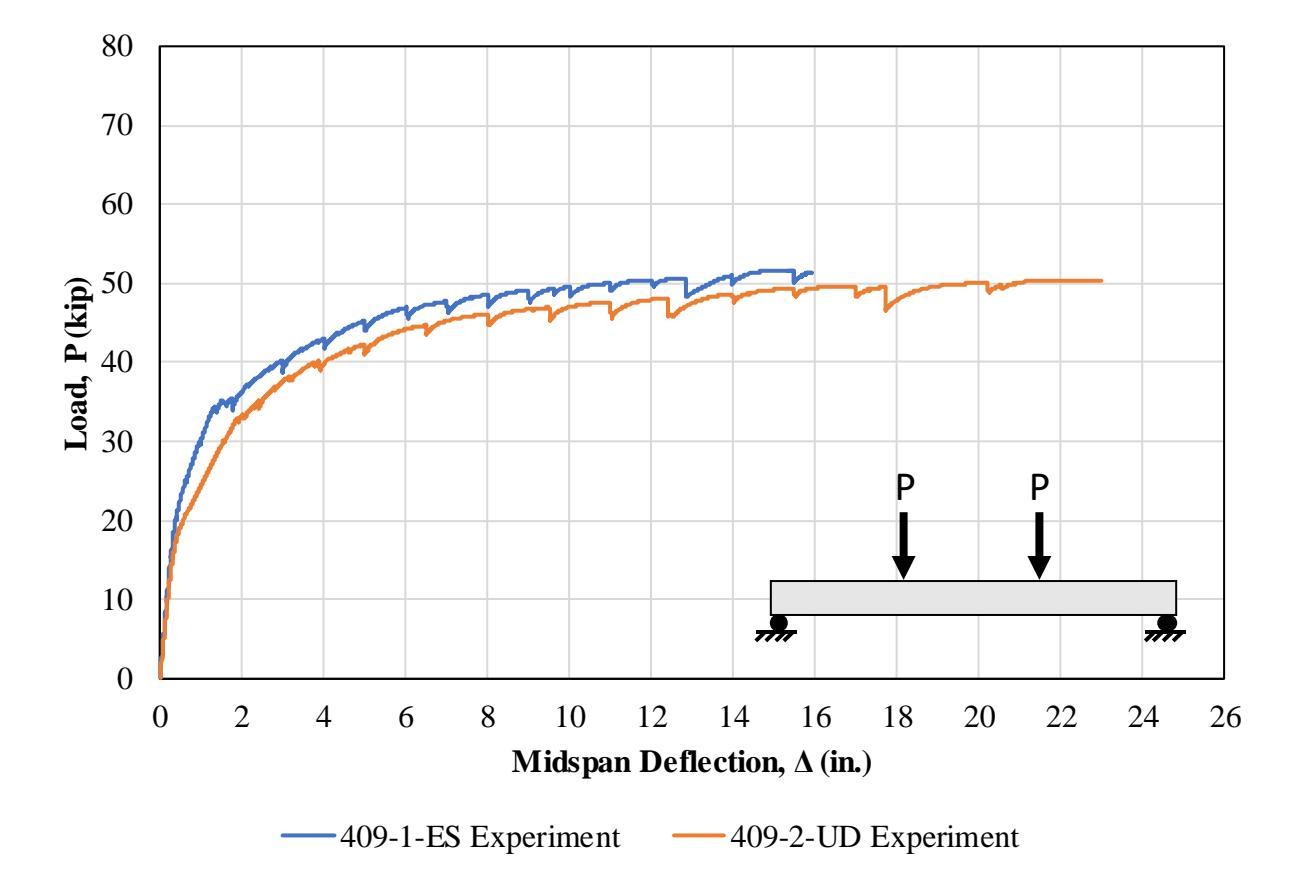
Figure 4.129: Specimen Comparison - 409-1-ES vs. 409-2-UD

Specimens 409-1-ES and 409-2-UD were constructed with the same cross-section and span. For comparison, the load-deflection data for Specimen 409-1-ES is plotted alongside the data for Specimen 409-2-UD in Figure 4.129. As shown, both specimens overall exhibited excellent behavior and achieved approximately the same ultimate load. The only effect of deterioration on Specimen 409-1-ES was that strand fracture was observed prior to the specimen achieving the same midspan deflection as Specimen 409-2-UD. The deterioration of Specimen 409-1-ES was located outside of the maximum moment region. In addition, the extent of strand corrosion did not affect the redevelopment of strand into the maximum moment region.

Considering the location and extent of the deterioration, the effect of the deterioration was minimal and could be neglected in load rating calculations. The presence of flexural cracks,
however, did influence the ductility of the strands in Specimen 409-1-ES. Corrosion of these strands at the crack location was observed and likely led to the slight loss of full strain capacity. It should be noted that the presence of flexural cracks in Specimen 409-2-UD had no impact on strain capacity.

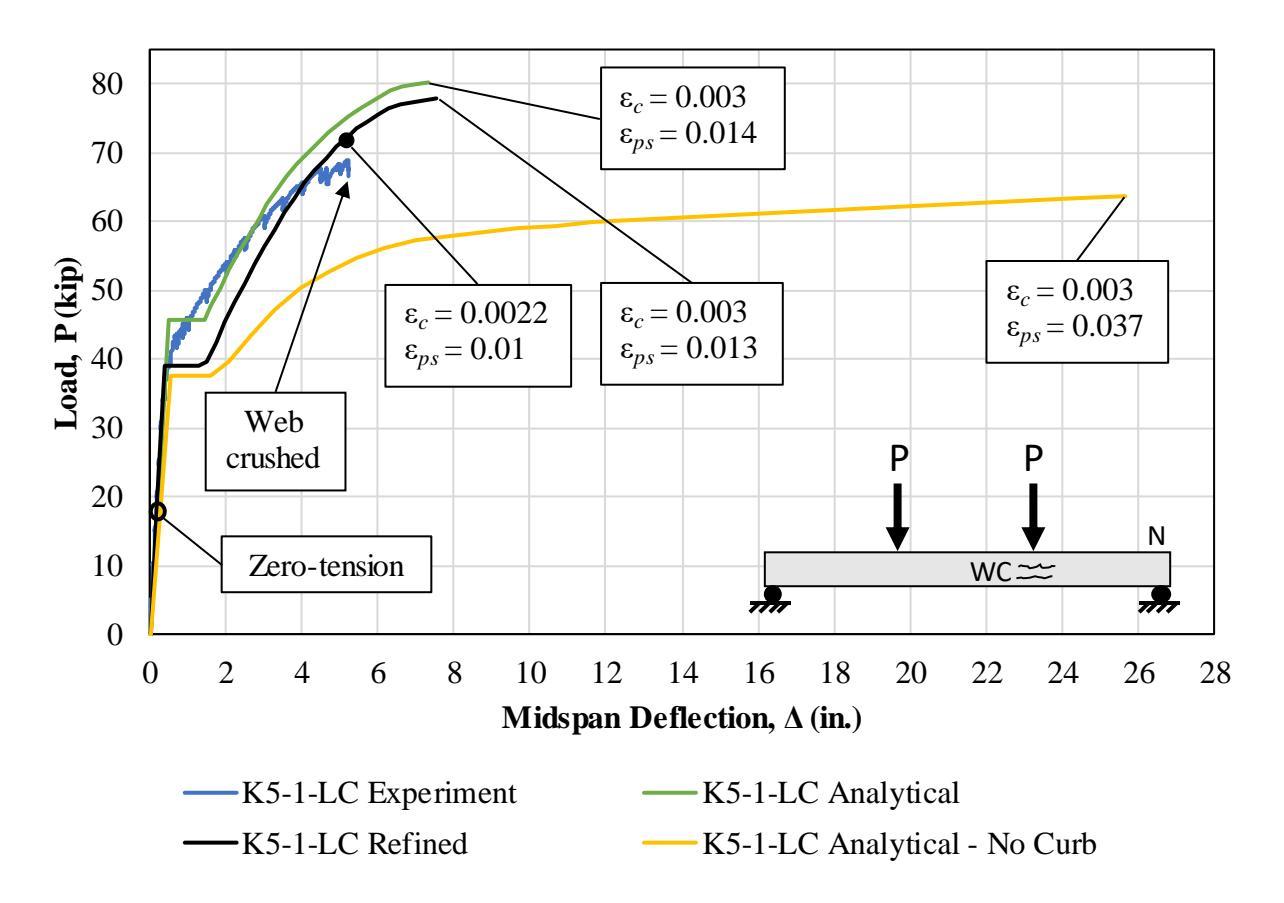
Figure 4.130: Specimen K5-1-LC Load vs. Deflection

The load-deflection curves for Specimen K5-1-LC are provided in Figure 4.130. This specimen included a curb which was modeled with the simplified method. As shown, the simplified curb analysis for undeteriorated behavior trends well with the test data. While the analysis considers flexural failure, this specimen failed due to web crushing. The localized web failure occurred very close to the ultimate capacity. Overall, this specimen can be considered to

have achieved its full design capacity (strength). In general, the simplified analysis estimated the general trend of the load-deflection behavior well and the ultimate load (78 kips) within 14% of the load measured at failure.

Typically in design, the curb is not considered. Therefore, an analysis was conducted for the beam without a curb using the analytical model. As shown, the curb significantly increases the strength of the section. In addition, the overall deflection capacity is reduced.
