EVALUATION AND STRUCTURAL BEHAVIOR OF DETERIORATED PRECAST, PRESTRESSED CONCRETE BOX BEAMS

A Dissertation

Doctor of Philosophy

Lyles School of Civil Engineering West Lafayette, Indiana December 2019

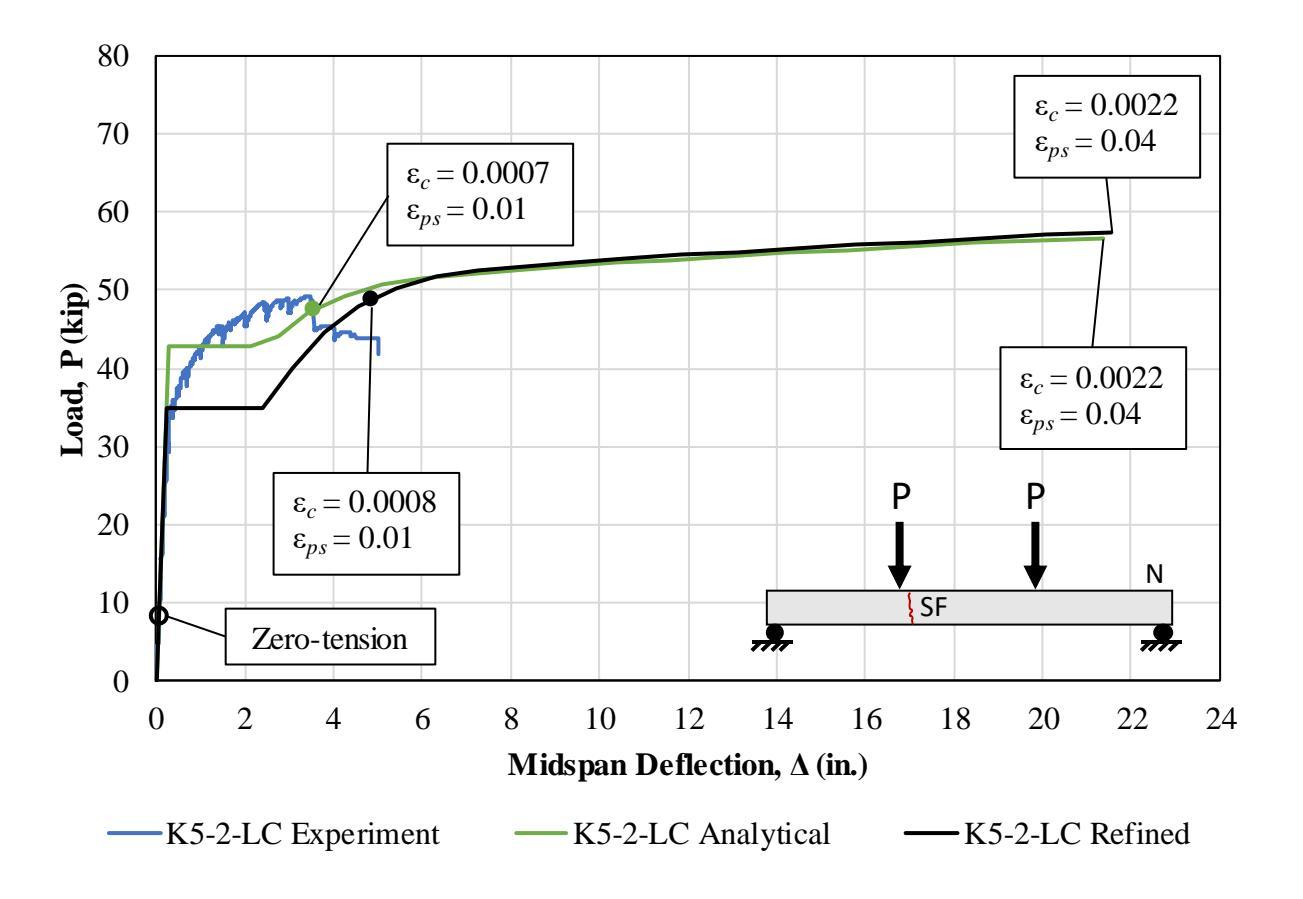
Figure 4.131: Specimen K5-2-LC Load vs. Deflection

The load-deflection curves for Specimen K5-2-LC are provided in Figure 4.131. As shown, the primary difference between the analytical and refined models was the estimated load at cracking. The difference was caused by the estimate of remaining prestress use in the analytical

model. The remaining prestress in the beam was actually very low. It was calculated as only 109 ksi.

After cracking, the refined model curve shows a similar post-cracking stiffness as the test data up to a midspan deflection of 3.5 in. where the load decreases due to strand fractures. This indicates that all strands were engaged in resisting the applied moment at the onset of the test. As shown in Figure 4.131, the calculated strain in the steel at peak measured load was 0.01 which is within the range of strain at fracture for the corroded strands tested (Table 4.13). This is consistent with the observation that popping sounds (individual wire fractures) were heard prior to the load decrease at 3.5 in. of midspan deflection. In addition, the concrete strain estimated at peak load (0.0008) corresponds to crushing of the concrete observed just after the decrease in load observed during the test at 3.5 in. of midspan deflection. The estimated concrete strain at peak load (0.0008) is approximately the same as the strain in the concrete at crushing calculated for Specimen 244-1-LC (0.0009). While the concrete strain did not control failure for Specimen K5-2-LC, the repaired flange and delaminated concrete (Figure D.6) indicate that compression failure was likely if the strand would have had more strain capacity.

Specimen K5-2-LC was observed with three longitudinal cracks meeting at a single section (Figure 3.5). Considering the results of the corroded strand tests, the capacity of the specimen was estimated using the refined model assuming that at a strain in the strands of 0.01, the corroded strands would fracture causing failure of the specimen. These assumptions resulted in an estimated capacity of 48.0 kips which is within 3% of the ultimate measured load of 49.3 kips and shown as a black dot on the refined curve in Figure 4.131. When the same assumptions were used with the analytical model, the estimated capacity was 47.2 kips which is within 5% of the ultimate measure load and shown as the green dot on the analytical curve in Figure 4.131.

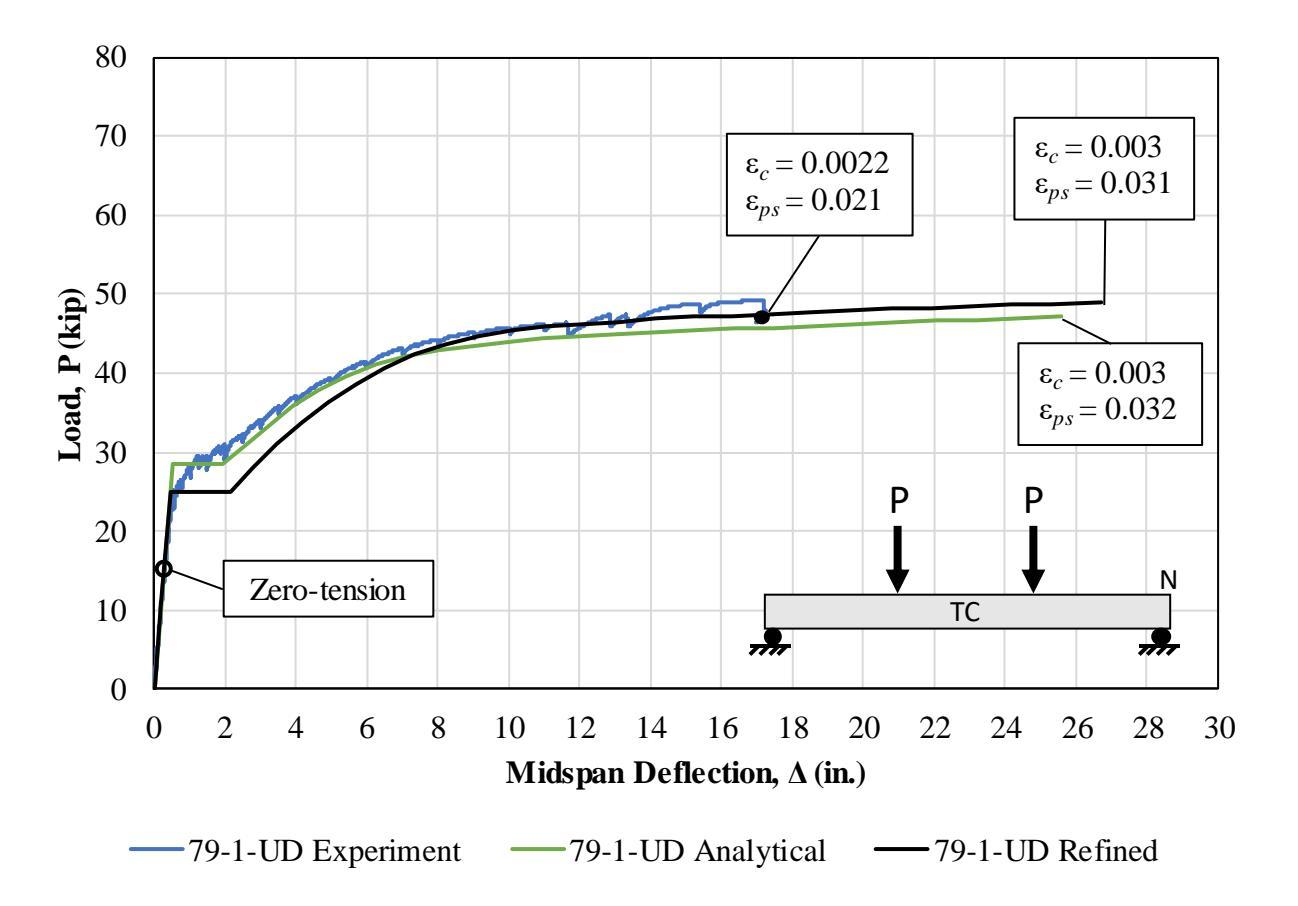
Figure 4.132: Specimen 79-1-UD Load vs. Deflection

The load-displacement curves for Specimen 79-1-UD are provided in Figure 4.132. As shown, the estimated curves for the undeteriorated section follow the test data up to a midspan deflection of 17.2 in. where the test was concluded. The black dot on the refined curve indicates the load and deflection corresponding to an extreme compressive fiber strain of 0.0022 and strain in the strands of 0.021. The last point on the calculated curves corresponds to an extreme compressive fiber strain of 0.003 and a strain in the strands of 0.032 for the analytical model and 0.031 for the refined model.

The compression test results for Specimen 79-1-UD indicated that, on average, the peak compressive stress occurred at a strain of 0.0028 (Table 4.4). Additionally, the average strain at fracture for the tested strands was 0.043 (Table 4.6). Therefore, the lack of concrete crushing and strand fracture at the end of the test is consistent. This specimen was capable of reaching its full capacity both in terms of strength and deformation.

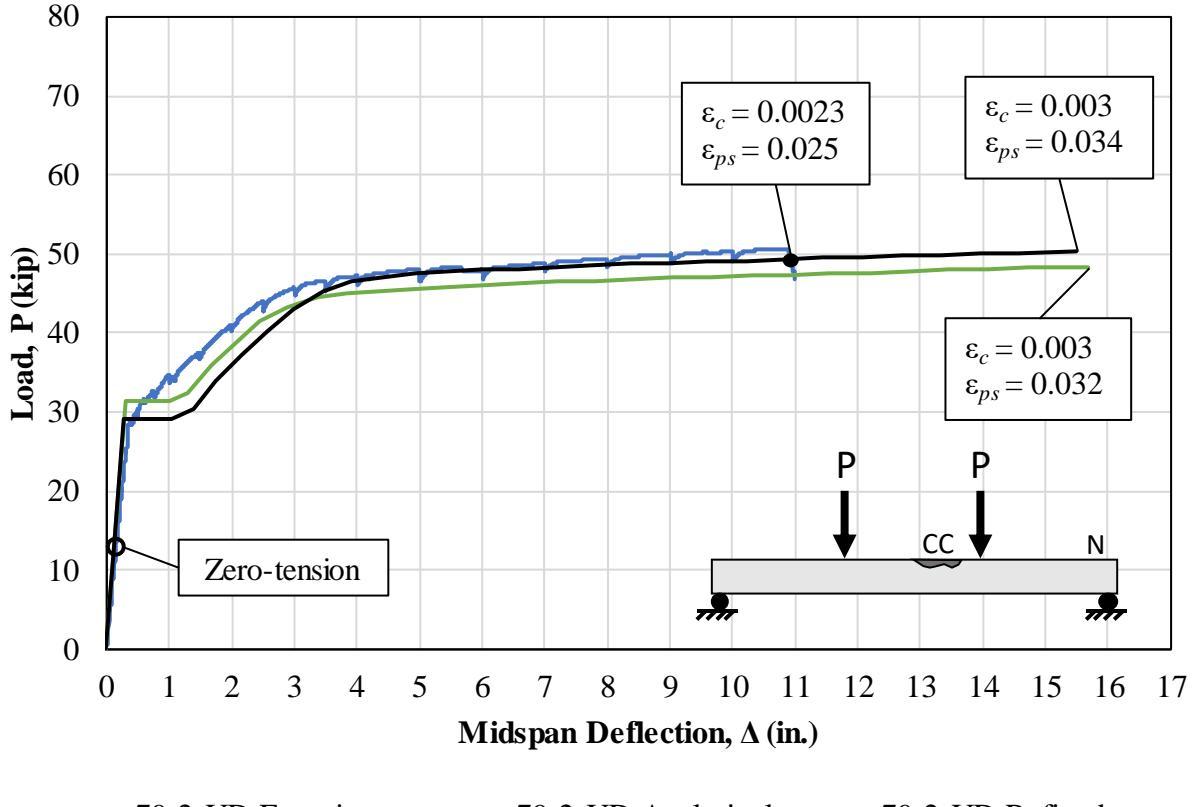
Figure 4.133: Specimen 79-2-UD Load vs. Deflection

The load-deflection curves for Specimen 79-2-UD are provided in Figure 4.133. As shown, the model curves for the undeteriorated section follow the test data up to a midspan deflection of 11.0 in. when the test ended in concrete crushing in the top flange. The black dot on the refined curve indicates the load and deflection corresponding to an extreme fiber compressive strain of 0.0023 and a strain in the strands of 0.025. The last point on the model curves corresponds to an extreme fiber compressive strain of 0.003 and a strain in the strands of 0.032 for the analytical model and 0.034 for the refined model. This specimen is considered to have reached its theoretical capacity.

The compression test results for Specimen 79-2-UD showed that, on average, the strain at peak stress was 0.0024 (Table 4.4), which is very close to the calculated extreme compression

fiber strain. In addition, the average strain at fracture for the strands tested from Specimen 79-2-UD was 0.043 (Table 4.6), which is much higher than the estimated strain in the strands when the concrete reached peak stress. Therefore, the analysis matches the observation that the concrete crushed prior to strand fracture. Again, this specimen reached full capacity (strength and deformation).

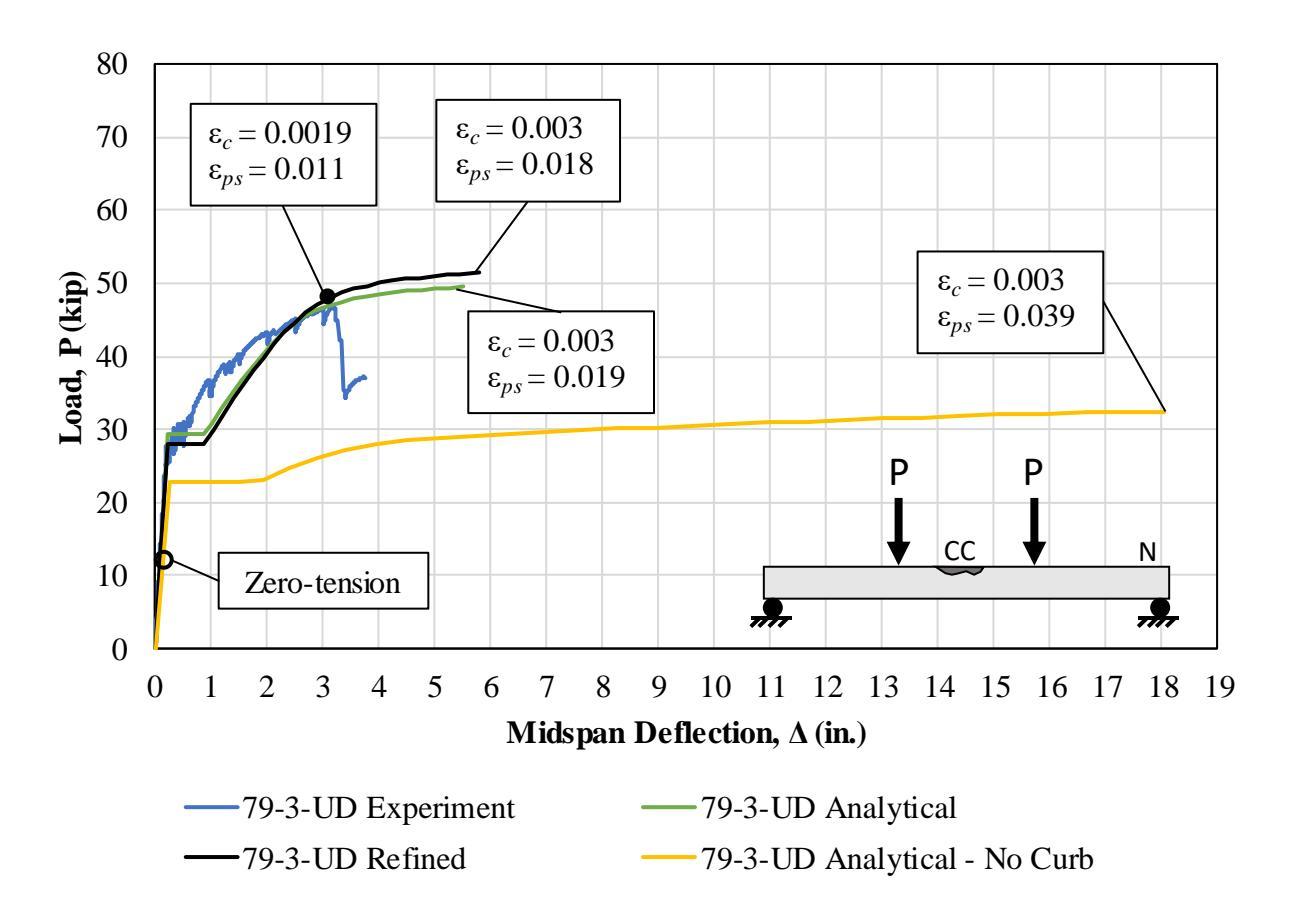
Figure 4.134: Specimen 79-3-UD Load vs. Deflection

The load-deflection curves for Specimen 79-3-UD are provided in Figure 4.134. This specimen included a curb which was modeled with the simplified method. As shown, the simplified curb analysis for both analysis models trends well with the test up to a midspan deflection of 3.2 in. when the concrete in the curb crushed. The black dot on the refined curve

The compression test results for the concretes cores from the curb of Specimen 79-3-UD showed that, on average, the strain at peak stress was 0.0027 (Table 4.4) which is higher than the estimated strain of 0.0019. This indicates that the piece of wood embedded in the curb (Figure 4.72) prevented the surrounding concrete from reaching its full strain capacity and caused premature concrete crushing in the curb of the specimen, resulting in reduced ductility of the specimen.

The ultimate load predicted by the simplified analysis was 52.1 kips which is within 12% of the actual peak load of 46.7 kips. The difference between the test result and analysis is assumed to be an effect of the embedded piece of wood.

For consistency with design practices, the capacity of the specimen was estimated using the analytical model assuming no curb. The resulting load-deformation response is shown in Figure 4.134 as the yellow curve ("Analytical - No Curb"). As shown, the curb increased the strength of the specimen by over 40% and significantly reduced the deflection capacity.

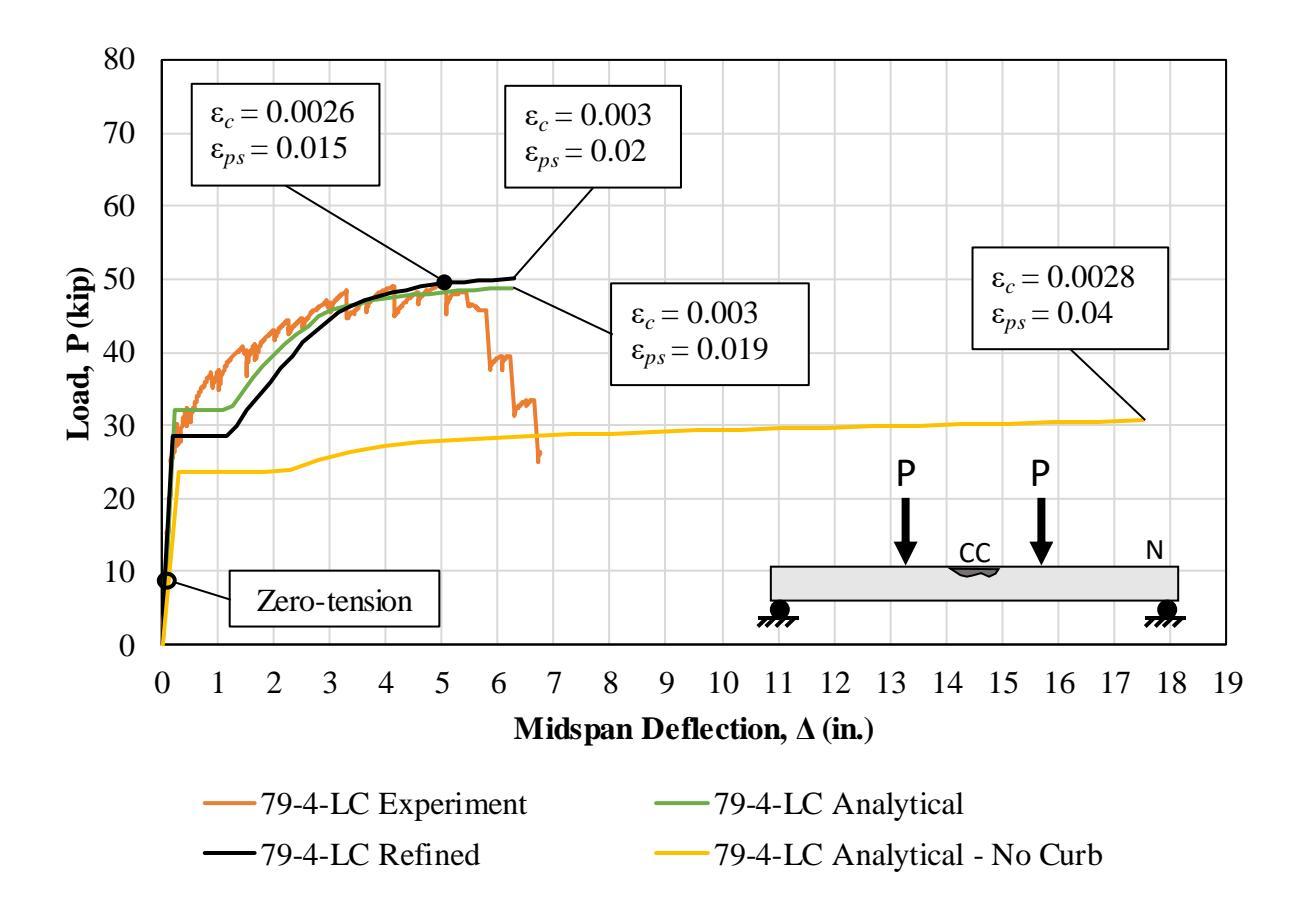
Figure 4.135: Specimen 79-4-LC Load vs. Deflection

The load-deflection curves for Specimen 79-4-LC are provided in Figure 4.136. This specimen included a curb which was modeled with the simplified method. As shown, the simplified curb analysis for both analysis models trends well with the test data up to the peak load measured at 5.1 in. of midspan deflection. The black dot on the refined curve indicates the load and deflection corresponding to an extreme fiber compressive strain of 0.0026 and a strain in the strands of 0.015. The last point on the model curves corresponds to an extreme fiber compressive strain of 0.003 and a strain in the strands of 0.019 for the analytical model and 0.02 for the refined model.

estimated strain of 0.0026. In addition, the average strain at fracture for the strands tested from Specimen 79-4-LC was 0.058 (Table 4.6), which is much higher than the estimated strain in the strands of 0.019 when the concrete reached a strain of 0.0026. This indicates that the observed failure mode of concrete crushing is consistent with the analysis models.

The ultimate load estimated by the simplified analysis was 50.8 kips which agrees very well with the peak measured load of 49.3 kips (within 3%).

For consistency with design practices, the capacity of the specimen was also estimated using the analytical model assuming no curb. The resulting load-deformation response is shown in Figure 4.135 as the yellow curve ("Analytical - No Curb"). As shown, the curb increased the strength of the specimen by over 50% and significantly reduced the deflection capacity.

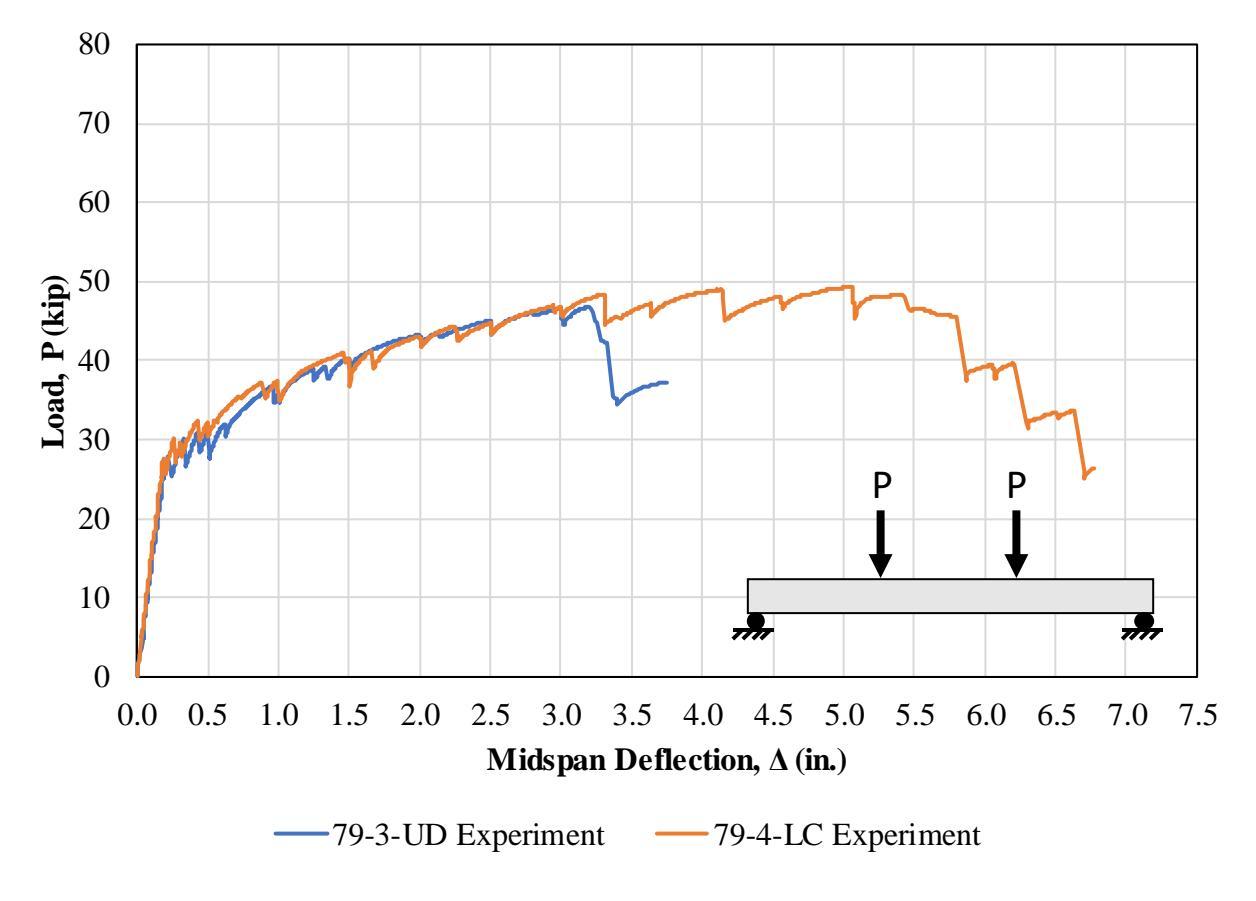
Figure 4.136: Specimen Comparison - 79-3-UD vs. 79-4-LC

Specimens 79-3-UD and 79-4-LC have identical cross-sections and span lengths. Furthermore, Specimen 79-3-UD did not have any deterioration while only limited deterioration of longitudinal cracking at the north end existed in Specimen 79-4-LC. Therefore, the test data for Specimen 79-3-UD is plotted in Figure 4.136 to evaluate the effect of deterioration in Specimen 79-4-LC. As, shown, the load-displacement curves for both specimens are identical up to the failure of Specimen 79-3-UD which was initiated by the wood embedded in the curb. The longitudinal cracks observed in the end of Specimen 79-4-LC caused minimal strand corrosion and had no effect on the structural capacity of the specimen. As shown, there was no impact of the end corrosion on Specimen 79-4-LC. In fact, the wood embedded in the curb during construction was shown to have a greater impact on structural capacity of Specimen 79-3-UD than the bottom flange deterioration of Specimen 79-4-LC.

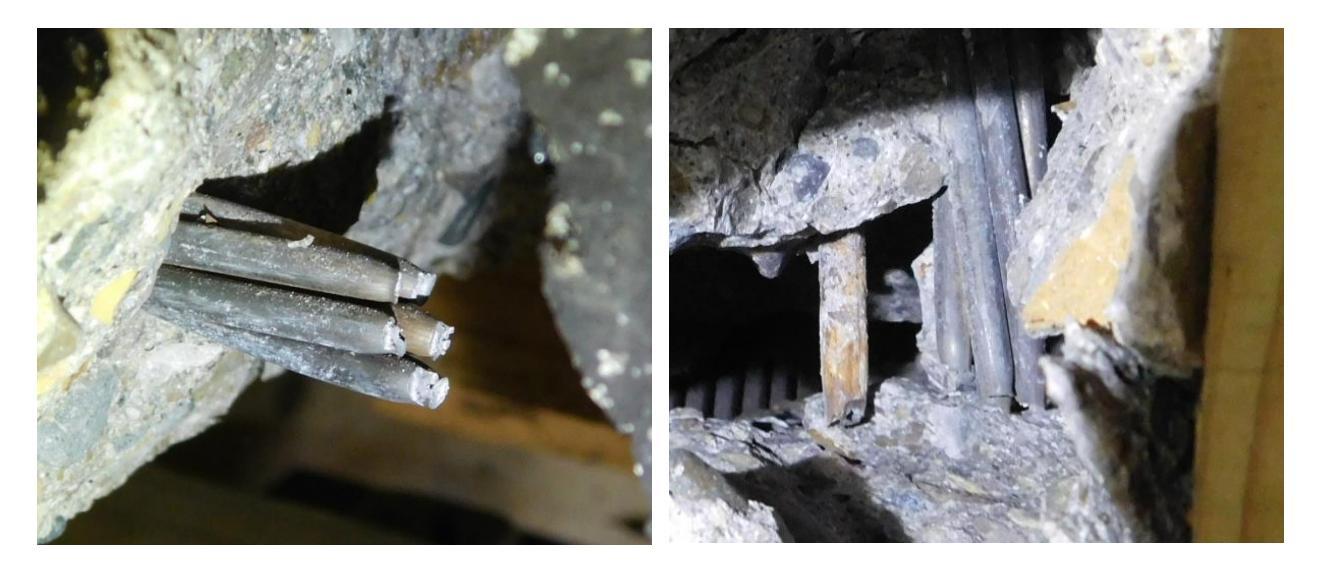
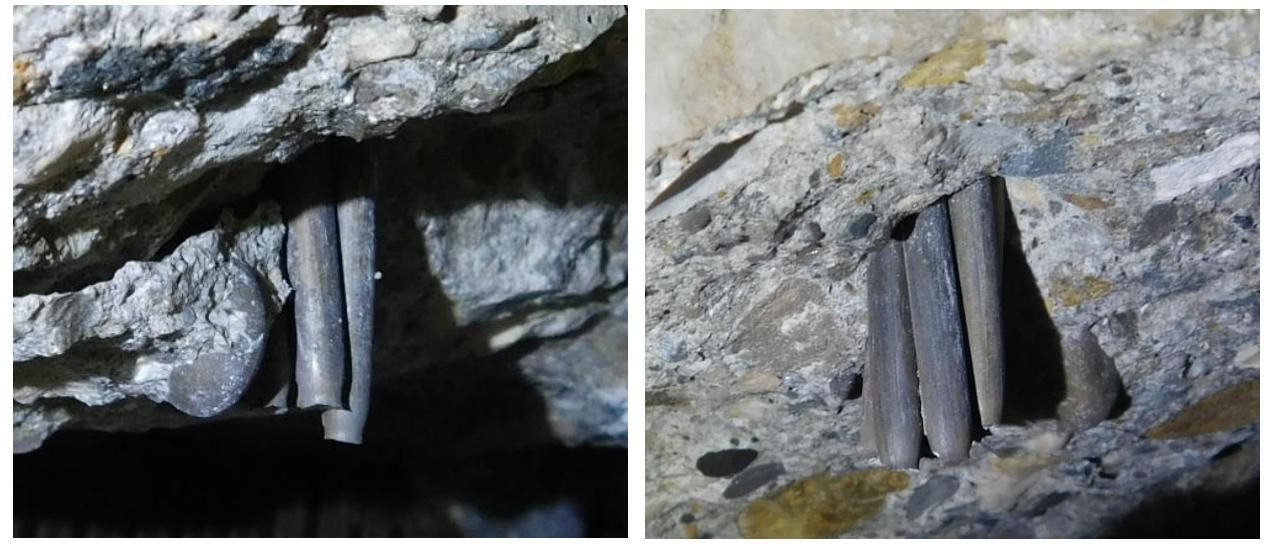
(c) Strand 10 (d) Strand 11 Figure 4.138: Strand Fractures in Specimen 56-1-LC

The results from the compression tests indicated that peak concrete stress occurred, on average, at a strain of 0.0032 which accounts for the lack of crushing prior to the first strand fracture observed during the test. The first fracture was attributed to minor pitting observed during the post-failure review. The calculated strain at fracture of 0.025 is close to the strain at fracture measured for Strand Specimen 79-4-LC-1_{cor} (0.019, Table 4.13) which had slightly more corrosion (Figure 4.17(a)) and achieved 100% of the average breaking strength of the uncorroded strands. This again illustrates the loss of ductility in the strand and overall beam behavior caused by corrosion. The remaining strands in the section were observed to have exhibited ductile type fractures consistent with those observed during tensile testing (Figure 4.9 and Figure 4.138). The fracture of these strands was assumed to be caused by the increase in strain caused by the increase

in neutral axis depth when the concrete began crushing after the first strand facture. While the full strain capacity was not achieved, the specimen exhibited excellent ductility and achieved 98% of the ultimate capacity. This specimen can be considered as achieving design strength.

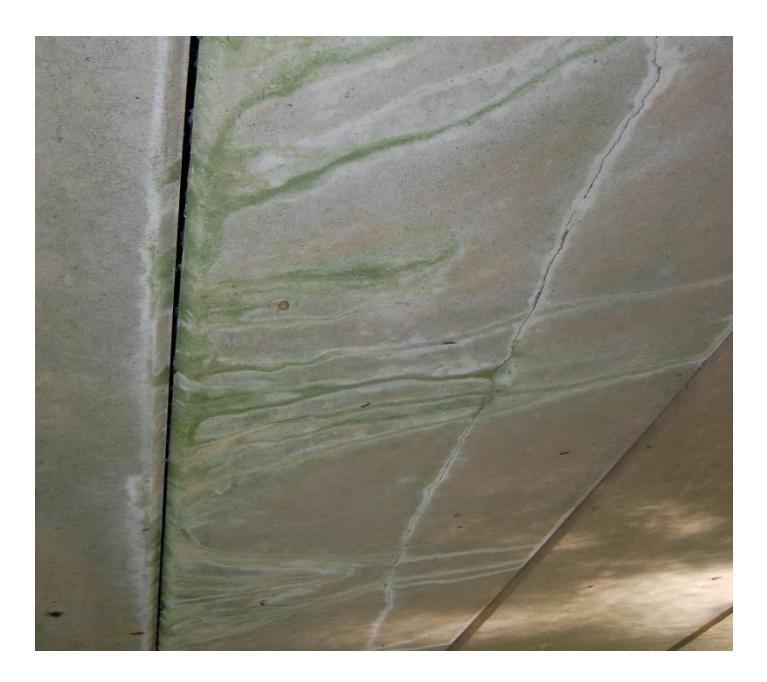
Evidence of a leaking shear key or presence of a reflective crack calls into question the condition of a shear key and the capacity of a shear key to transfer load between beams (Figure 5.1). The position of a shear key within an adjacent box beam bridge makes visual inspection impossible, and there is no standard non-destructive inspection method to evaluate the condition of the shear key. The lack of dependable inspection may lead load rating engineers to assume that there is no load distribution where signs of shear key deterioration are observed.

Figure 5.1: Leaking Shear Key (Bridge 35-00013, Pond Creek)

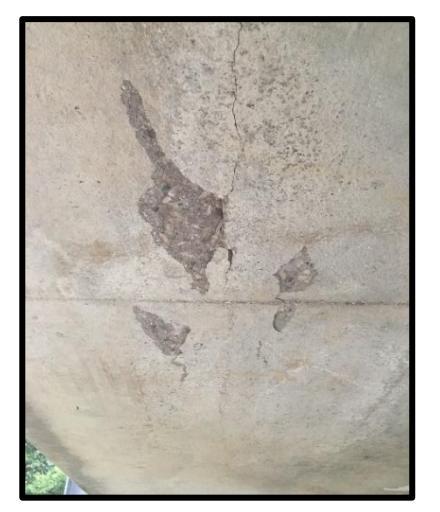
A supplementary bridge inspection was performed by an INDOT bridge inspector before testing began to determine the condition of the bridge (Figure 5.3). The investigation revealed deterioration on Beam 1 and Beam 7 (Figure 5.4). Minor longitudinal cracking was observed on the west end of Beam 7 (Figure 5.4(a)). The cracking in Beam 7 was considered minimal and assumed to have a negligible effect on the flexural strength of the beam. Beam 1 was observed to have three exposed strands at the east support (Figure 5.4(d)) and two rust-stained longitudinal cracks approximately 5-ft long located at midspan (Figure 5.4(b) and (c)). Concern regarding the deterioration of Beam 1 prevented direct loading until the concrete deck was placed. Evidence of water leaking through the shear keys was also observed between every beam with exception to the joint between Beams 4 and 5 (Figure 5.3). In addition to the observed deterioration, the thickness of the bituminous wearing surface was estimated to be 5 in. based on a survey using GPR. The supplementary inspection report is provided in Appendix I.

(a) Longitudinal cracking in Beam 7

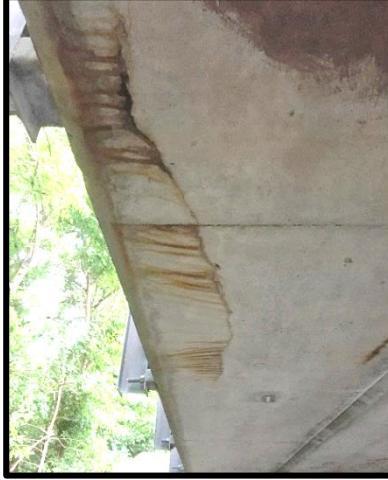
(b) Rust stained longitudinal crack on south side of Beam 1

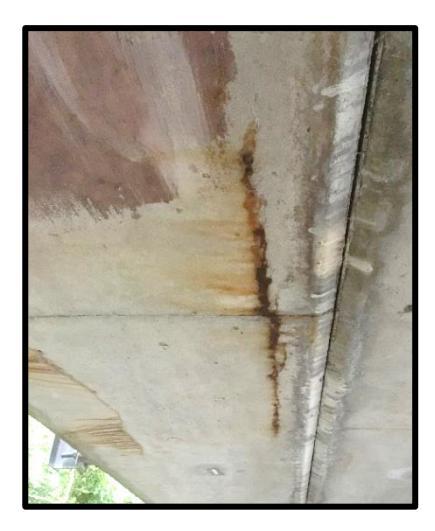
(c) Rust stained longitudinal crack on north side of Beam 1

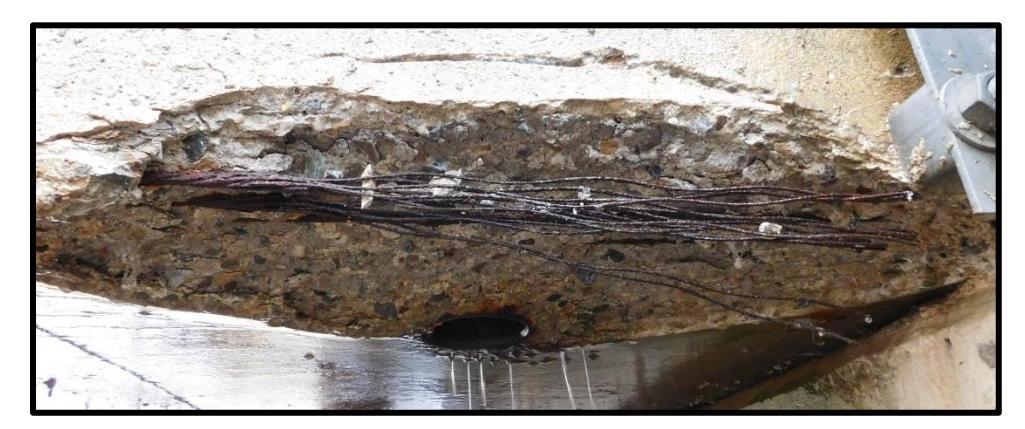
(d) Three exposed strands at east support of Beam 1

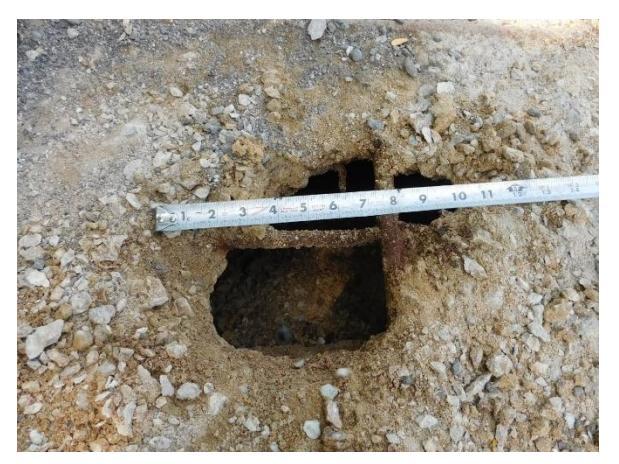
After LT1 was completed, the bridge was closed on 2 July 2018 to all traffic to allow bridge modifications to be completed safely. Yates Construction, a bridge contractor, was hired to remove the bituminous wearing surface (Figure 5.10). During removal of the wearing surface, the milling machine removed a portion of the top flange of each beam and exposed regions of deterioration in Beam 1 (Figure 5.11(a)) and Beam 3 (Figure 5.11(b)). The hole in Beam 1 was approximately 10 in. by 10 in., and the concrete around the hole had been reduced to rubble. Both holes in Beam 3 were approximately 30 in. long and 10 in. wide after removing the deteriorated concrete.

(a) Hole in Beam 1

Figure 5.12 shows the location of the top flange deterioration exposed by the milling machine. The holes in each beam were prepared for repair by removing any deteriorated concrete and cleaning the surface around each hole. The top flange was then repaired with Quikrete mixed in a wheelbarrow by the contractor (Figure 5.13).

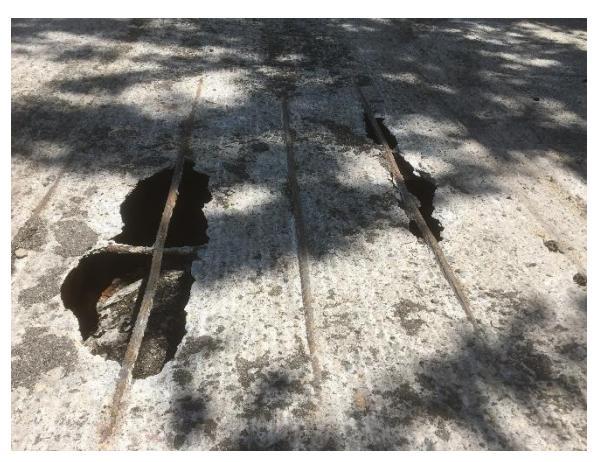
(b) Holes in Beam 3 before deterioration was removed

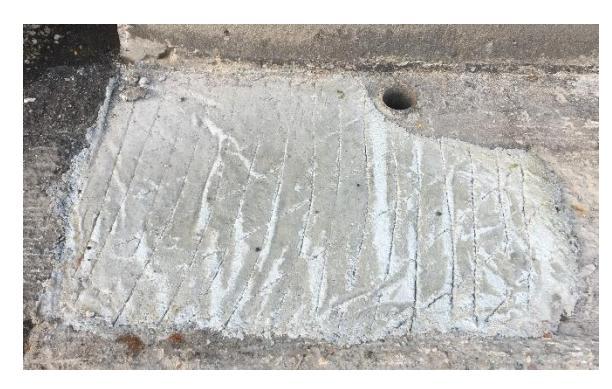
(a) Beam 1 repair patch

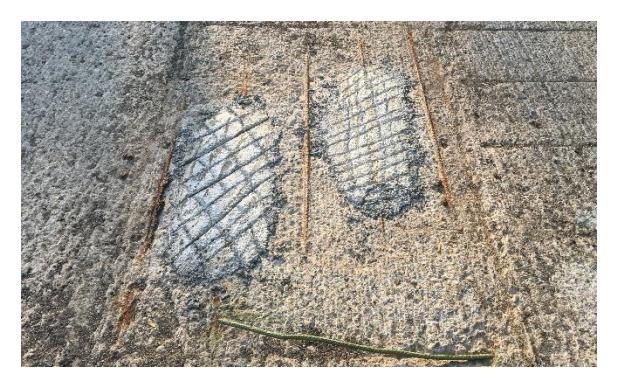
(b) Beam 3 repair patches

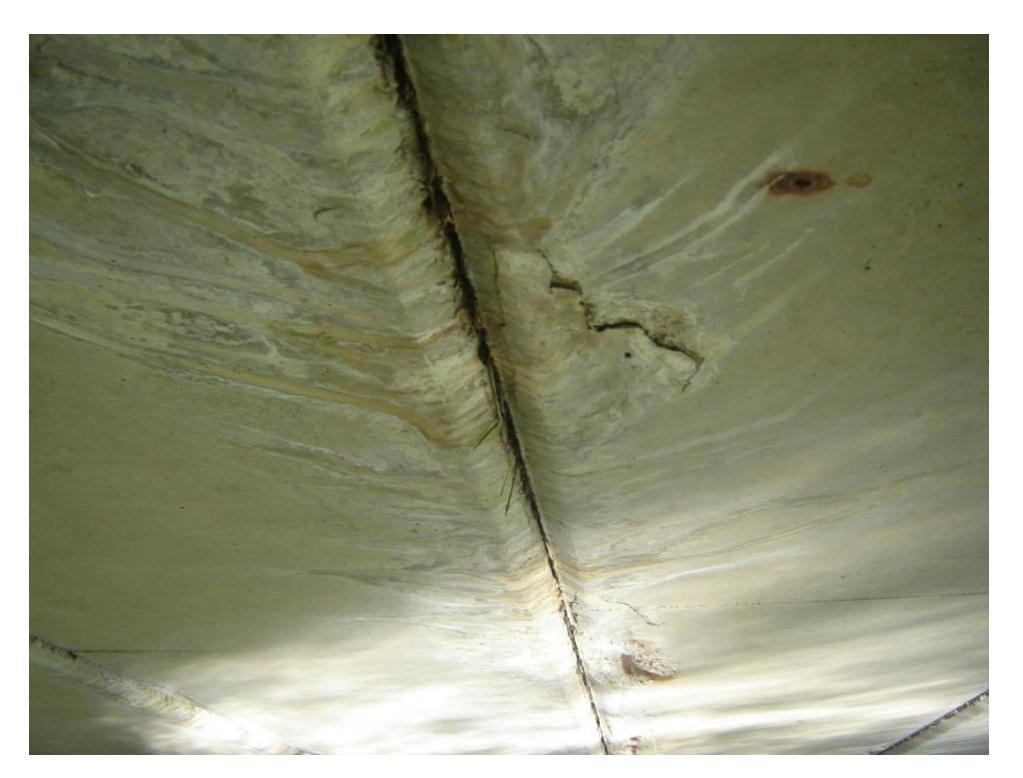
Figure B.1 to Figure B.17 provide examples of deterioration caused by leaking shear keys or water draining over the side of the bridge. Photos courtesy of Beam, Longest, and Neff LLC.

Figure B.1: Leaking Shear Key Deterioration

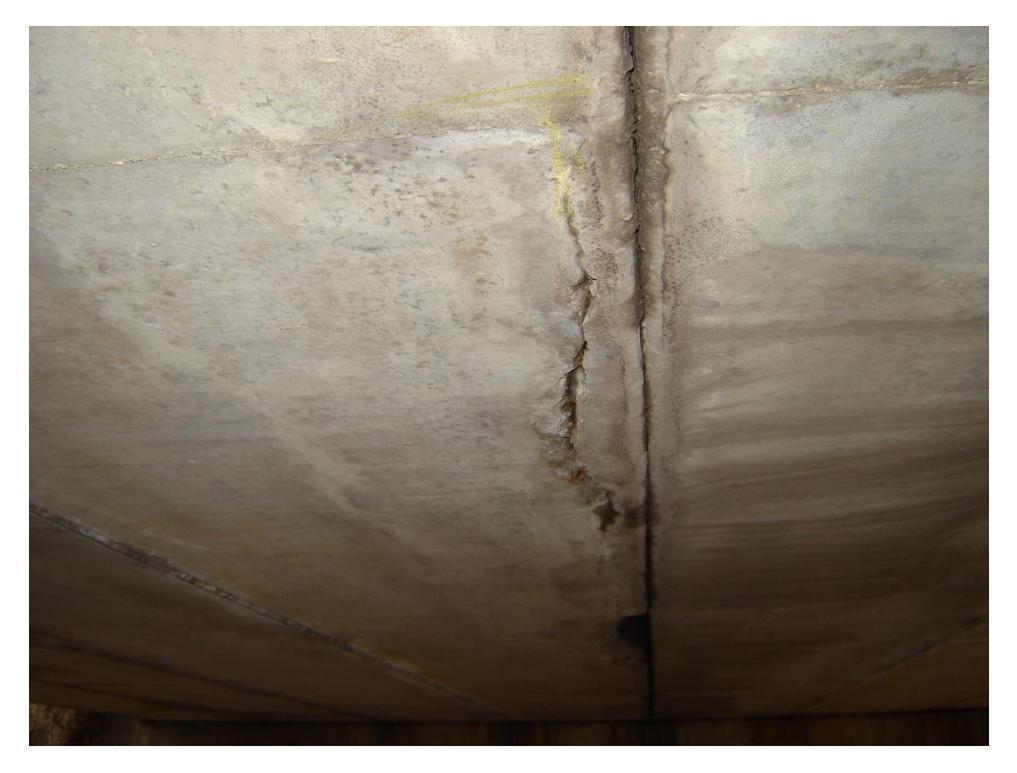
Figure B.2: Leaking Shear Key Deterioration

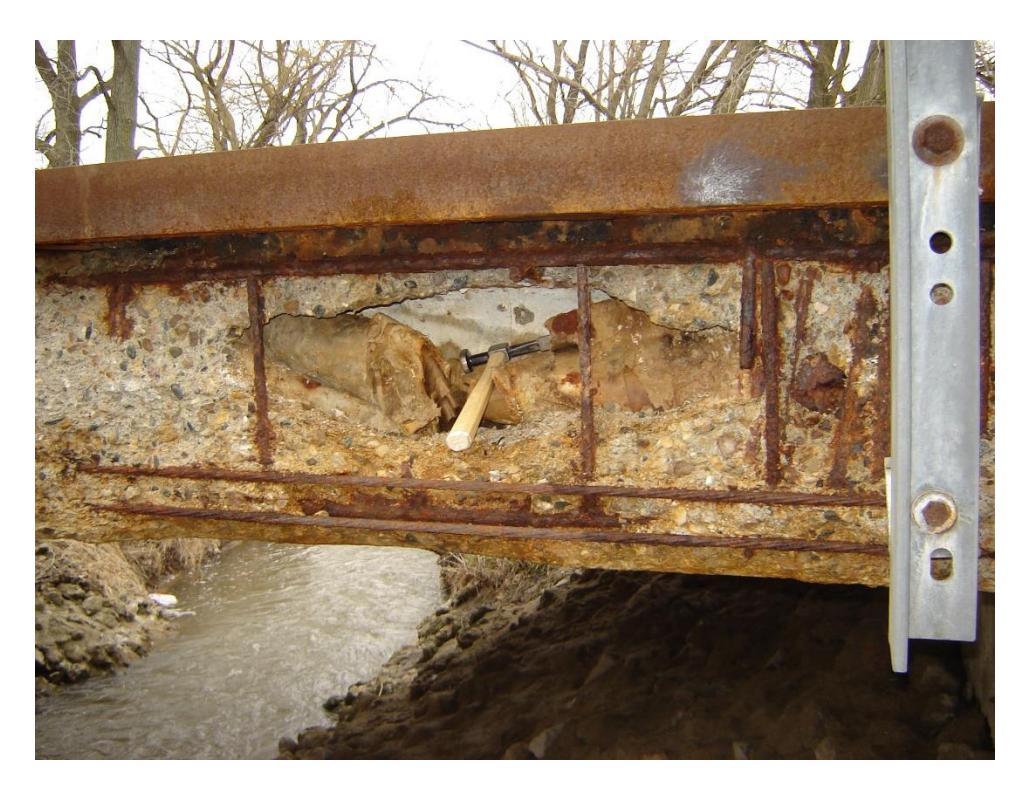
Figure B.3: Water Draining Over the Side of the Bridge Deterioration

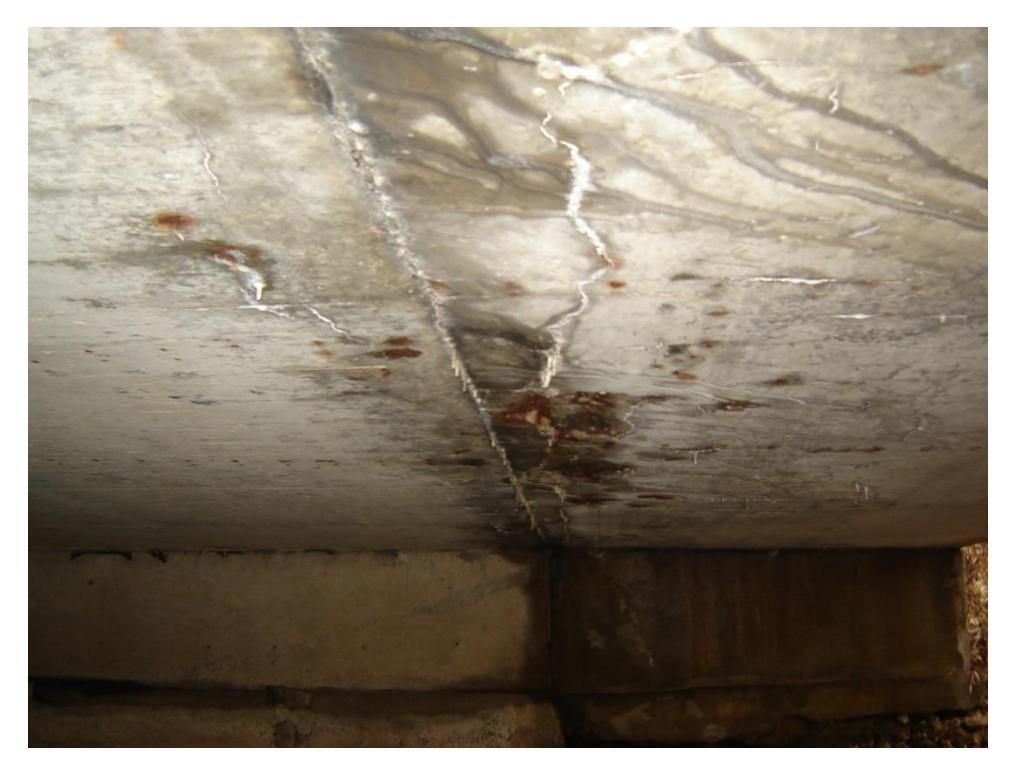
Figure B.4: Leaking Shear Key Deterioration

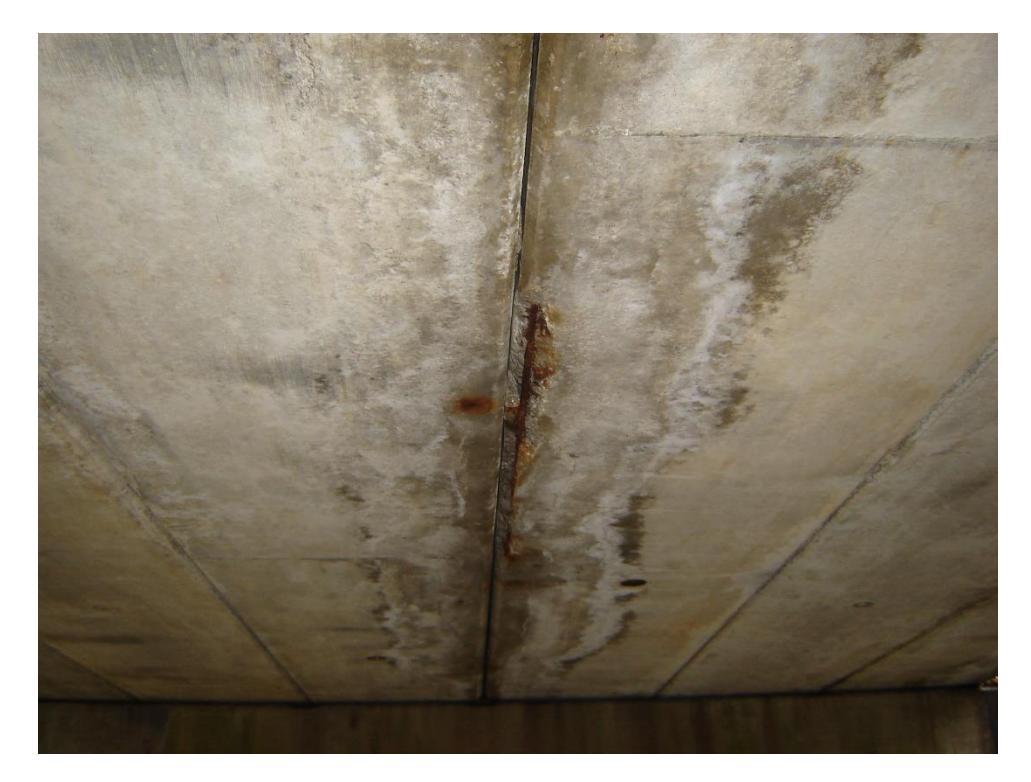
Figure B.5: Leaking Shear Key Deterioration

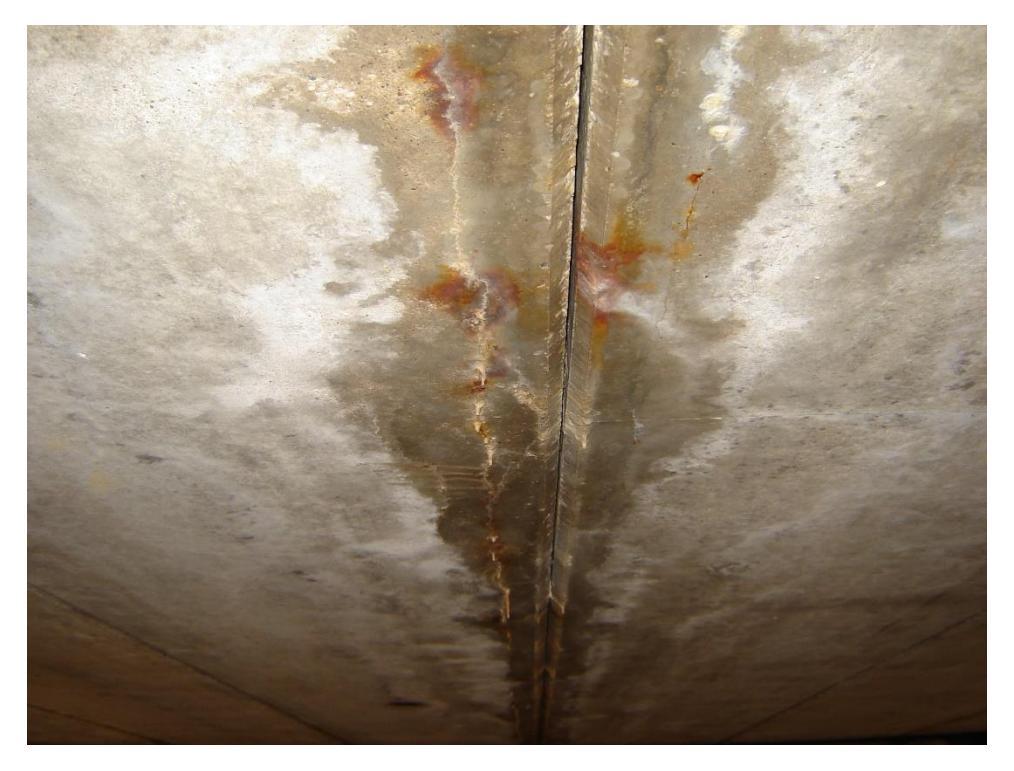
Figure B.6: Leaking Shear Key Deterioration

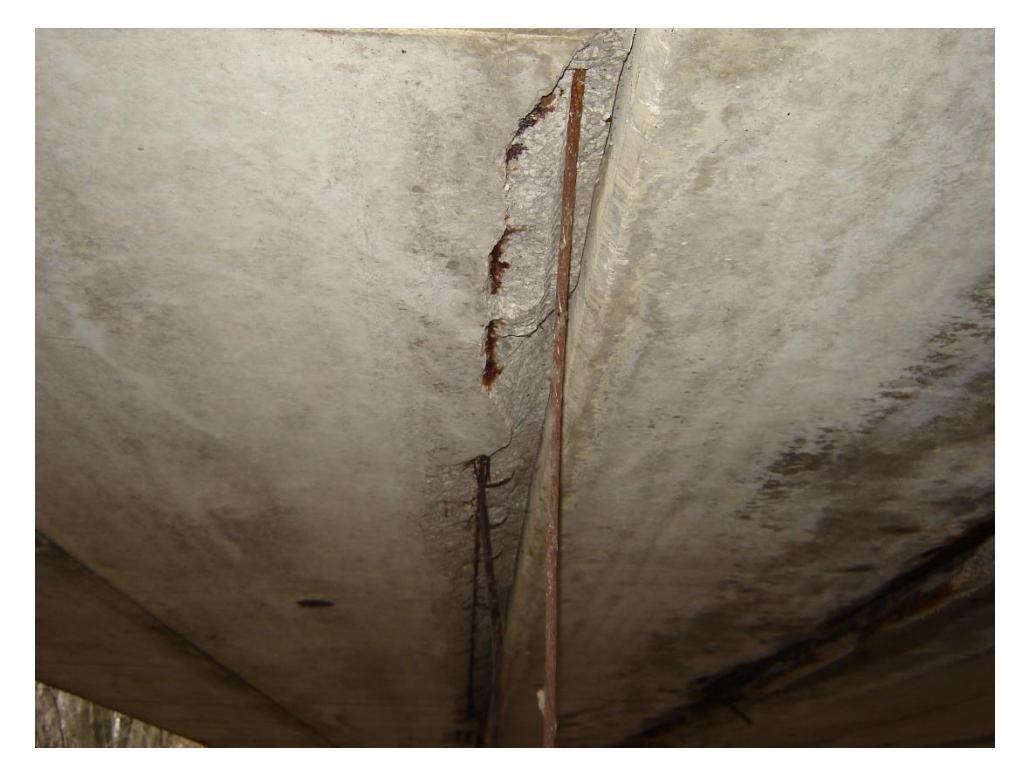
Figure B.7: Leaking Shear Key Deterioration

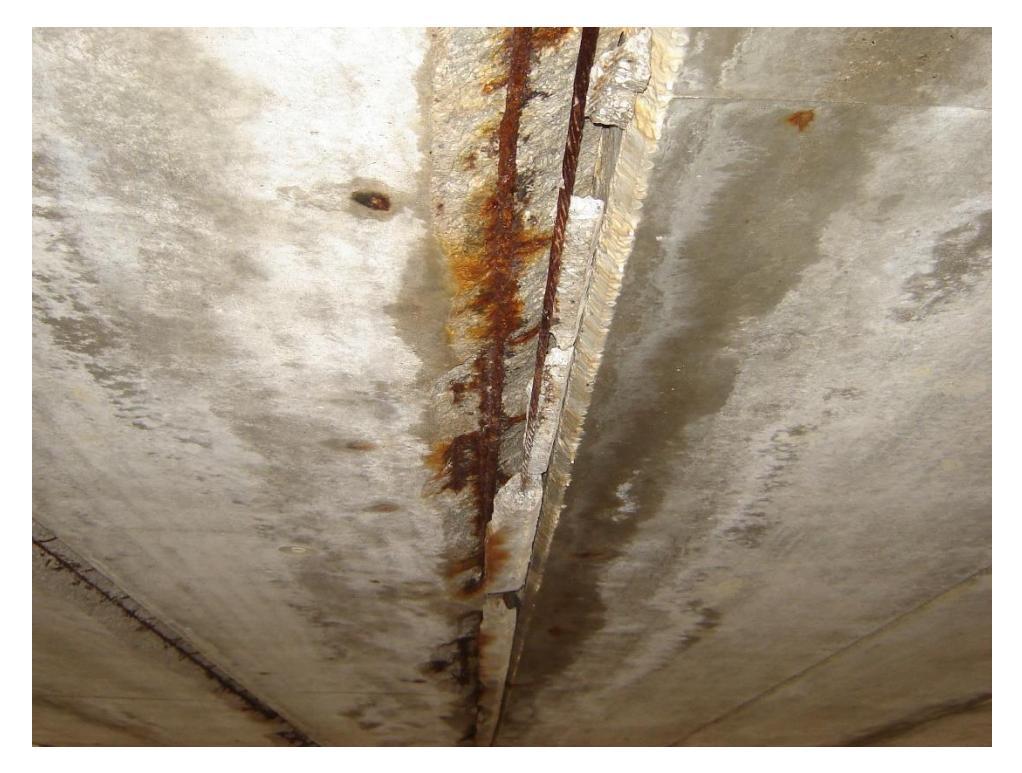
Figure B.8: Leaking Shear Key Deterioration

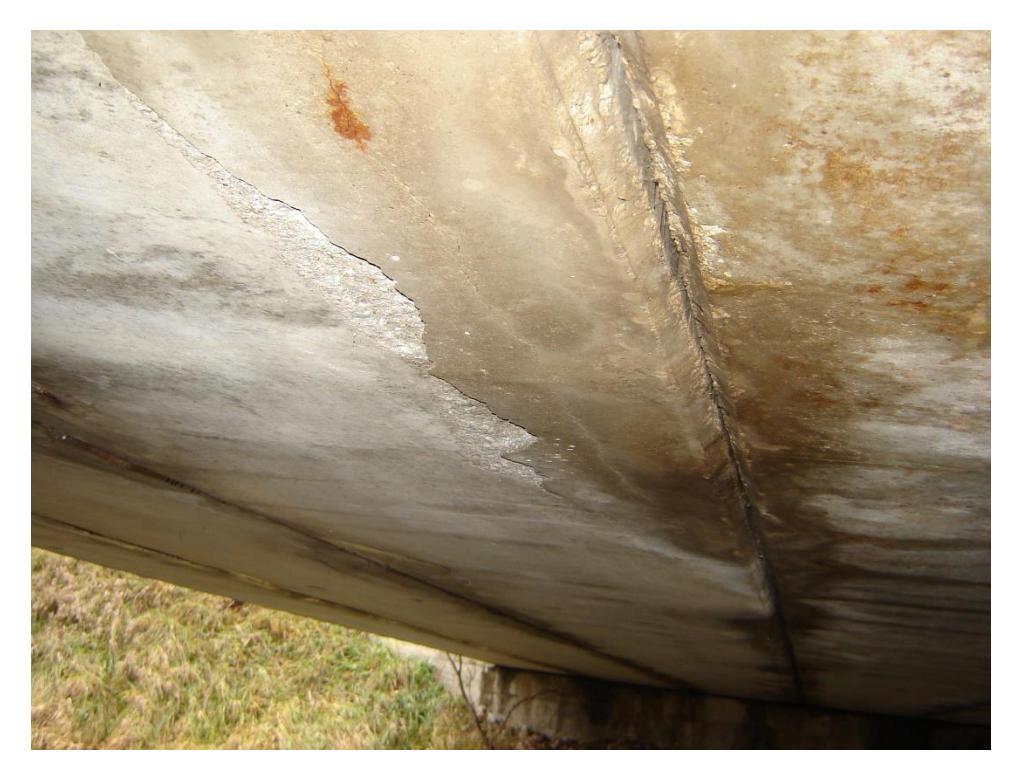
Figure B.9: Leaking Shear Key Deterioration

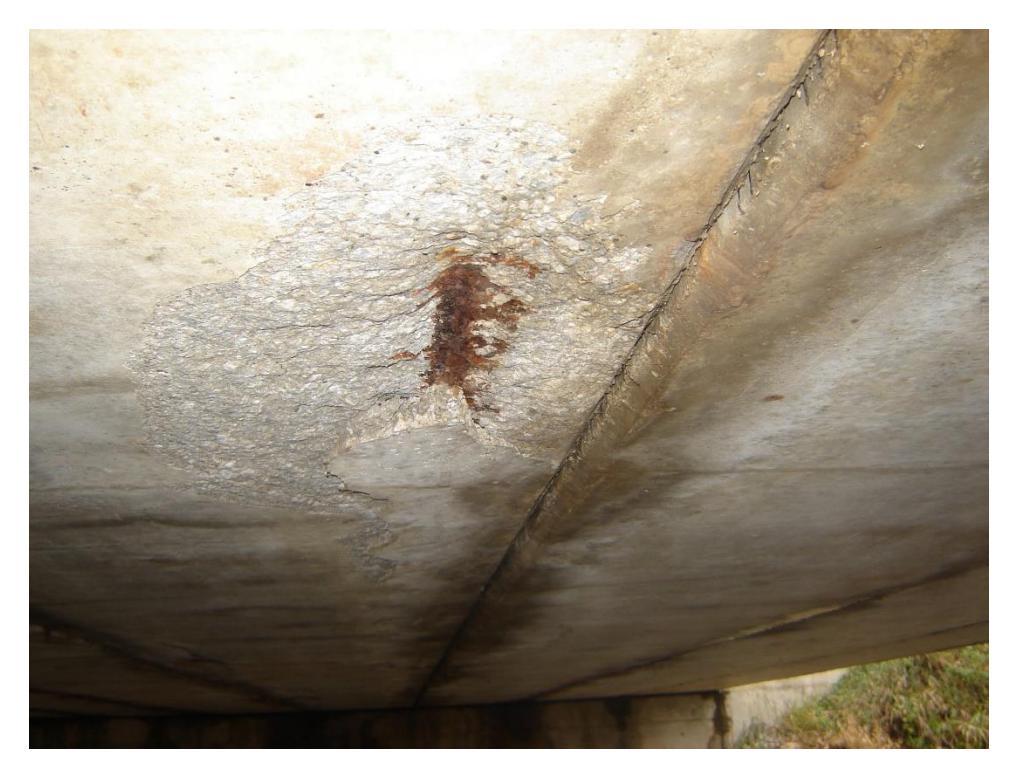
Figure B.10: Leaking Shear Key Deterioration
