EVALUATION AND STRUCTURAL BEHAVIOR OF DETERIORATED PRECAST, PRESTRESSED CONCRETE BOX BEAMS

A Dissertation

Doctor of Philosophy

Lyles School of Civil Engineering West Lafayette, Indiana December 2019

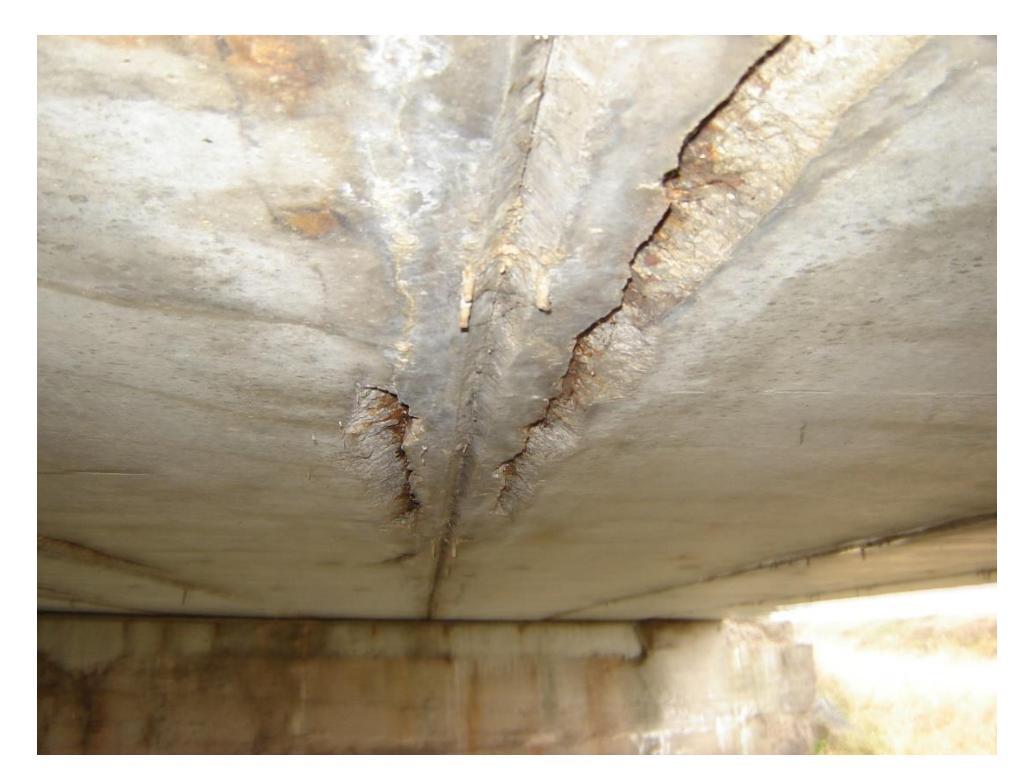
Figure B.11: Leaking Shear Key Deterioration

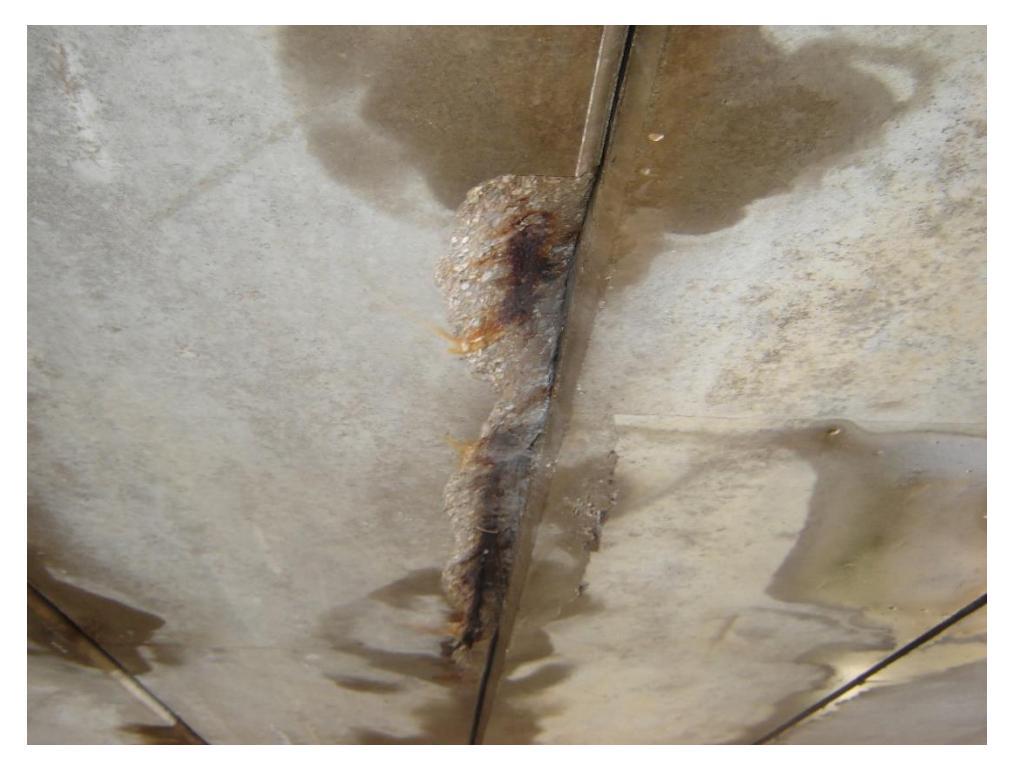
Figure B.12: Leaking Shear Key Deterioration

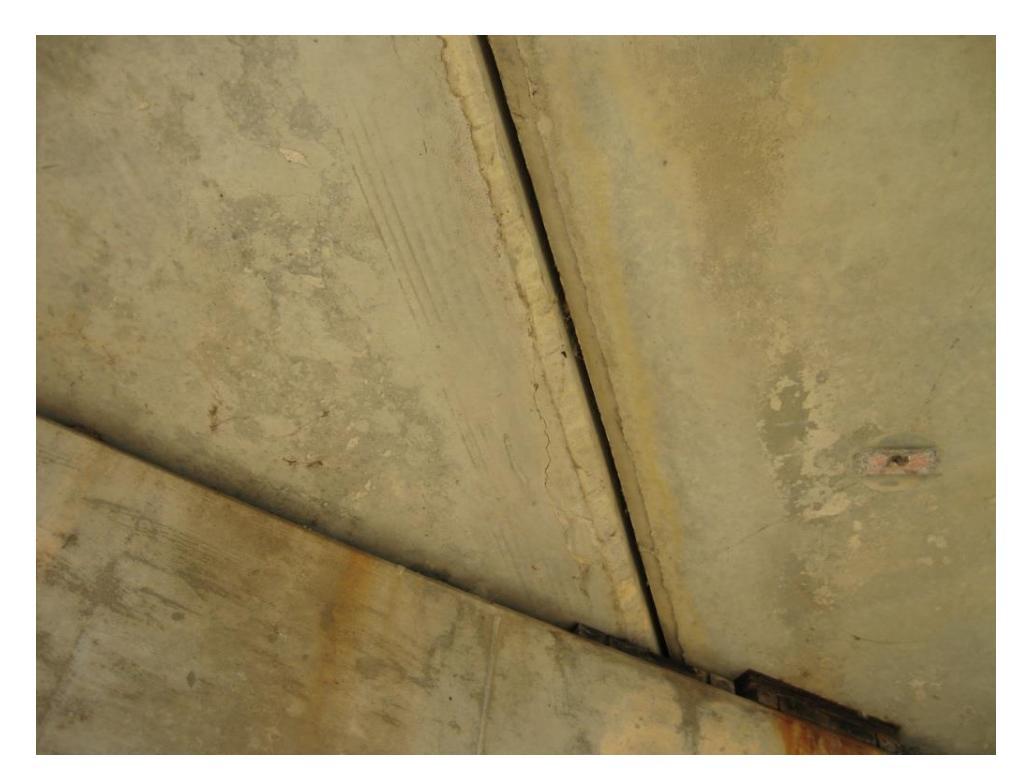
Figure B.13: Leaking Shear Key Deterioration

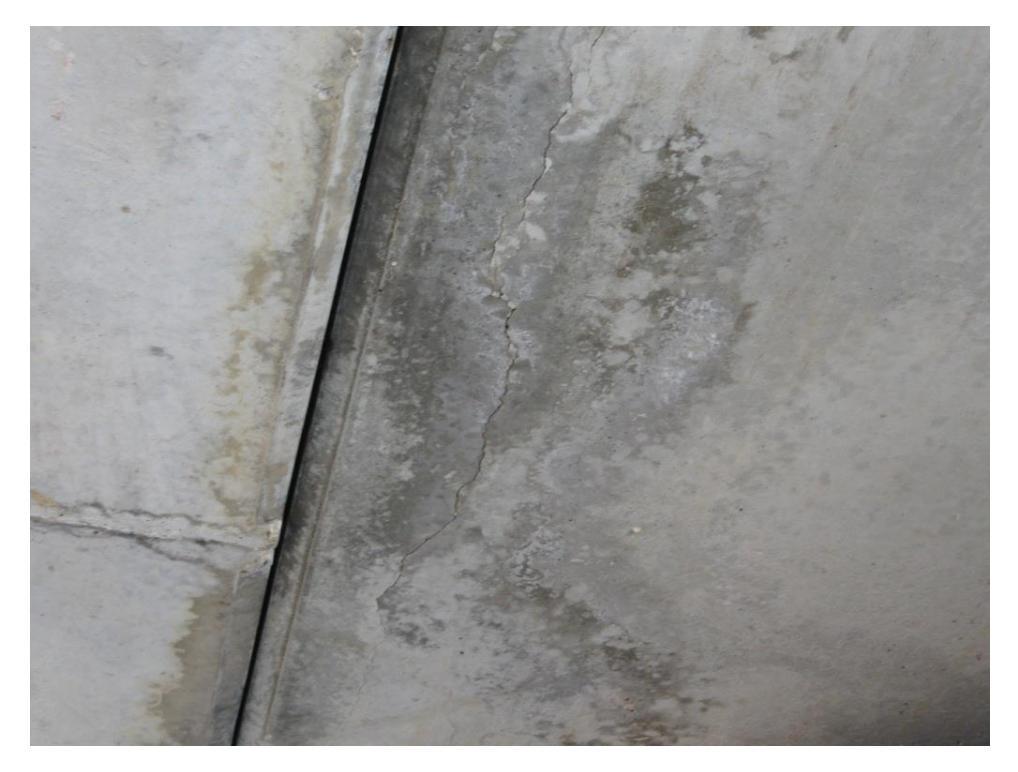
Figure B.14: Leaking Shear Key Deterioration

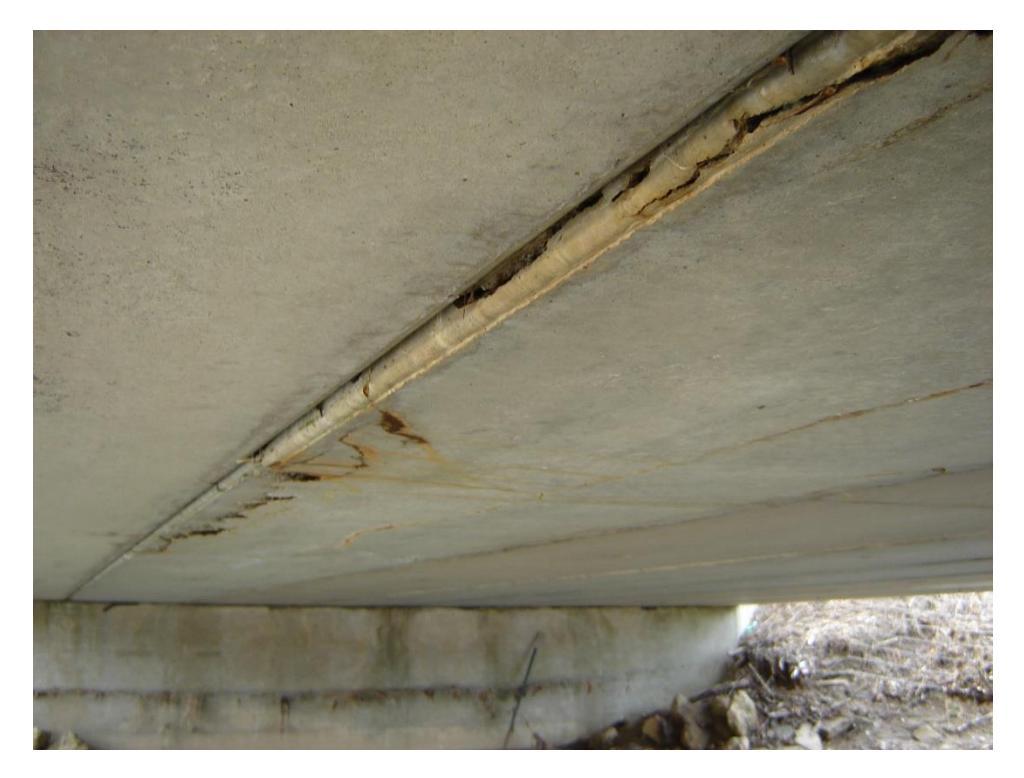
Figure B.15: Leaking Shear Key Deterioration

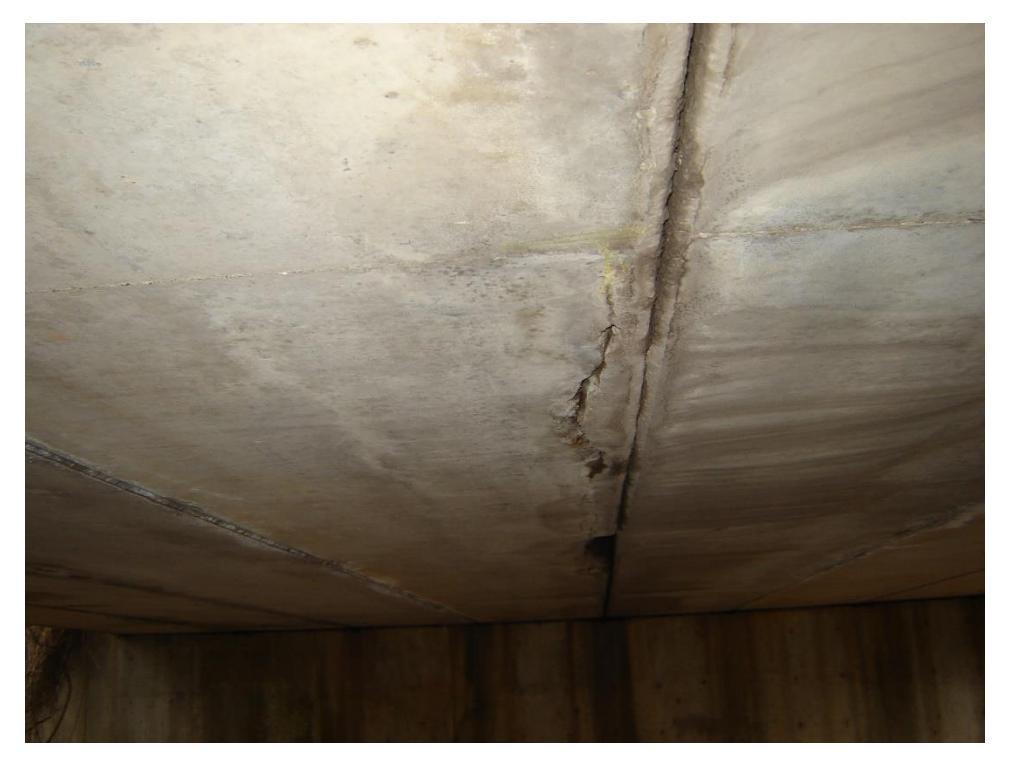
Figure B.16: Leaking Shear Key Deterioration

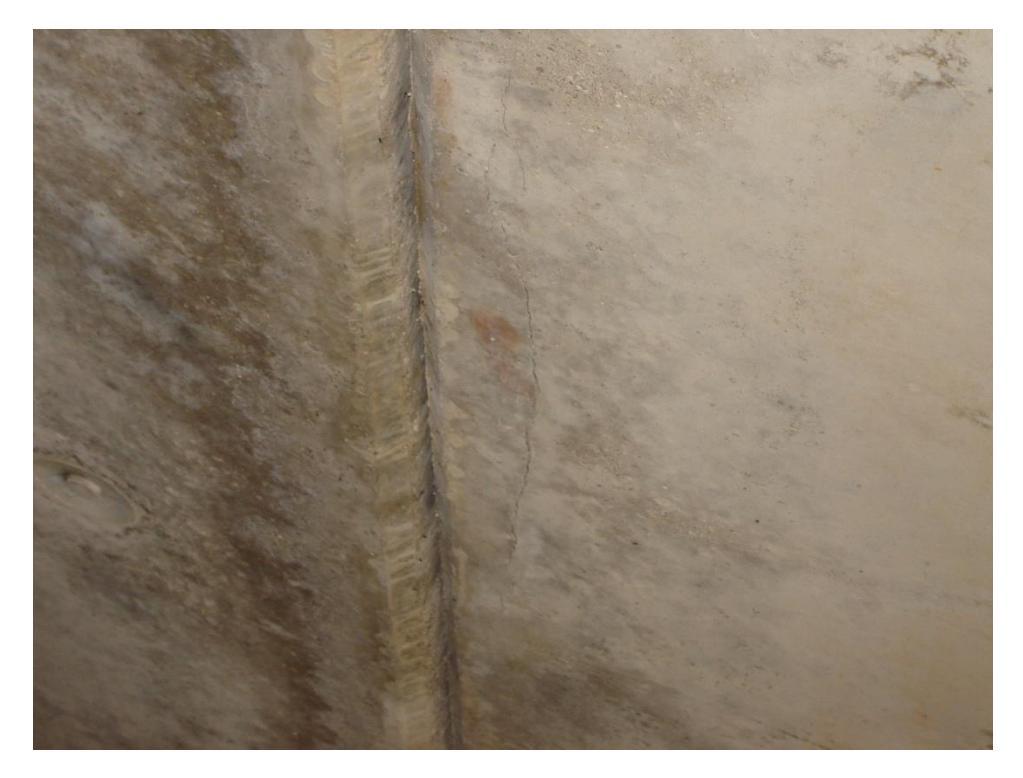
Figure B.17: Leaking Shear Key Deterioration

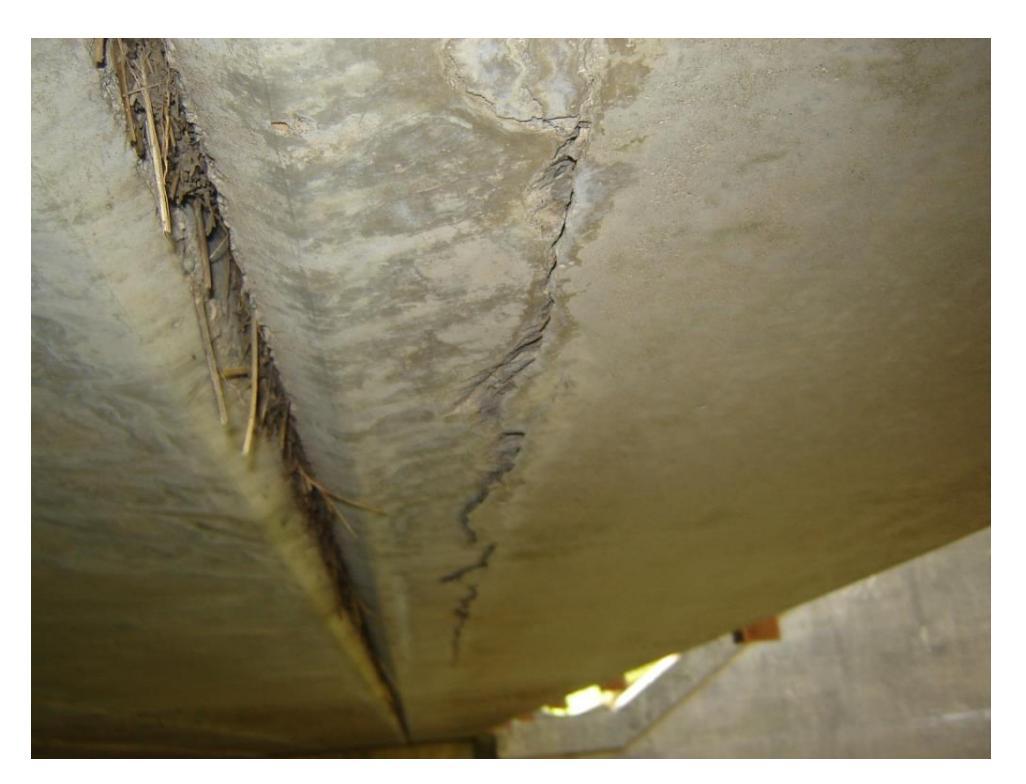
Figure C.1 to Figure C.17 provide examples of deterioration caused by water ingress into the box beam void. Photos courtesy of Beam, Longest, and Neff LLC.

Figure C.1: Water Ingress into the Box Beam Void Deterioration

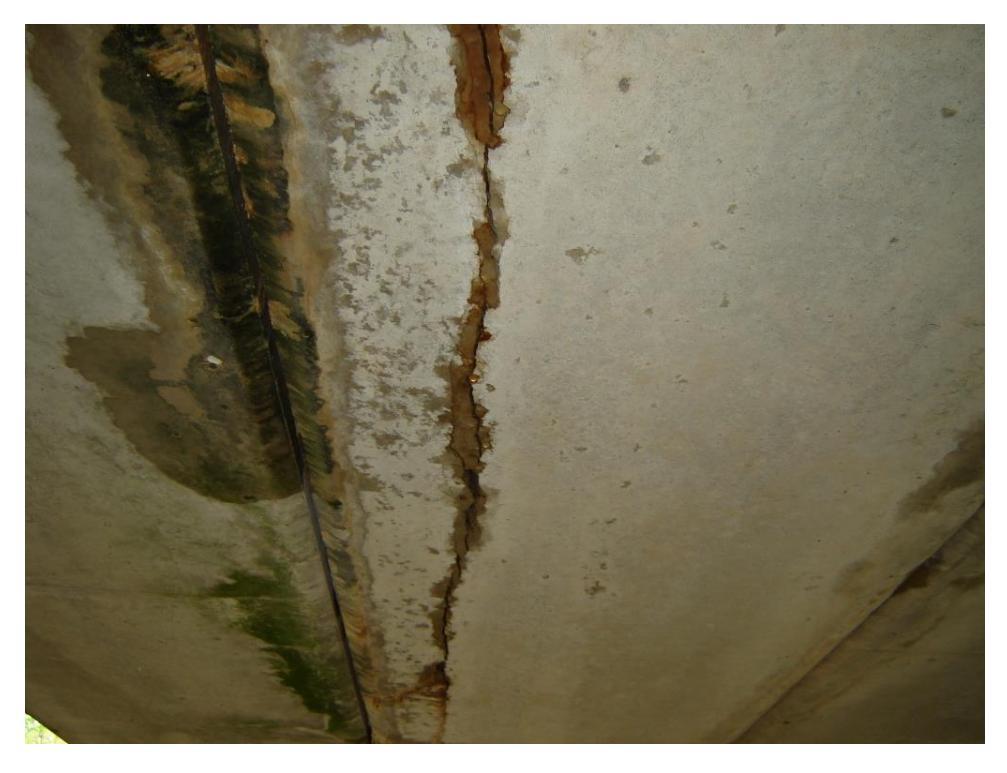
Figure C.2: Water Ingress into the Box Beam Void Deterioration

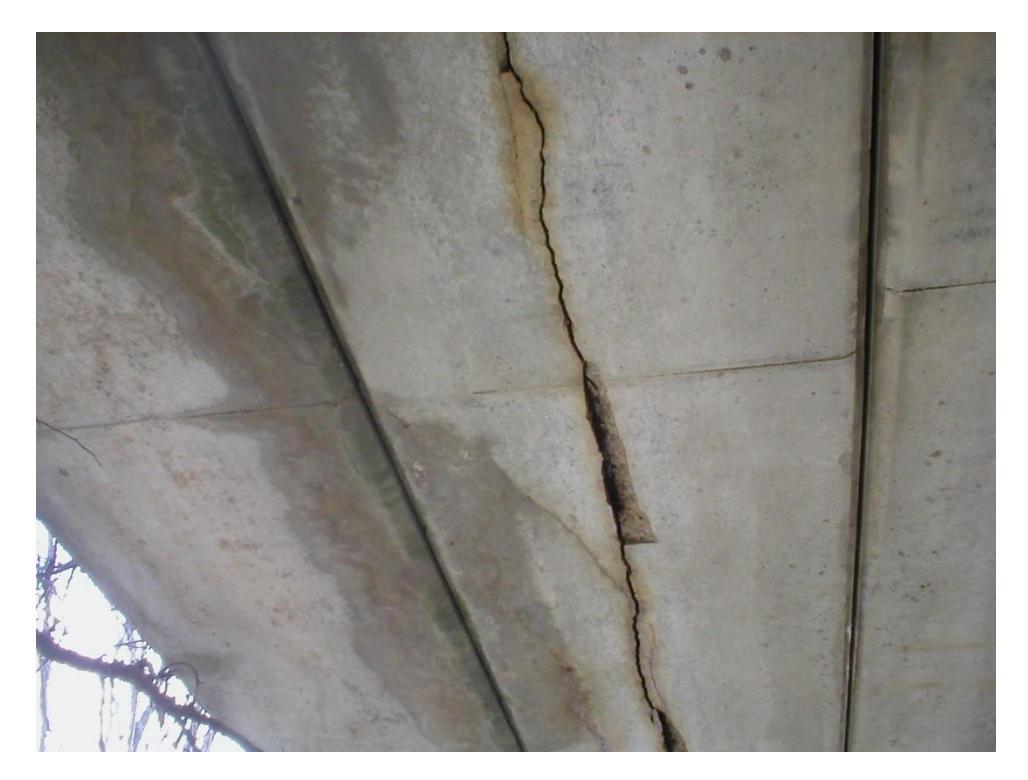
Figure C.3: Water Ingress into the Box Beam Void Deterioration

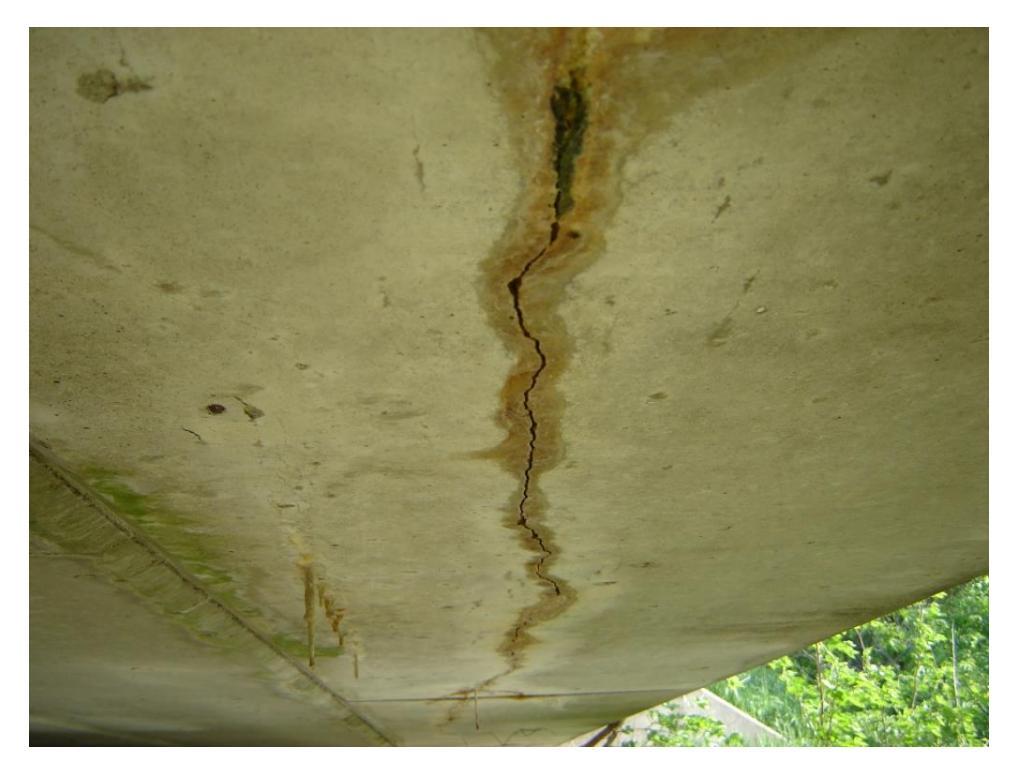
Figure C.4: Water Ingress into the Box Beam Void Deterioration

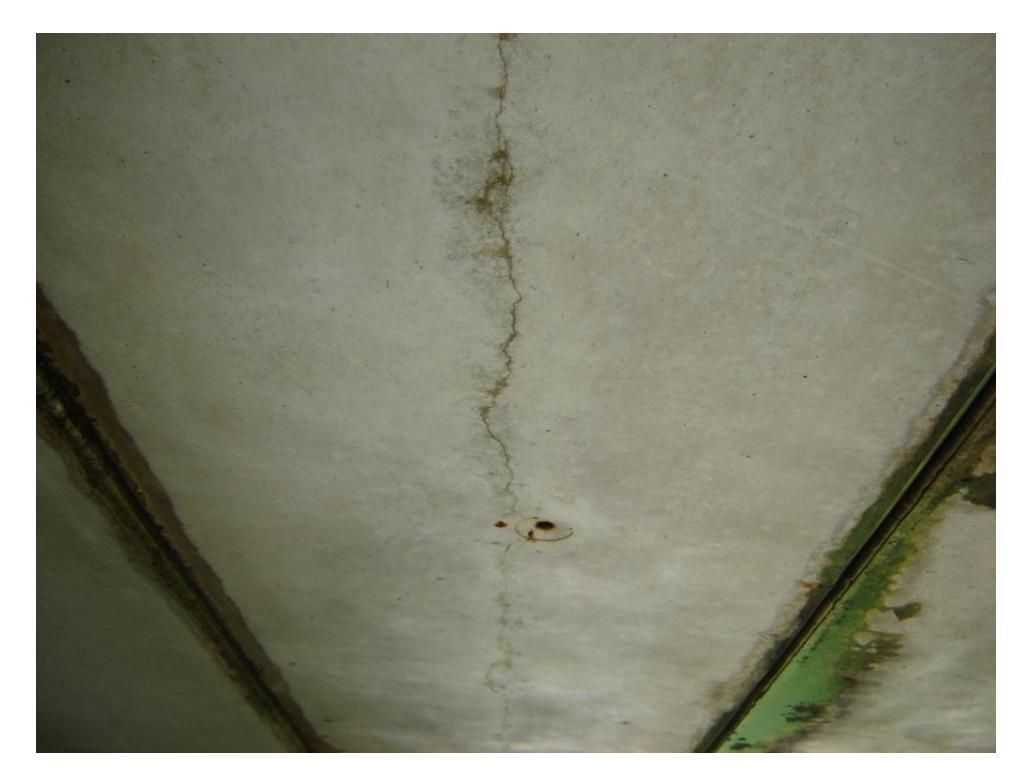
Figure C.5: Water Ingress into the Box Beam Void Deterioration

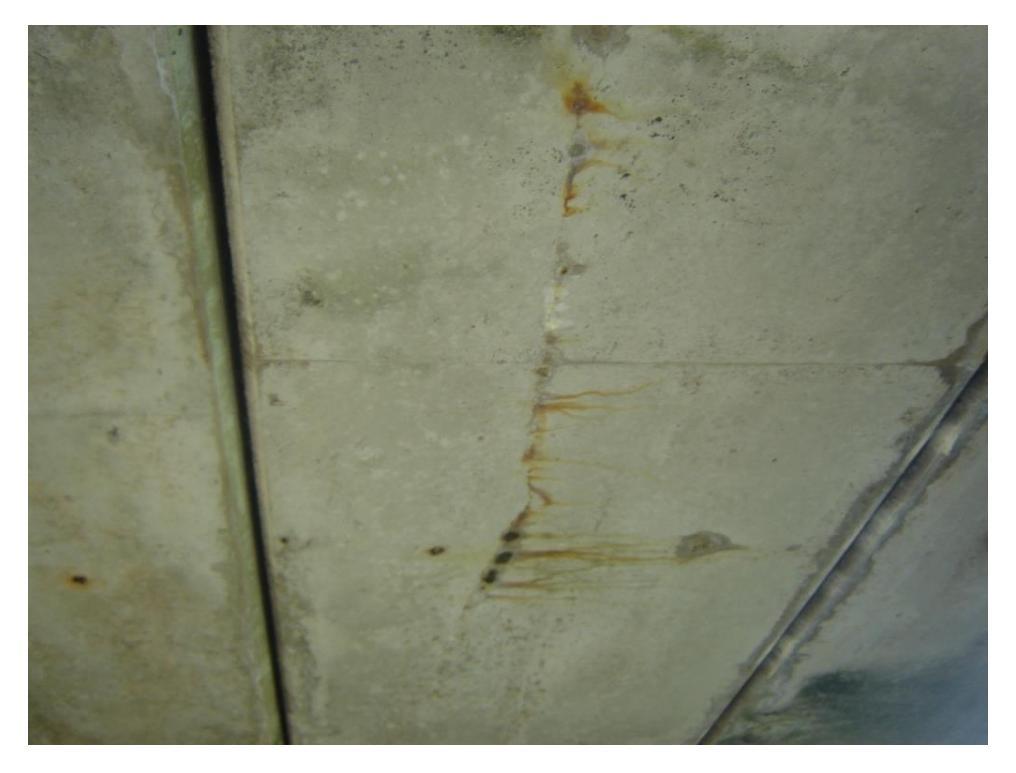
Figure C.6: Water Ingress into the Box Beam Void Deterioration

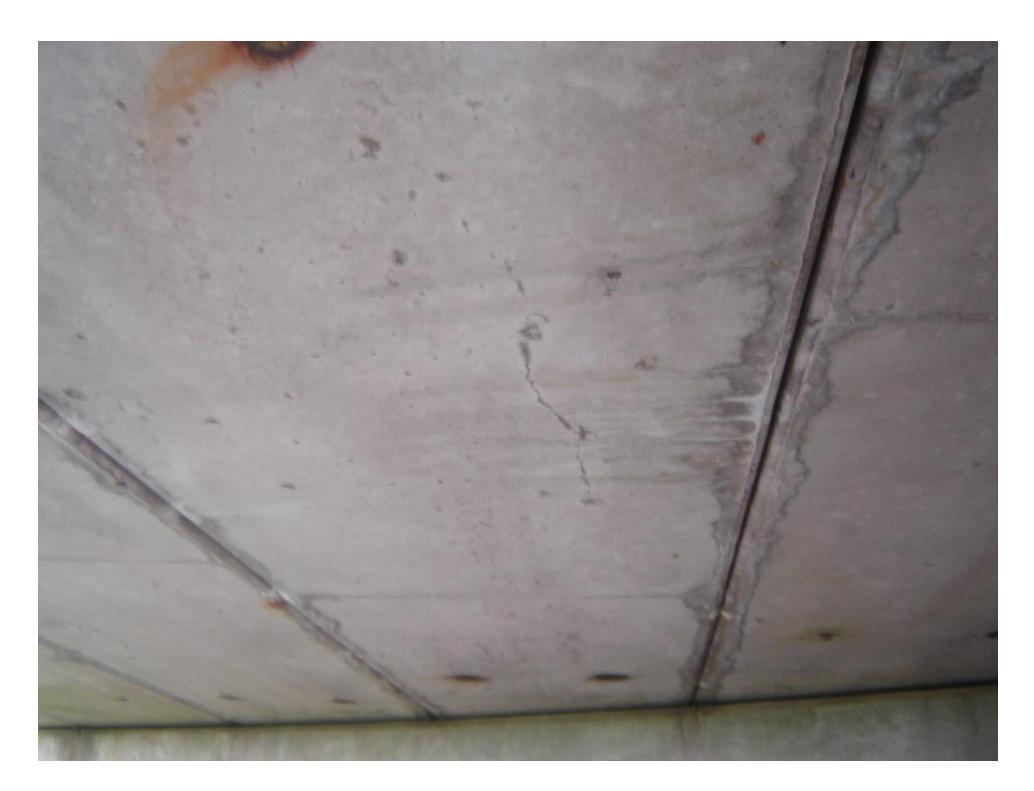
Figure C.7: Water Ingress into the Box Beam Void Deterioration

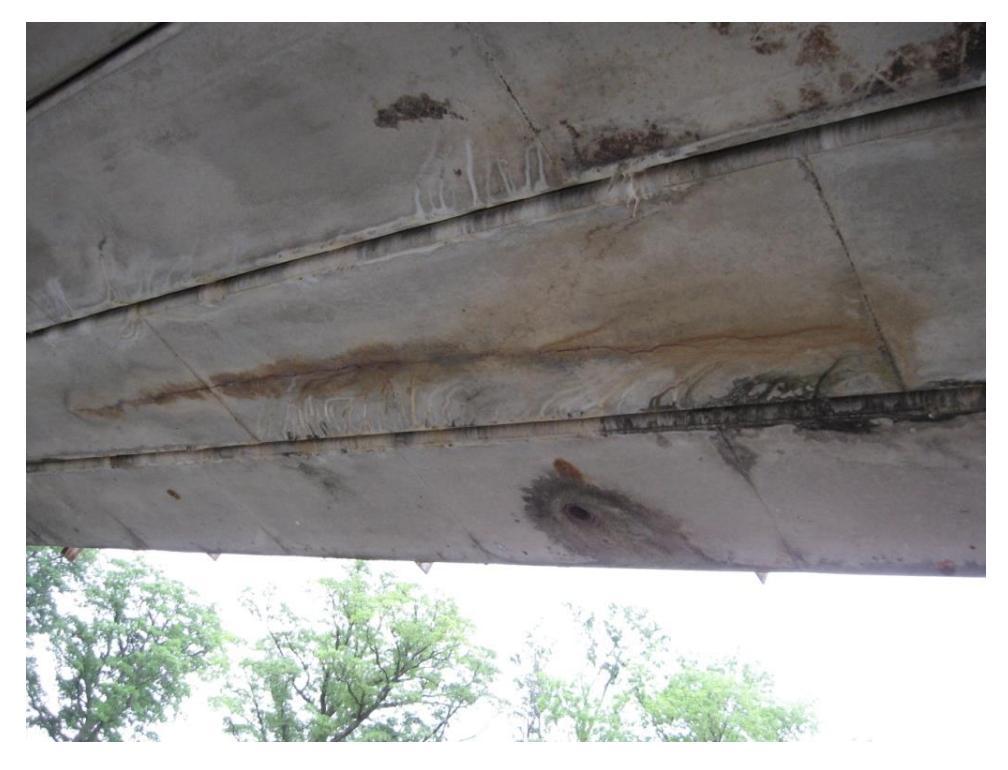
Figure C.8: Water Ingress into the Box Beam Void Deterioration

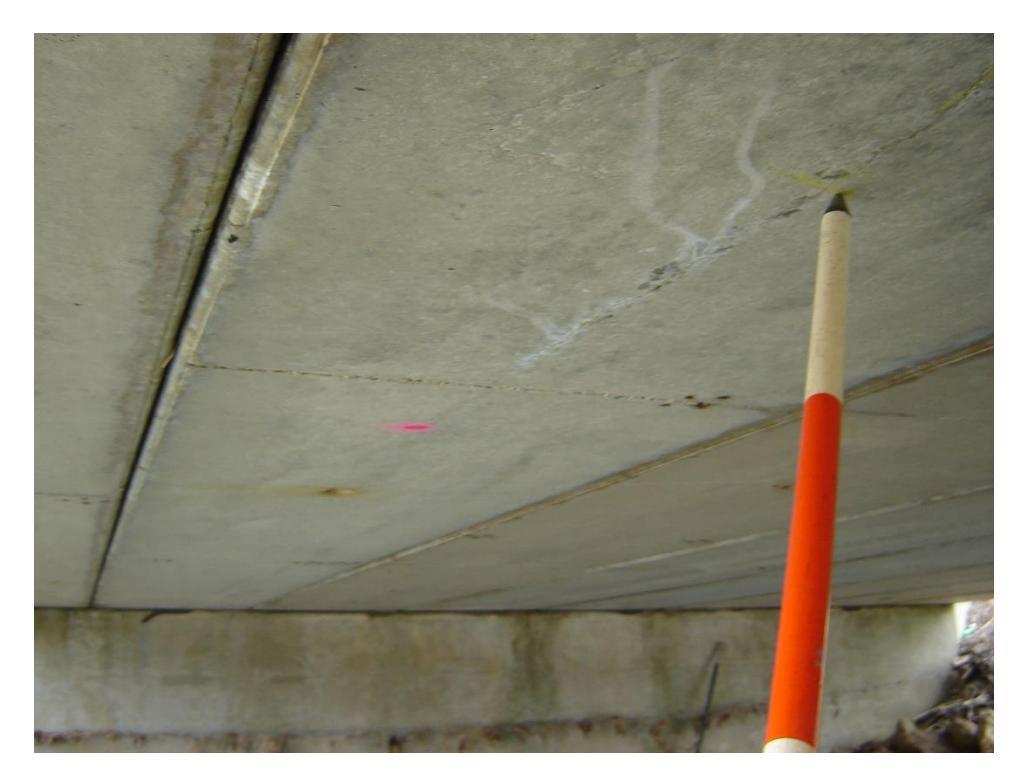
Figure C.9: Water Ingress into the Box Beam Void Deterioration

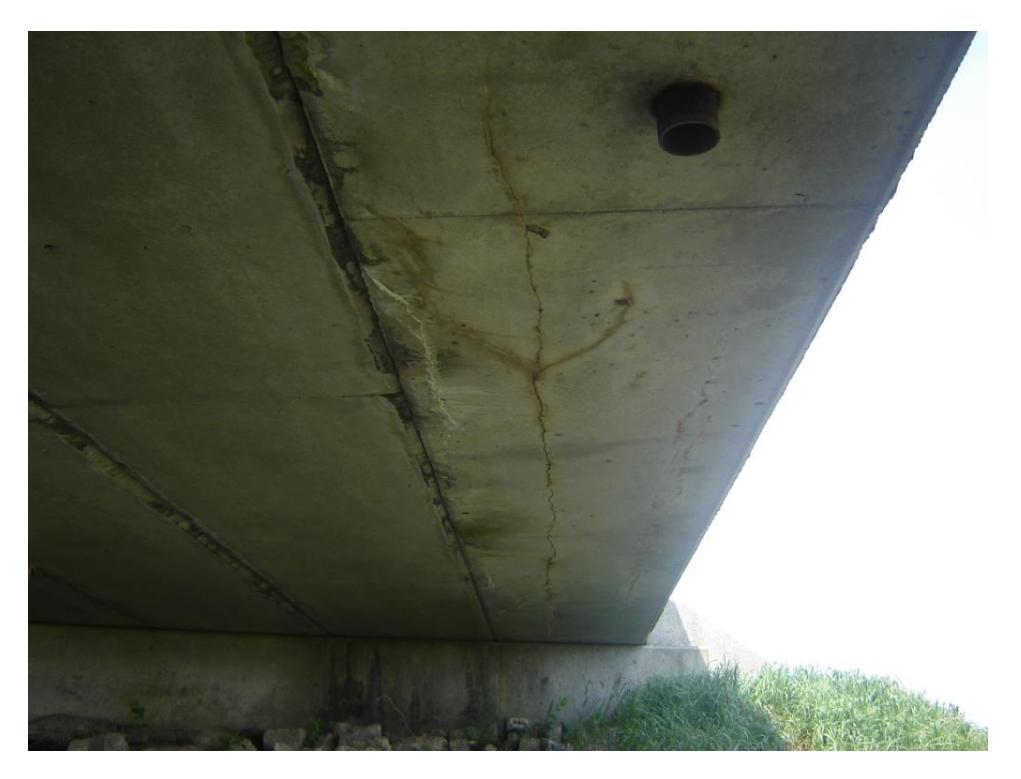
Figure C.10: Water Ingress into the Box Beam Void Deterioration

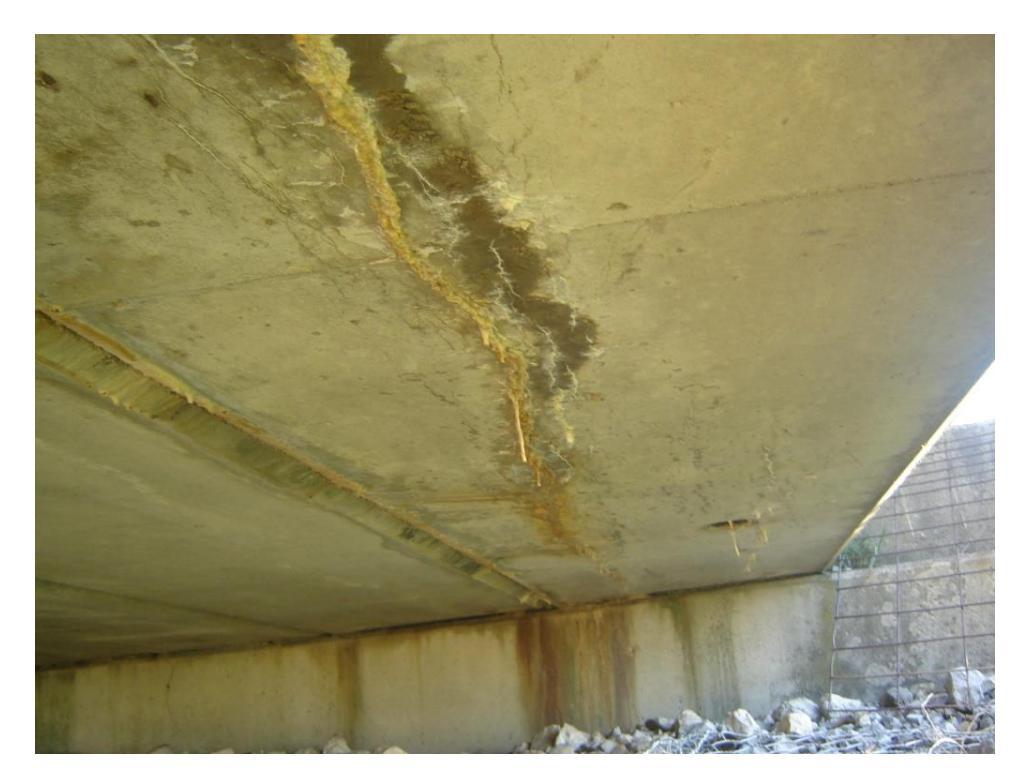
Figure C.11: Water Ingress into the Box Beam Void Deterioration

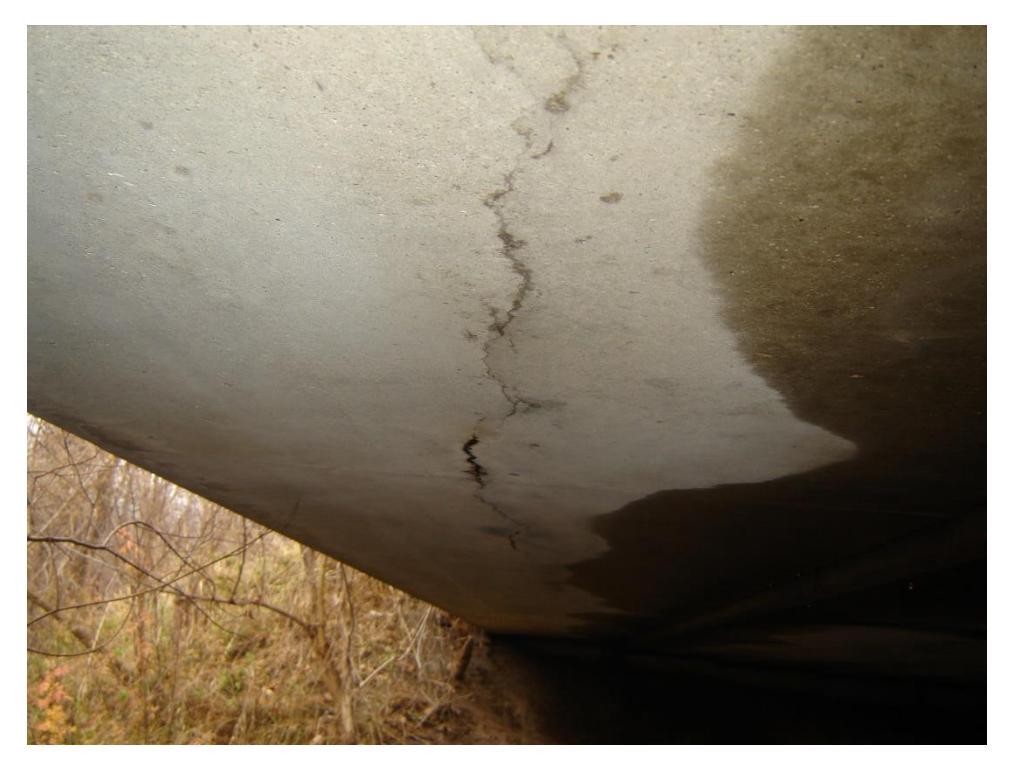
Figure C.12: Water Ingress into the Box Beam Void Deterioration

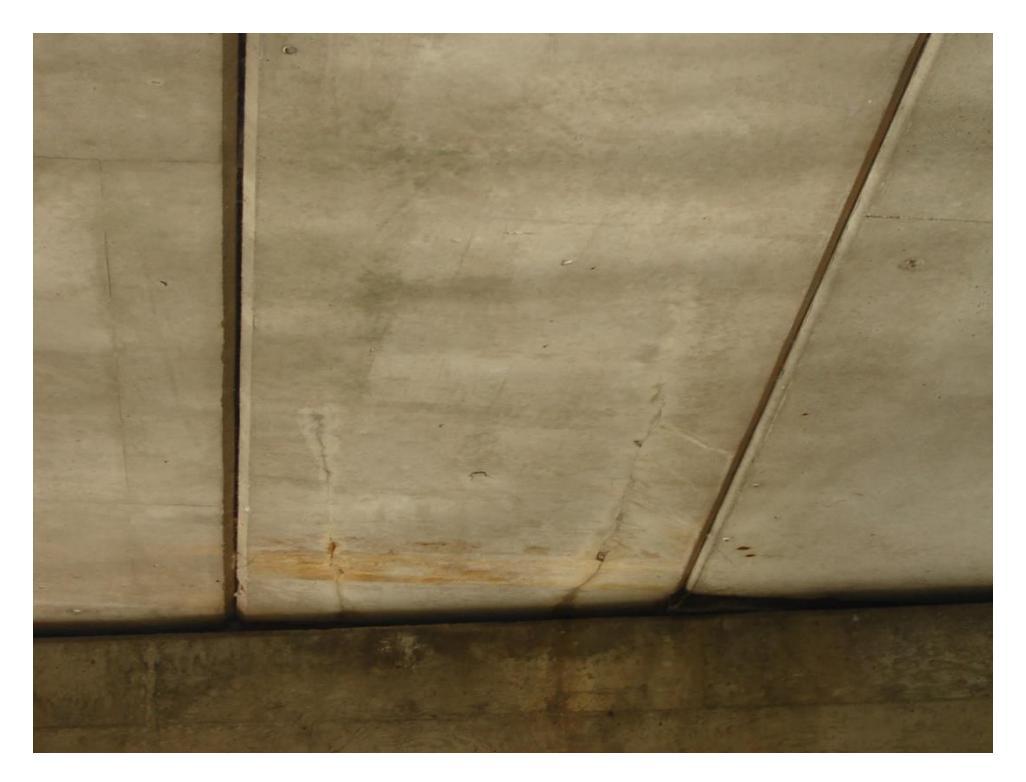
Figure C.13: Water Ingress into the Box Beam Void Deterioration

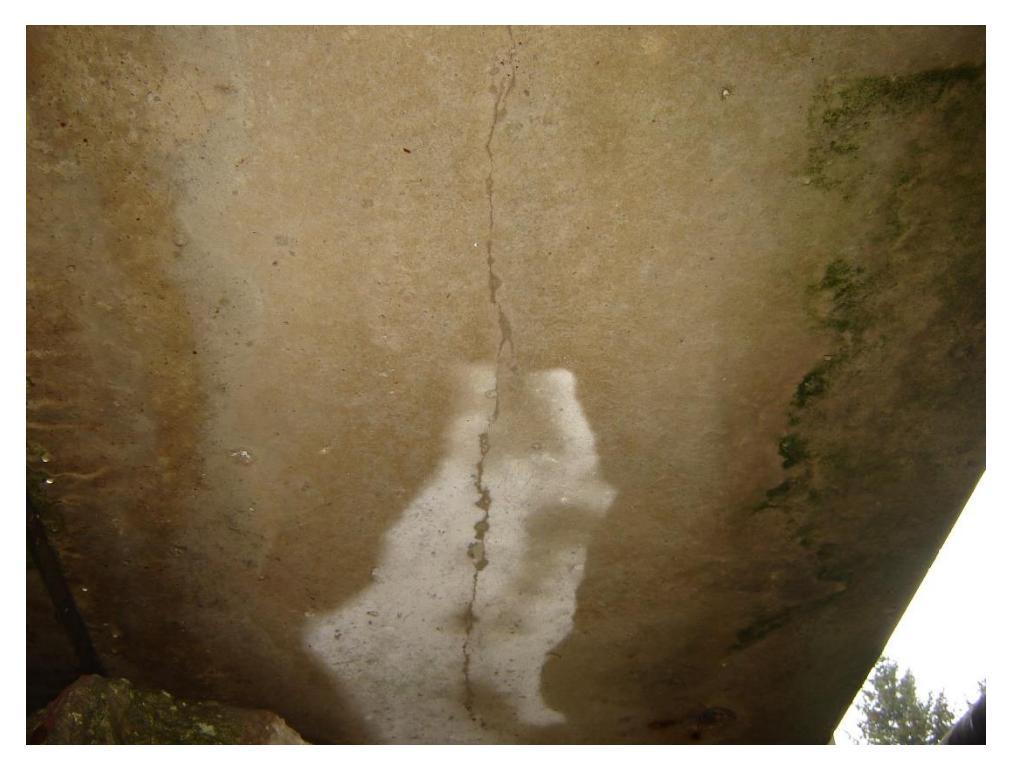
Figure C.14: Water Ingress into the Box Beam Void Deterioration

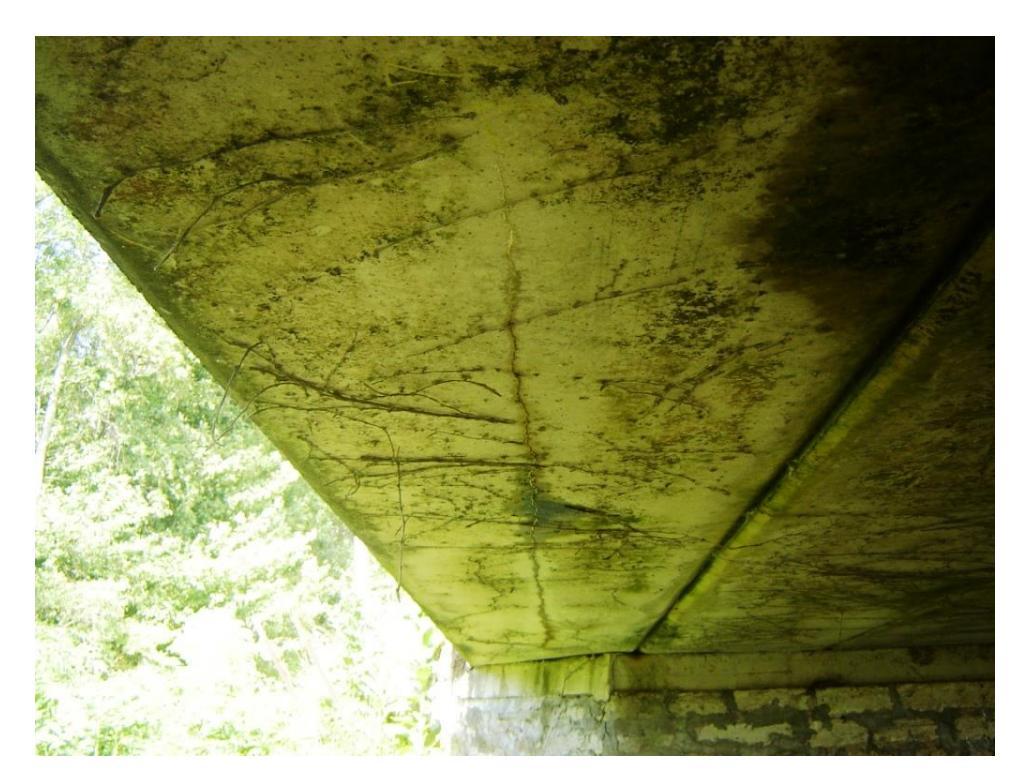
Figure C.15: Water Ingress into the Box Beam Void Deterioration

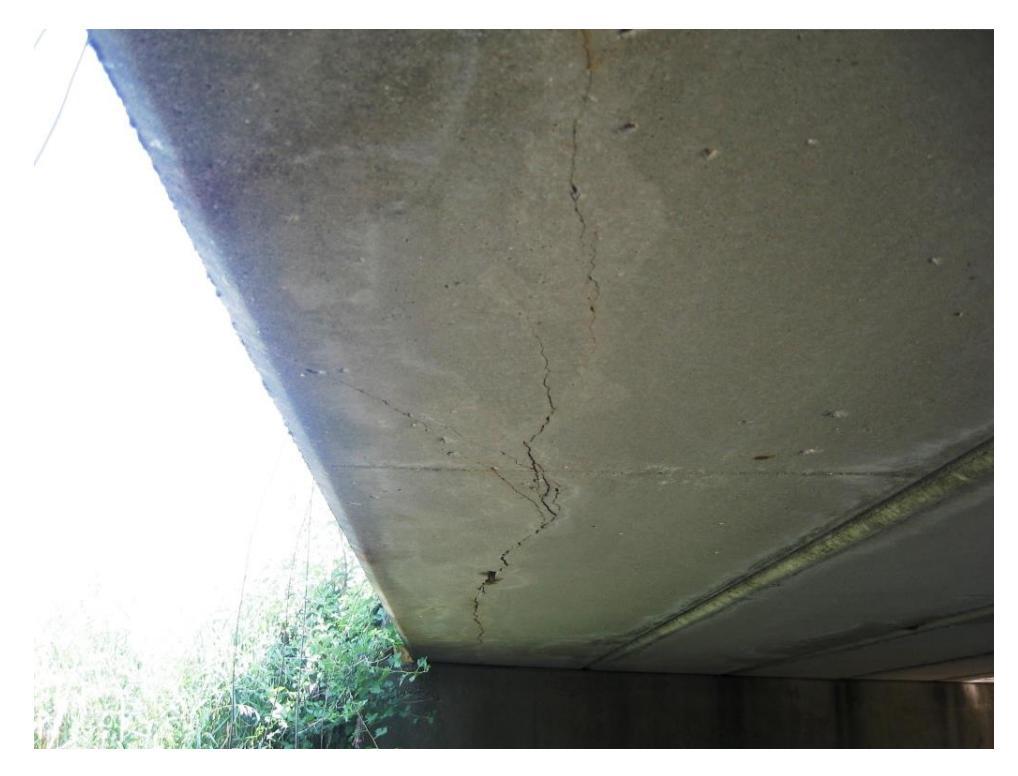
Figure C.16: Water Ingress into the Box Beam Void Deterioration

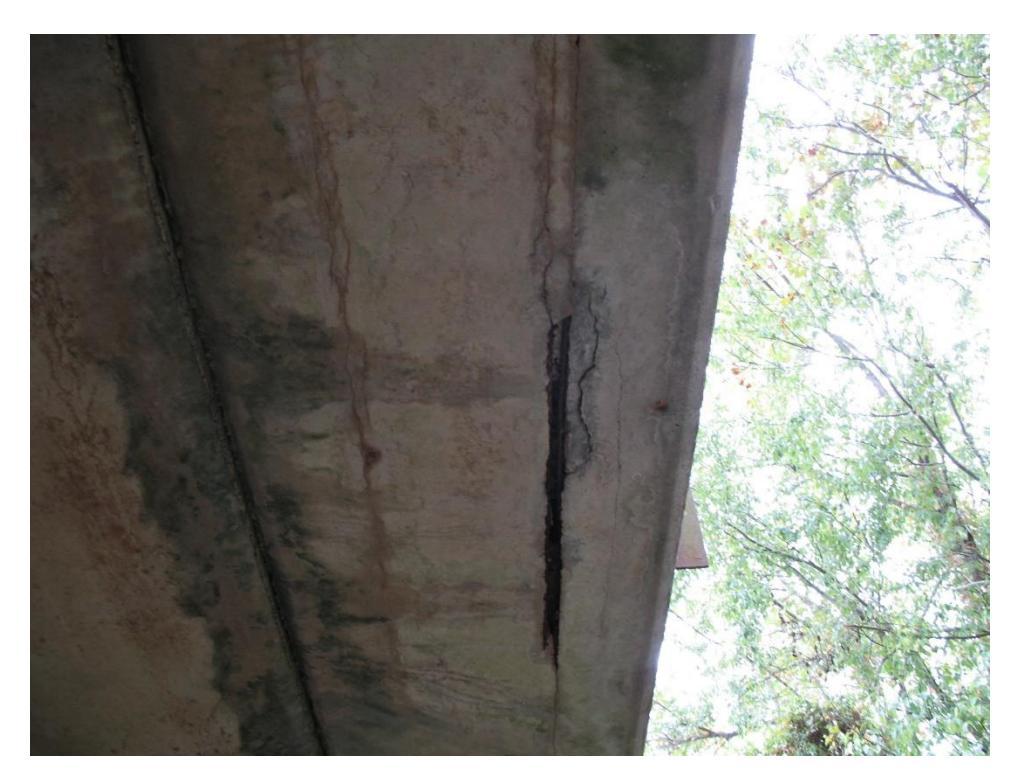
Figure C.17: Water Ingress into the Box Beam Void Deterioration

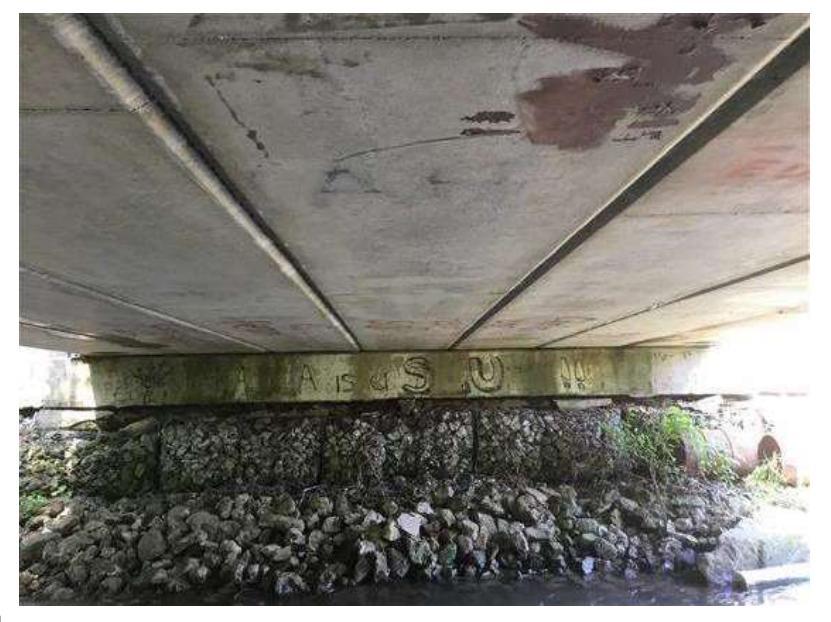
PHOTO 1

Description 6-1-2018 str 79-00115 - W abutment looking W

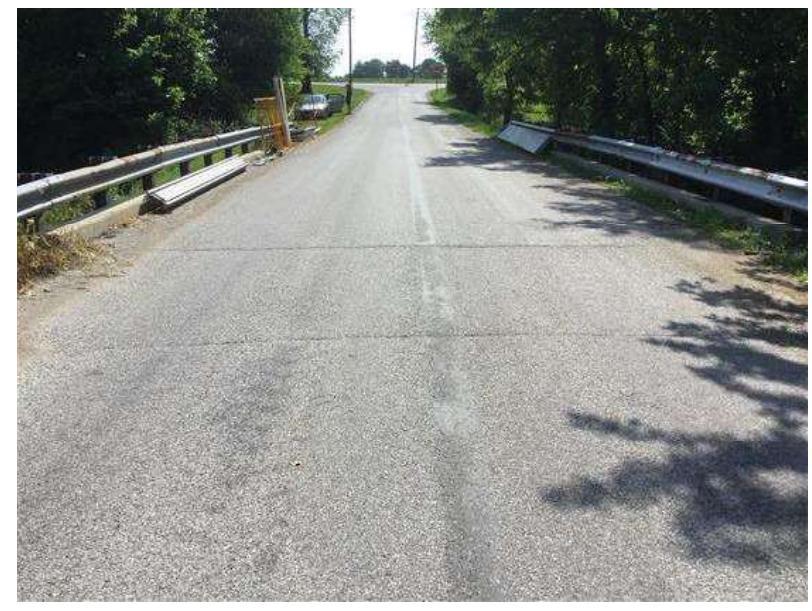
PHOTO 2

Description 6-1-2018 str 79-00115 - Alignment looking E

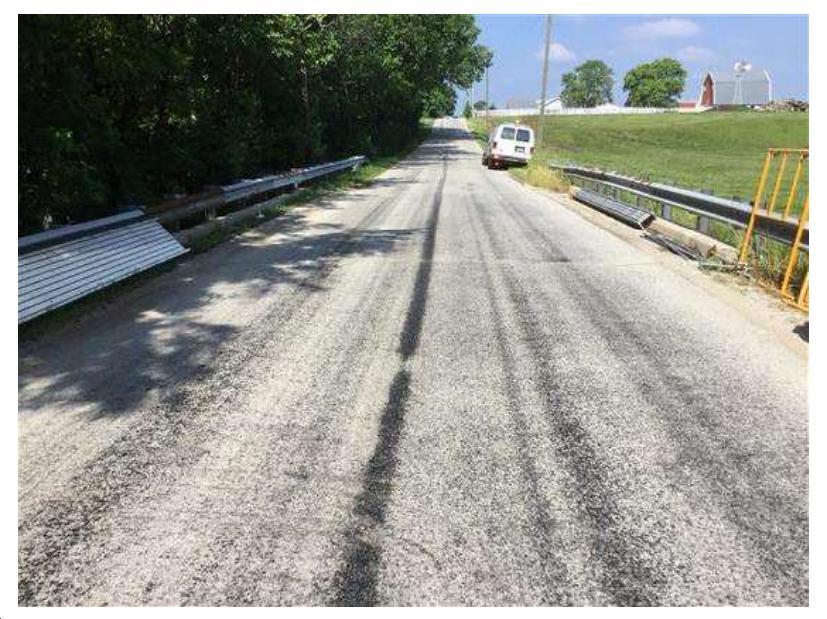
РНОТО 3

Description 6-1-2018 str 79-00115 - Alignment looking W

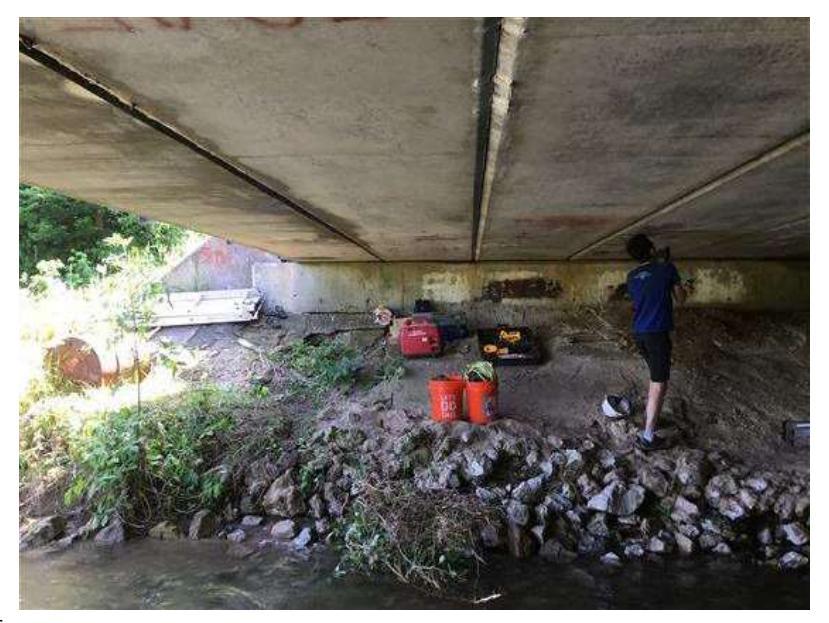
PHOTO 5

Description 6-1-2018 str 79-00115 - N half E abutment looking E

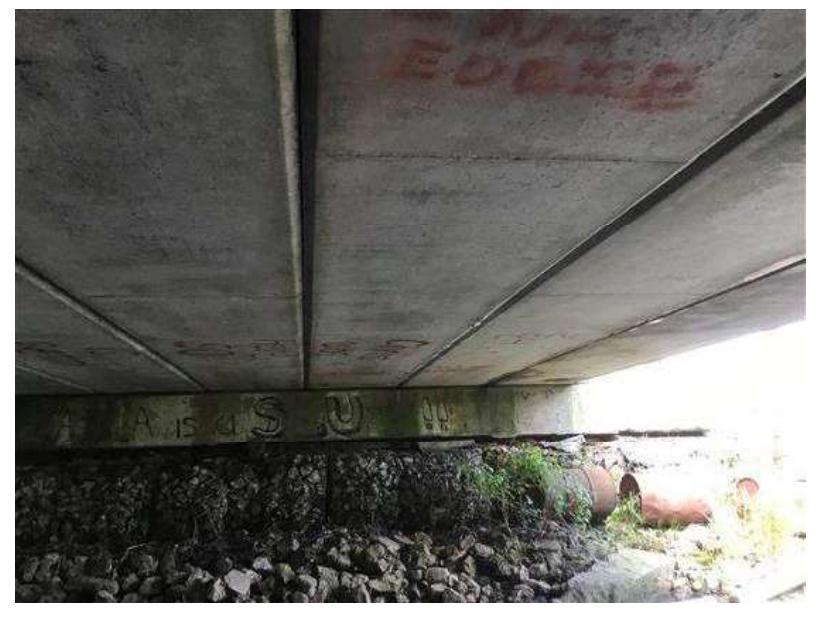
PHOTO 6

Description 6-1-2018 str 79-00115 - N half W abutment looking W

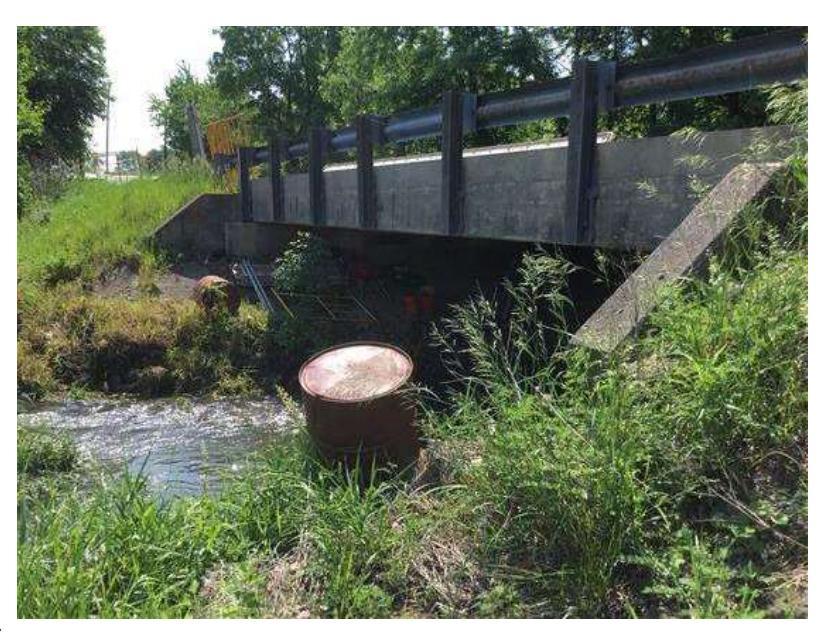
PHOTO 7

Description 6-1-2018 str 79-00115 - Profile looking SE

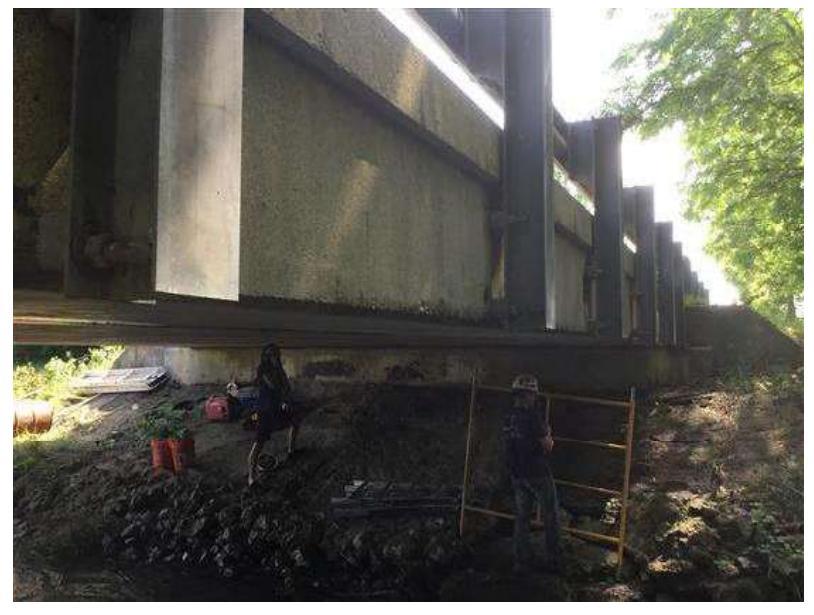
PHOTO 8

Description 6-1-2018 str 79-00115 - S coping looking E
