EVALUATION AND STRUCTURAL BEHAVIOR OF DETERIORATED PRECAST, PRESTRESSED CONCRETE BOX BEAMS

A Dissertation

Doctor of Philosophy

Lyles School of Civil Engineering West Lafayette, Indiana December 2019

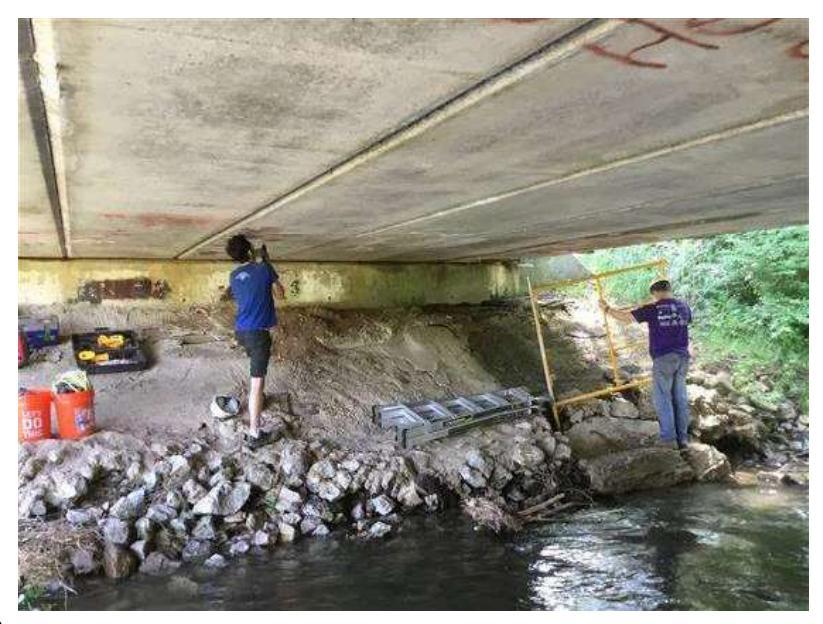
PHOTO 9

Description 6-1-2018 str 79-00115 - S half E abutment looking SE

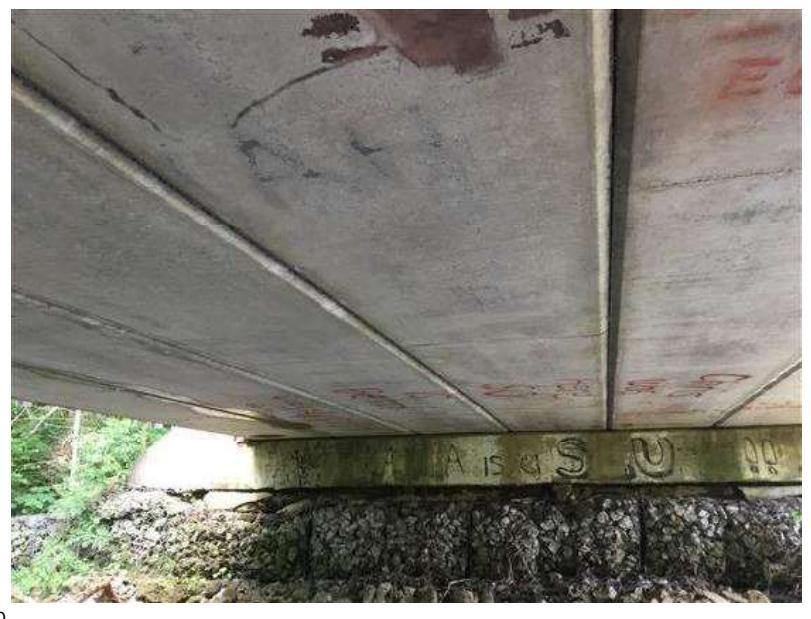
PHOTO 10

Description 6-1-2018 str 79-00115 - S half W abutment looking W

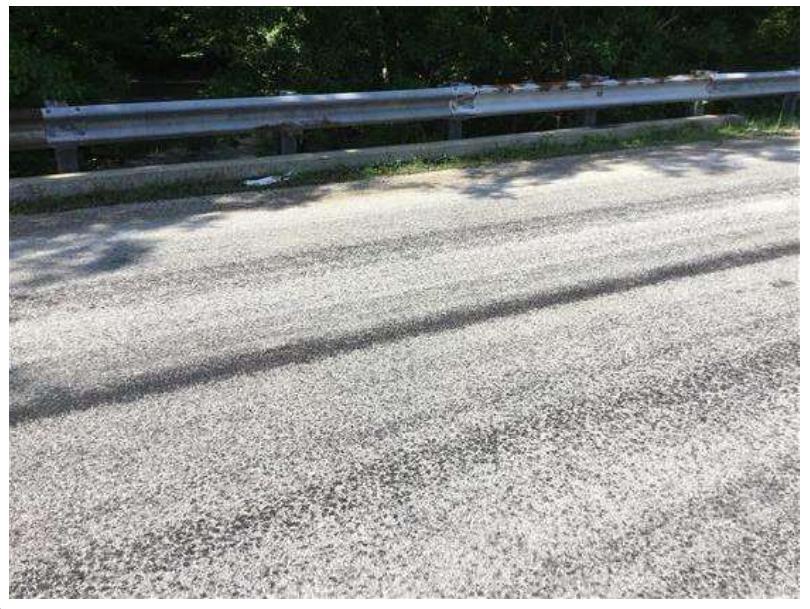
PHOTO 11

Description 6-1-2018 str 79-00115 - Top side condition looking SW

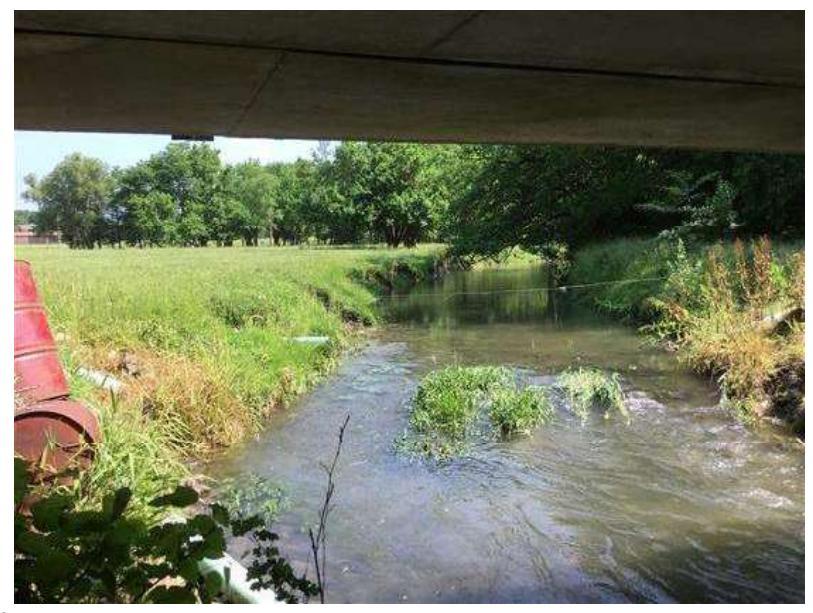
PHOTO 12

Description 6-1-2018 str 79-00115 - Upstream channel looking N

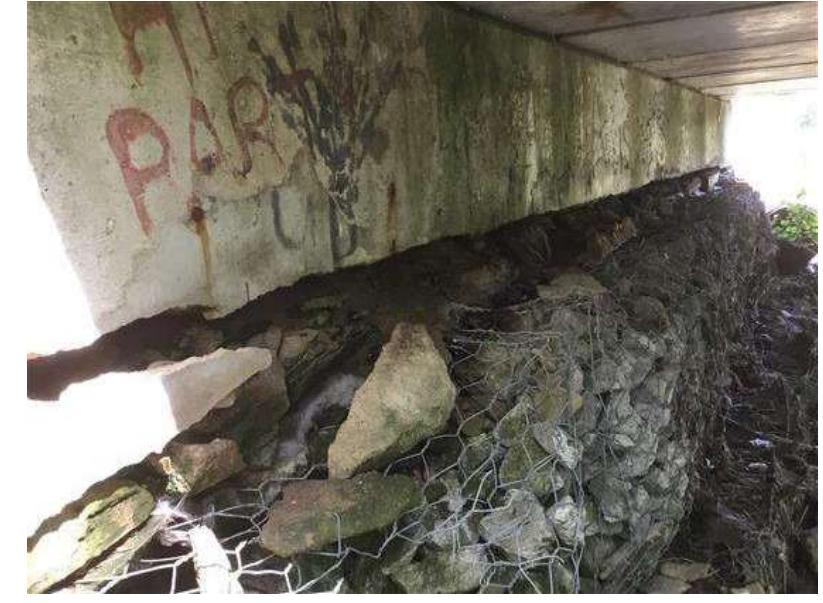
PHOTO 13

Abutments have minor cracking and efflorescence. West abutment has exposed timber piling with voids below the bent cap. Gabion baskets are present in front of piles and some have been cut open. East abutment has had flowable grout placed in front of bent cap. (NP 6/1/2018)

Description 6-1-2018 str 79-00115 - W abutment exposed piles looking N

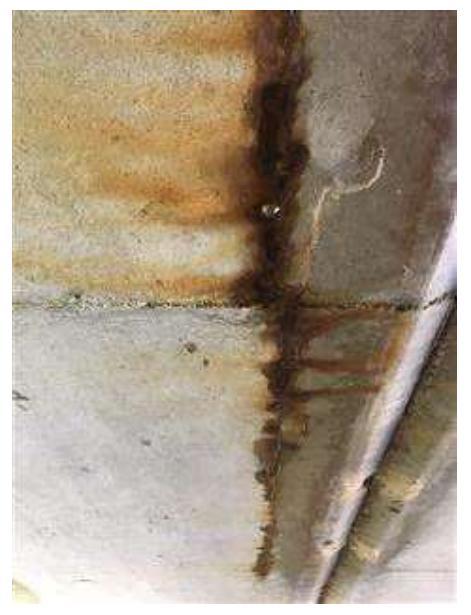
PHOTO 14

Description 6-7-2018 str 79-00115 - S facia beam crack with rust staining looking W

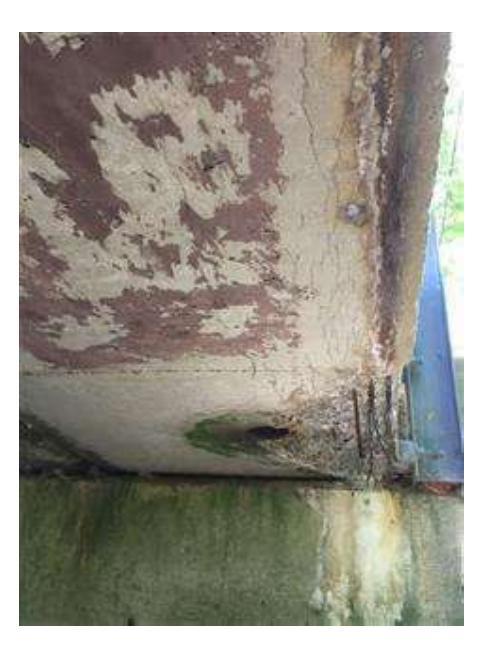
PHOTO 15

Description 6-7-2018 str 79-00115 - E end S facia beam looking E

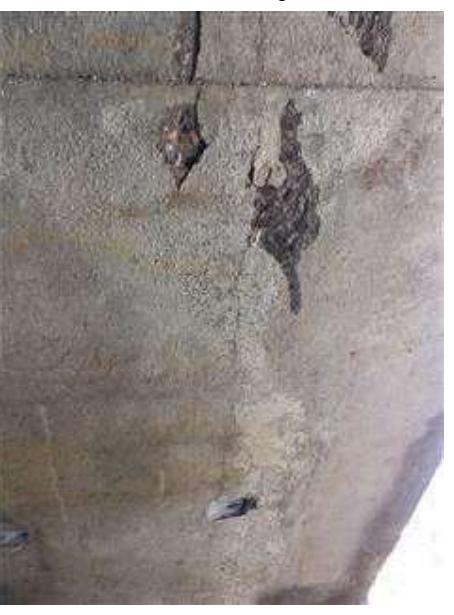
PHOTO 16

Description 6-7-2018 str 79-00115 - N facia beam cracking looking W

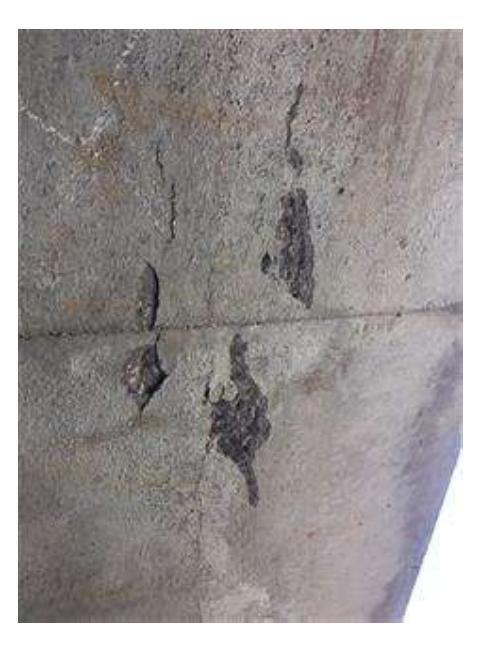
PHOTO 17

6-7-2018 str 79-00115 - N facia beam spalling delamination looking W

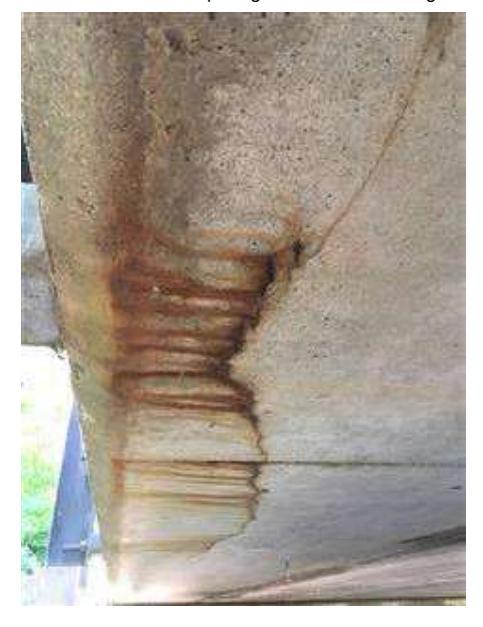
PHOTO 18

Description 6-7-2018 str 79-00115 - S facia beam crack along S side with rust staining looking W

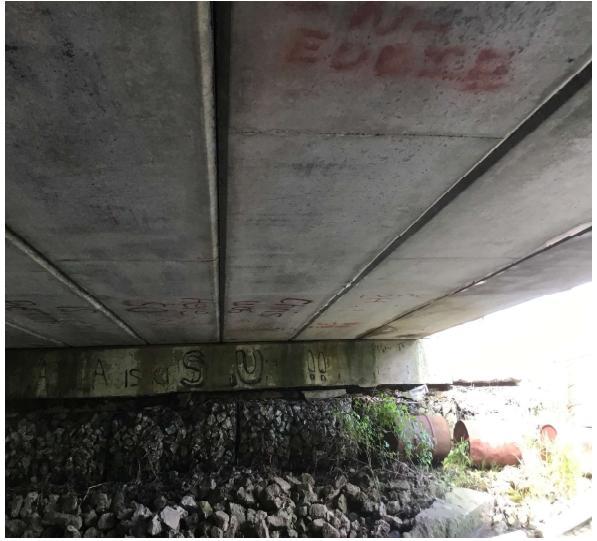
PHOTO 1 Description

6-1-2018 str 79-00115 - N half W abutment looking W

Work Code: Substructure Repair

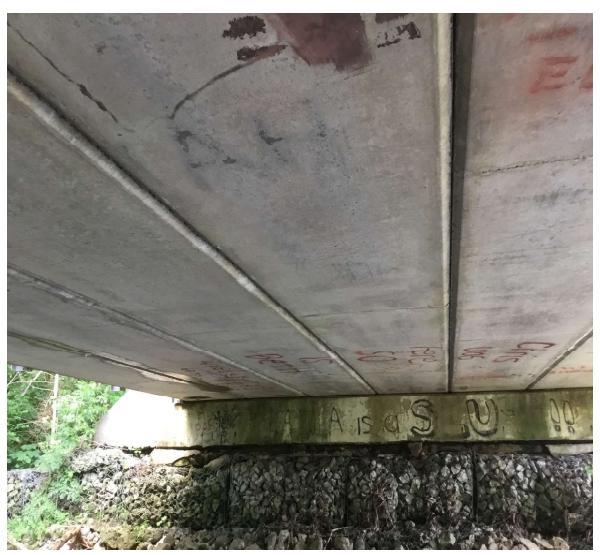
PHOTO 2 Description

6-1-2018 str 79-00115 - S half W abutment looking W

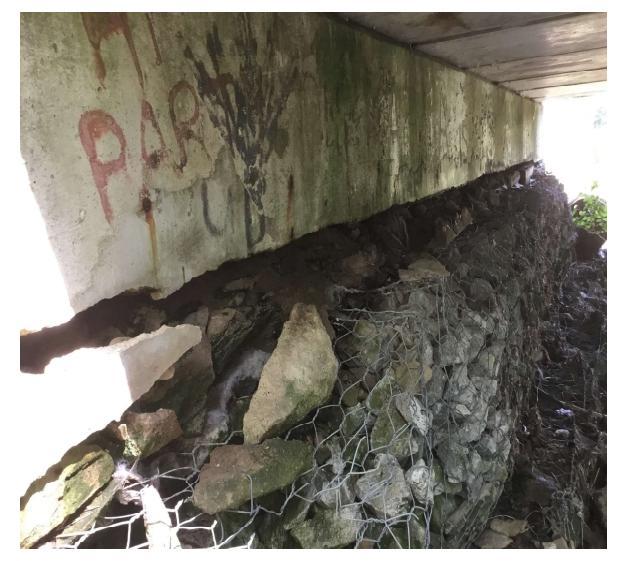
PHOTO 3 Description 6-1-2018 str 79-00115 - W abutment exposed piles looking N

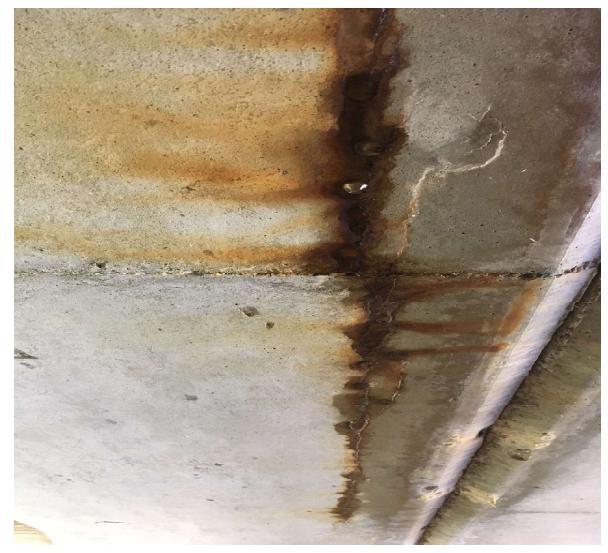
North facia beam is cracked with delamination. South facia beam is cracked with rust staining and spalled with broken & exposed strands.

PHOTO 1 Description

6-7-2018 str 79-00115 - S facia beam crack with rust staining looking W

Work Code: Superstructure Repair

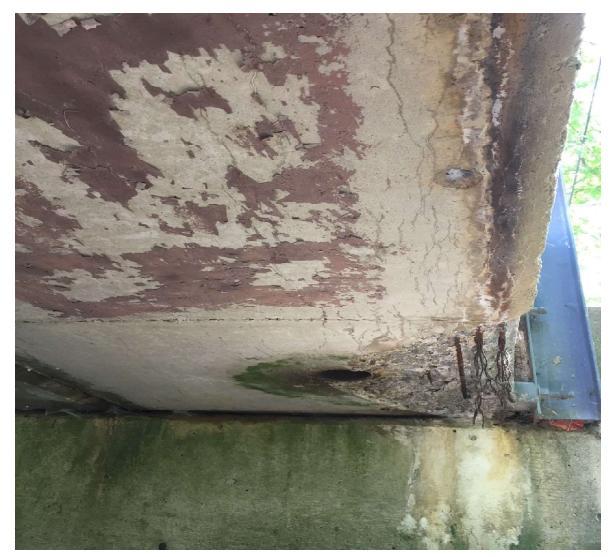
PHOTO 2 Description

6-7-2018 str 79-00115 - E end S facia beam looking E

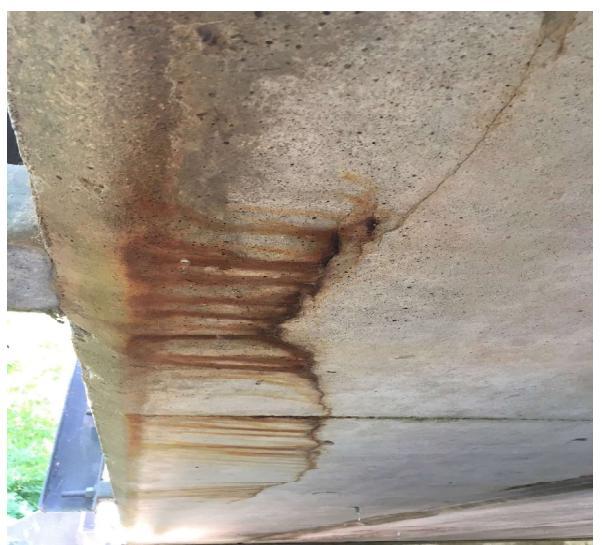
PHOTO 3 Description

6-7-2018 str 79-00115 - N facia beam cracking looking W

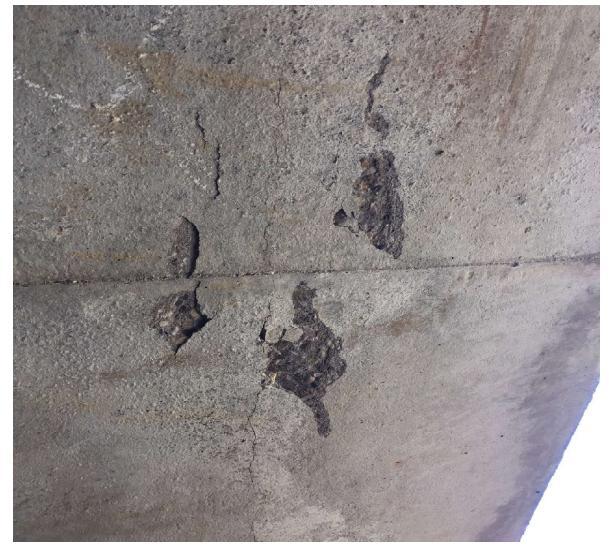
PHOTO 4 Description

6-7-2018 str 79-00115 - N facia beam spalling delamination looking W
